# **APPENDIX A**

# **ASSESSMENT PROTOCOL**

# **APPENDIX C**

# **SITE DESCRIPTIONS**

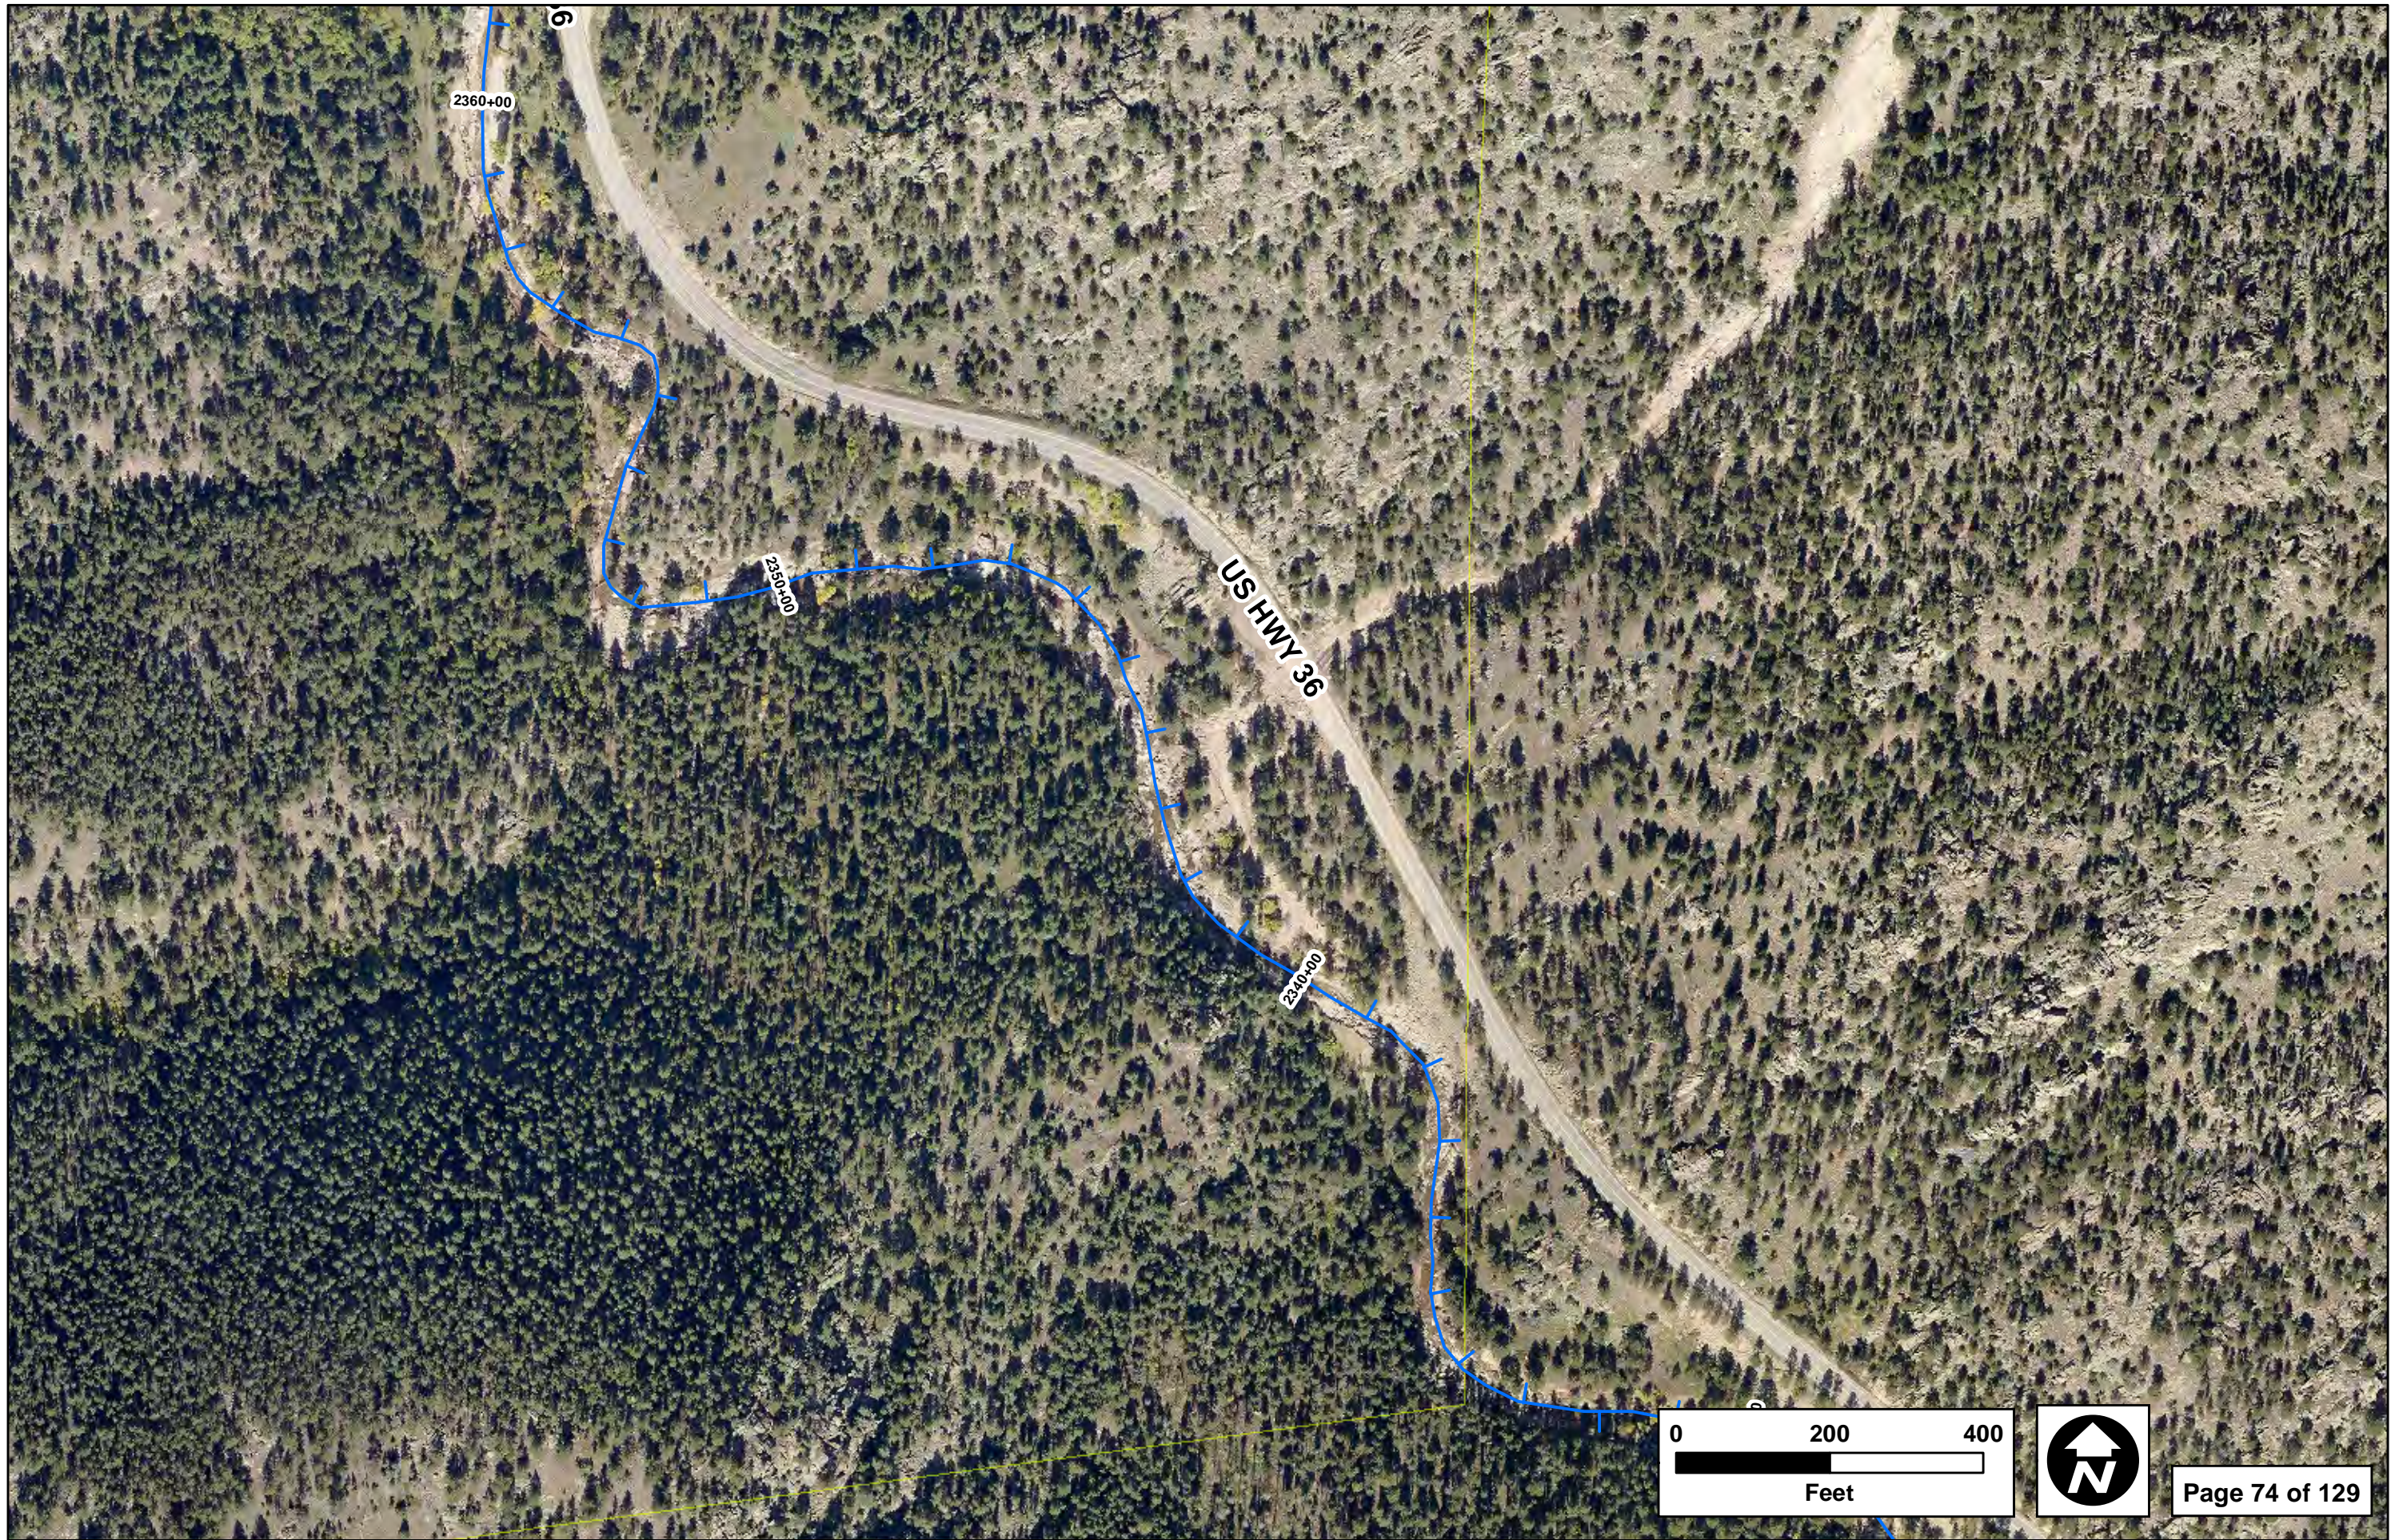
**NEIGHBORHOOD: Headwaters****SHEET: 75****STATION: 2361+00 to 2385+00**

This portion of the Little Thompson River runs parallel to U.S. Highway 36, approximately 200 to 400 feet south-southwest. The river traverses land owned privately. Aerial photos of pre-flood conditions and anecdotal information indicate this reach had a vegetated riparian corridor, typically less than 50 feet wide, comprised primarily of fir trees and willows, much of which were torn out during the flood. The river corridor is steep (in excess of 3 percent) narrow, and canyon bound, setting the sinuosity and river corridor alignment.

This reach sustained flood-related damage primarily due to large debris and boulders moving through the system and significant scour and loss of soils and vegetation. The most severe damage appeared to occur at culvert crossings or where the floodplain had been encroached by anthropogenic activities.

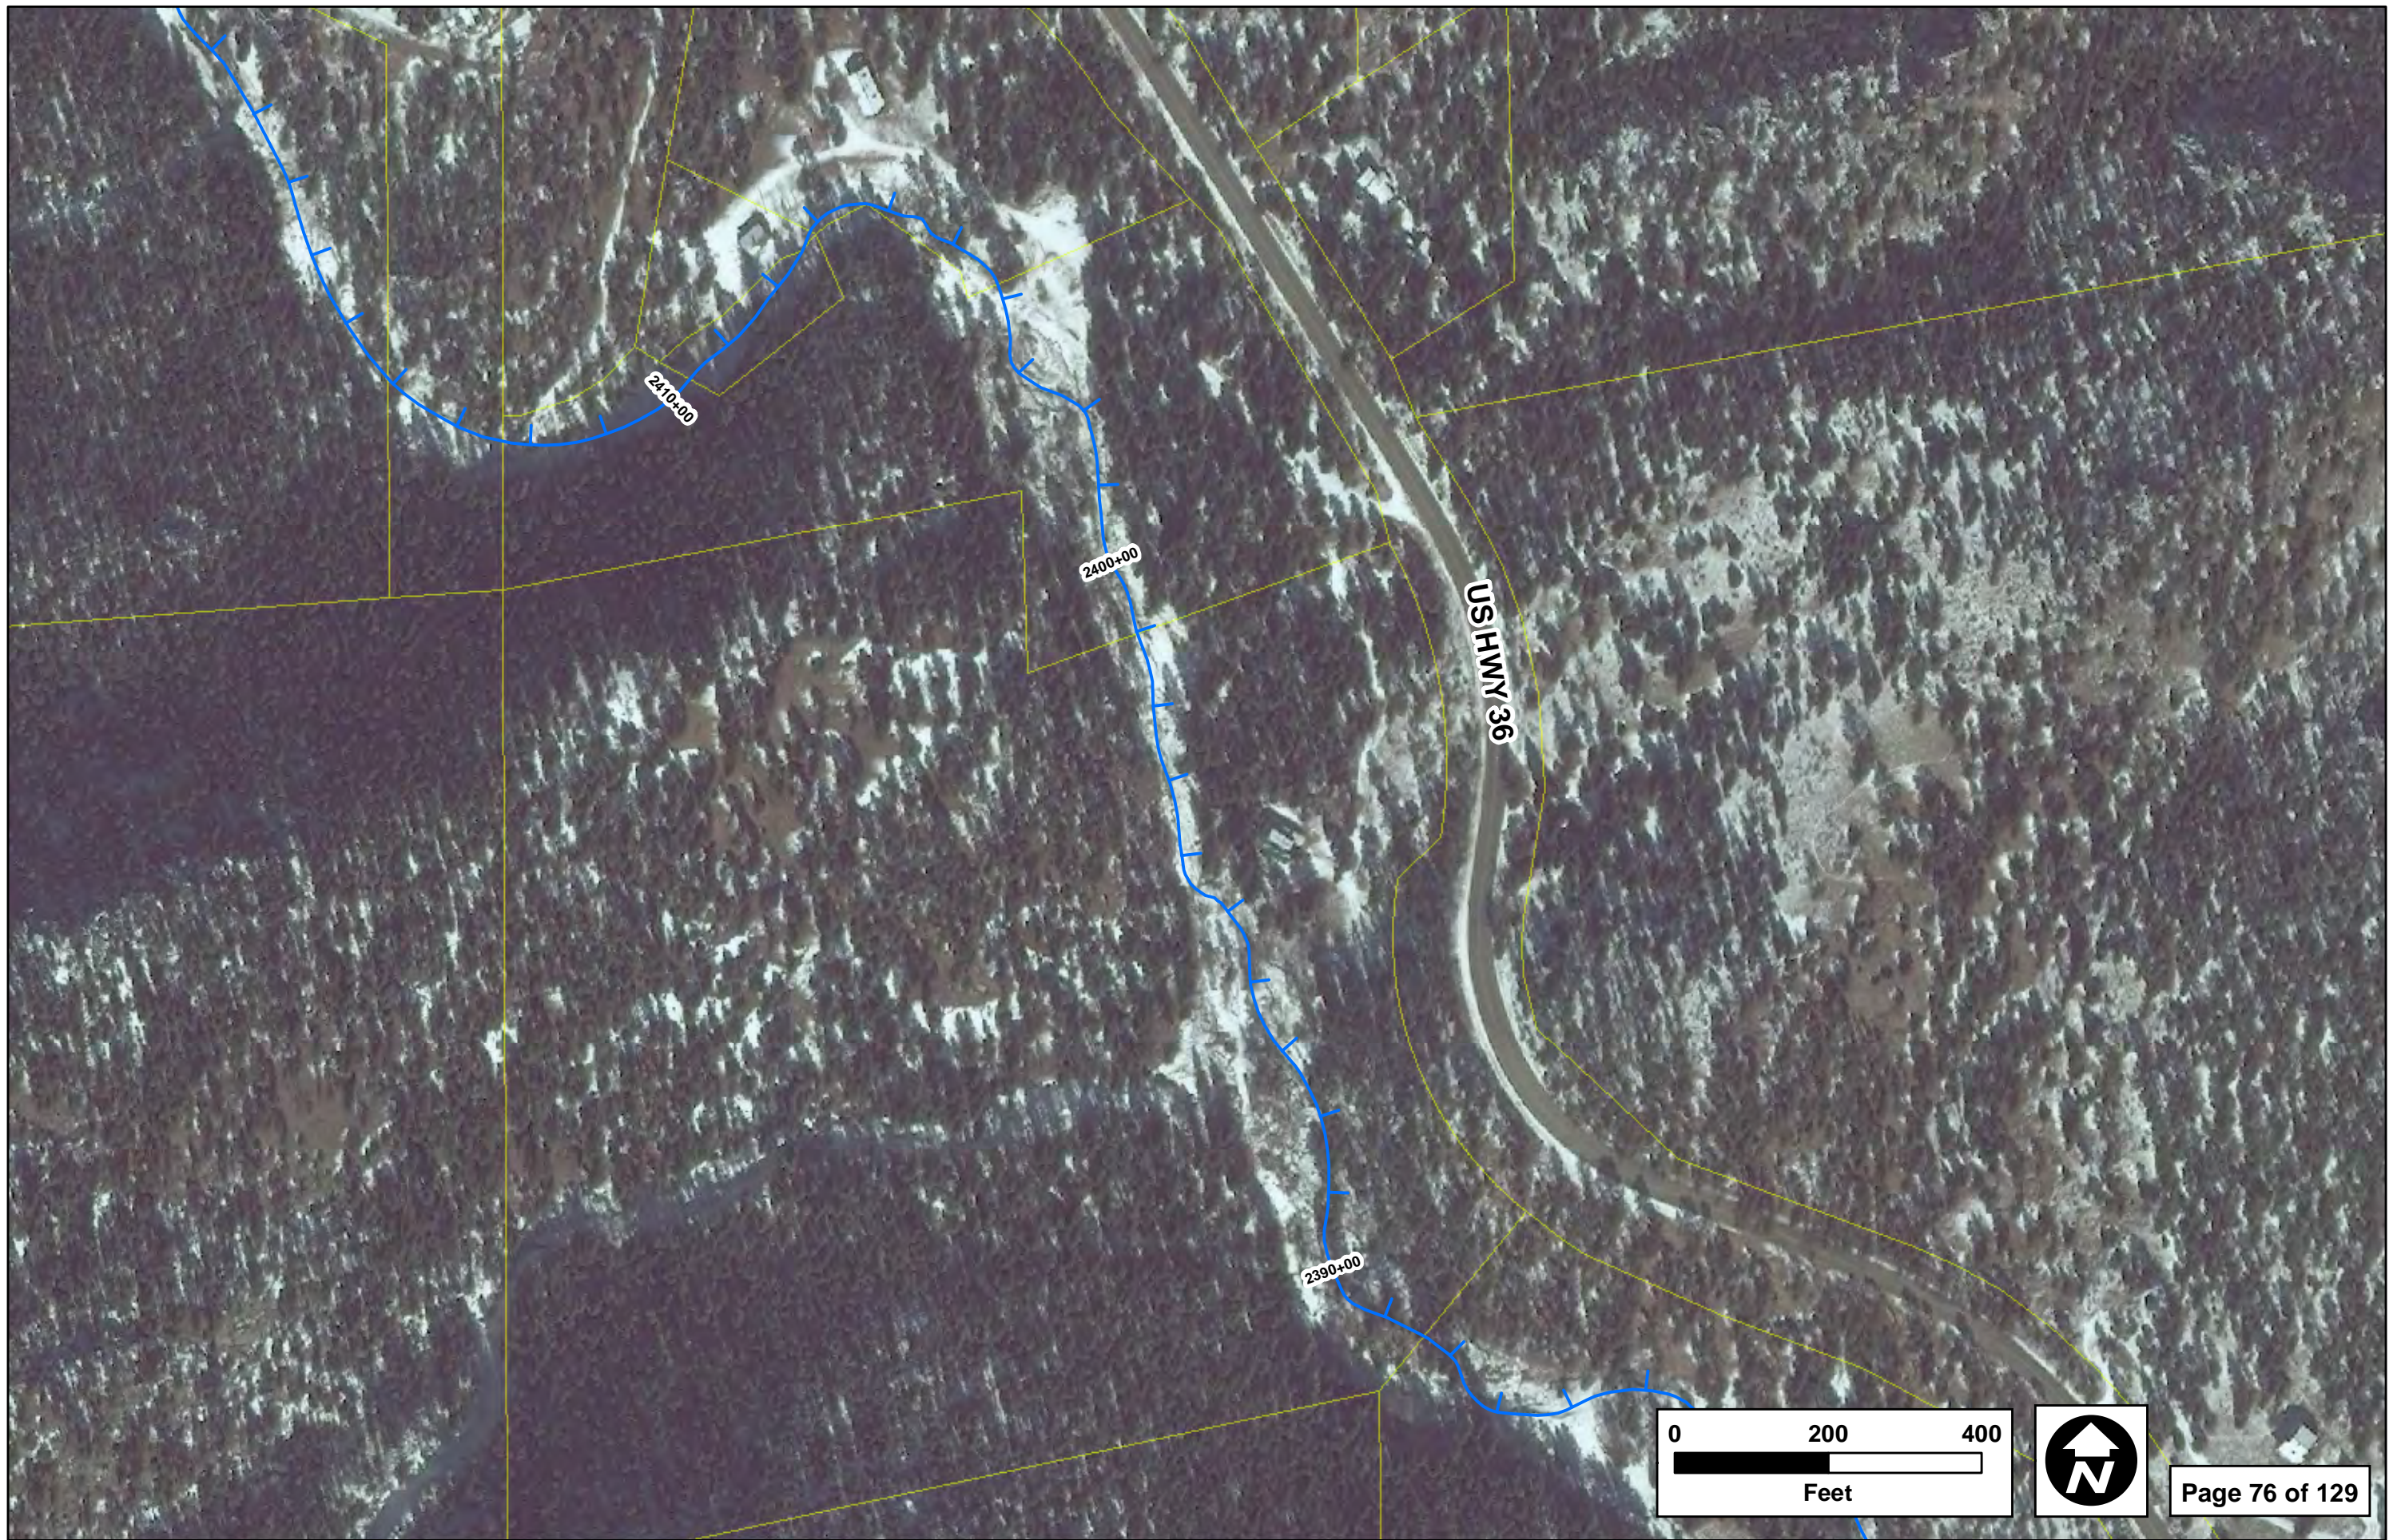
**NEIGHBORHOOD: Headwaters****SHEET: 77****STATION: 2419+00 to 2454+00**

This portion of the Little Thompson River runs parallel to U.S. Highway 36, approximately 200 to 400 feet south-southwest. The river traverses land owned privately and lands managed by the USFS. Aerial photos of pre-flood conditions and anecdotal information indicate this reach had a vegetated riparian corridor, typically less than 50 feet wide, comprised primarily of fir trees and willows, much of which were torn out during the flood. The river corridor is steep (in excess of 3 percent) narrow, and canyon-bound, setting the sinuosity and river corridor alignment.

This reach sustained flood-related damage primarily due to large debris and boulders moving through the system and significant scour and loss of soils and vegetation. The most severe damage appeared to occur at culvert crossings or where the floodplain had been encroached by anthropogenic activities.

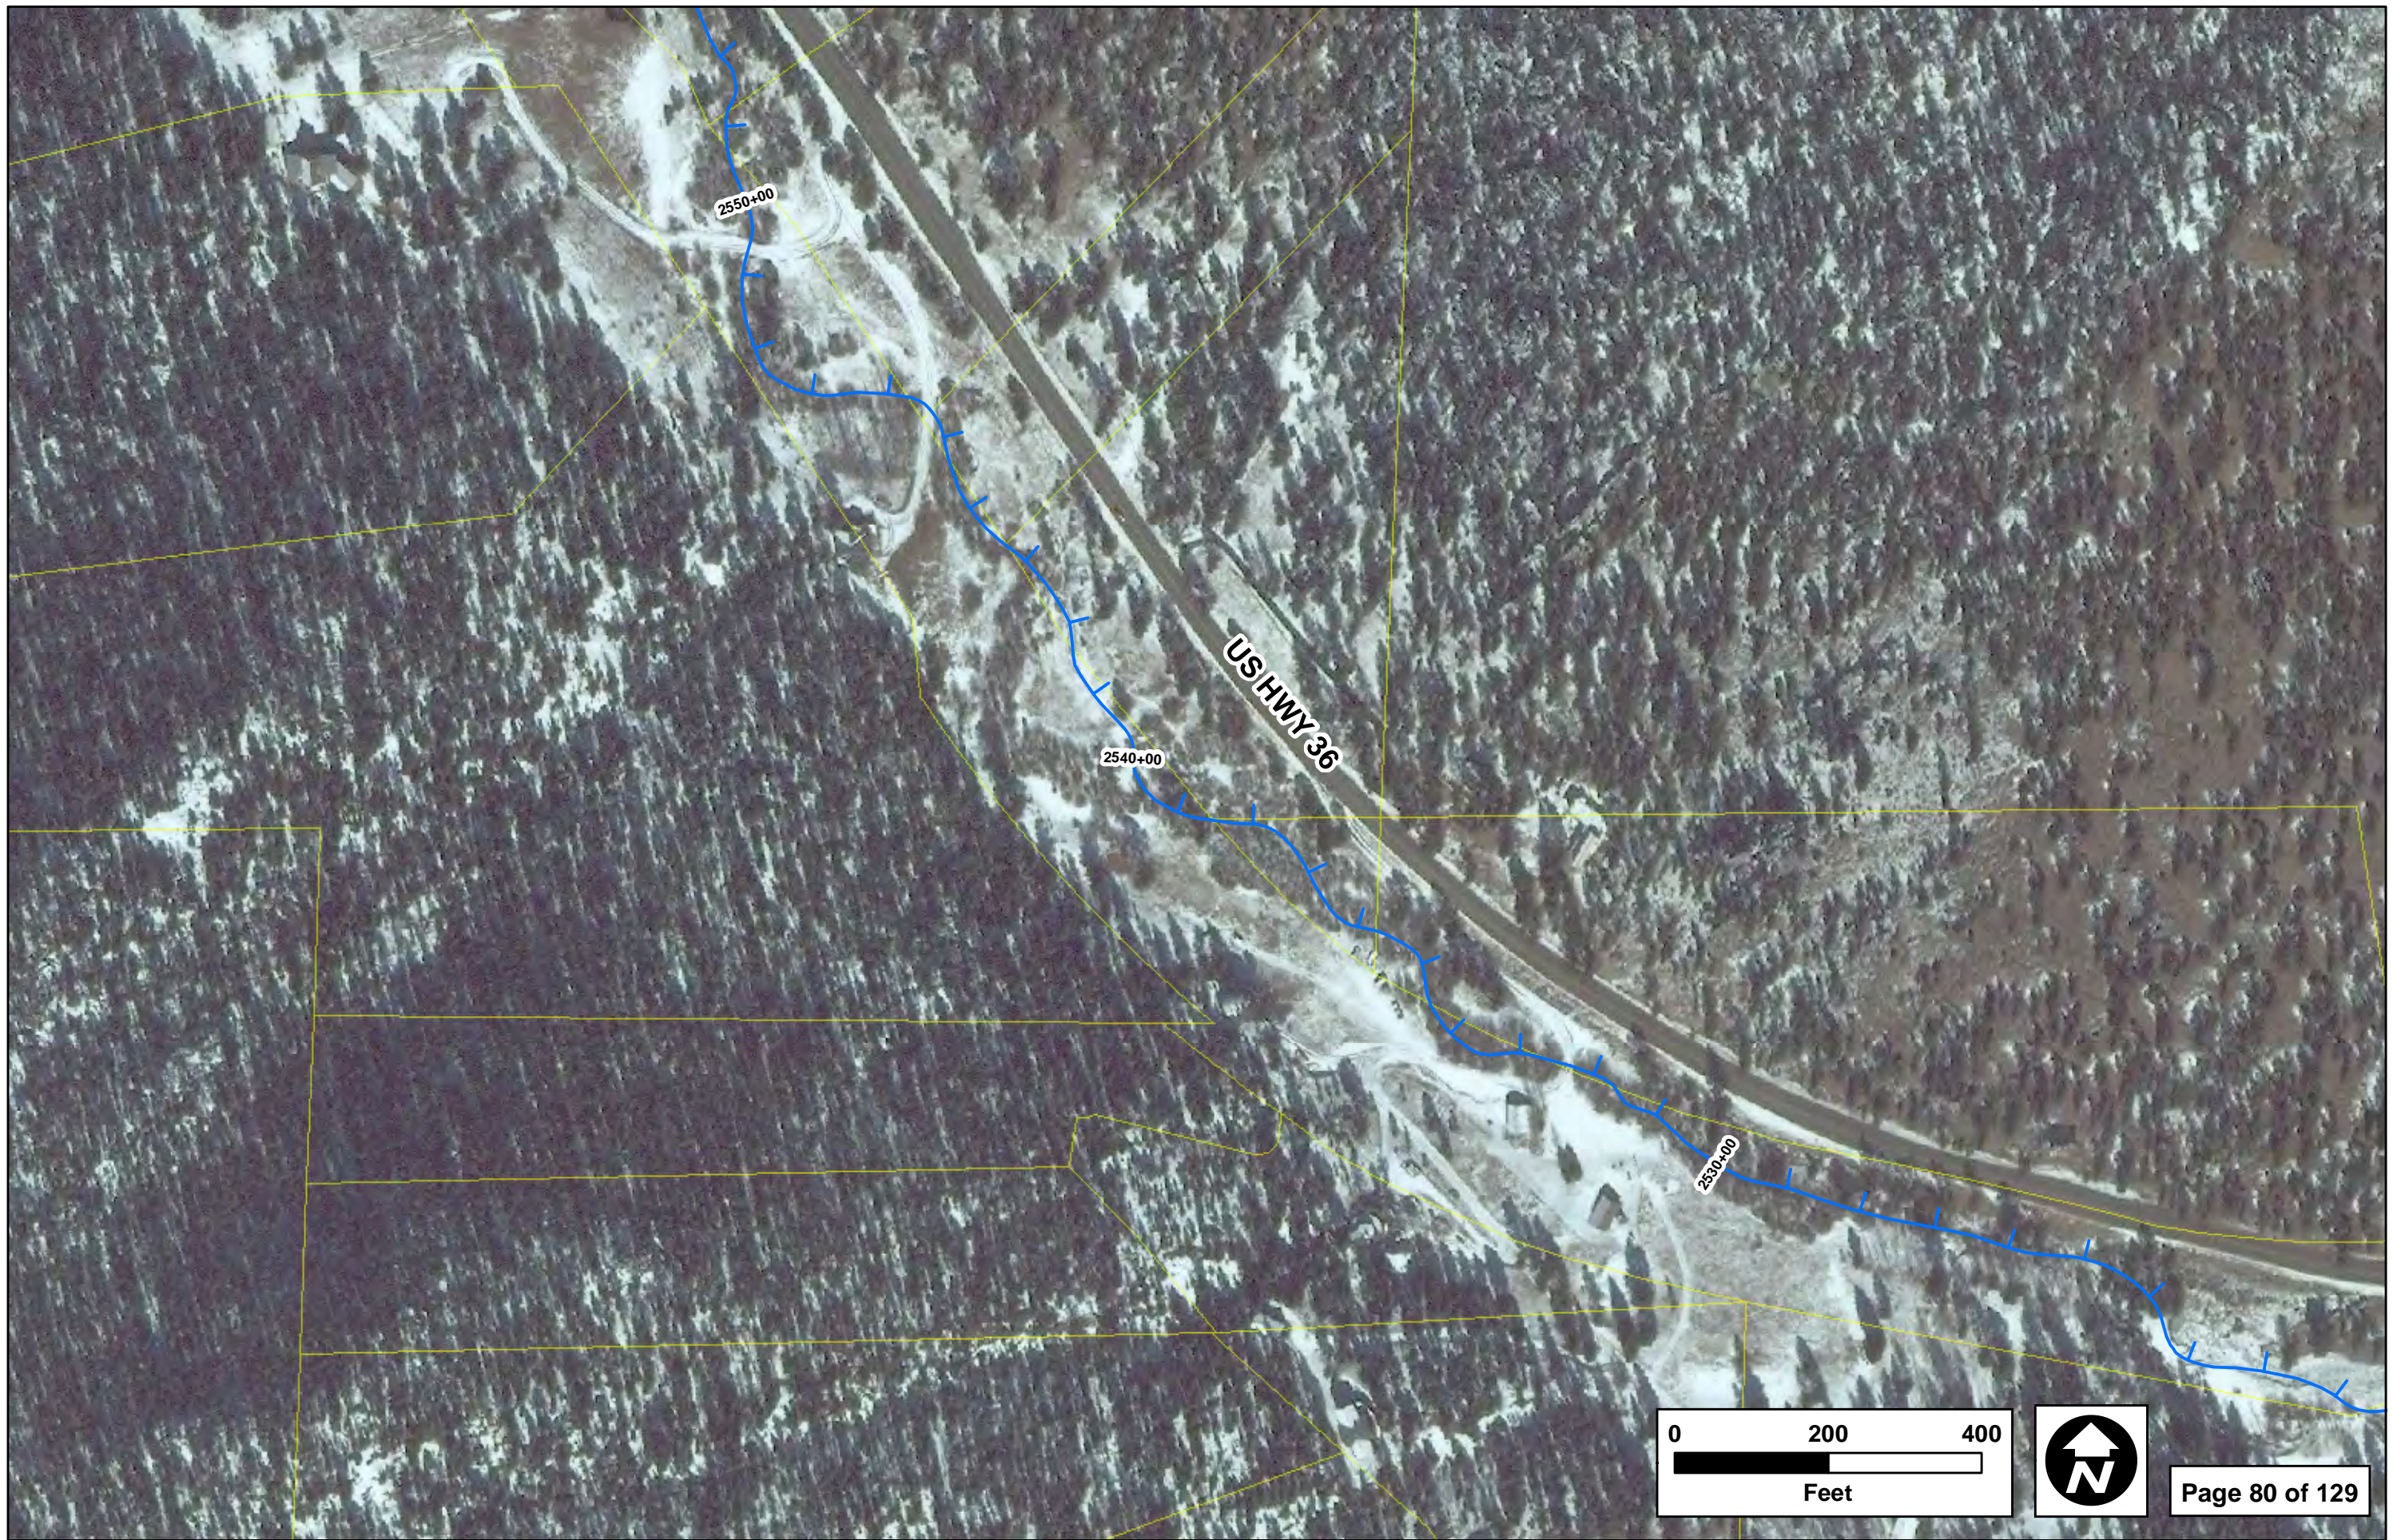
**NEIGHBORHOOD: Headwaters****SHEET: 81****STATION: 2552+00 to 2574+00**

This is the headwaters of the Little Thompson. The river runs adjacent to U.S. Highway 36, approximately 50 to 400 feet south-southwest. The river traverses privately owned land. The river corridor is wider than the downstream sections, with less canyon and rock formations controlling the vertical and horizontal alignments. The average channel slope through this reach is 2 percent.

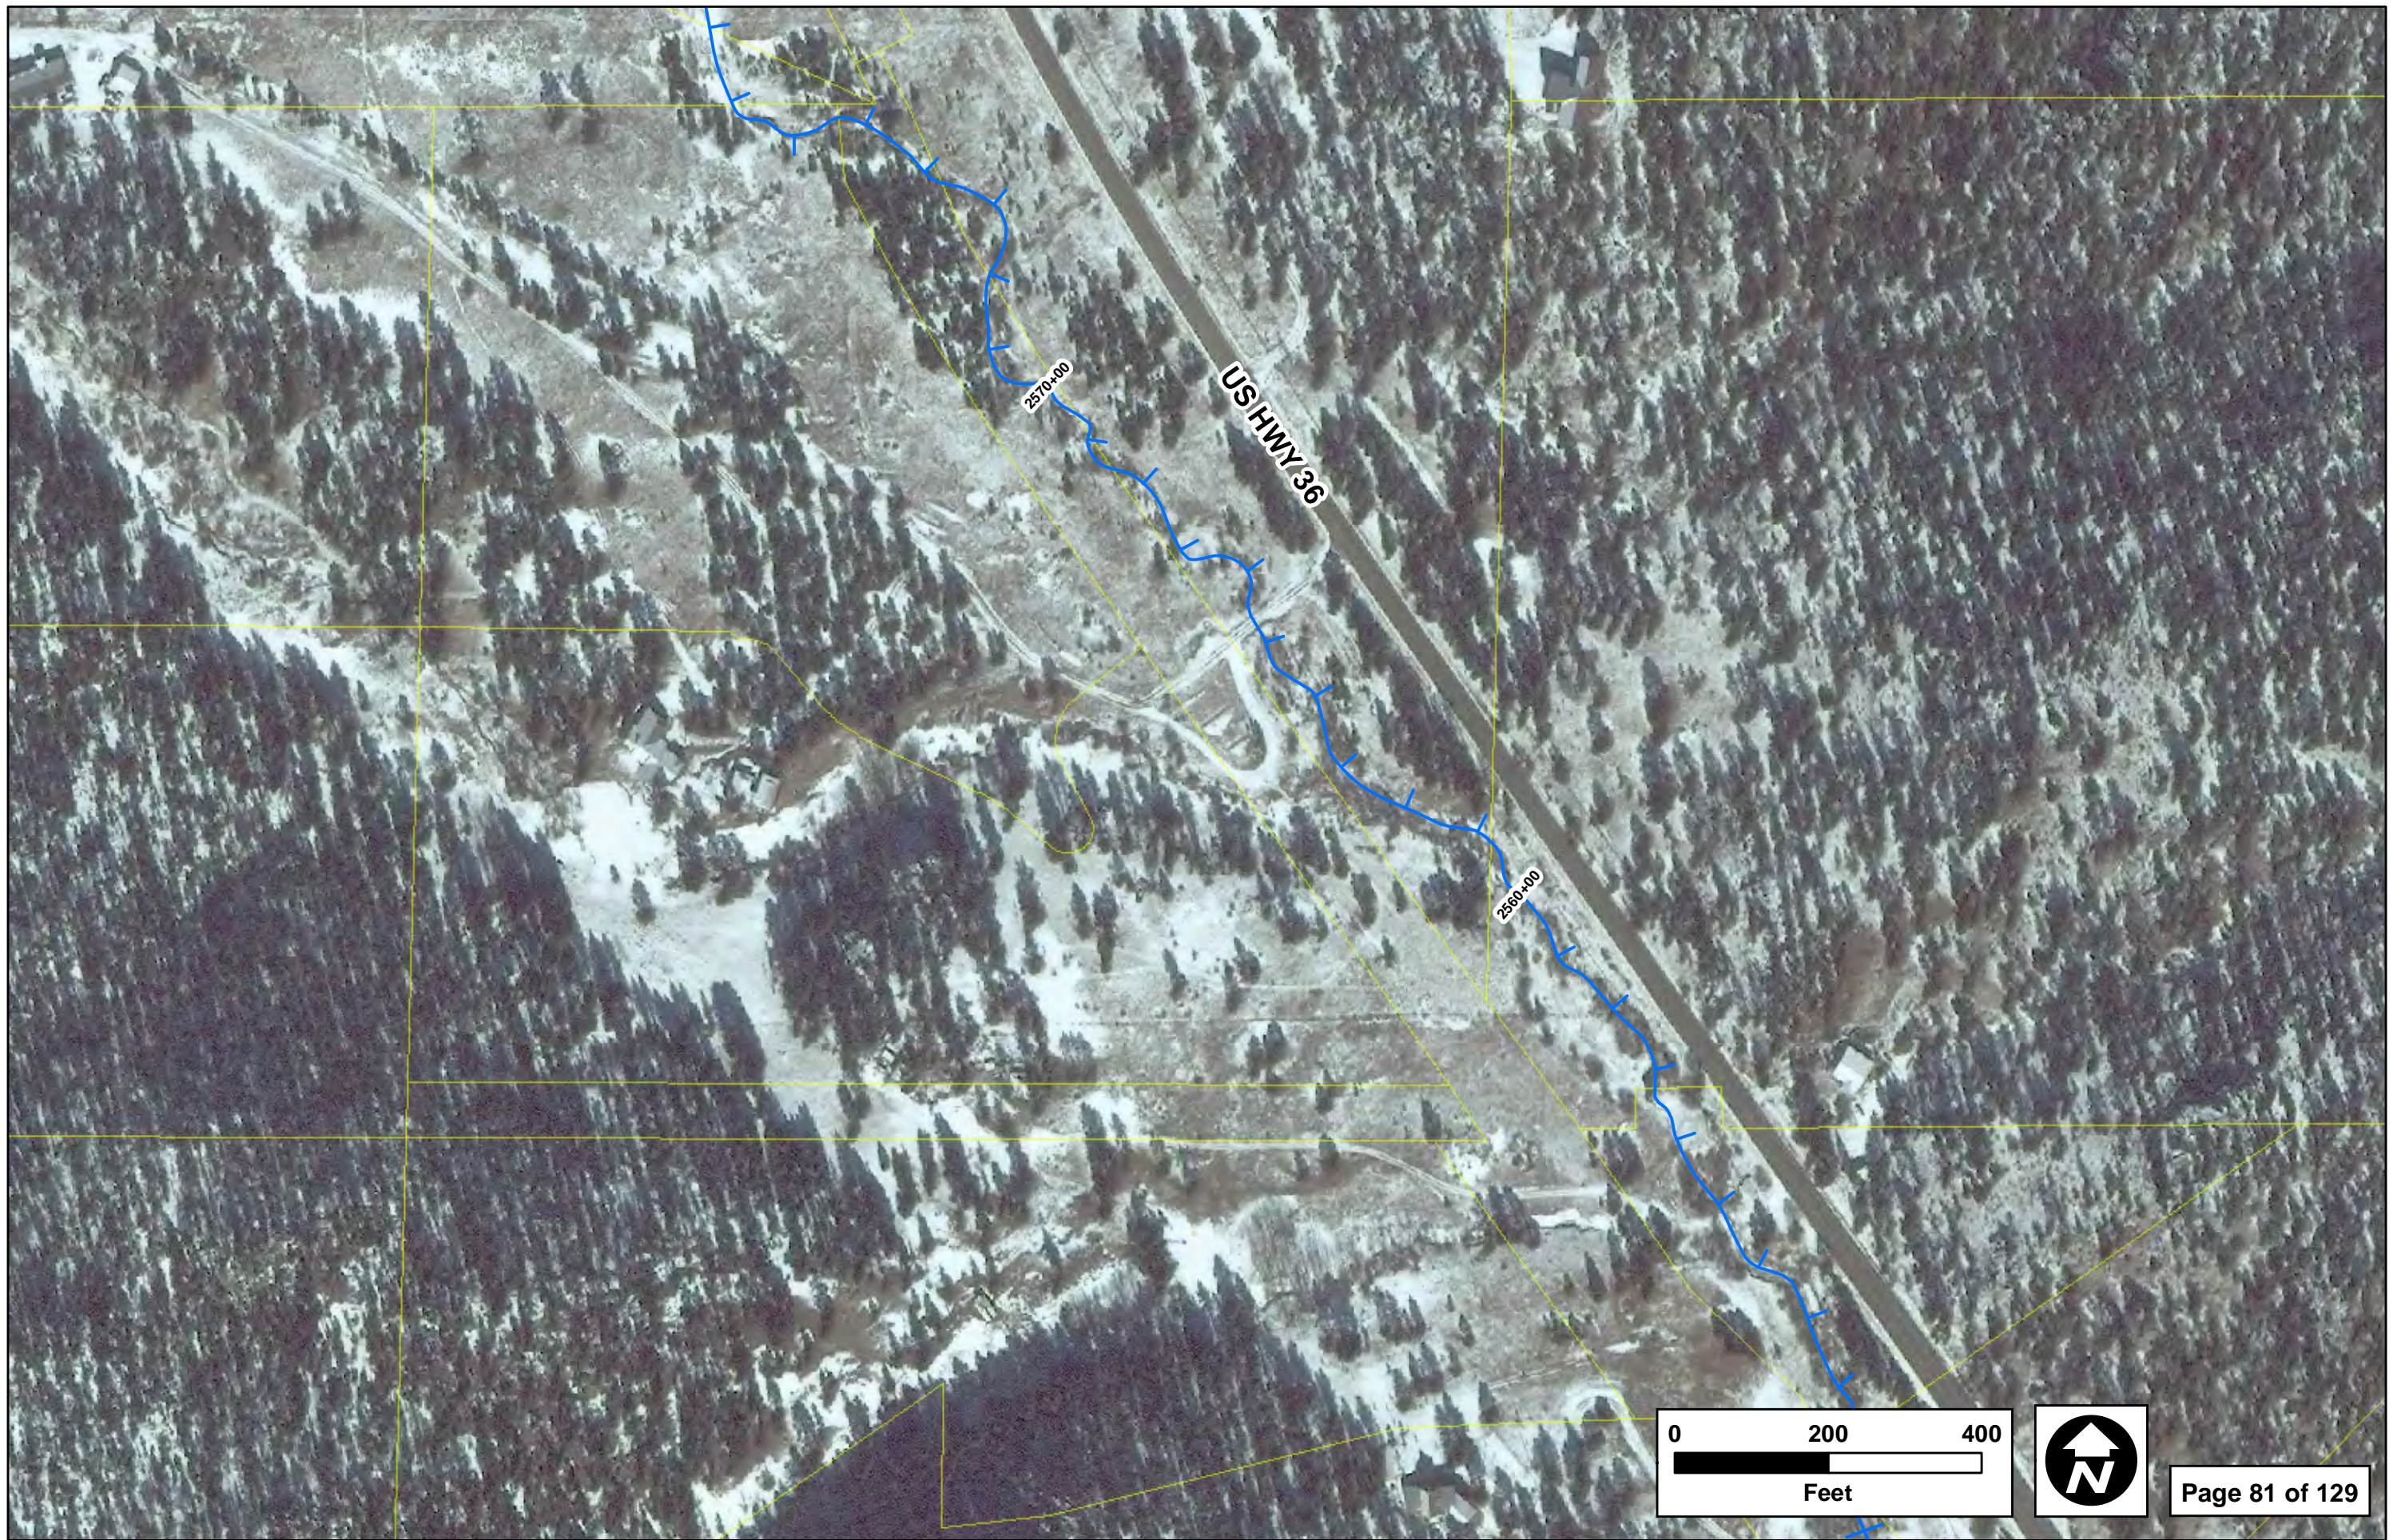
**NEIGHBORHOOD: Headwaters****SHEET: 82****STATION: 2574+00 to 2597+00**

This is the headwaters of the Little Thompson River. The river runs adjacent to U.S. Highway 36, approximately 200 to 400 feet south-southwest. The river traverses privately owned land. The river corridor is wider than the downstream sections, with less canyon and rock formations controlling the vertical and horizontal alignments. The average channel slope through this reach is 2 percent.

Aerial photos of pre-flood conditions and anecdotal information indicate this reach had a sparsely vegetated riparian corridor, typically less than 50 feet wide, comprised primarily of willows, much of which remains post-flood. This reach sustained very little flood-related damage typically related to culvert crossings and at private residences.

Geomorphic functions of this reach is likely sufficient to allow for the natural regeneration of cottonwood, willow, and other riparian species through seeding and cloning without active restoration. No further actions are suggested at this time.

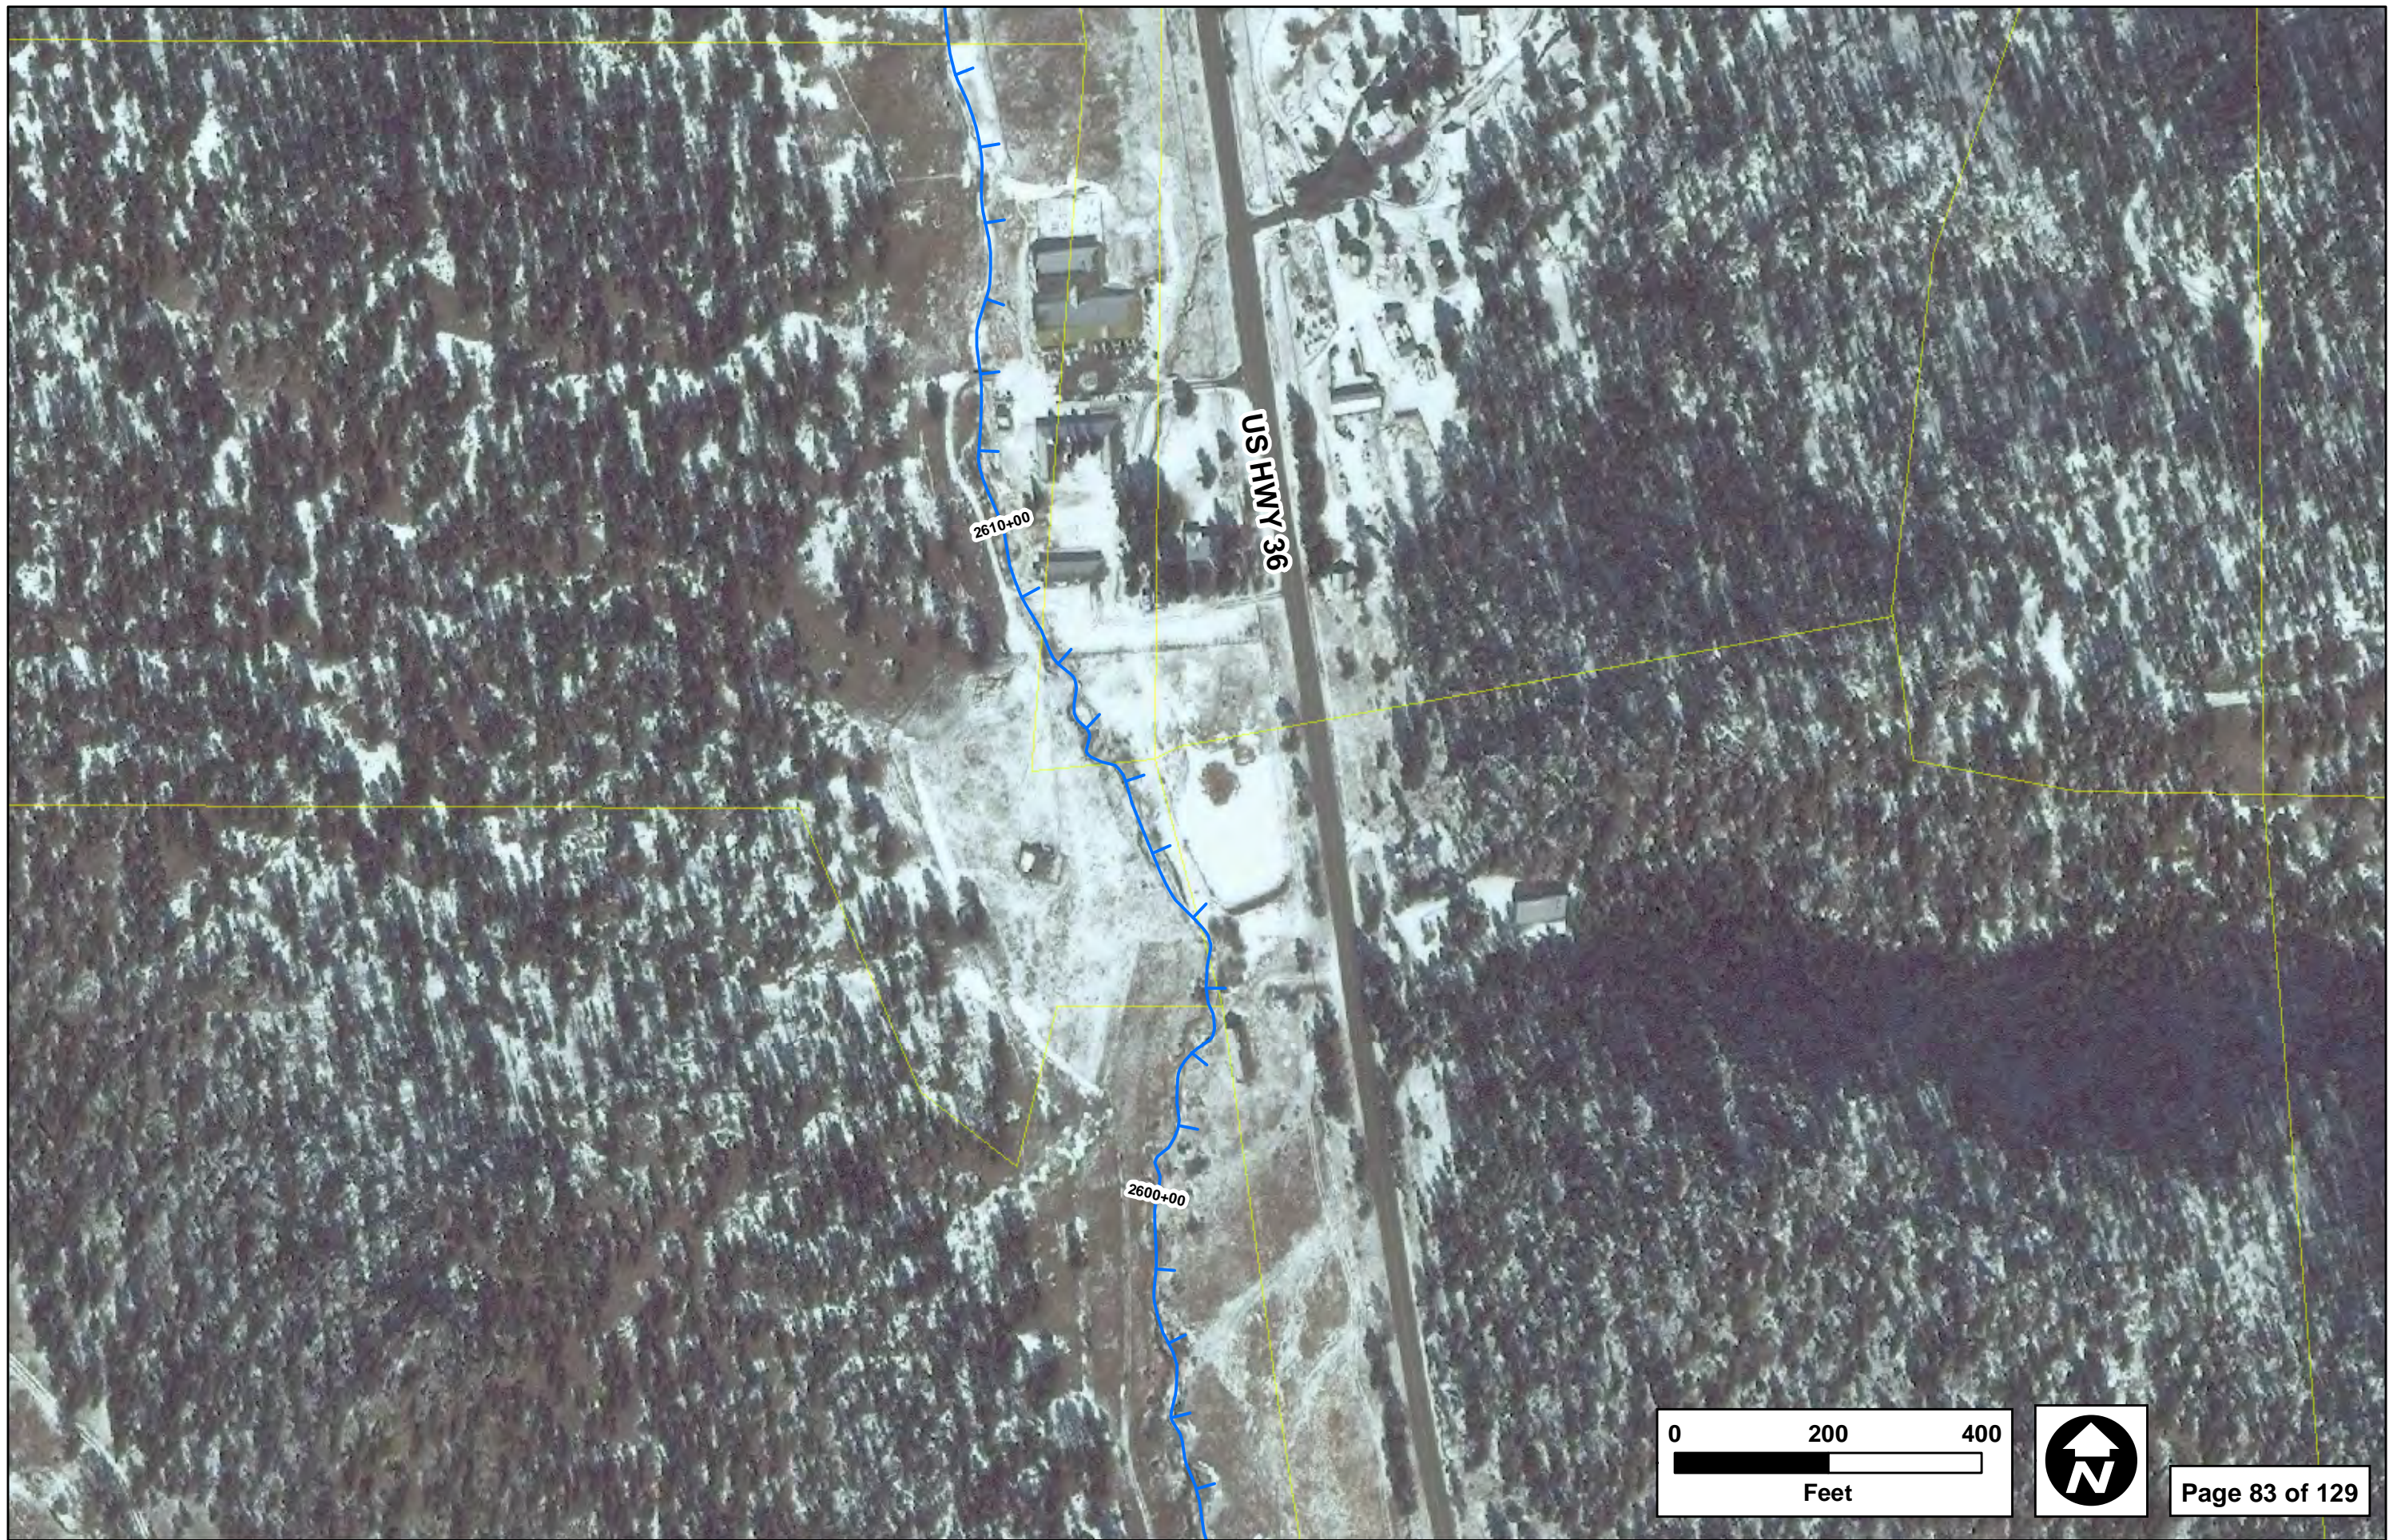
**NEIGHBORHOOD: Headwaters****SHEET: 84****STATION: 2617+00 to 2643+00**

This is the headwaters of the Little Thompson River. The river runs adjacent to U.S. Highway 36, approximately 200 to 400 feet south-southwest. The river traverses privately owned land. The river corridor is wider than the downstream sections, with less canyon and rock formations controlling the vertical and horizontal alignments. The average channel slope through this reach is 3.1 percent.

Aerial photos of pre-flood conditions and anecdotal information indicate this reach had a sparsely vegetated riparian corridor, typically less than 50 feet wide, comprised primarily of willows, much of which remains post-flood. This reach sustained very little flood-related damage.

Geomorphic functions of this reach is likely sufficient to allow for the natural regeneration of cottonwood, willow, and other riparian species through seeding and cloning without active restoration. No further actions are suggested at this time.
