# **APPENDIX A**

# **ASSESSMENT PROTOCOL**

# **APPENDIX C**

# **SITE DESCRIPTIONS**

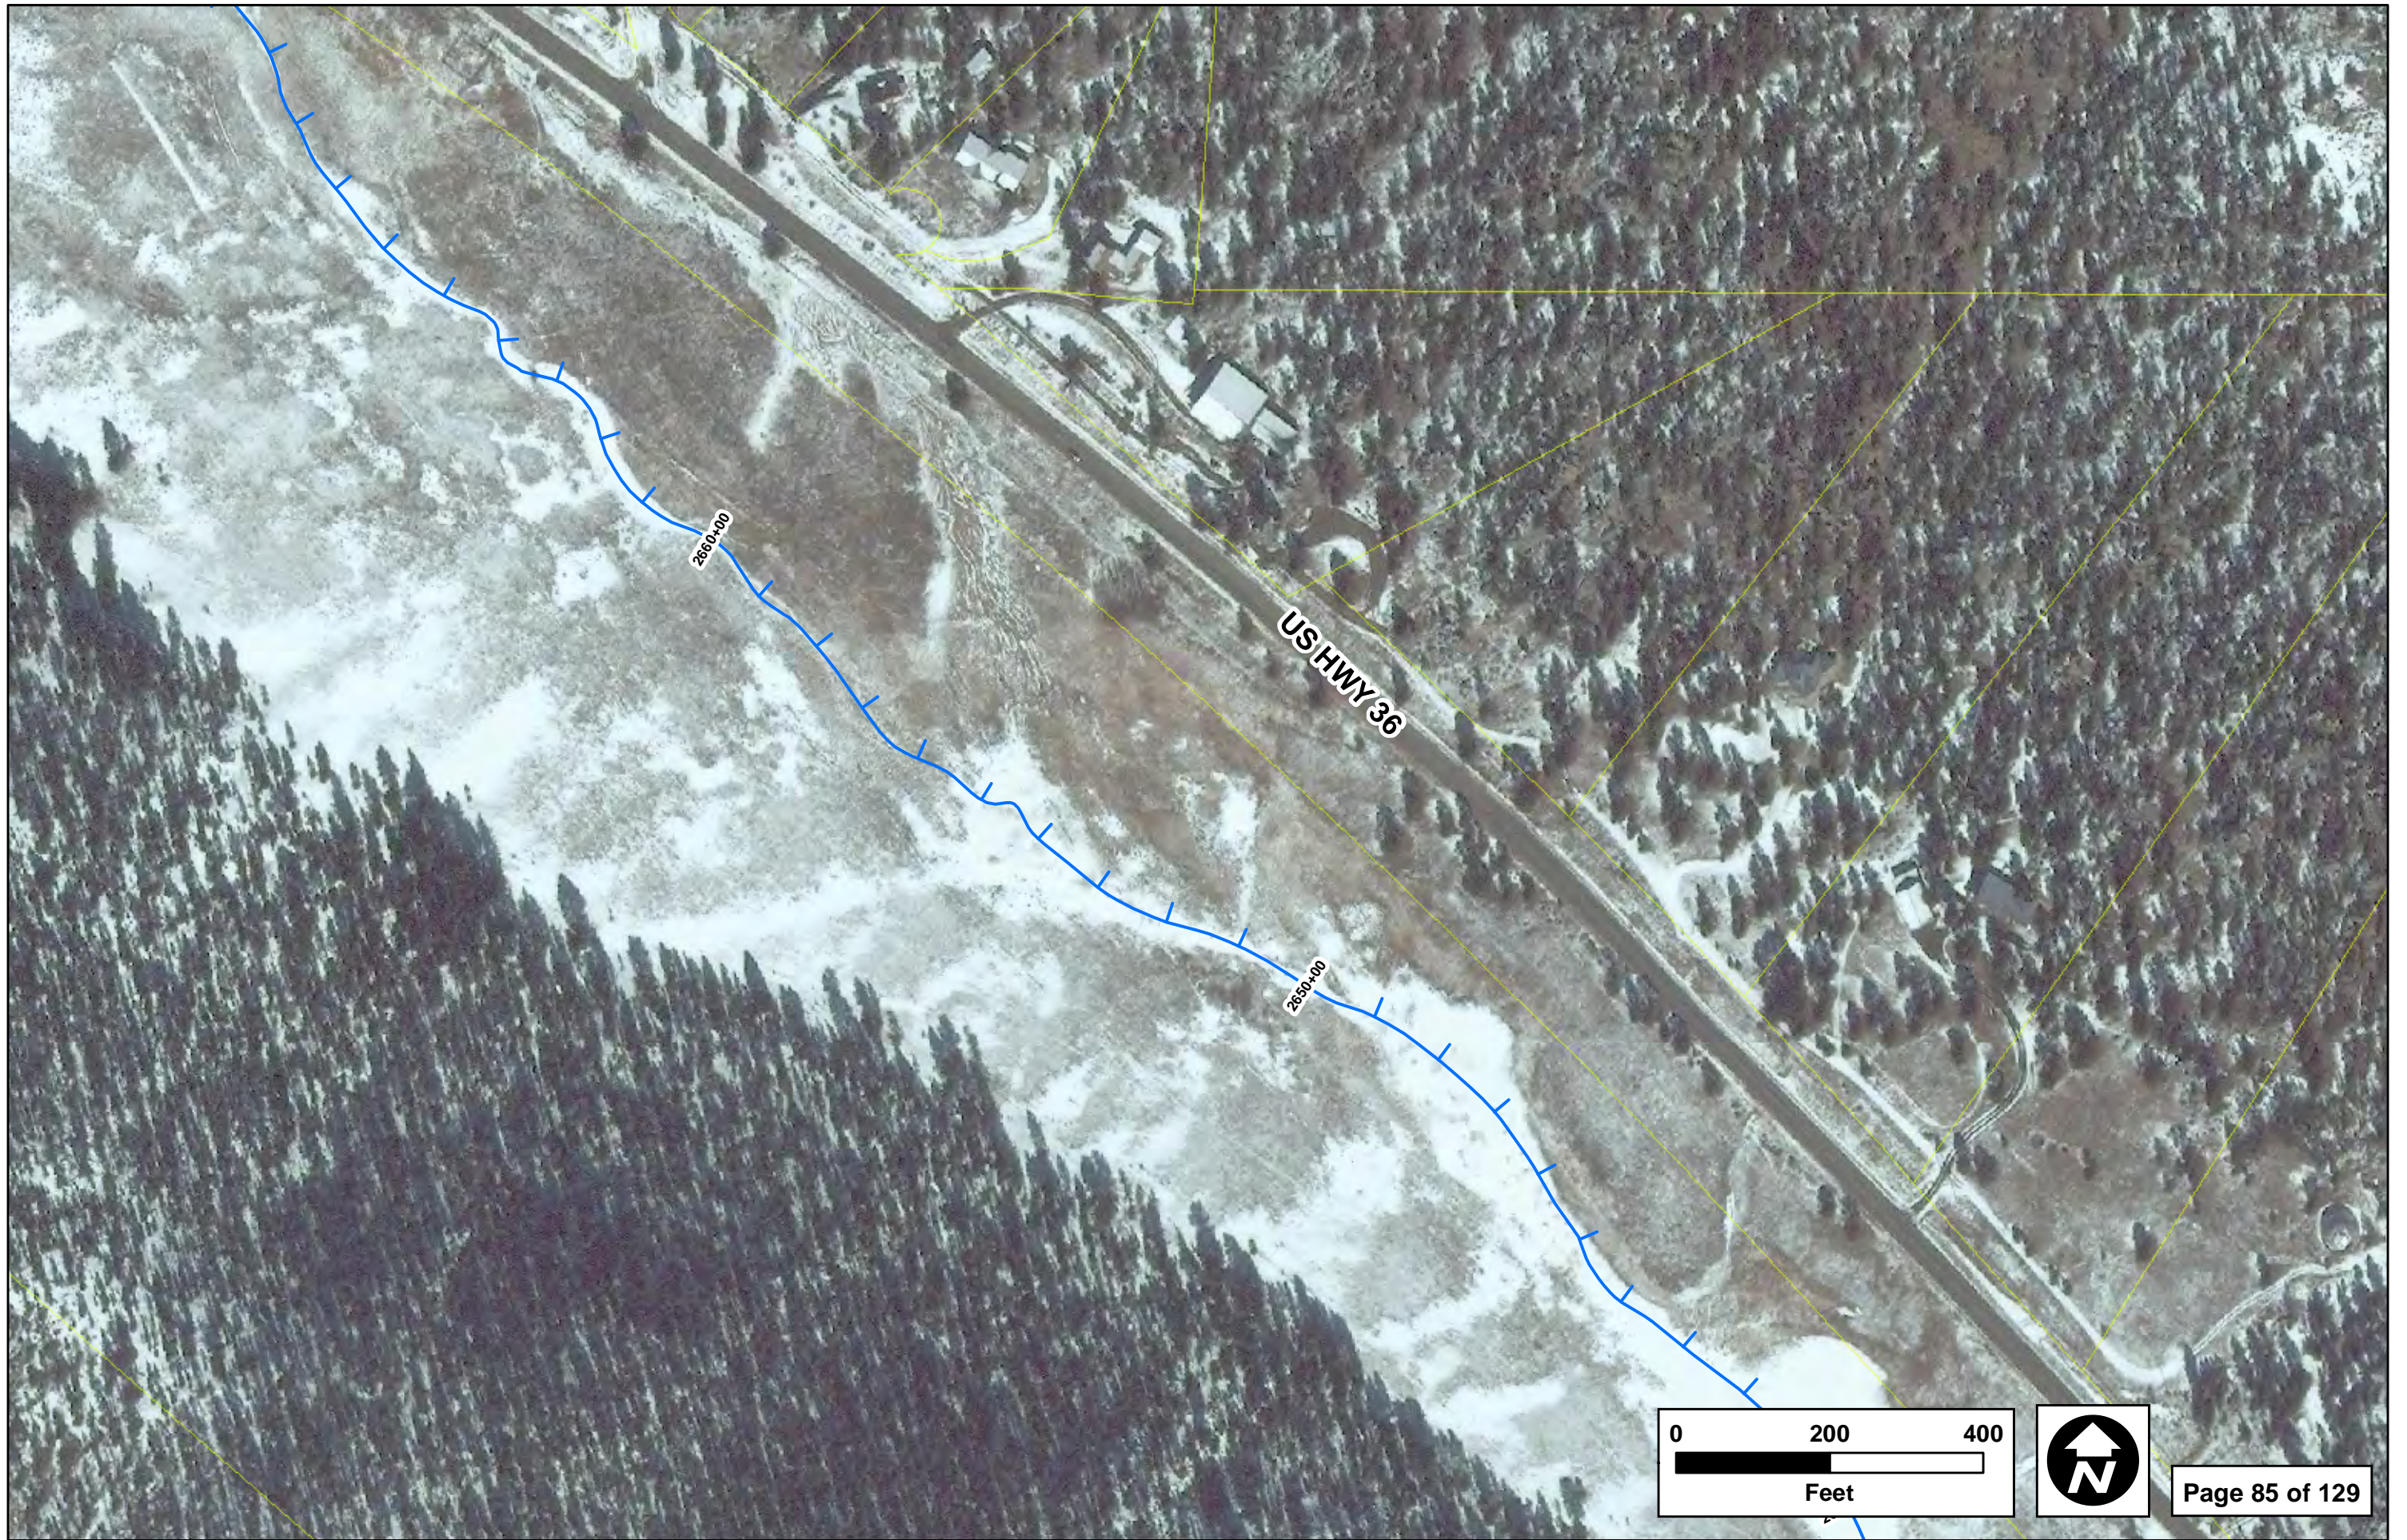
**NEIGHBORHOOD: Headwaters****SHEET: 86****STATION: 2669+00 to 2698+00**

This is the headwaters of the Little Thompson River. The river runs adjacent to U.S. Highway 36, approximately 200 feet south-southwest. The river traverses privately owned land. The river corridor is wider than the downstream sections, with less canyon and rock formations controlling the vertical and horizontal alignments. The average channel slope through this reach is 3.1 percent.

Aerial photos of pre-flood conditions and anecdotal information indicate this reach had a sparsely vegetated riparian corridor, comprised primarily of grasses, much of which remains post-flood. This reach sustained very little flood-related damage.

Geomorphic functions of this reach is likely sufficient to allow for the natural regeneration of cottonwood, willow, and other riparian species through seeding and cloning without active restoration. No further actions are suggested at this time.

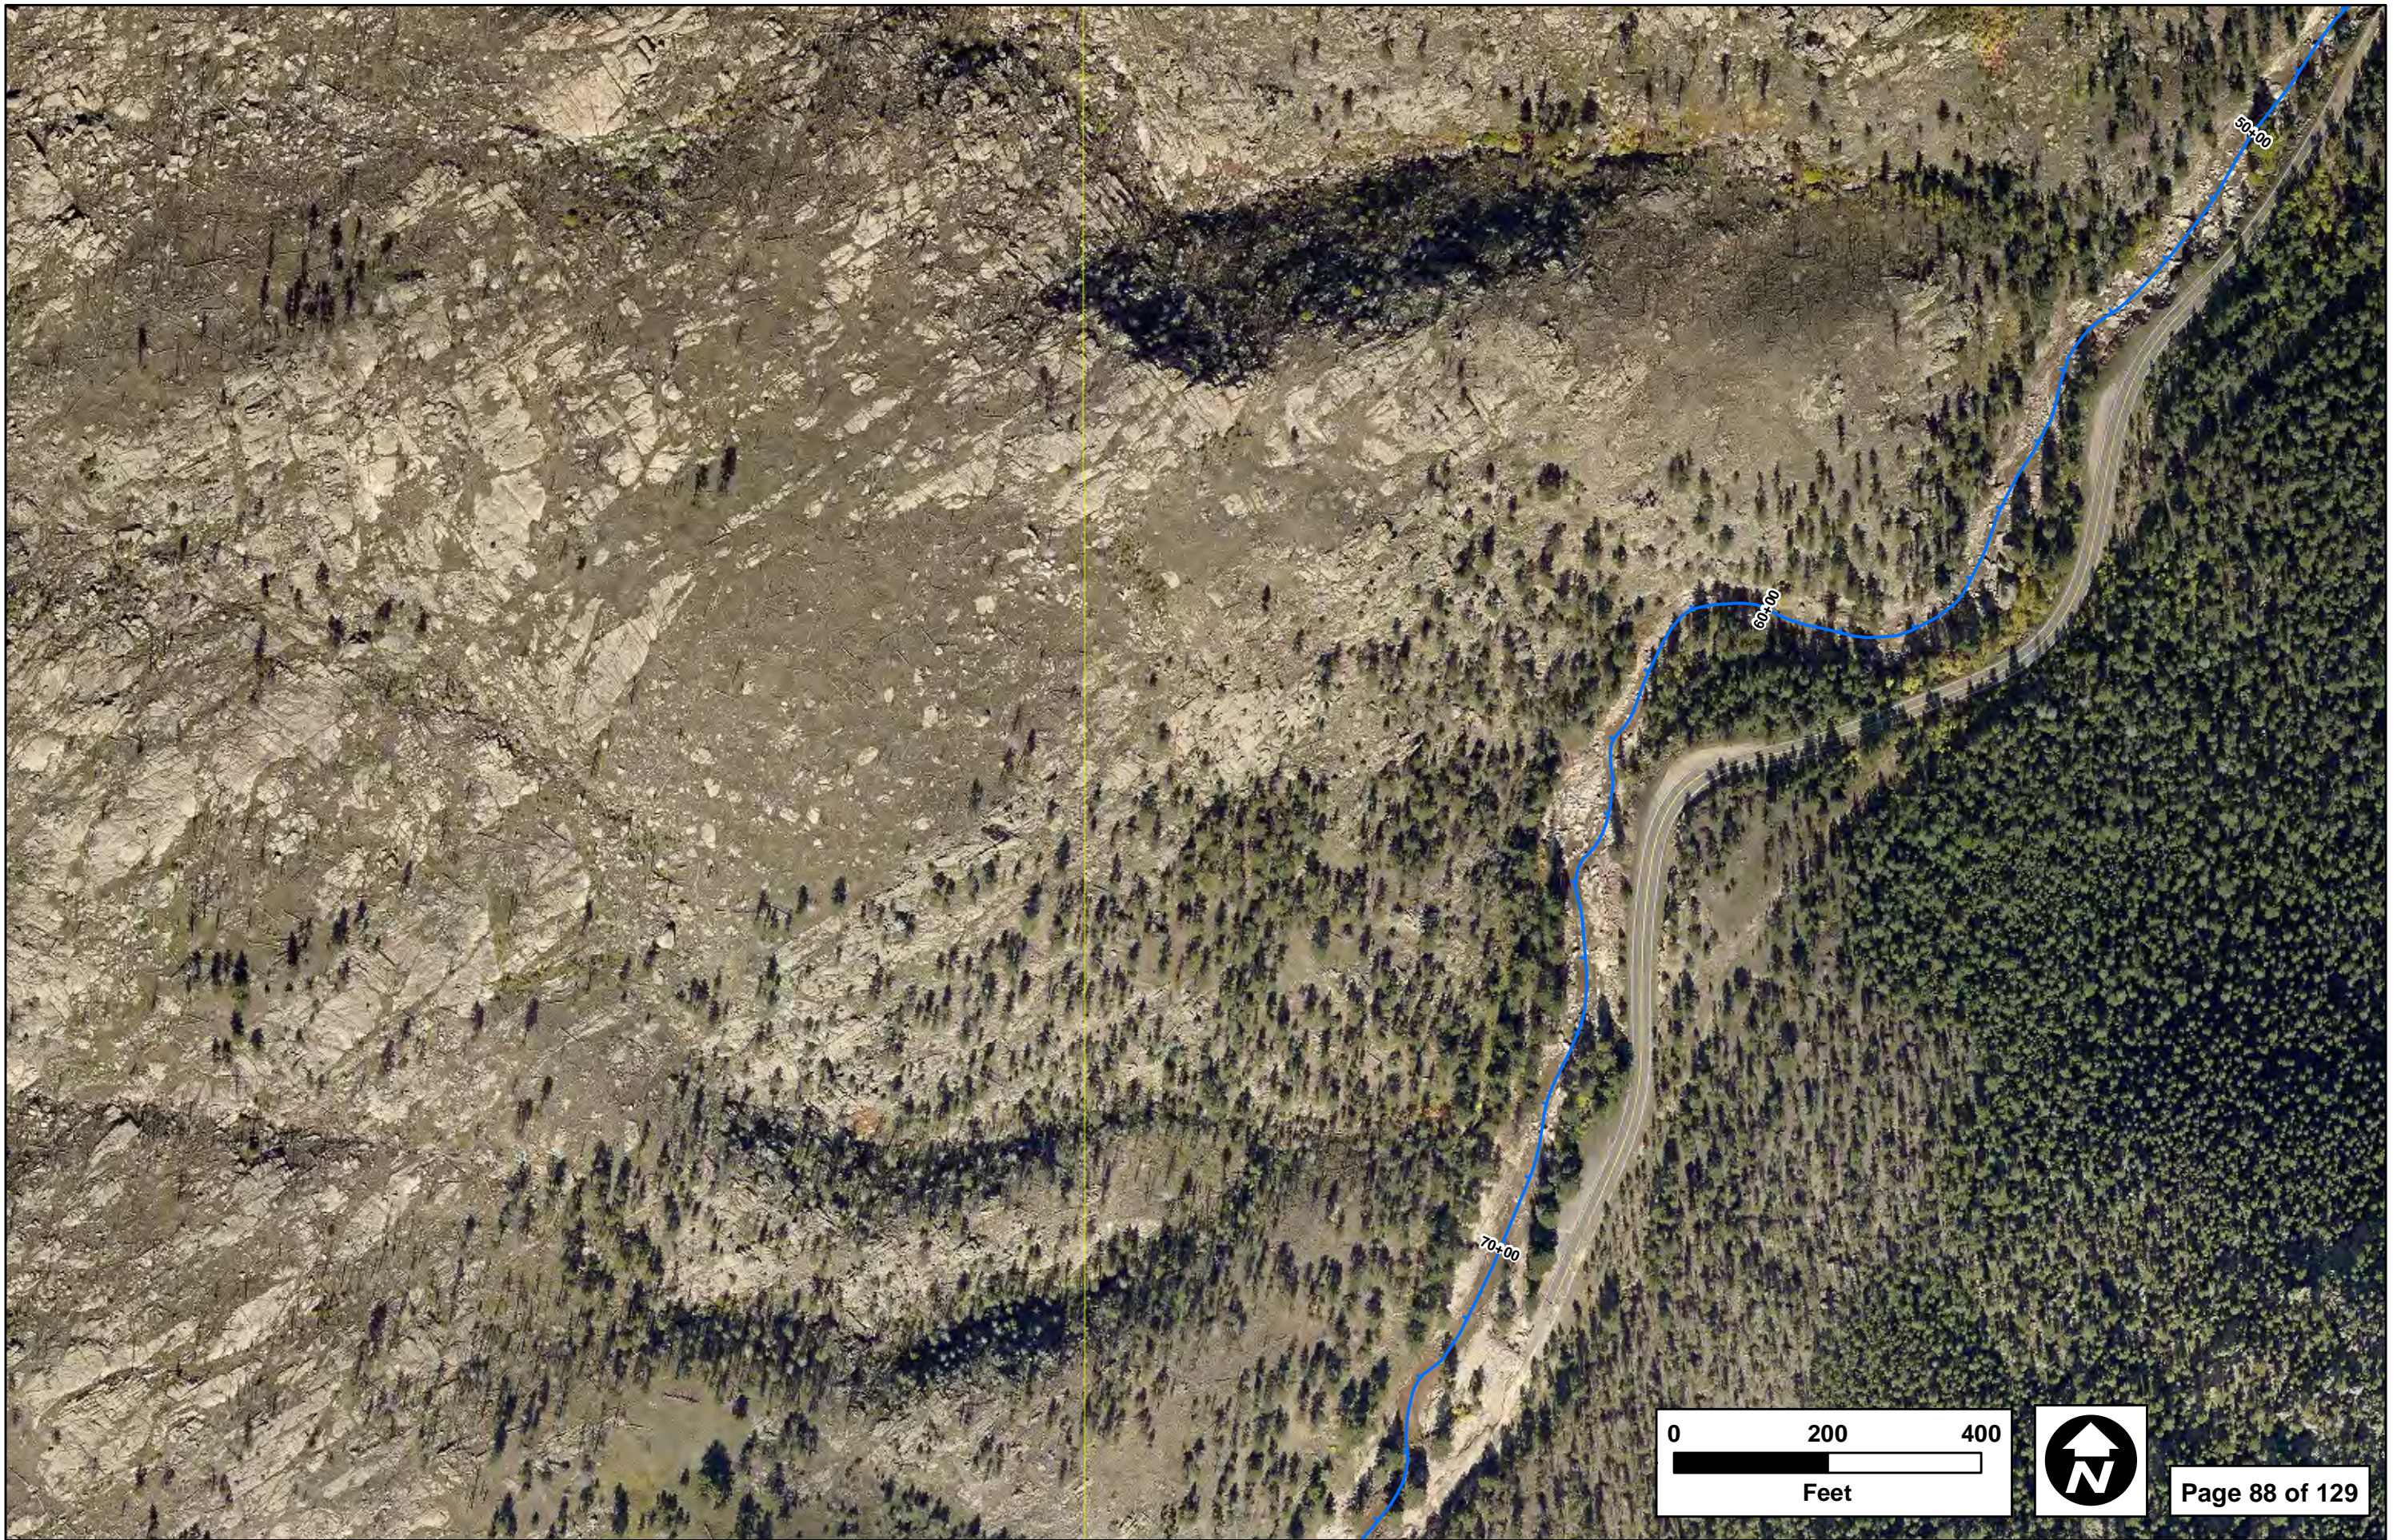
**NEIGHBORHOOD: Big Elk Meadows****SHEET: 89****STATION: West Fork below Big Elk Meadows**

The West Fork runs immediately adjacent to County Road 47, crossing it 5 times in less than 2 miles. These crossings were all destroyed during the 2013 flood and field evidence indicates the road was likely overtopped, with the road and canyon walls conveying floodwater. Larimer County replaced the culverts shortly after the flood. The USFS has expressed an interest in replacing these with culverts of increased capacity and culverts that can provide connectivity for aquatic species. As of the fall of 2014 Larimer County, FEMA, the USFS and Central Federal Lands are working to repair the road and possibly replace the culverts. Since this work is not complete, the recommendations and costs for the recommended work remain a part of this Master Plan.

Field observations indicate that the channel size was insufficient for the flood event. As the event was estimated to be in excess of the 500-year flood, it is understandable the channel capacity was exceeded, however, a channel assessment for capacity as well as bank stability under design flood conditions may be warranted along with the implementation of site-specific improvements and culvert replacements noted above.

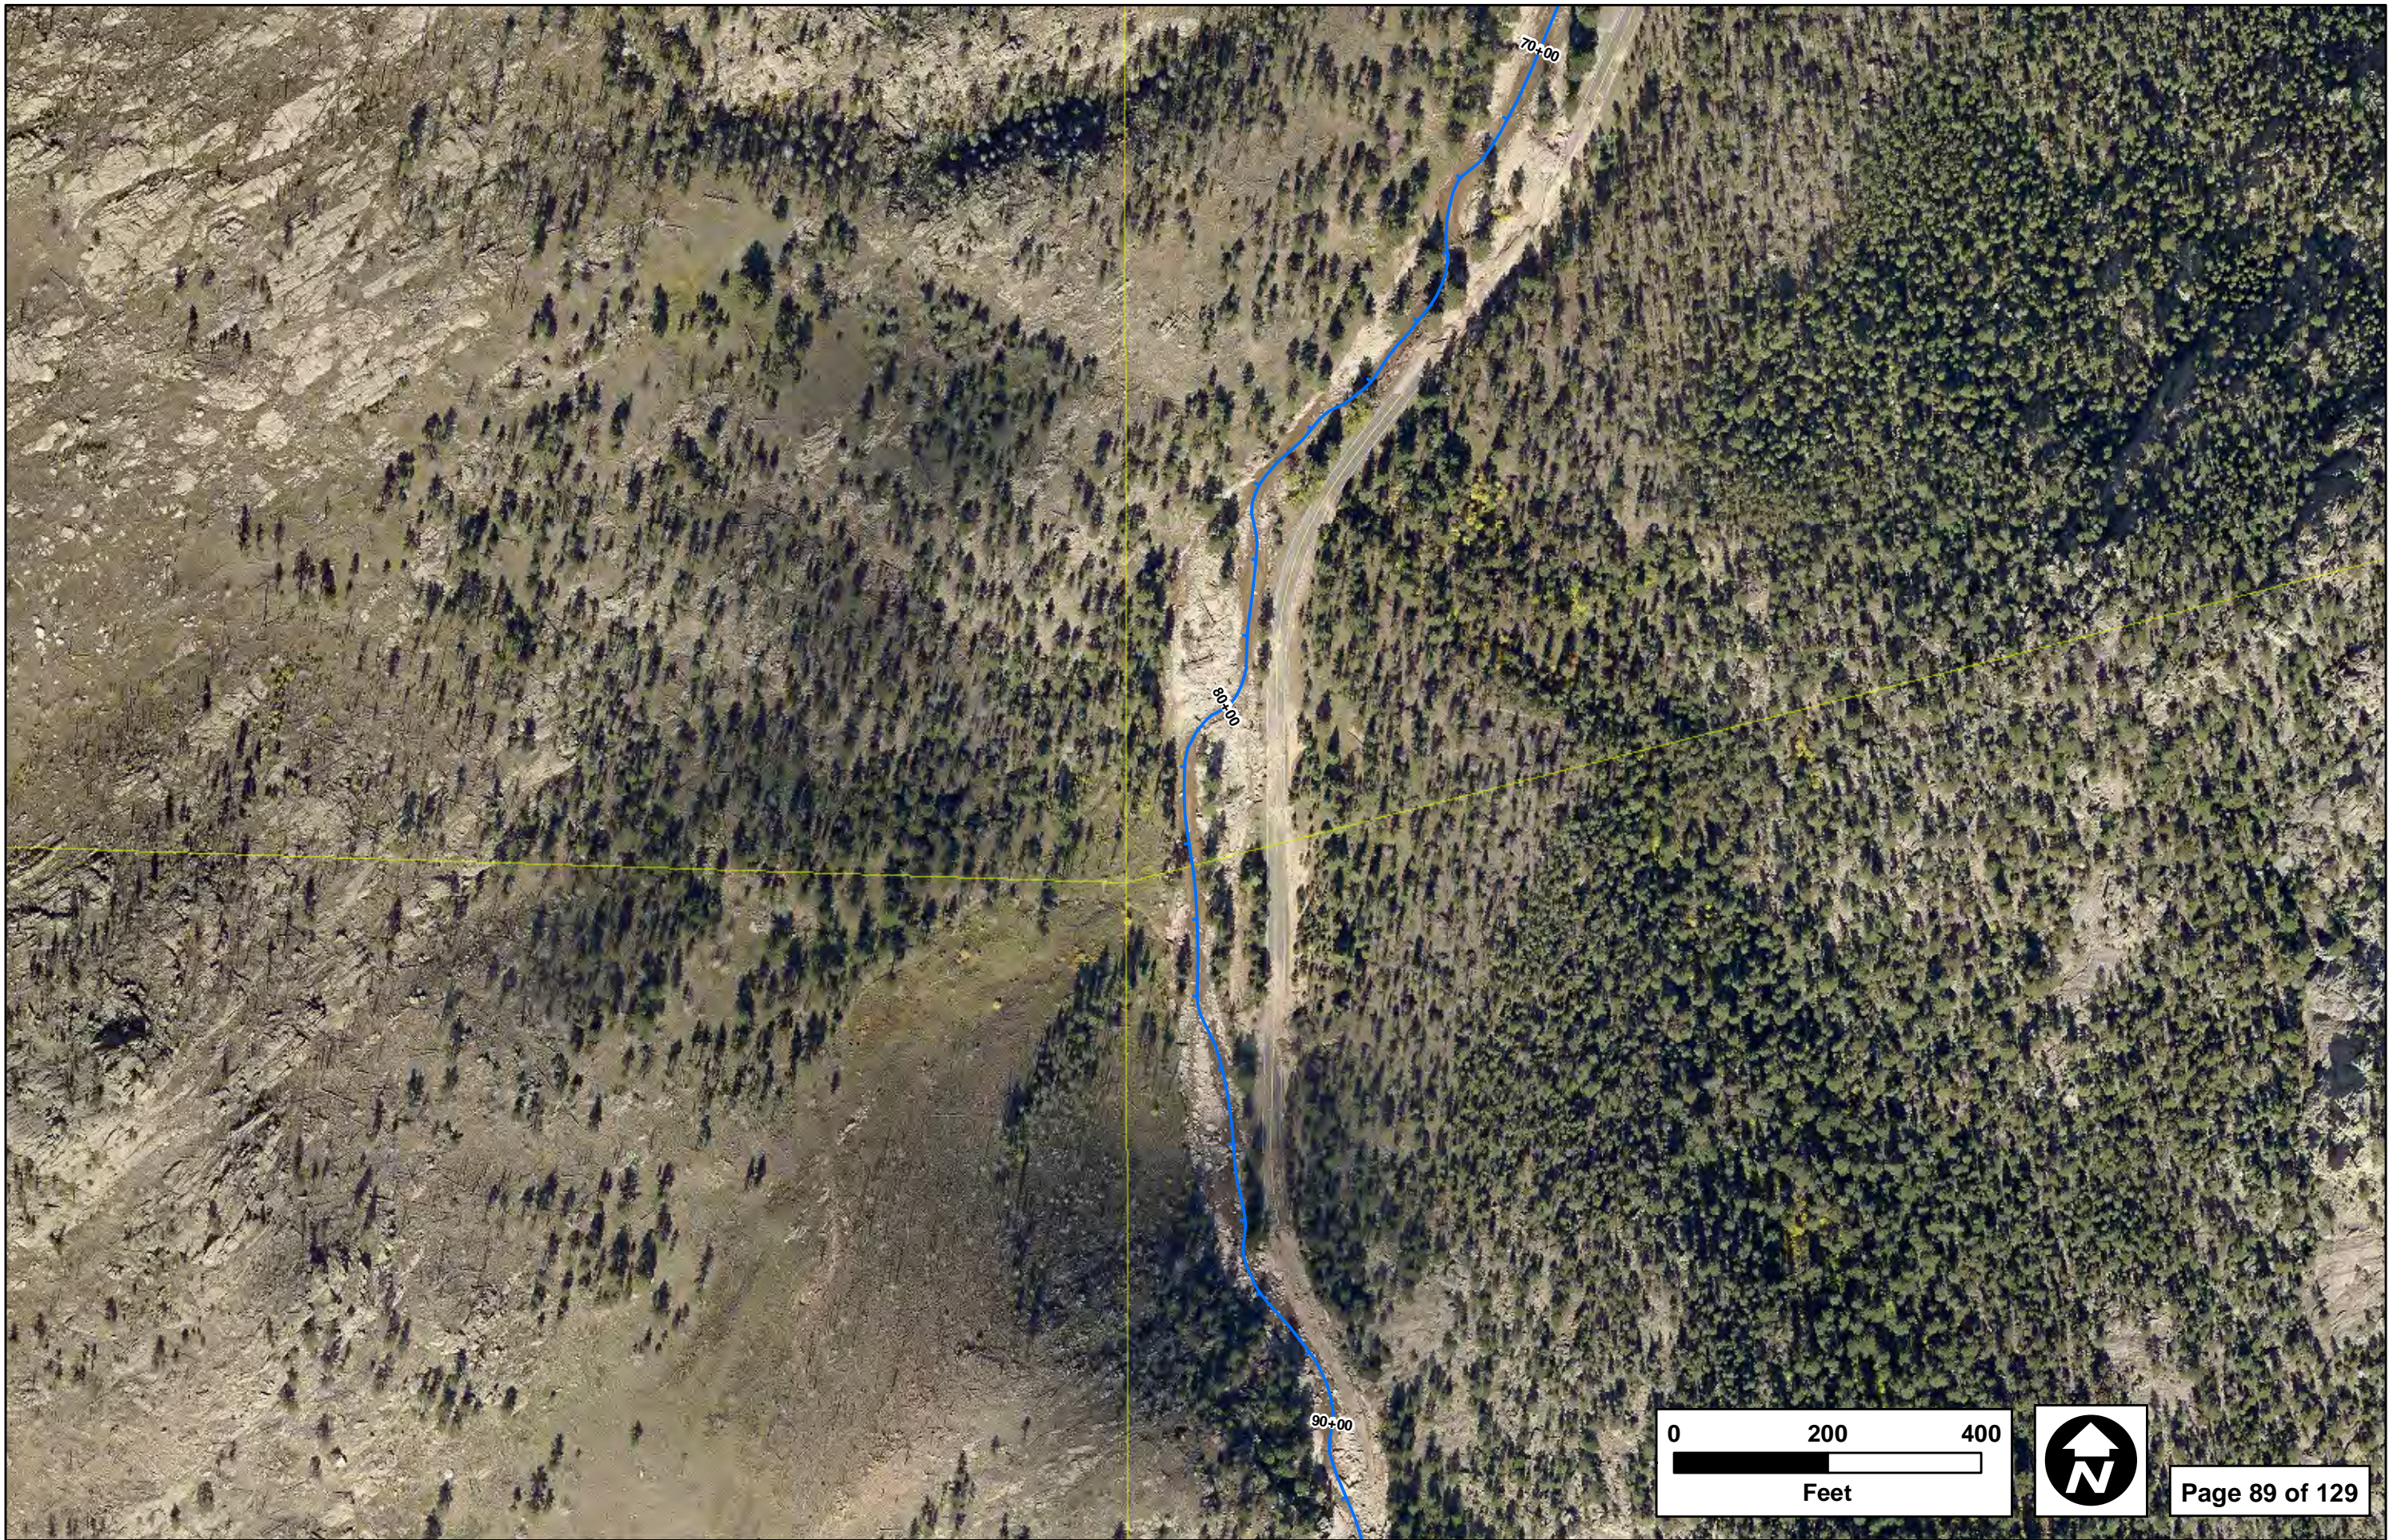
**NEIGHBORHOOD: Pinewood Springs****SHEET: 90****STATION: West Fork below Big Elk Meadows**

The West Fork runs immediately adjacent to County Road 47, crossing it 5 times in less than 2 miles. These crossings were all destroyed during the 2013 flood and field evidence indicates the road was likely overtopped, with the road and canyon walls conveying floodwater. Larimer County replaced the culverts shortly after the flood. The USFS has expressed an interest in replacing these with culverts of increased capacity and culverts that can provide connectivity for aquatic species. As of the fall of 2014 Larimer County, FEMA, the USFS and Central Federal Lands are working to repair the road and possibly replace the culverts. Since this work is not complete, the recommendations and costs for the recommended work remain a part of this Master Plan.

Field observations indicate that the channel size was insufficient for the flood event. As the event was estimated to be in excess of the 500-year flood, it is understandable the channel capacity was exceeded, however, a channel assessment for capacity as well as bank stability under design flood conditions may be warranted along with the implementation of site-specific improvements and culvert replacements noted above.

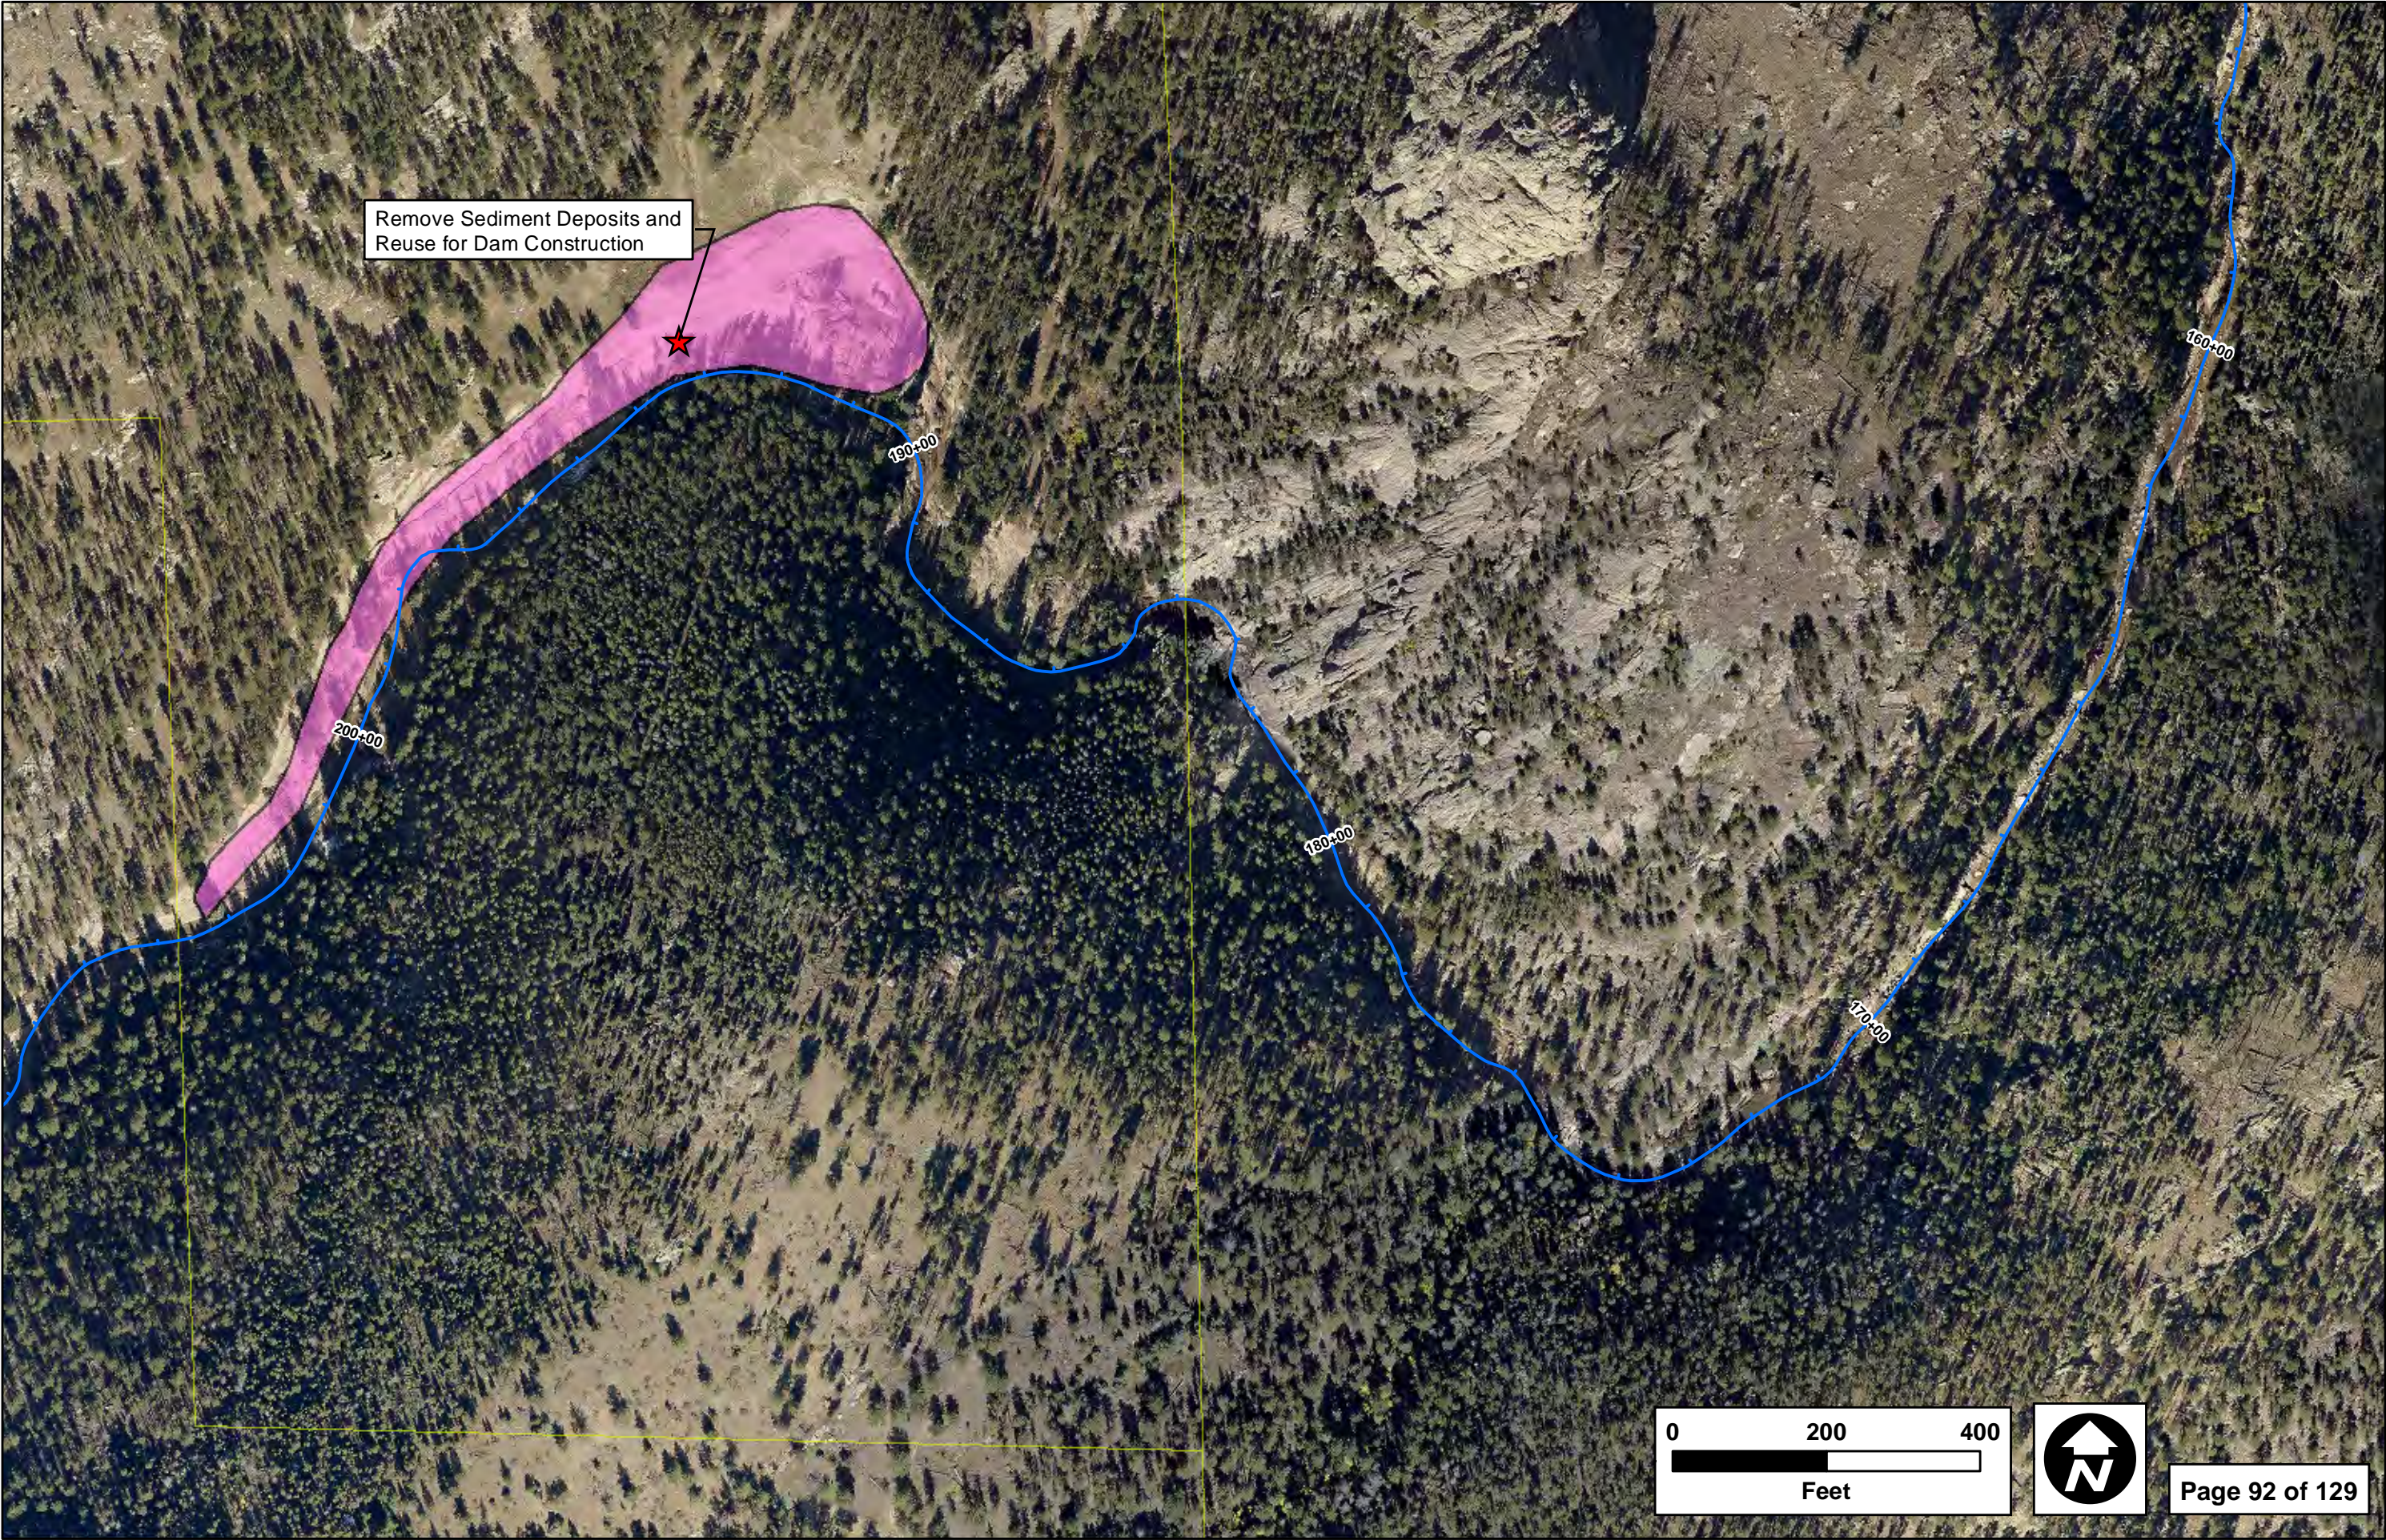
Remove Sediment Deposits and Reuse for Dam Construction

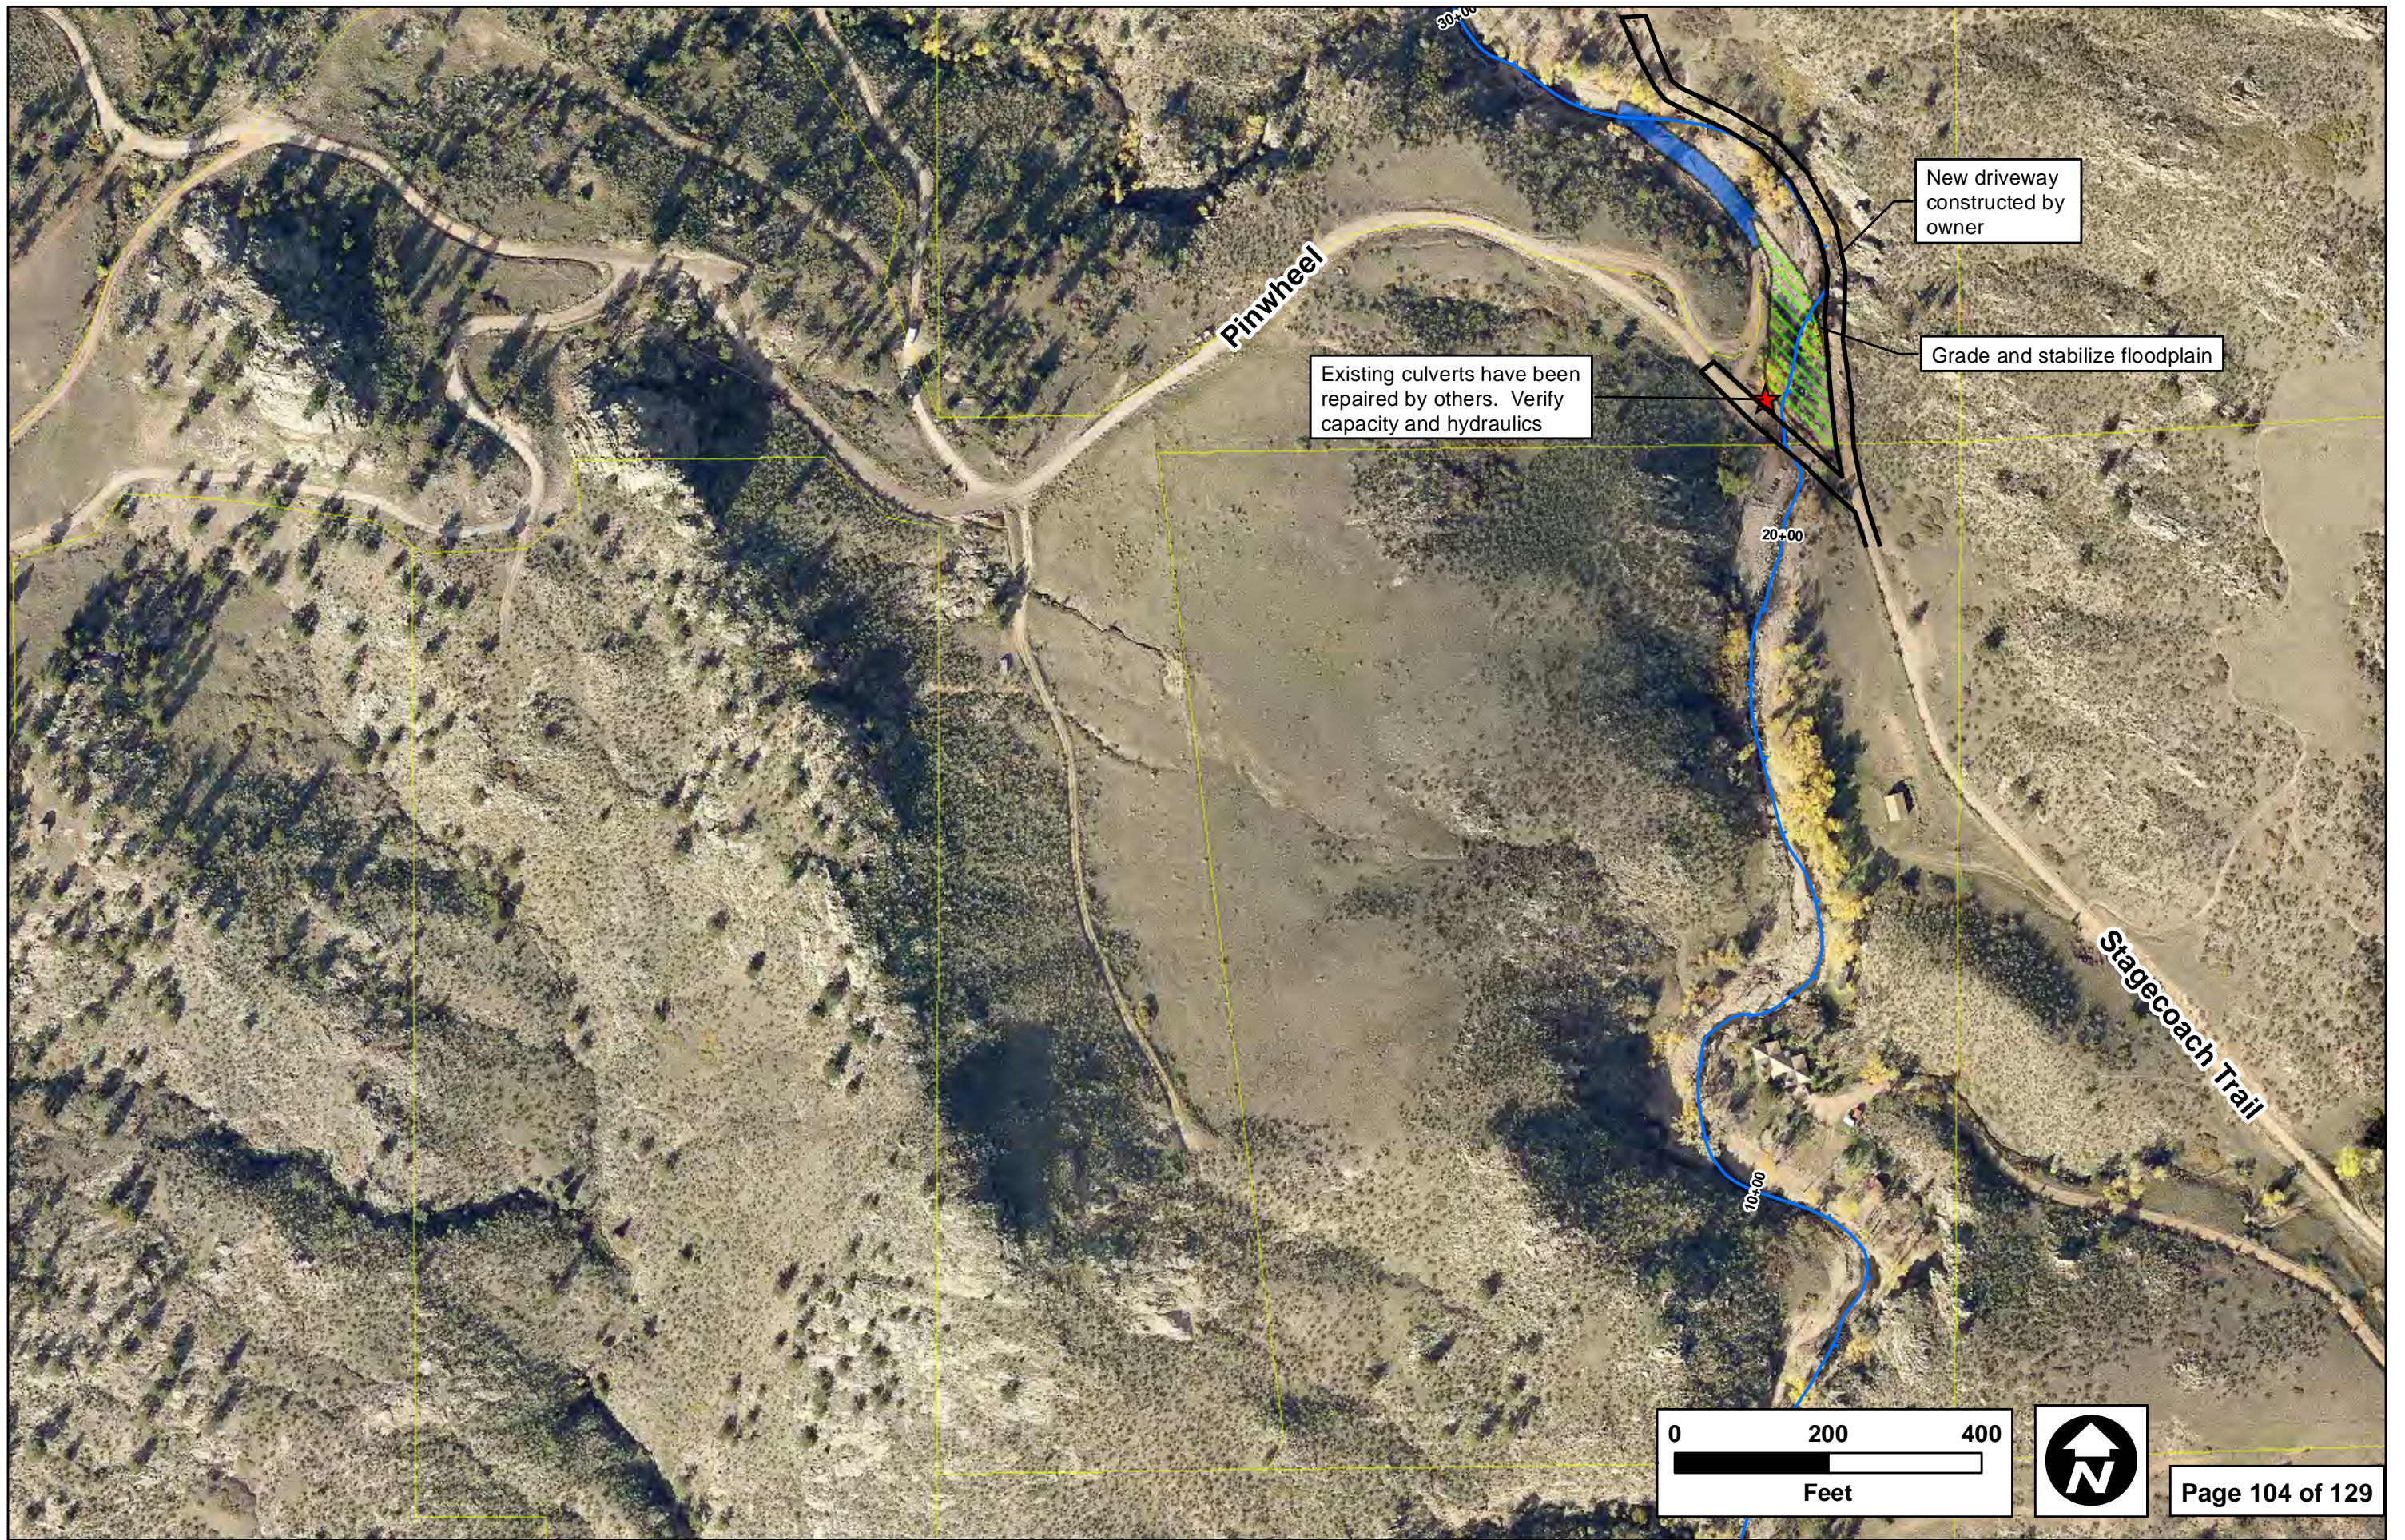
This specific reach includes a road crossing where Stagecoach Trail/Pinwheel Ranch Road crosses the river. The crossing was reportedly washed out but had been replaced prior to conducting the site assessments. The driveway to the one residence was also washed out but has since been replaced. The new driveway is located to the east of the river, thereby eliminating one culvert crossing. Additional recommendations are noted below.

1. Grade, stabilize and revegetate banks and floodplain.
2. Verify culvert capacity on Pinwheel.

Existing culverts have been repaired by others. Verify capacity and hydraulics

New driveway constructed by owner
