# **APPENDIX A**

# **ASSESSMENT PROTOCOL**

# **APPENDIX C**

# **SITE DESCRIPTIONS**

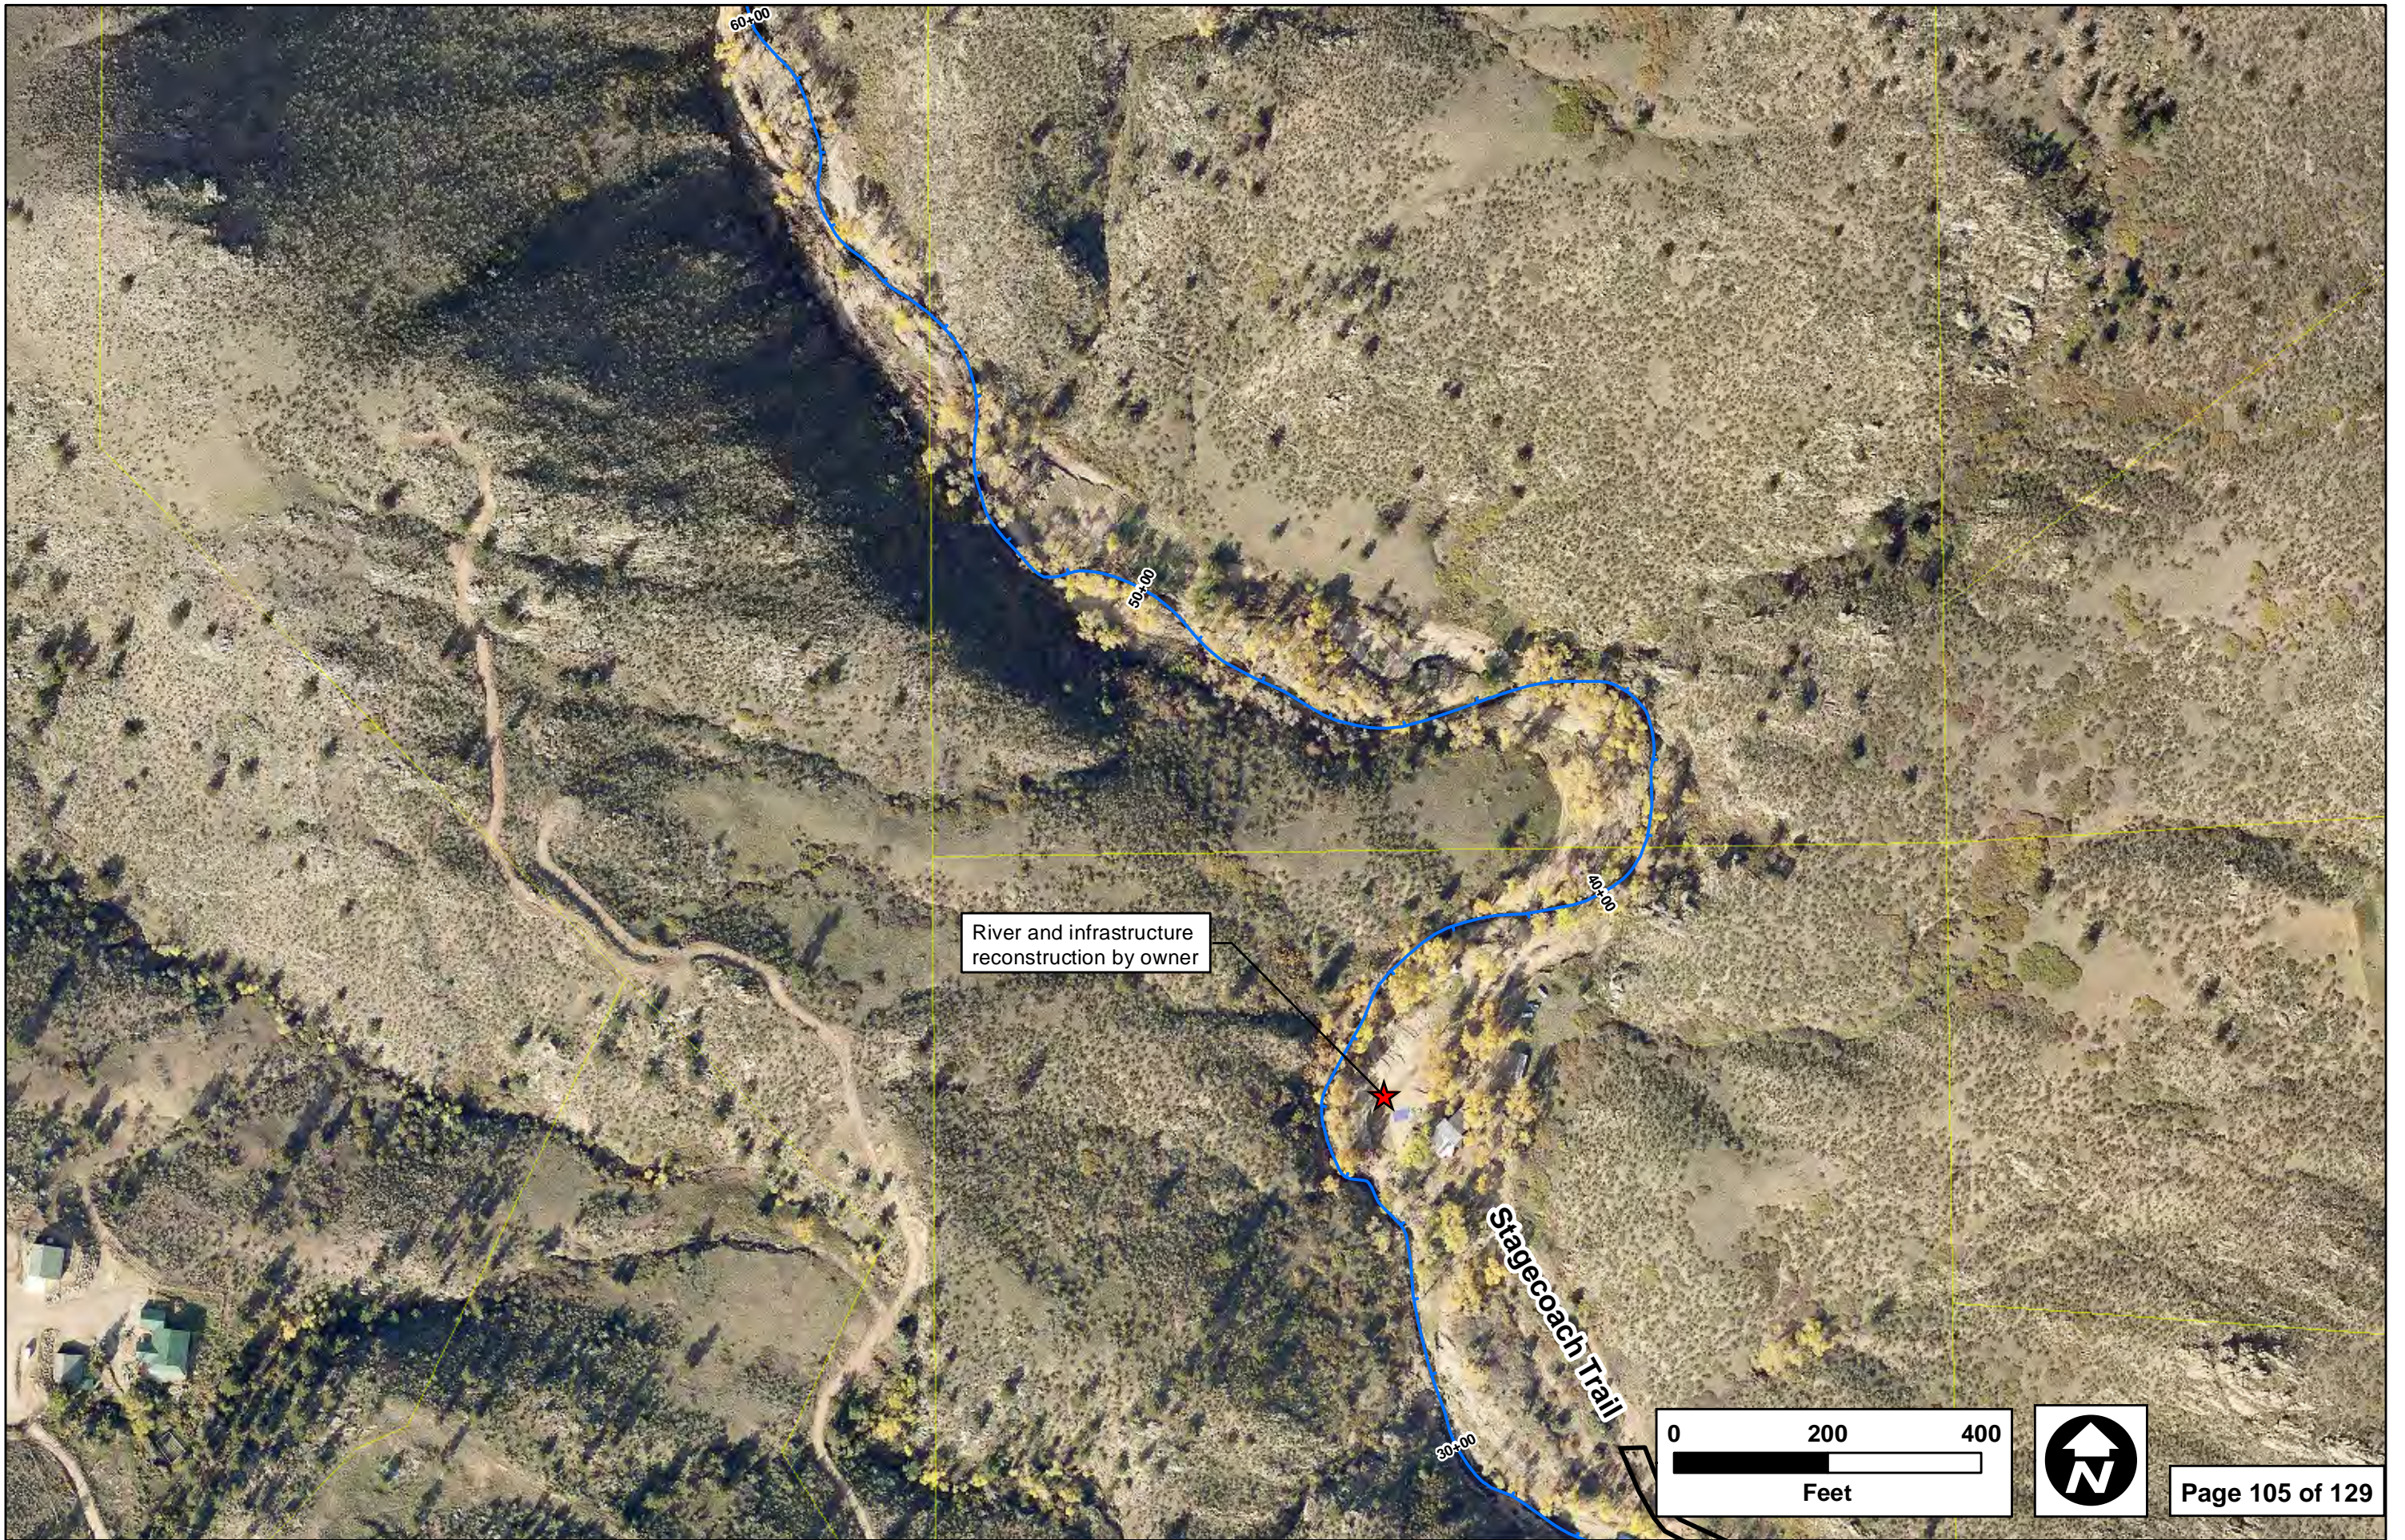
This specific reach includes a private residence (Vancleve/Larson) which was inundated during the 2013 Flood, sustaining primarily water damage. Other structures which were lost or damaged included a small bridge, several outbuildings, and two ponds. In addition the property experienced some erosion and debris accumulation. Flood related damage and debris clean up noted on this sheet are being, or have been, repaired or addressed by the property owner.

River and infrastructure reconstruction by owner

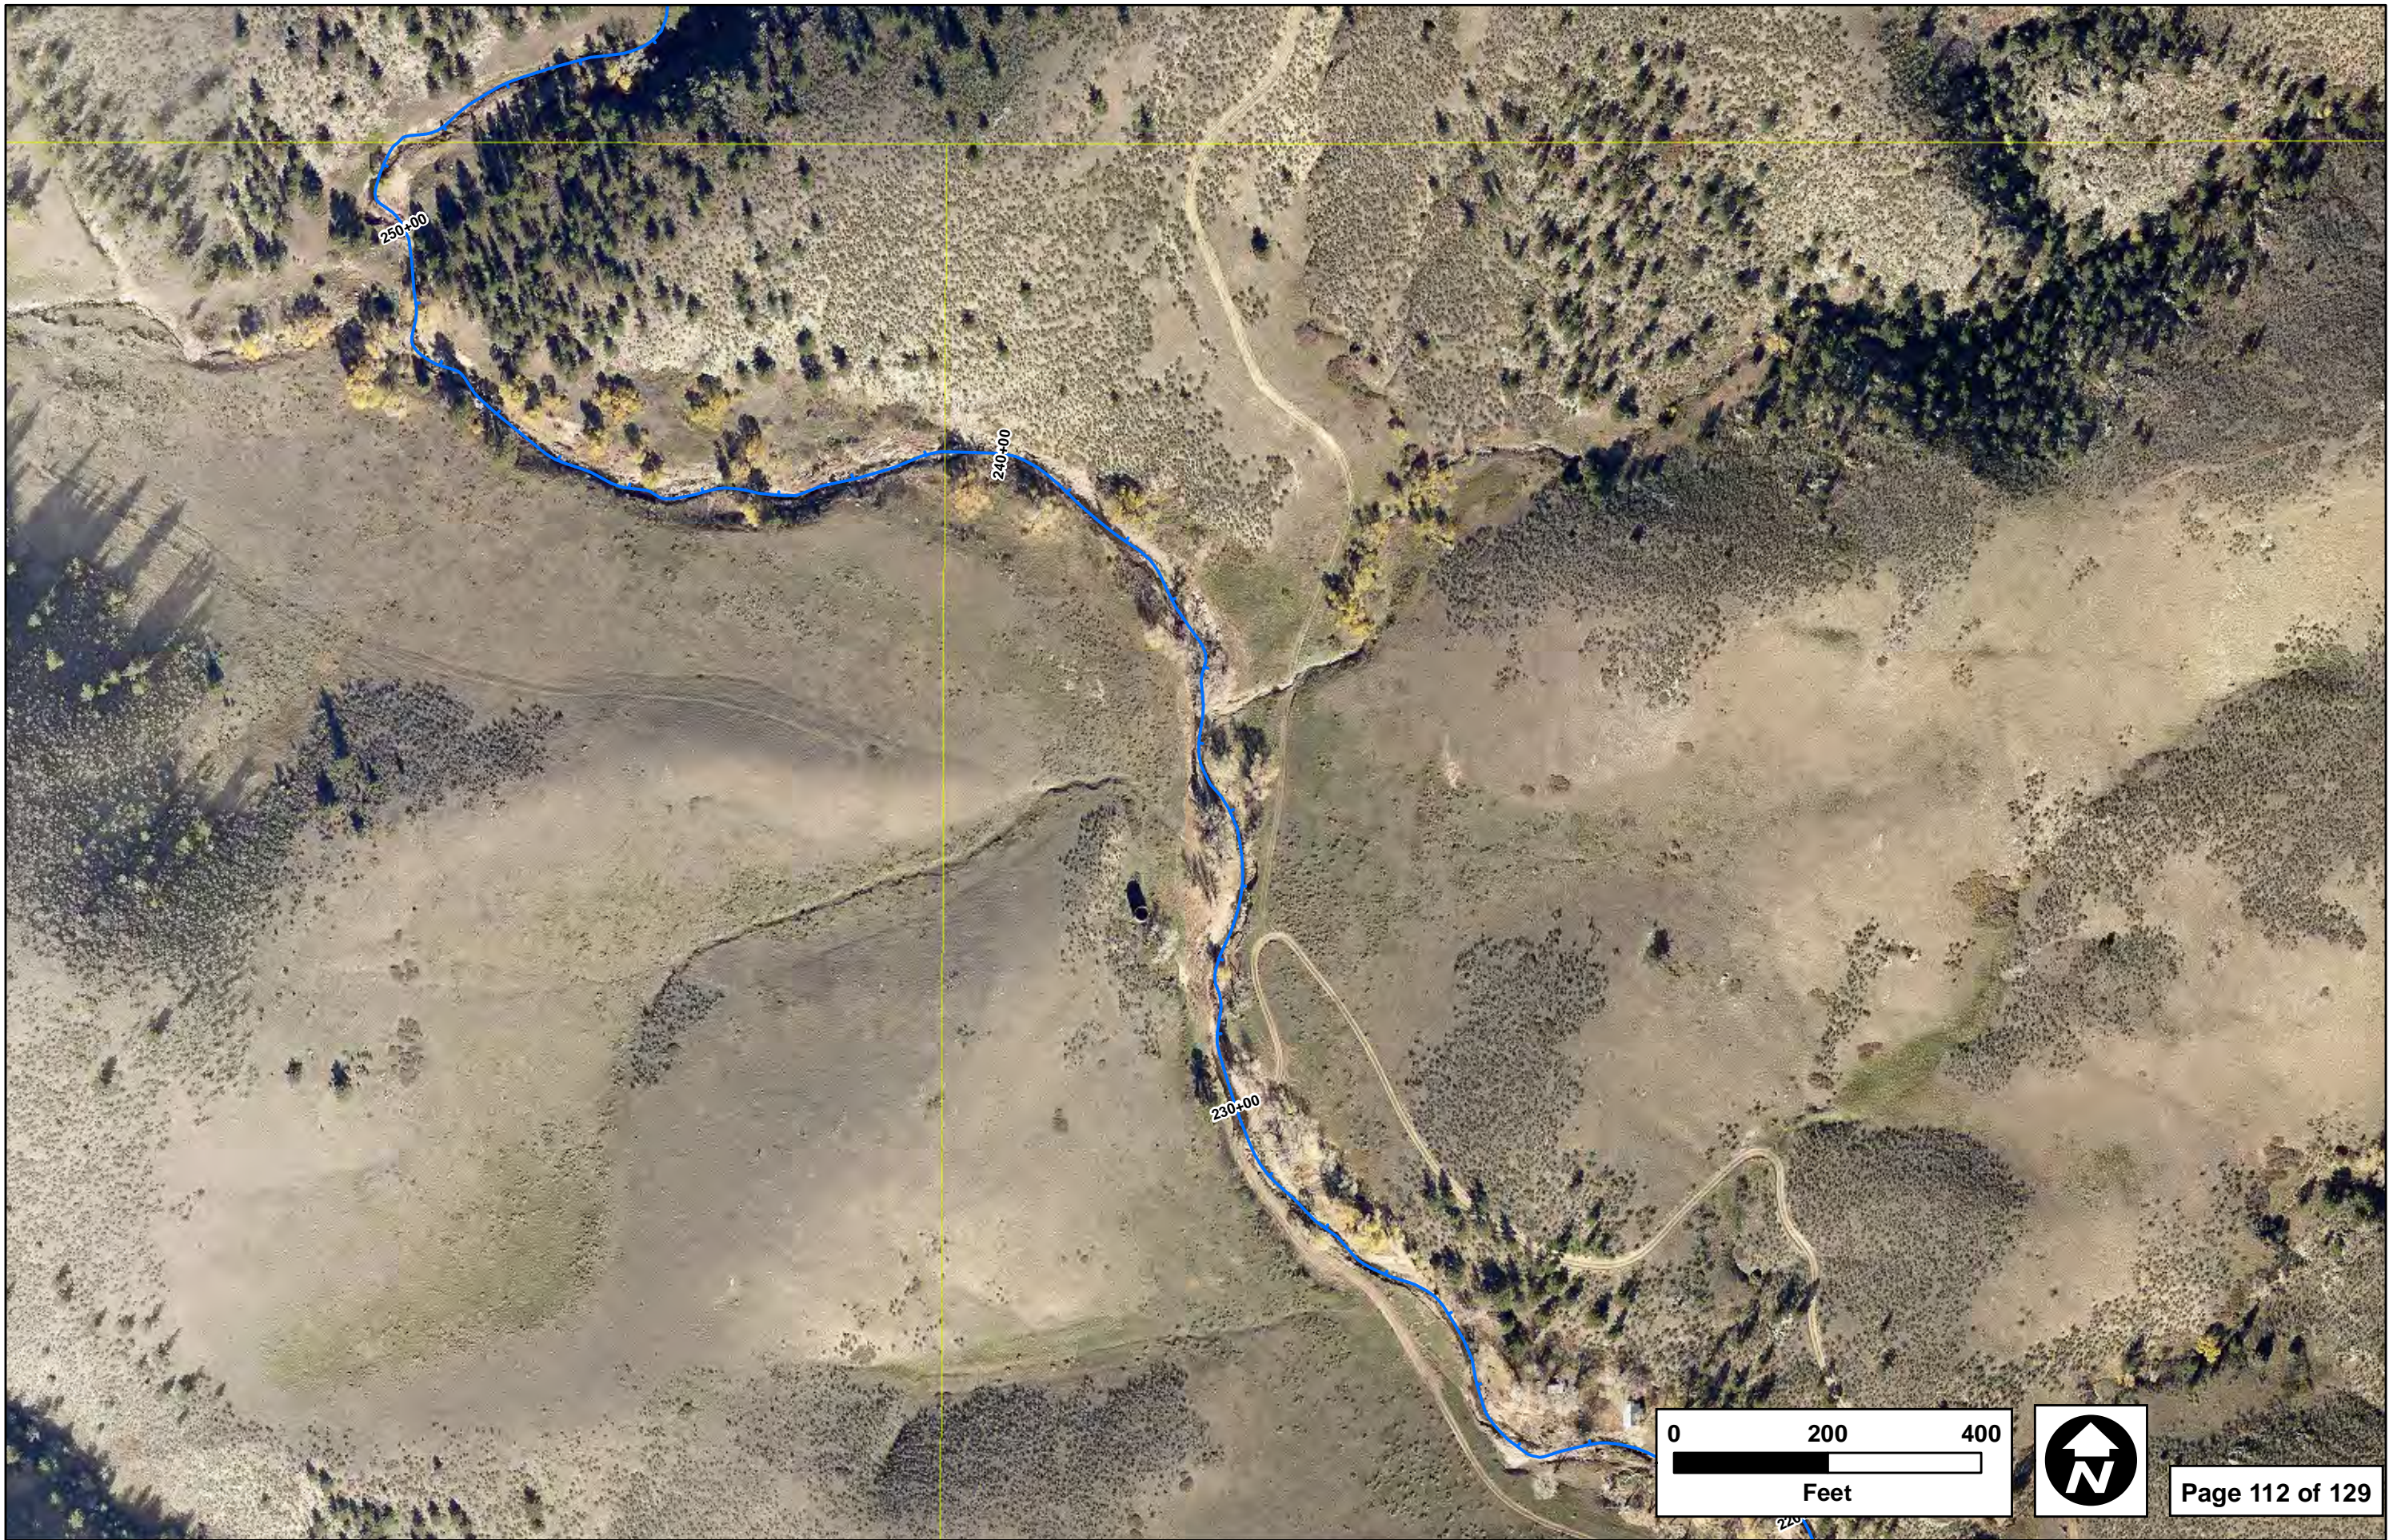
**SHEET:** 113

Aerial photos of pre-flood conditions and anecdotal information indicate this reach had a densely vegetated riparian corridor, approximately 50 feet wide, comprised primarily of cottonwoods and willows, some of which were torn out during the flood. The river is generally bound by hillsides and some rock outcrops, setting the riparian corridor alignment. The North Fork is a relatively small stream system that often goes dry by late summer.

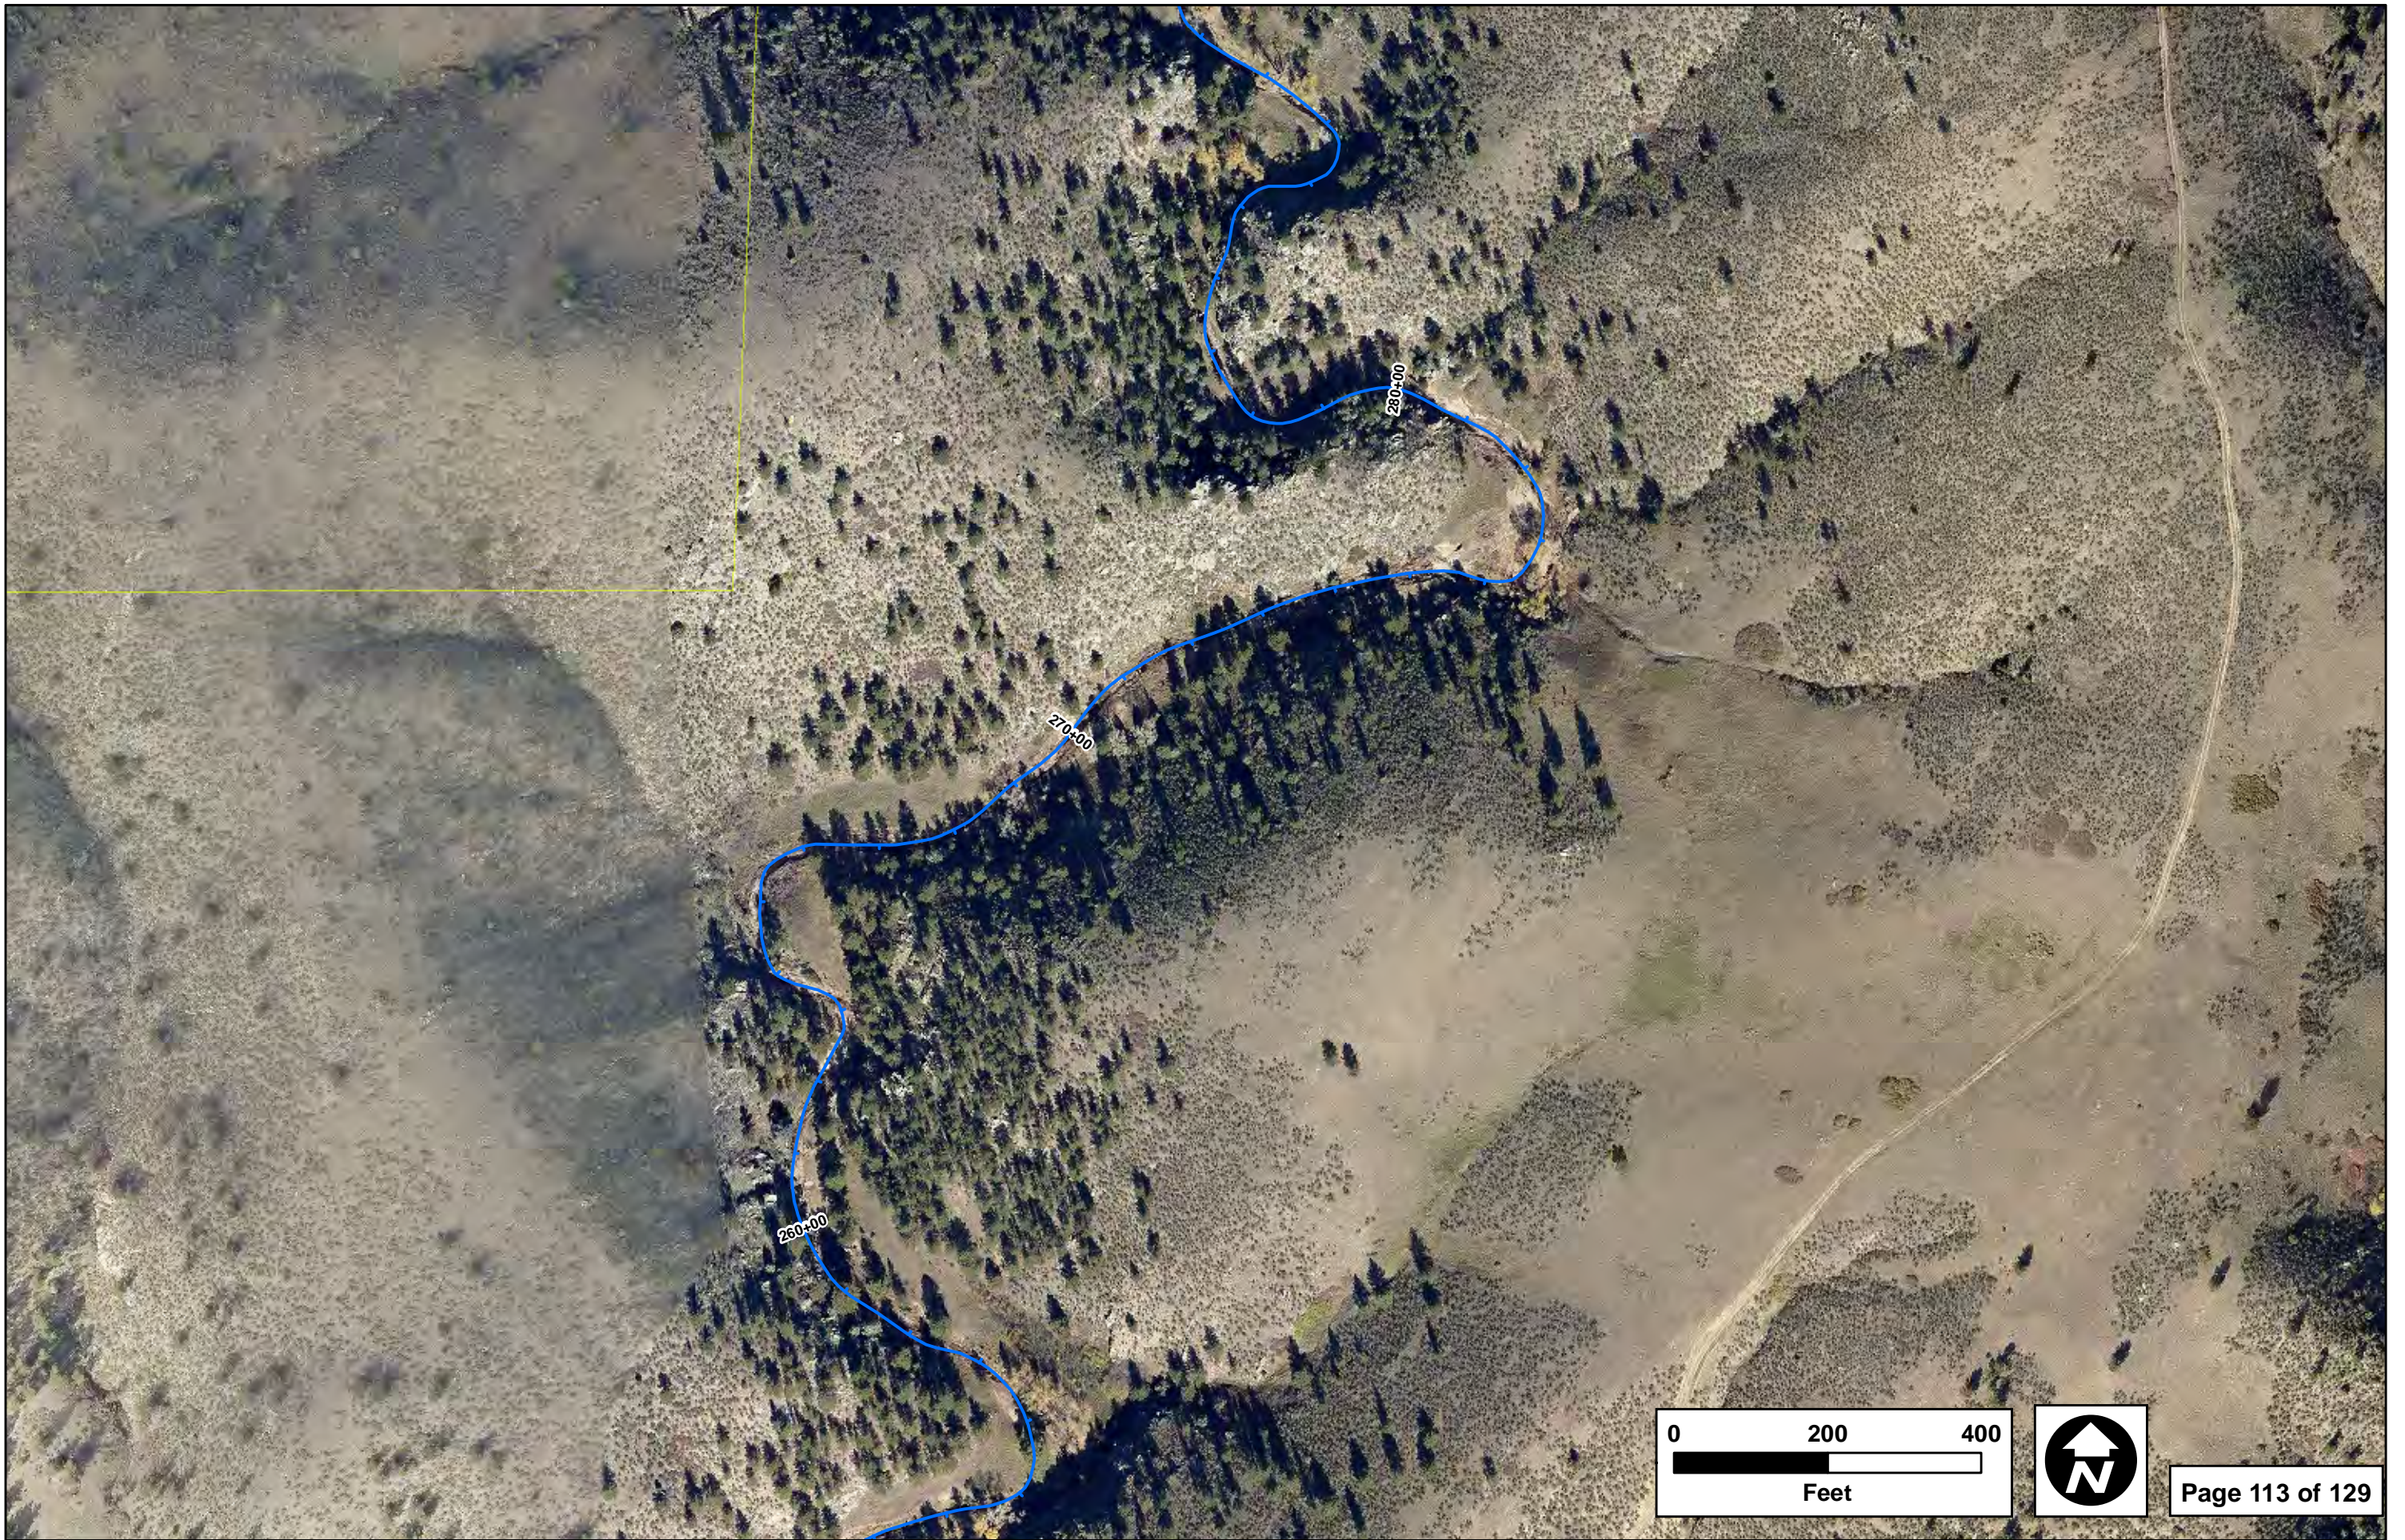
**NEIGHBORHOOD: Blue Mountain****SHEET: 114****STATION: North Fork—upstream of Stagecoach**

Aerial photos of pre-flood conditions and anecdotal information indicate this reach had a densely vegetated riparian corridor, approximately 50 feet wide, comprised primarily of cottonwoods and willows, some of which were torn out during the flood. The river is generally bound by hillsides and some rock outcrops, setting the riparian corridor alignment. The North Fork is a relatively small stream system that often goes dry by late summer.

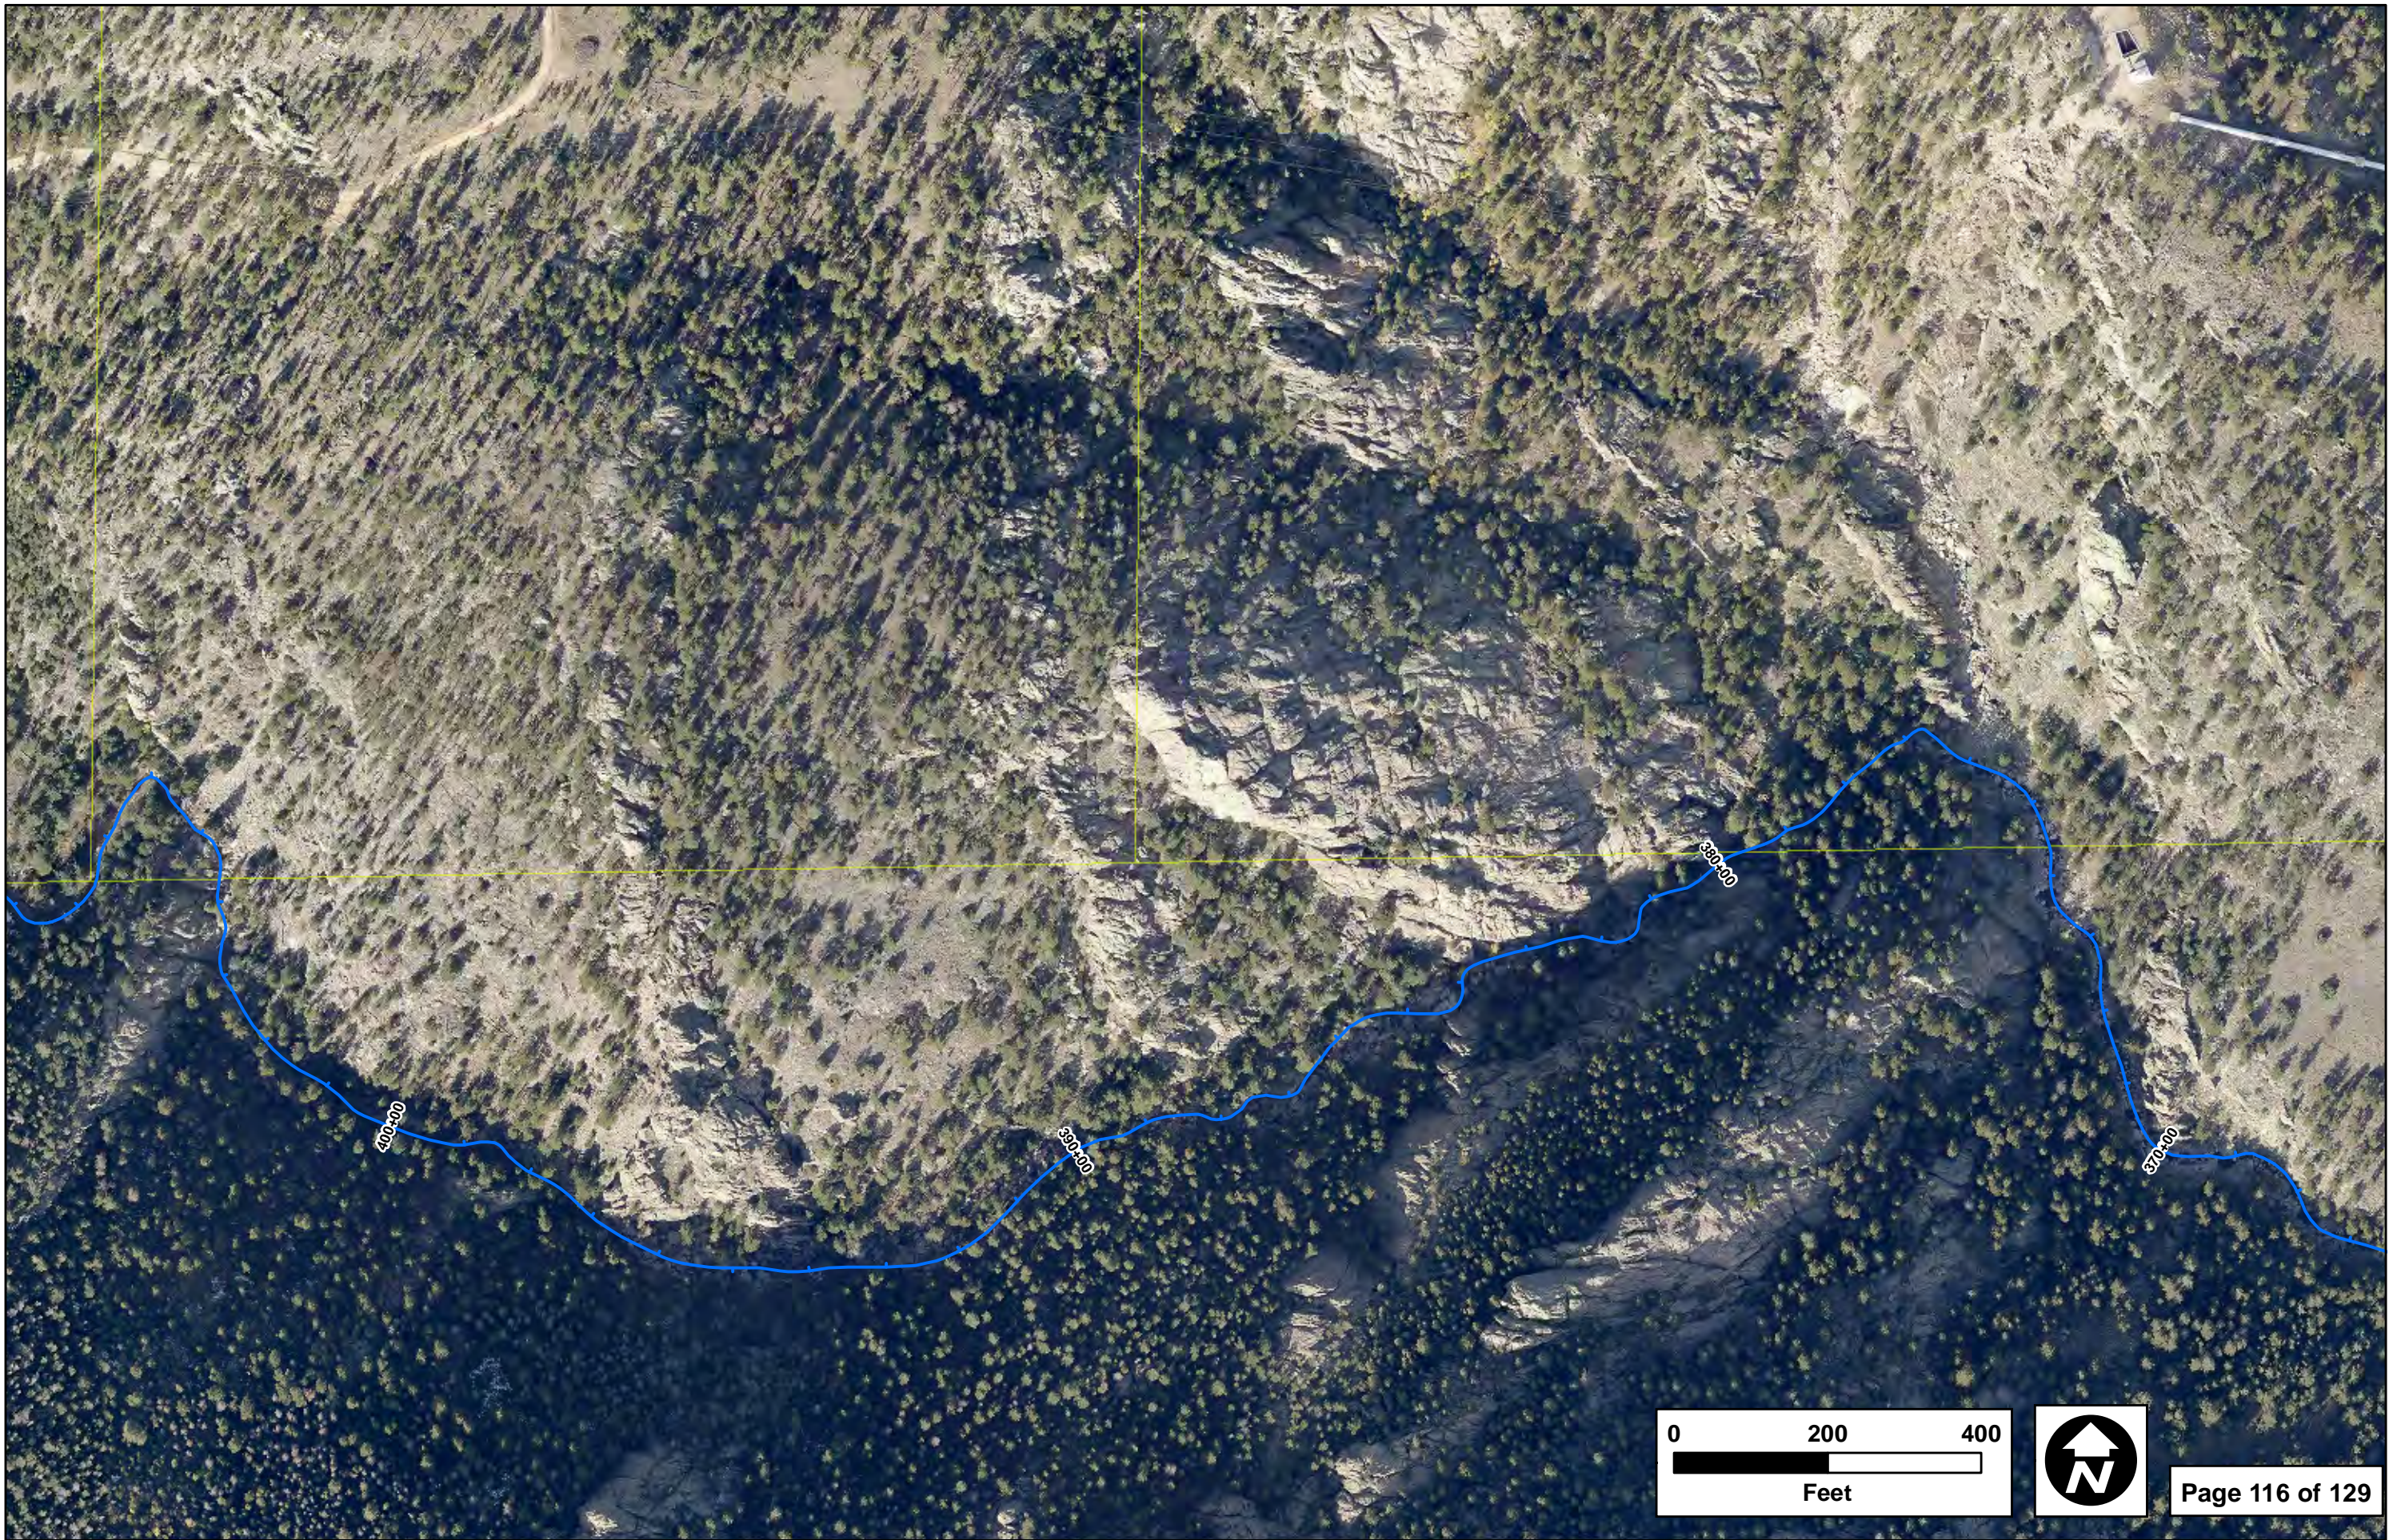
**SHEET:** 117

Aerial photos of pre-flood conditions and anecdotal information indicate this reach is extremely steep, canyon bound with little vegetation and rock outcrops controlling the river and its alignment. This section of the North Fork is within the boundaries of the Roosevelt National Forest and is difficult to access.

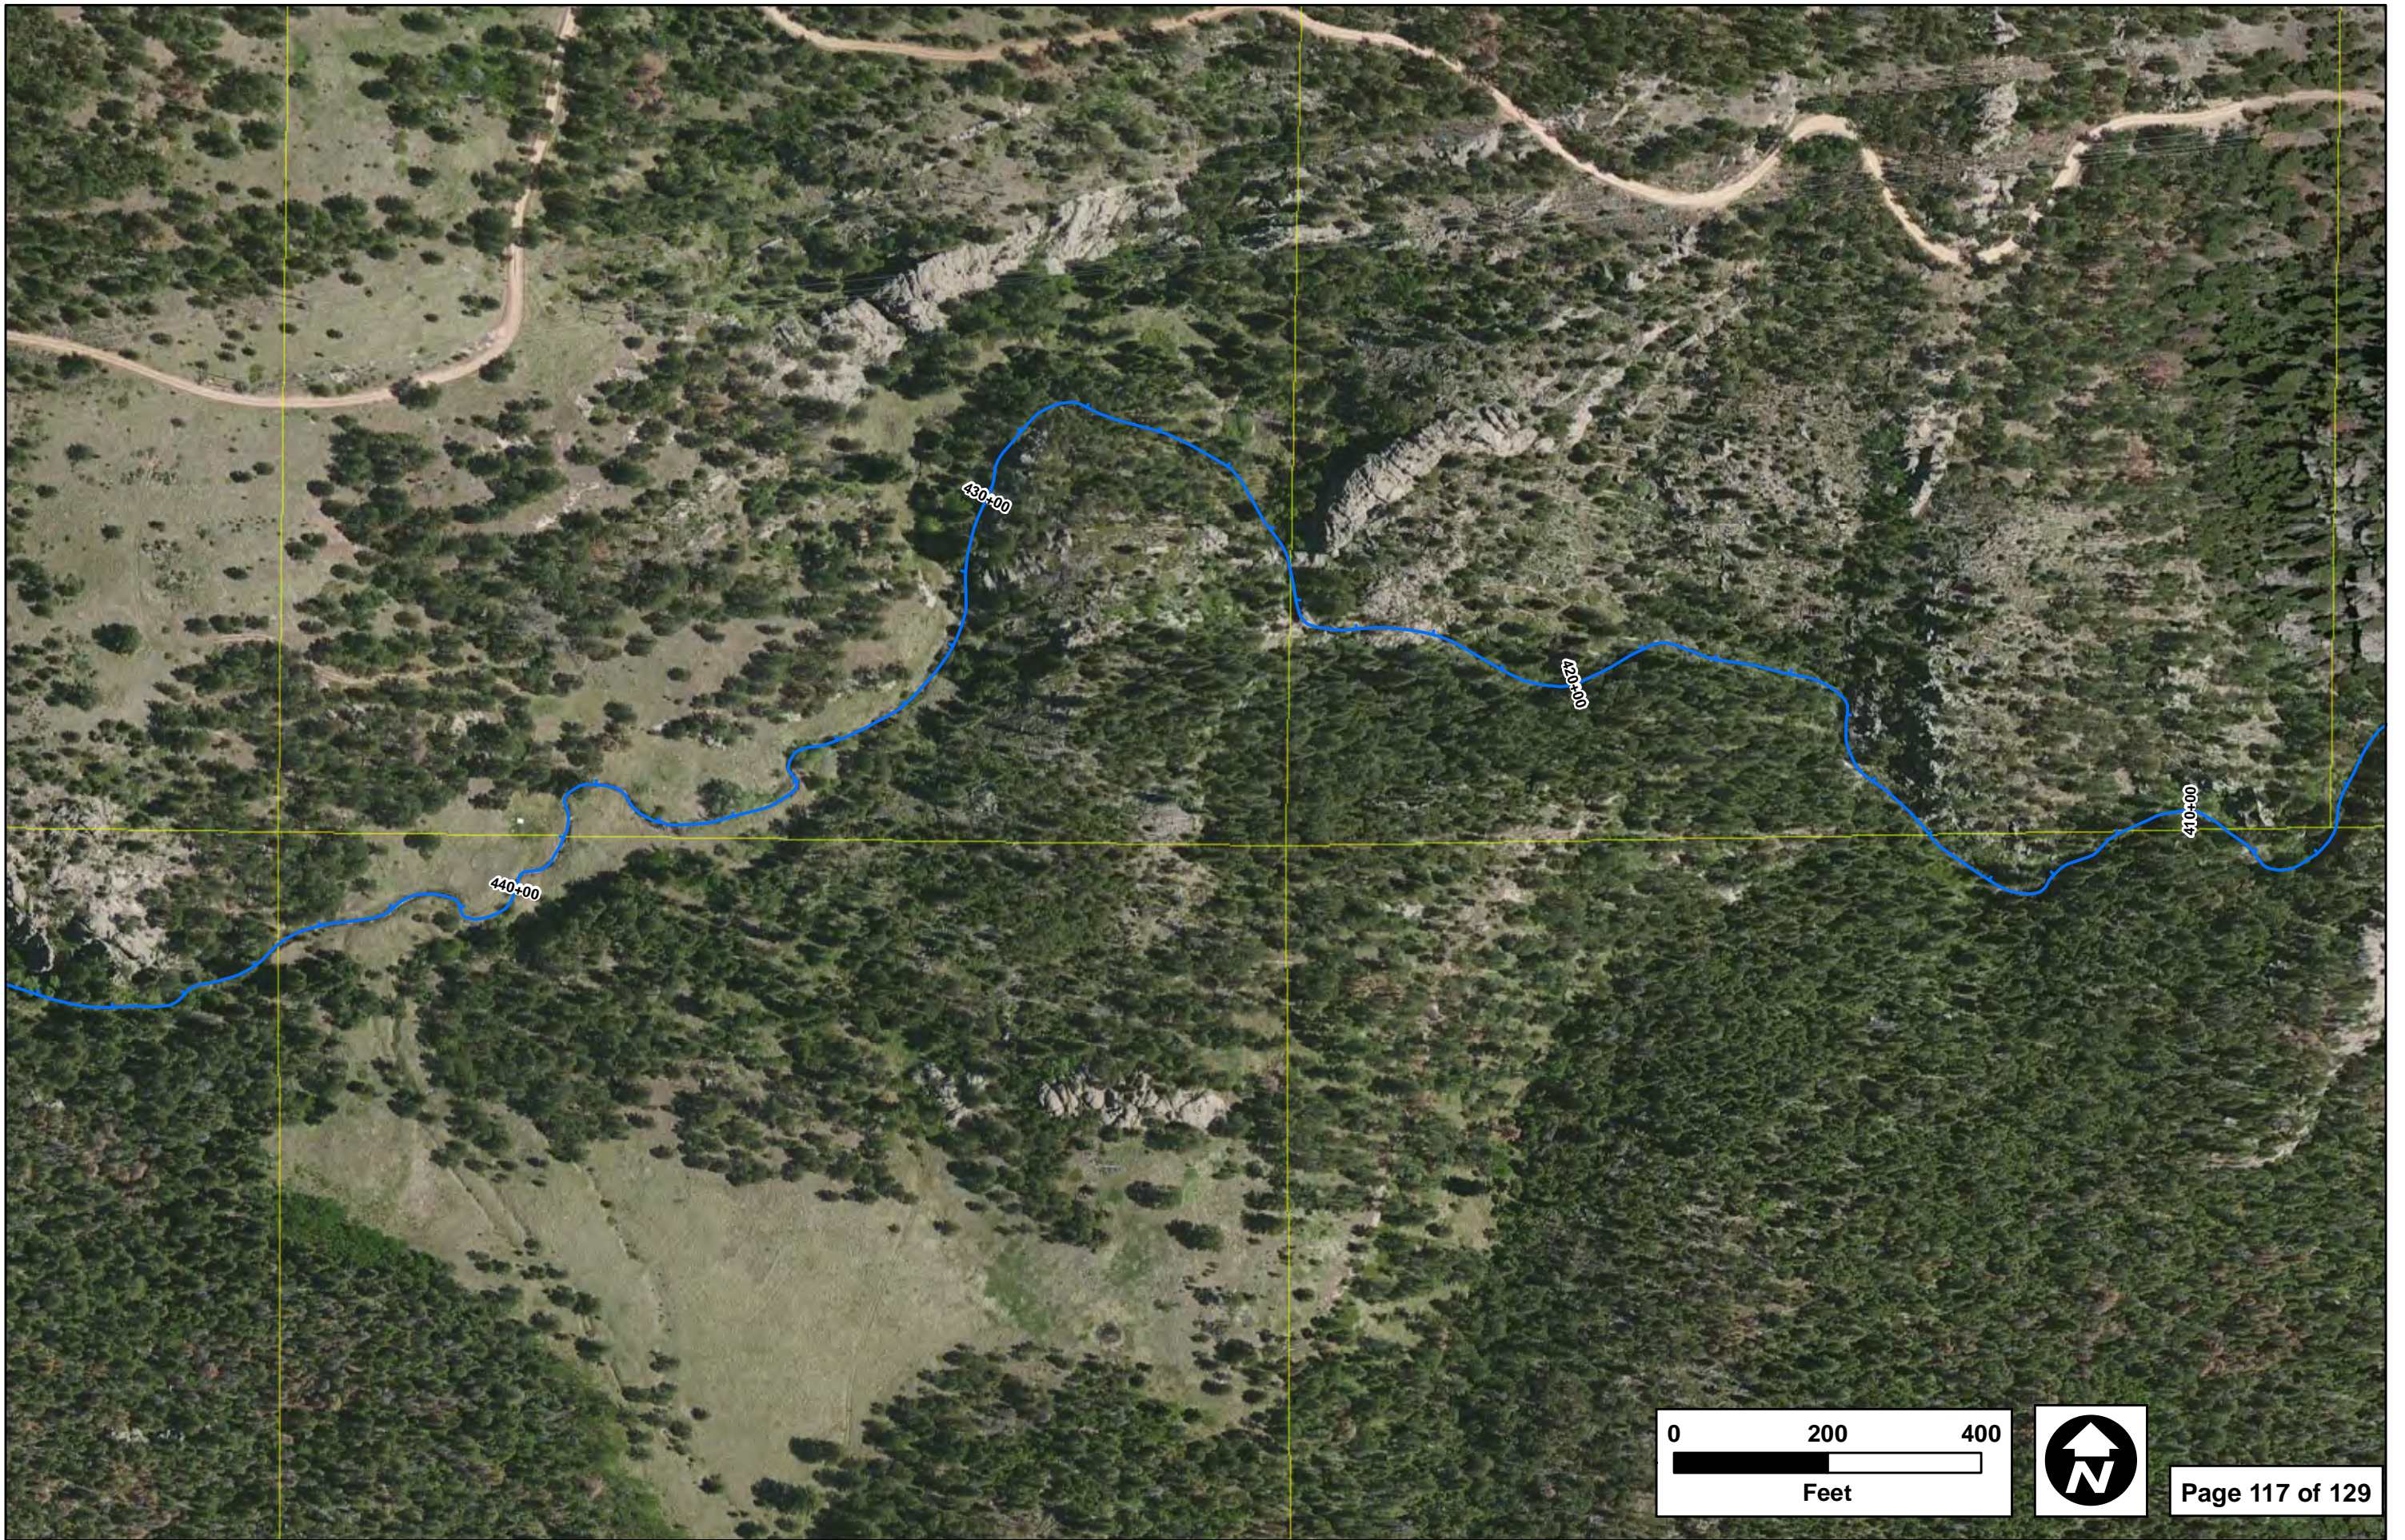
**NEIGHBORHOOD:** Blue Mountain  
**SHEET:** 118  
**STATION:** North Fork—upstream of Pole Hill

This section of the North Fork is within the boundaries of the Roosevelt National Forest. Aerial photos of pre-flood conditions and anecdotal information indicate the lower portion of this reach is extremely steep, canyon bound with little vegetation and rock outcrops controlling the river and its alignment. The upper portion of this reach begins to flatten out and private land ownership checkerboards the watershed and riparian corridor.

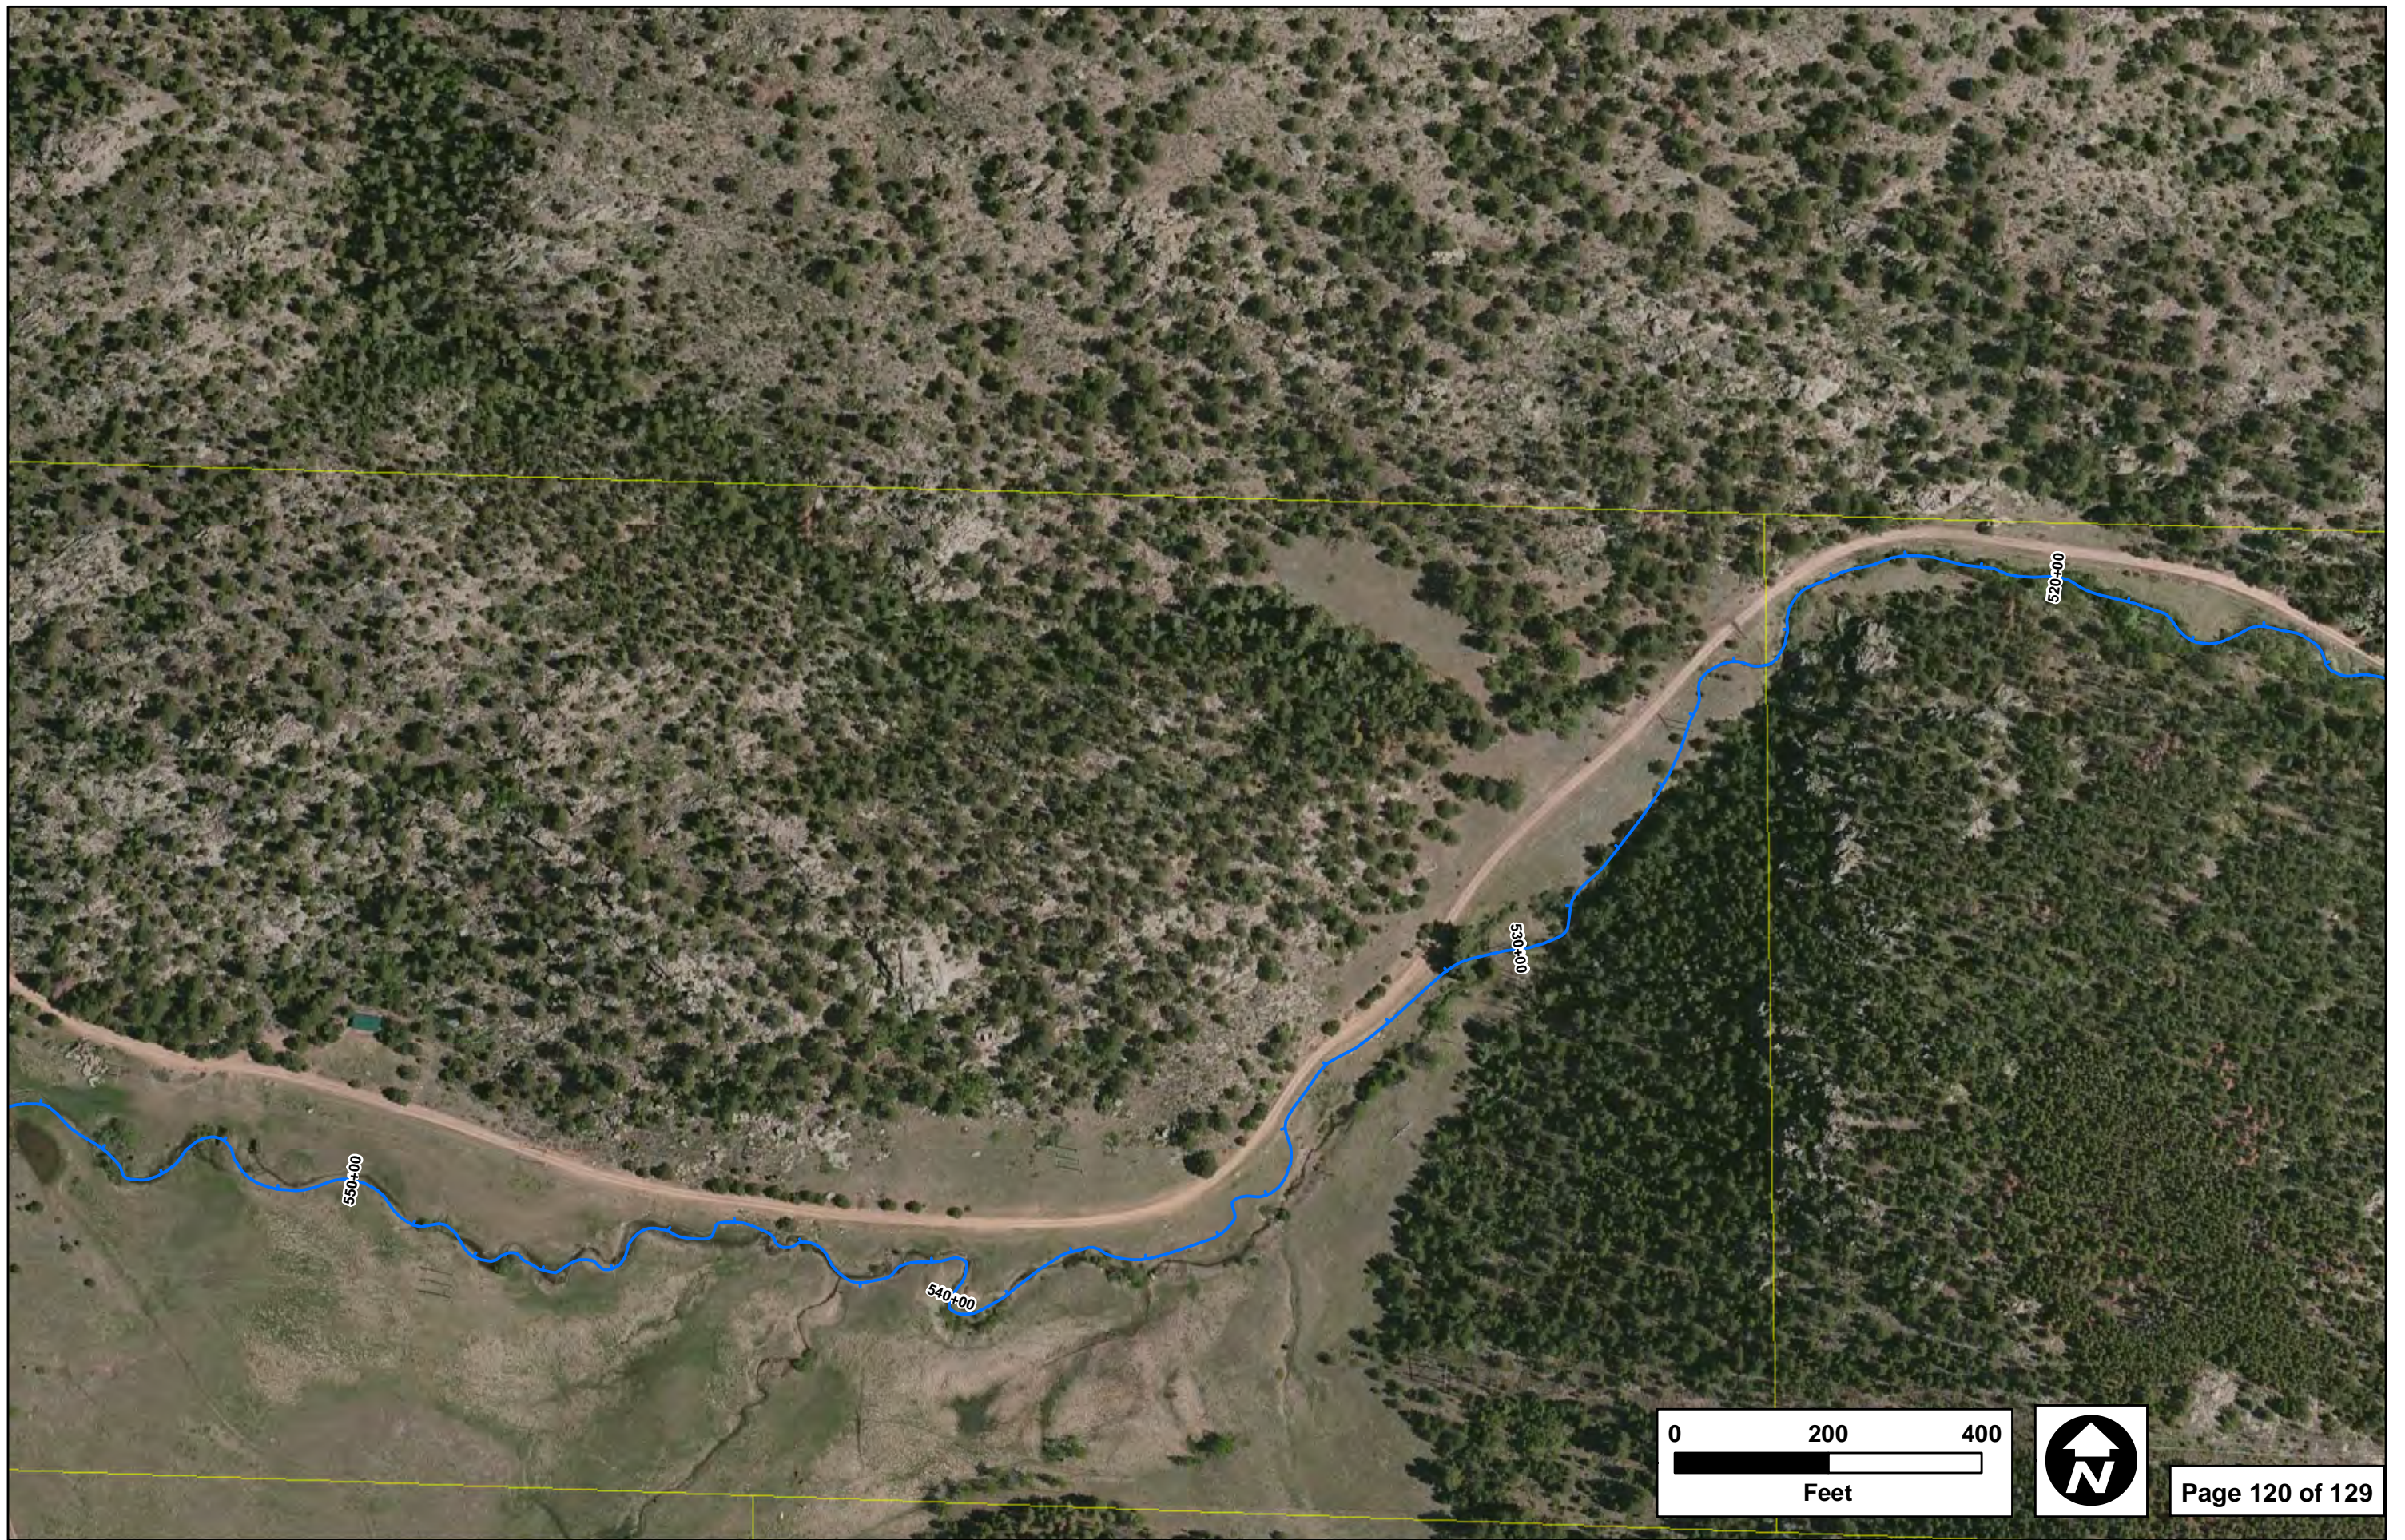
**NEIGHBORHOOD: Blue Mountain****SHEET: 121****STATION: North Fork—upstream of Pole Hill**

This section of the North Fork is within the boundaries of the Roosevelt National Forest although some private land ownership exists. Aerial photos of pre-flood conditions and anecdotal information indicate the lower portion of this reach is transitions between steep sections and meadows typical of headwater regions in the Rocky Mountains.
