# **APPENDIX A**

# **ASSESSMENT PROTOCOL**

# **APPENDIX C**

# **SITE DESCRIPTIONS**

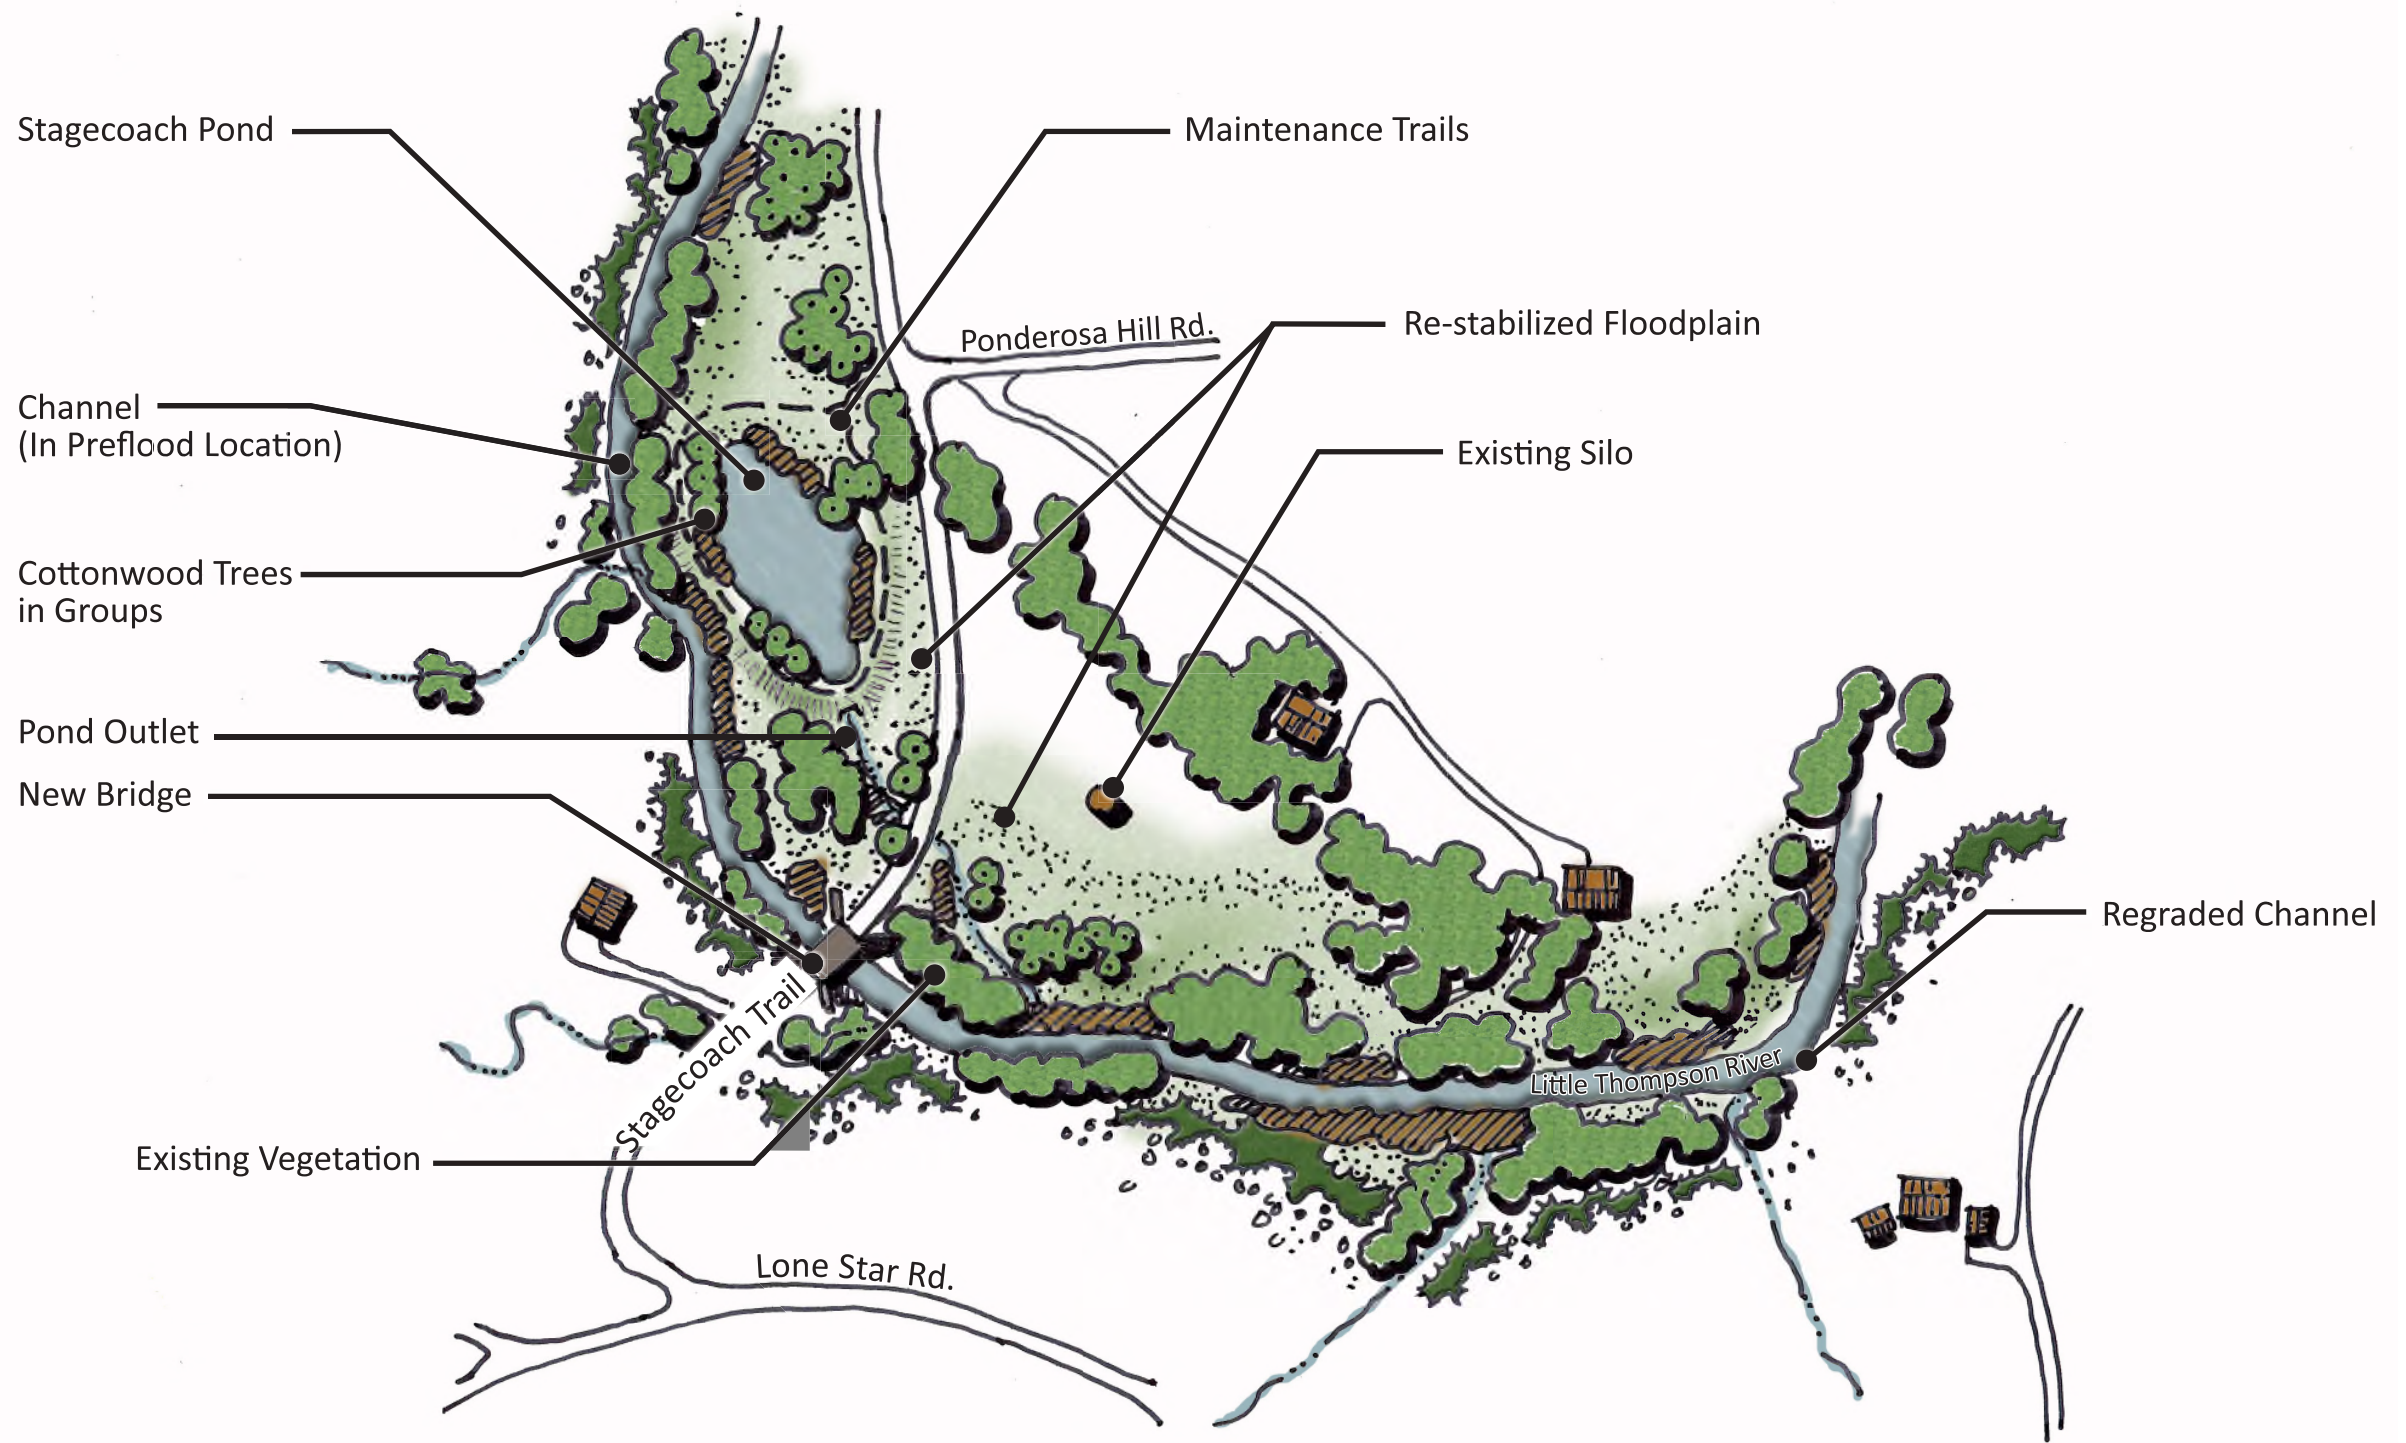
# Stagecoach Trail Blue Mountain (SH 59)

Stagecoach Pond

Maintenance Trails
