Report No. CDH-DTP-R-82-8

# THERMAL INSULATION AND PREFERENTIAL ICING OF BRIDGE DECKS

Final Report  
December, 1982

Prepared in cooperation with the  
U.S. Department of Transportation  
Federal Highway Administration

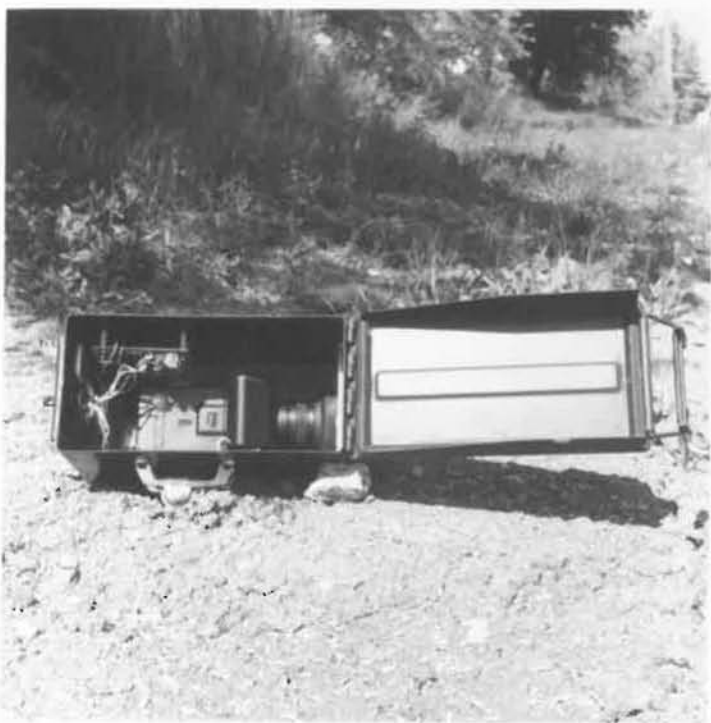
Figure 8

Time Lapse Camera  
Mounted In Box

A visual record of the condition of the bridge deck and approaches was obtained using an 8-mm movie camera. The three cameras were each mounted in an army surplus ammo can (see Figure 8). Holes were cut in each box for the view finder, the lens and the usage indicator. A special electronic circuit was built to turn the camera on and take a single frame once every 8 minutes. Four D-cell alkaline batteries were used for power and could operate this system for about ten days, while a 50-foot roll of film would last for 20 days.

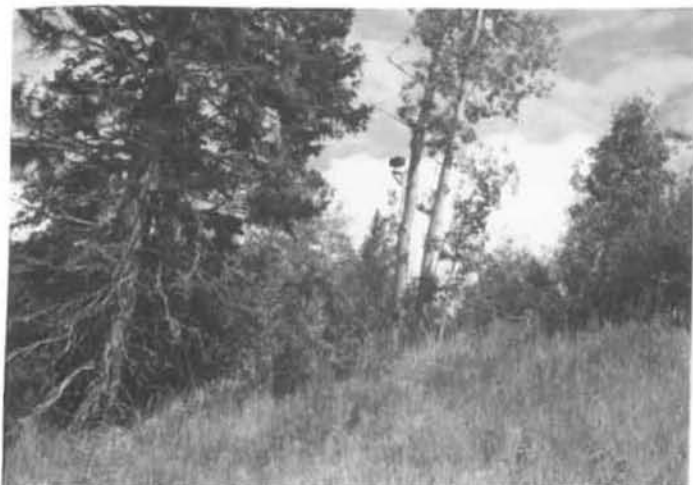
Figure 9

Polk Creek Camera  
Mount

Each camera was mounted to view the corresponding approach, insulated section, and standard section of each bridge. For Polk Creek a tree was available at the appropriate spot to mount the camera (see Figure 9). At Miller Creek a steel pole had to be installed for the camera (see Figure 10). At Dowd Junction the camera was mounted on a deer fence uphill from the bridge (see Figure 11). The cameras provided a visual record of the condition of the bridges and approaches during the daytime.

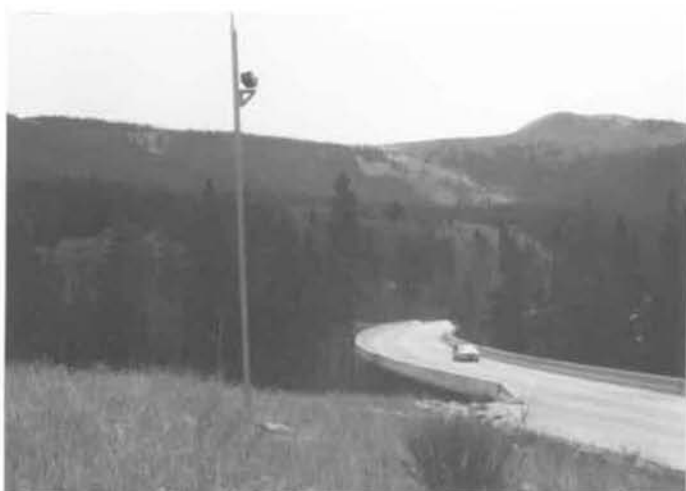
Figure 10

Miller Creek Camera  
Mount

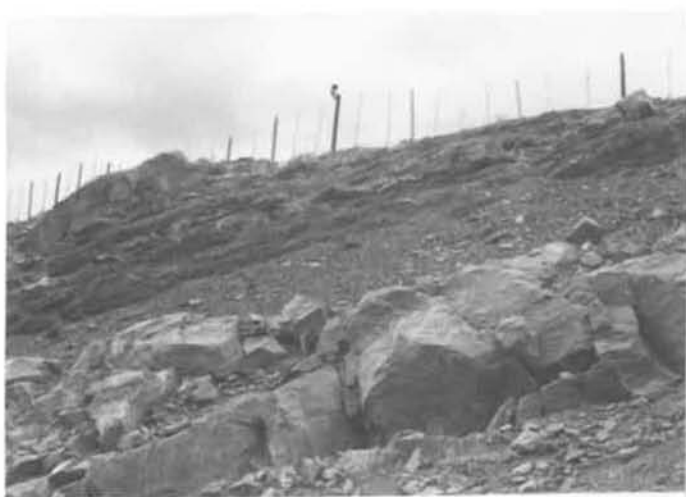
Figure 11

Dowd Junction Camera  
Mount

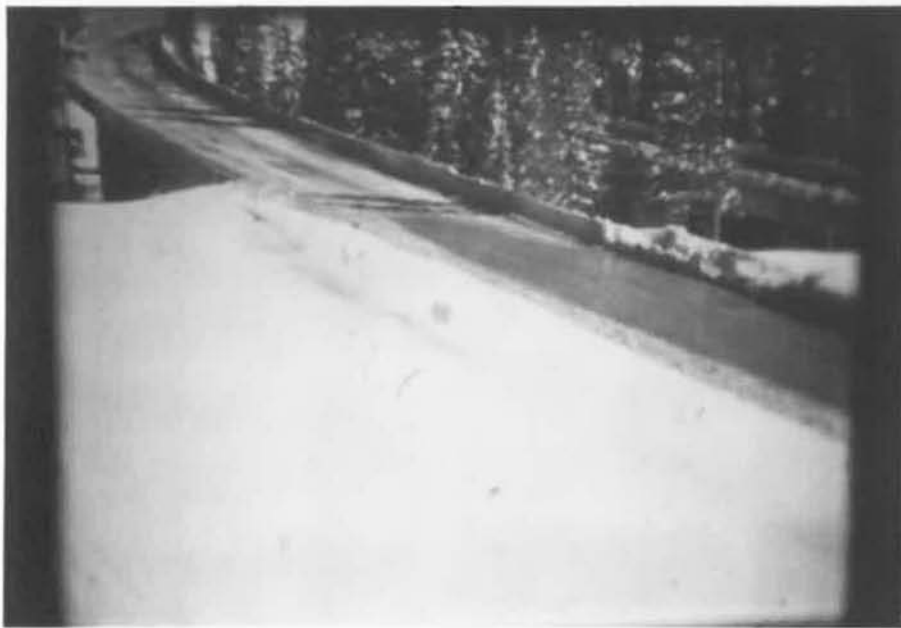
January 10, 1982 Preferential  
Icing Event at Miller Creek

January 10, 1982 at Miller Creek. Figure 21 is an enlargement up of the 8-mm time film for this day at Miller Creek when preferential icing

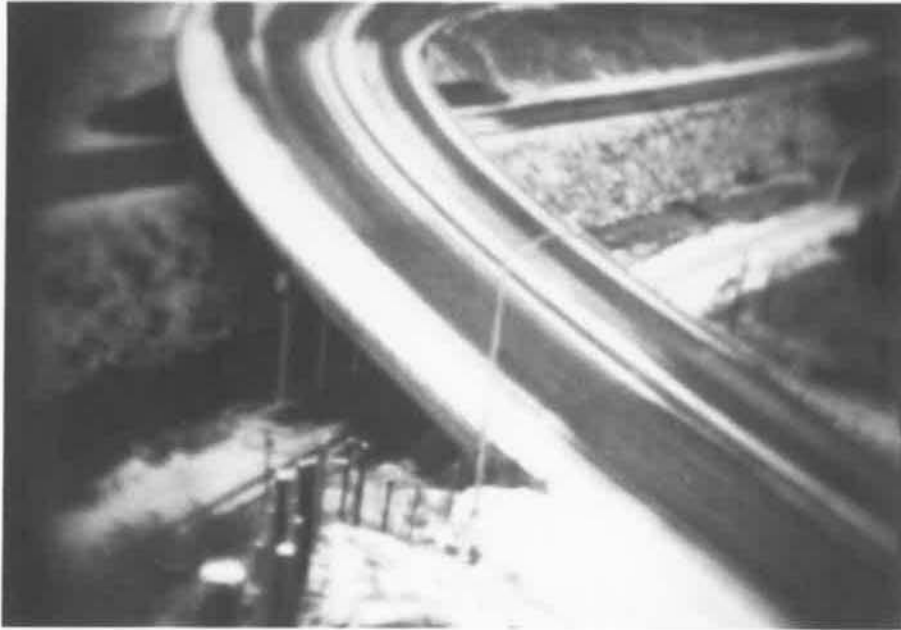
Preferential Icing Event at Dowd Junction

November 6, 1981 at Dowd Junction. Figure 22 shows three levels of snow cover for the roadway at Dowd Junction. The standard section (over the river) has the most snow cover; the insulated section (over the railroad tracks) has less snow cover, and the approach is almost completely clear. Temperatures below the photo are consistent with the visual conclusions.

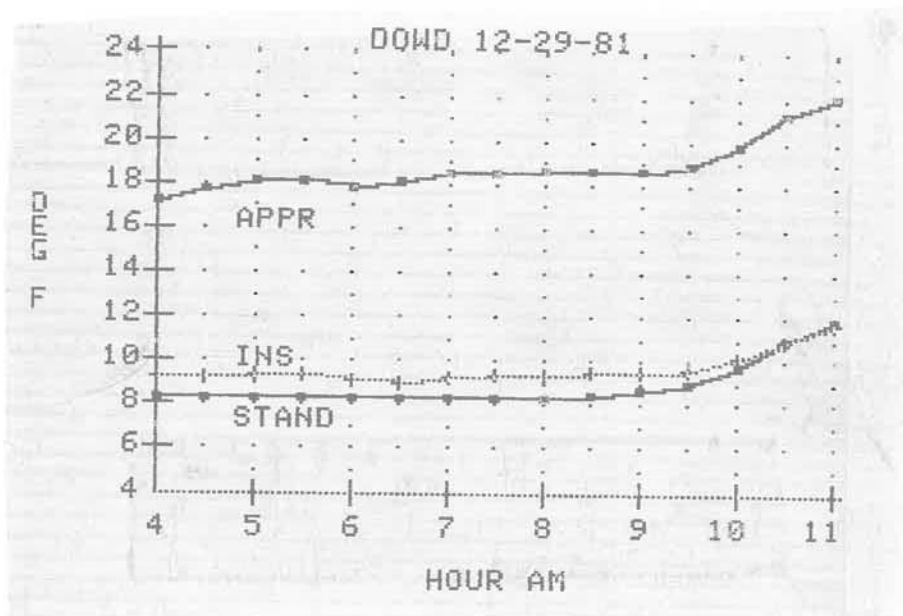
Preferential Icing Event at Dowd Junction

December 29, 1982 at Dowd Junction. Figure 23 shows a wet approach and a snow covered bridge with only a very slight difference between the insulated and standard sections. The temperature data also reflect the visual situation.

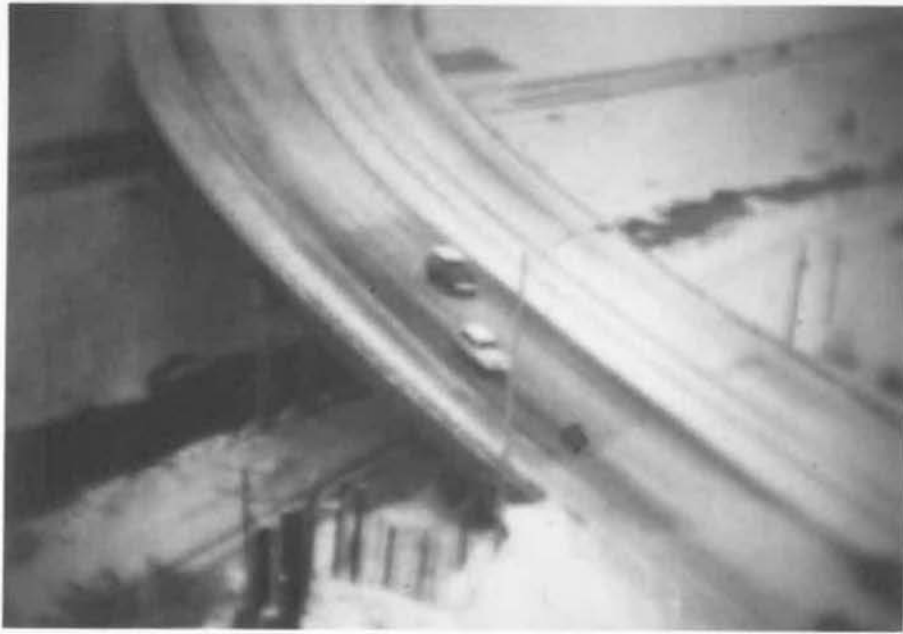
Preferential Icing Event at Dowd Junction

March 3, 1982 at Dowd Junction. Figure 24 shows an unusual situation where the insulated section is actually clearer than the approach.

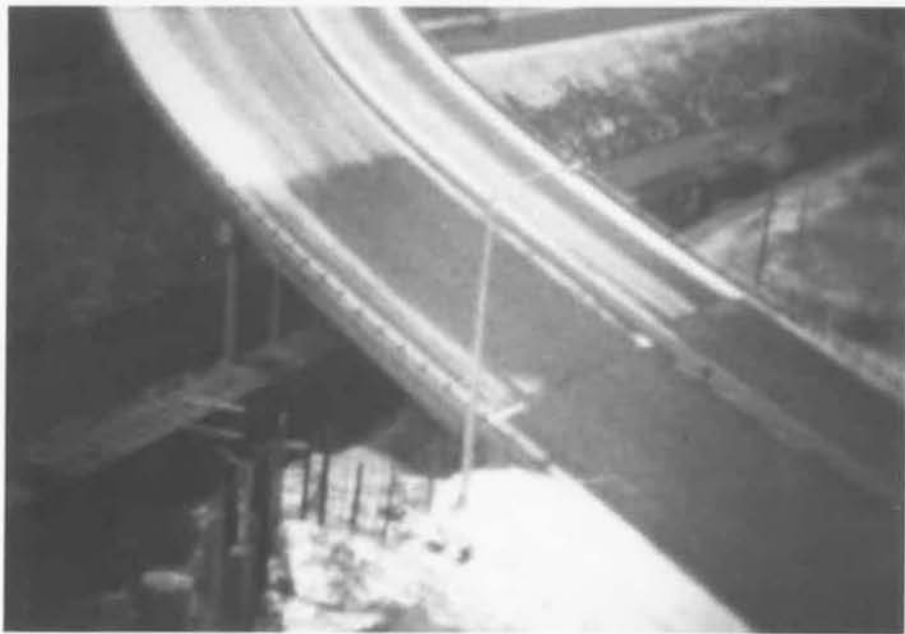
Preferential Icing Event at Dowd Junction

April 3, 1982 at Dowd Junction. Figure 25 gives a very clear picture of how the insulation can make the bridge deck behave like the approach even when the rest of the deck is snow covered.

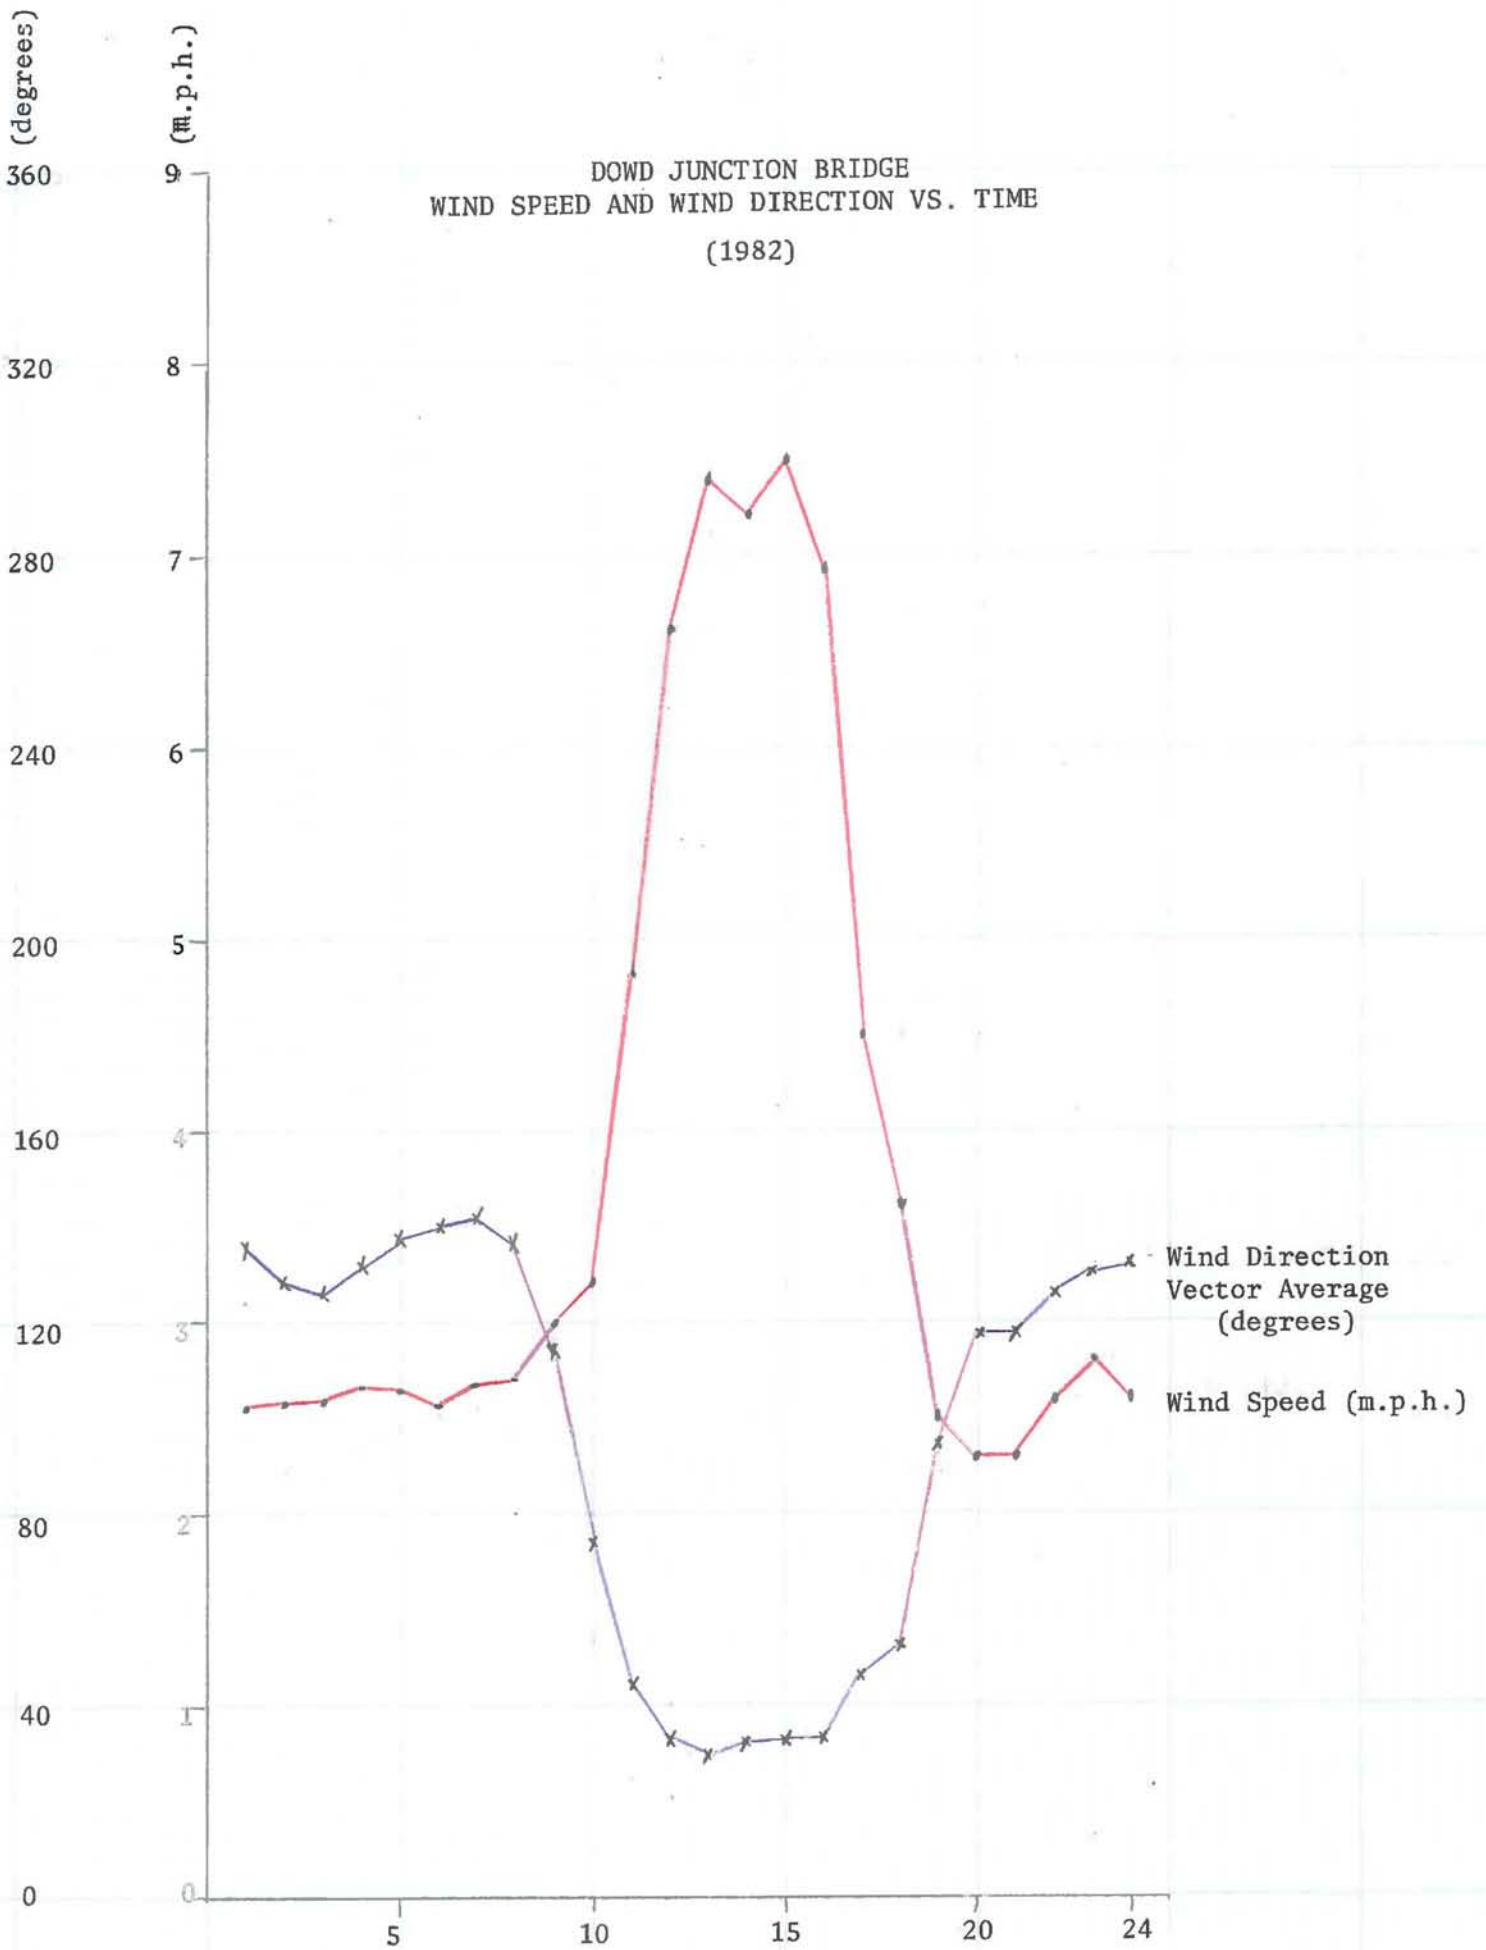
DOWD JUNCTION BRIDGE  
WIND SPEED AND WIND DIRECTION VS. TIME  
(1982)

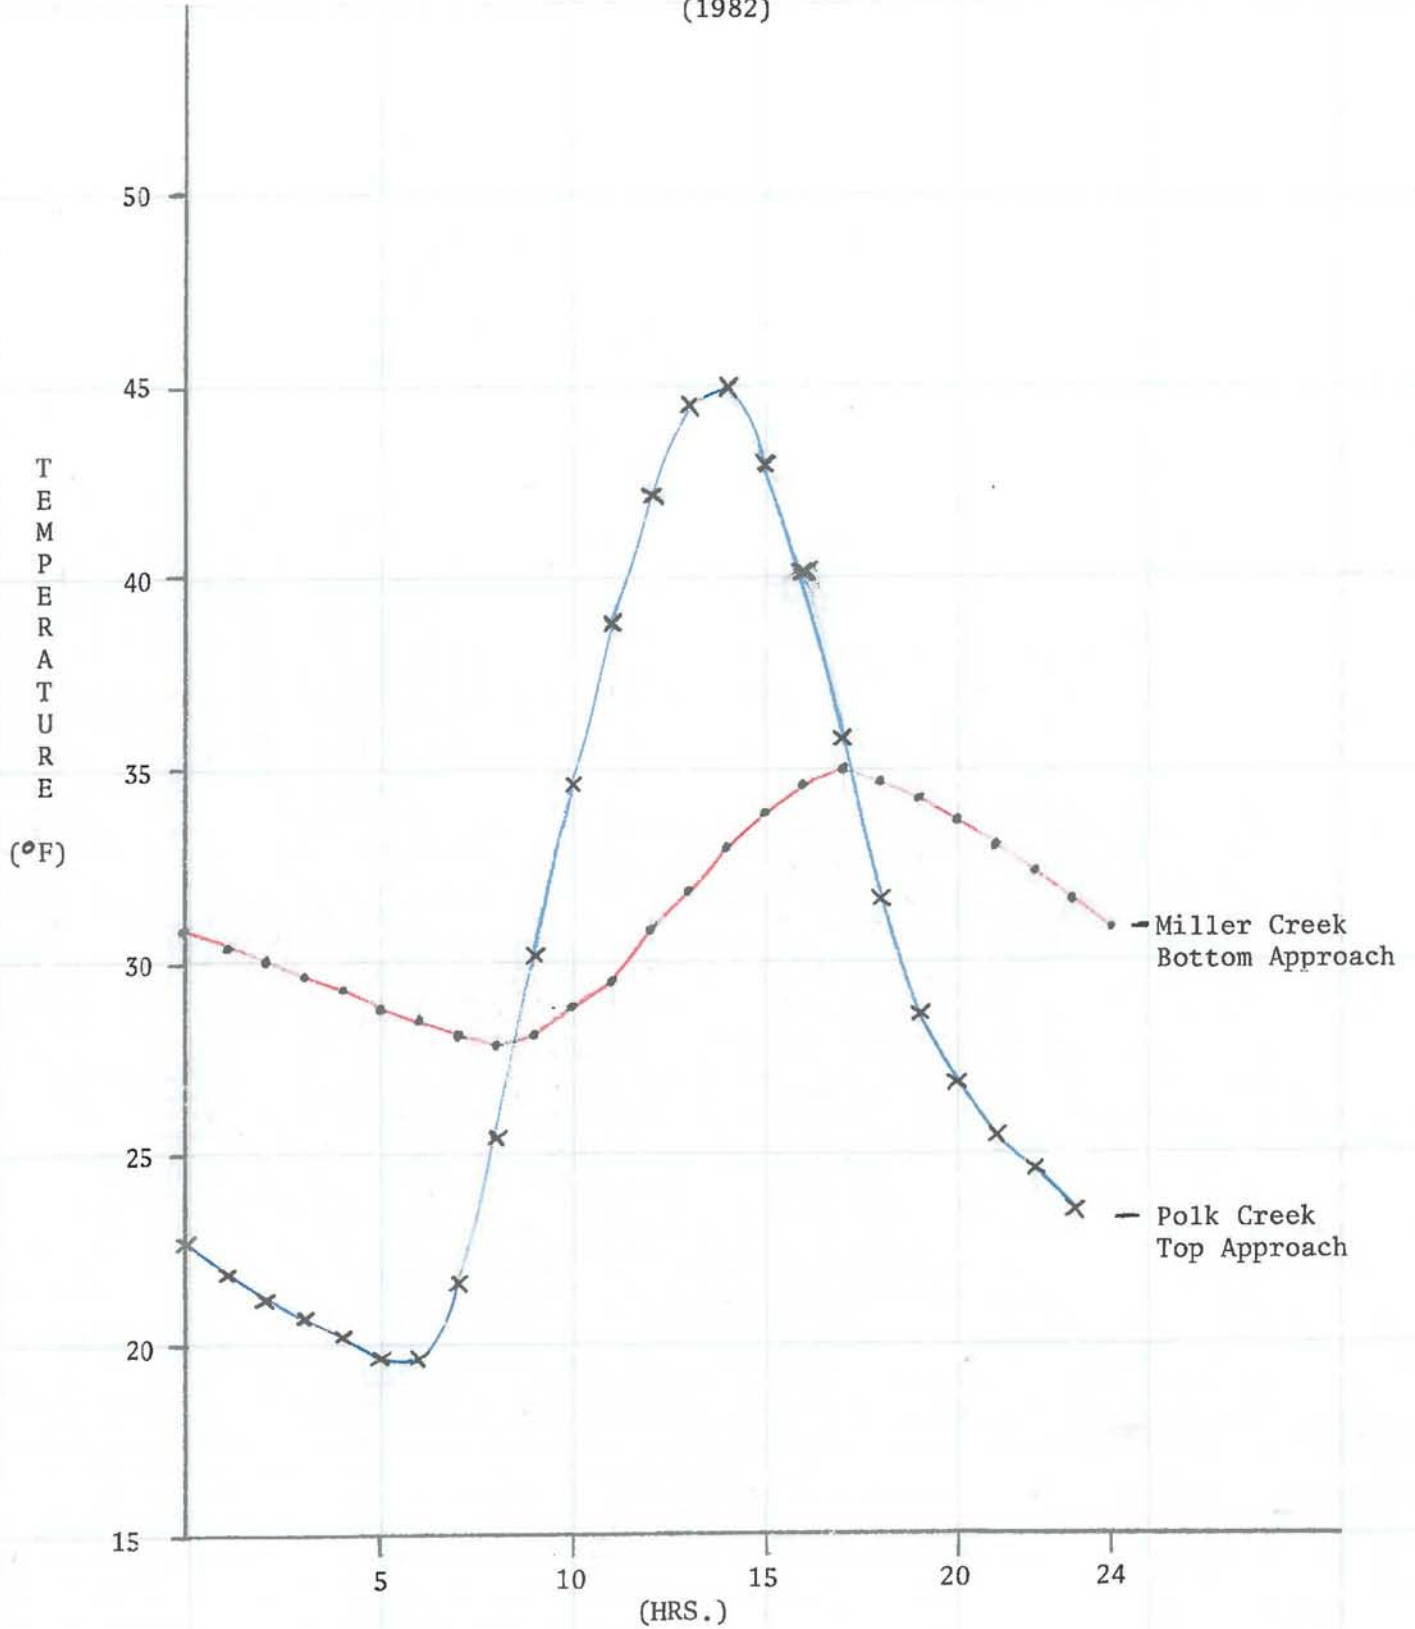
TOP APPROACH POLK CREEK AND  
 BOTTOM APPROACH MILLER CREEK  
 AVERAGE TEMPERATURE FOR EACH HOUR  
 (1982)

The only two available approach temperatures were plotted on Figure A-9 and A-10. Both the top and bottom approach temperatures are more stable than their corresponding bridge temperatures. This is expected because of the thermal mass of the earth below. Herein is the basic cause of preferential icing.

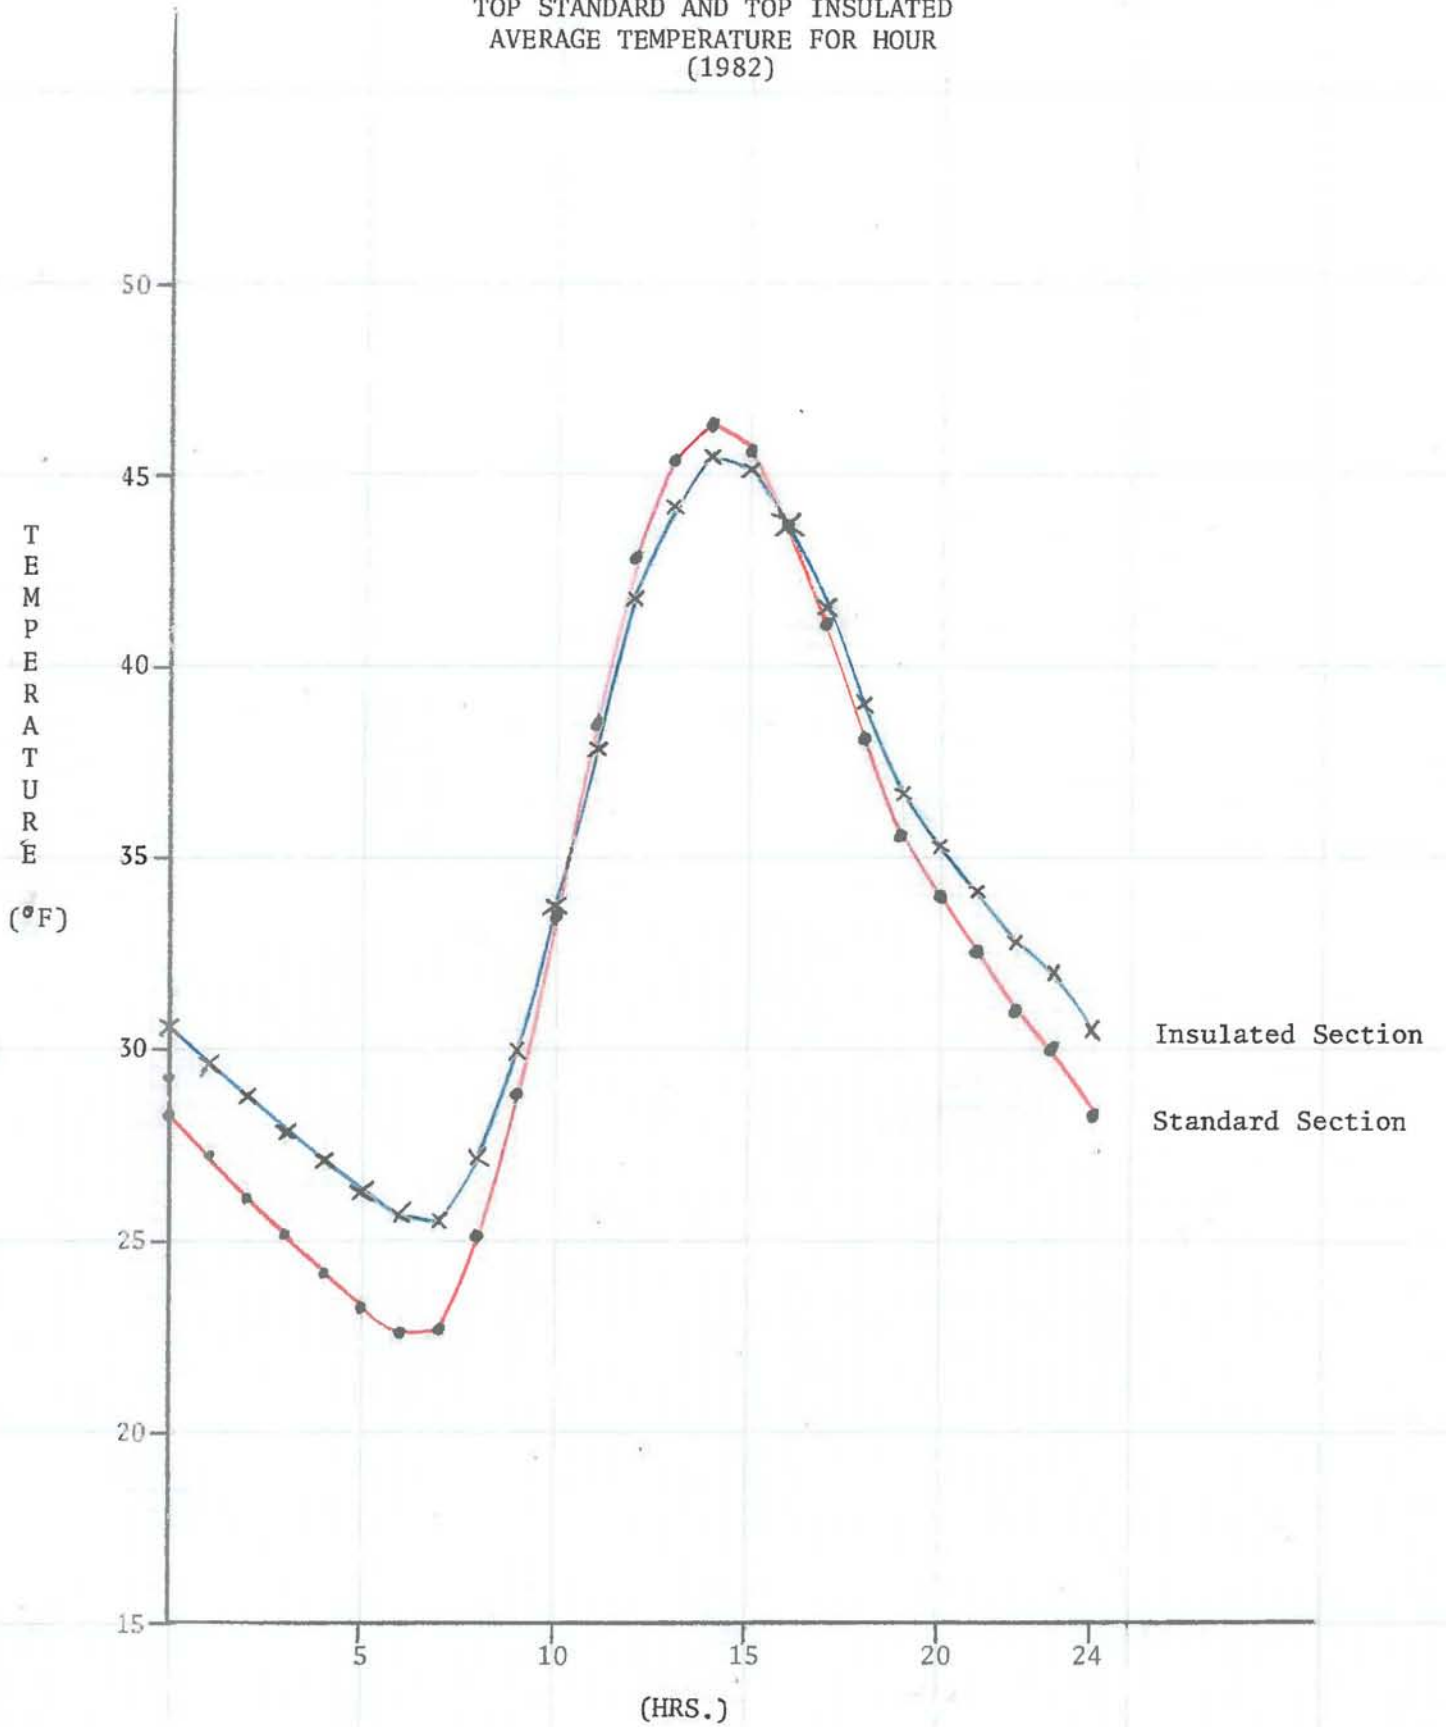
DOWD JUNCTION BRIDGE  
TOP STANDARD AND TOP INSULATED  
AVERAGE TEMPERATURE FOR HOUR  
(1982)

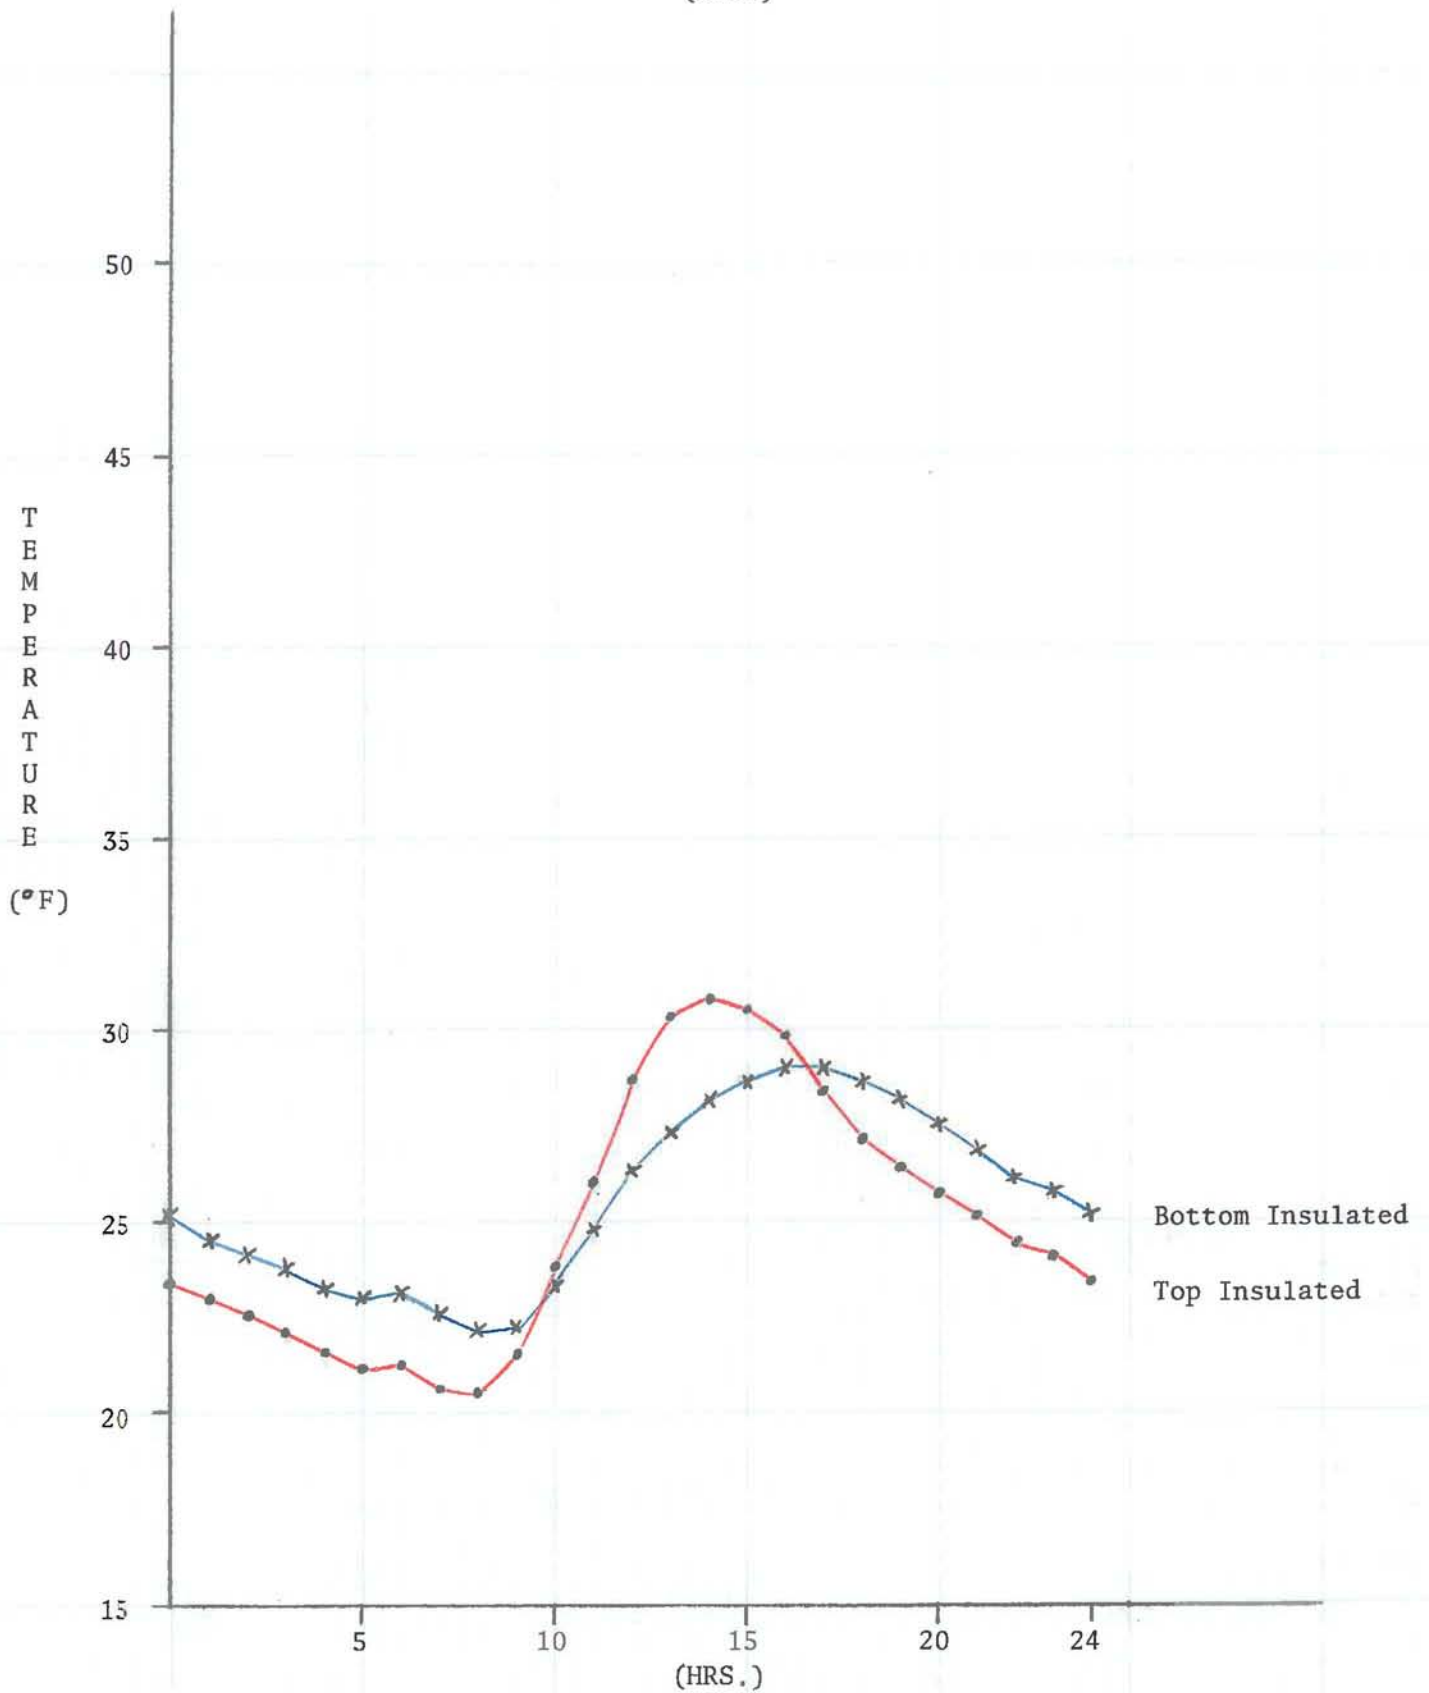
DOWD JUNCTION BRIDGE  
TOP INSULATED AND BOTTOM INSULATED  
AVERAGE TEMPERATURE PER HOUR  
(1981)

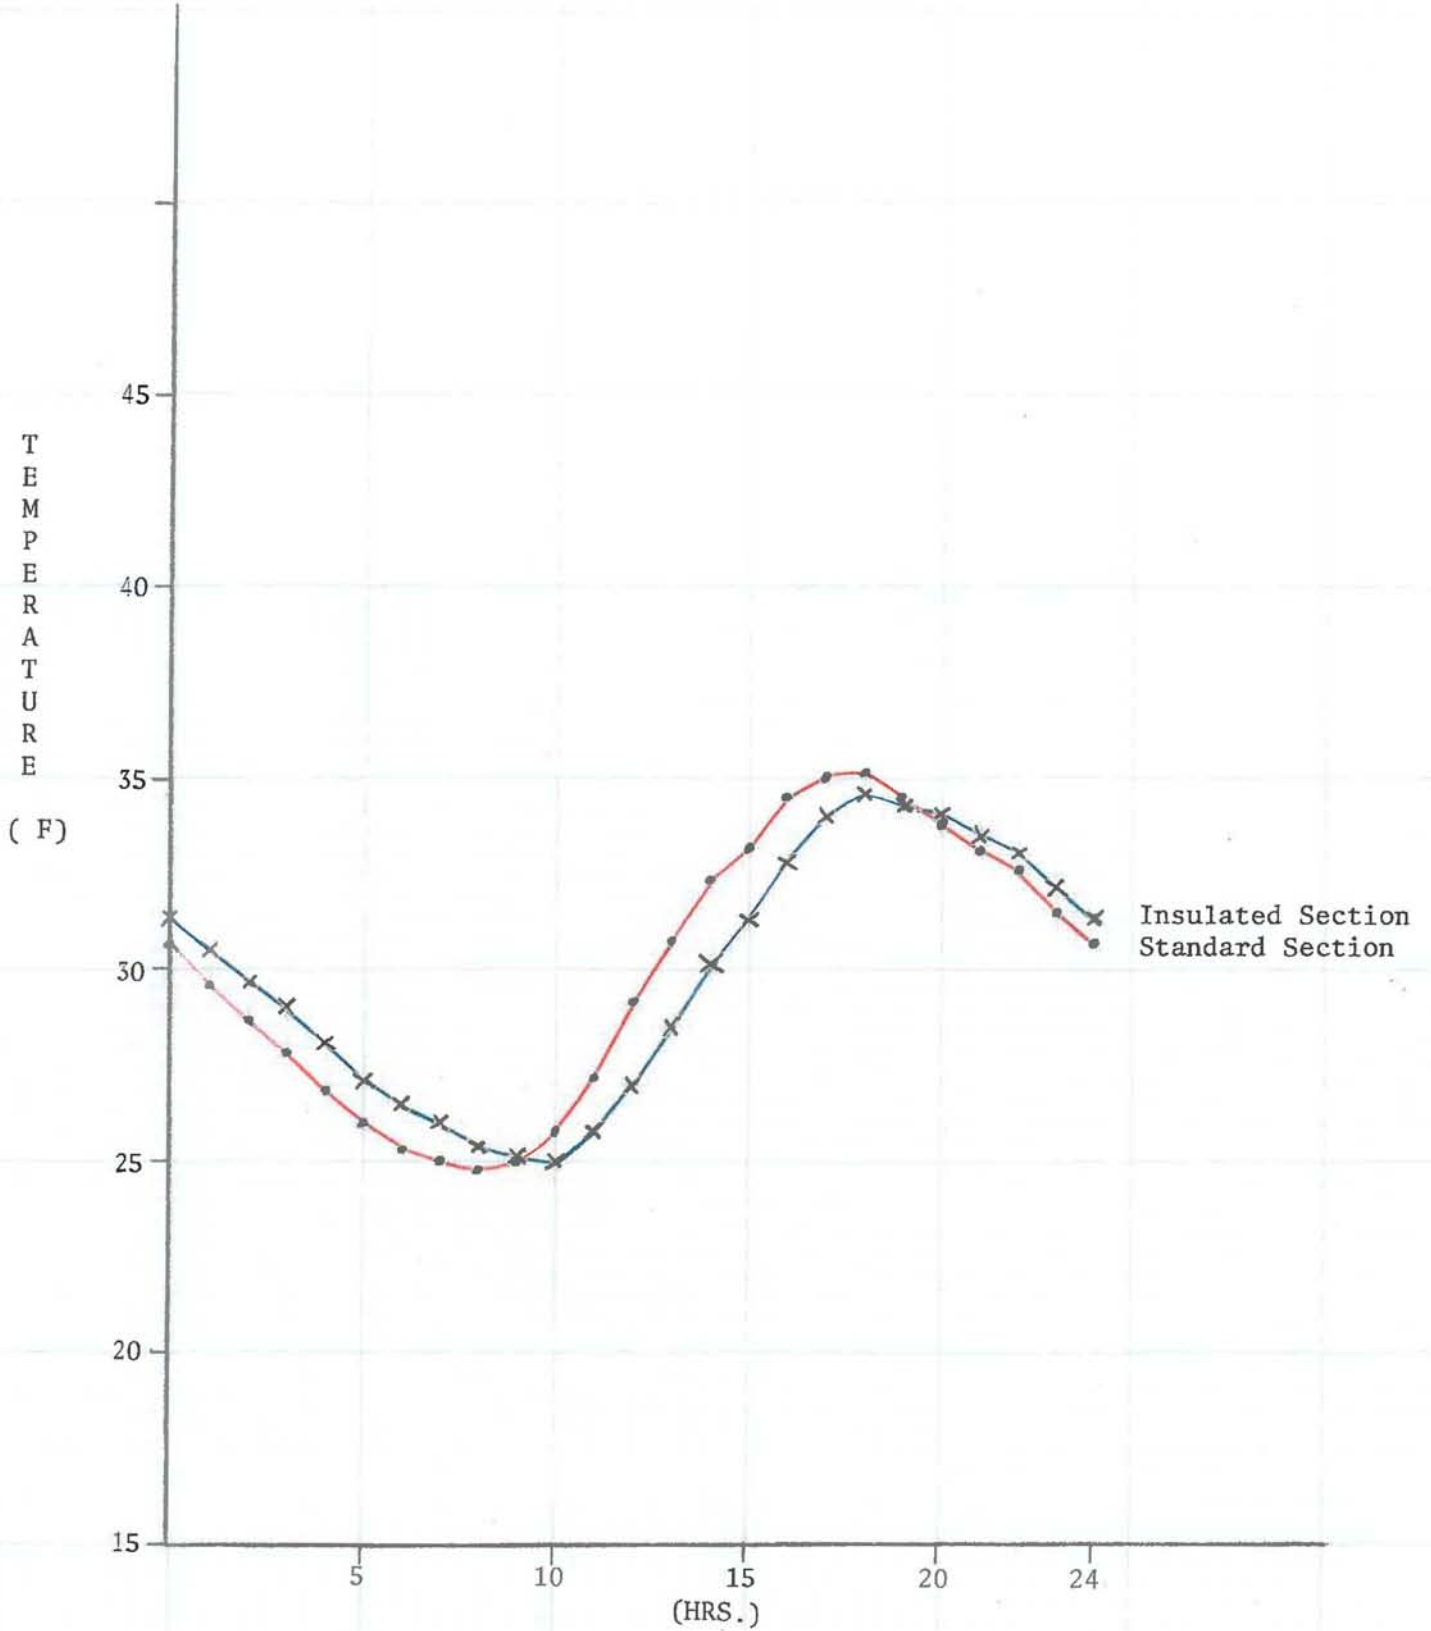
POLK CREEK BRIDGE  
BOTTOM STANDARD AND INSULATED  
AVERAGE TEMPERATURE FOR EACH HOUR  
(1982)

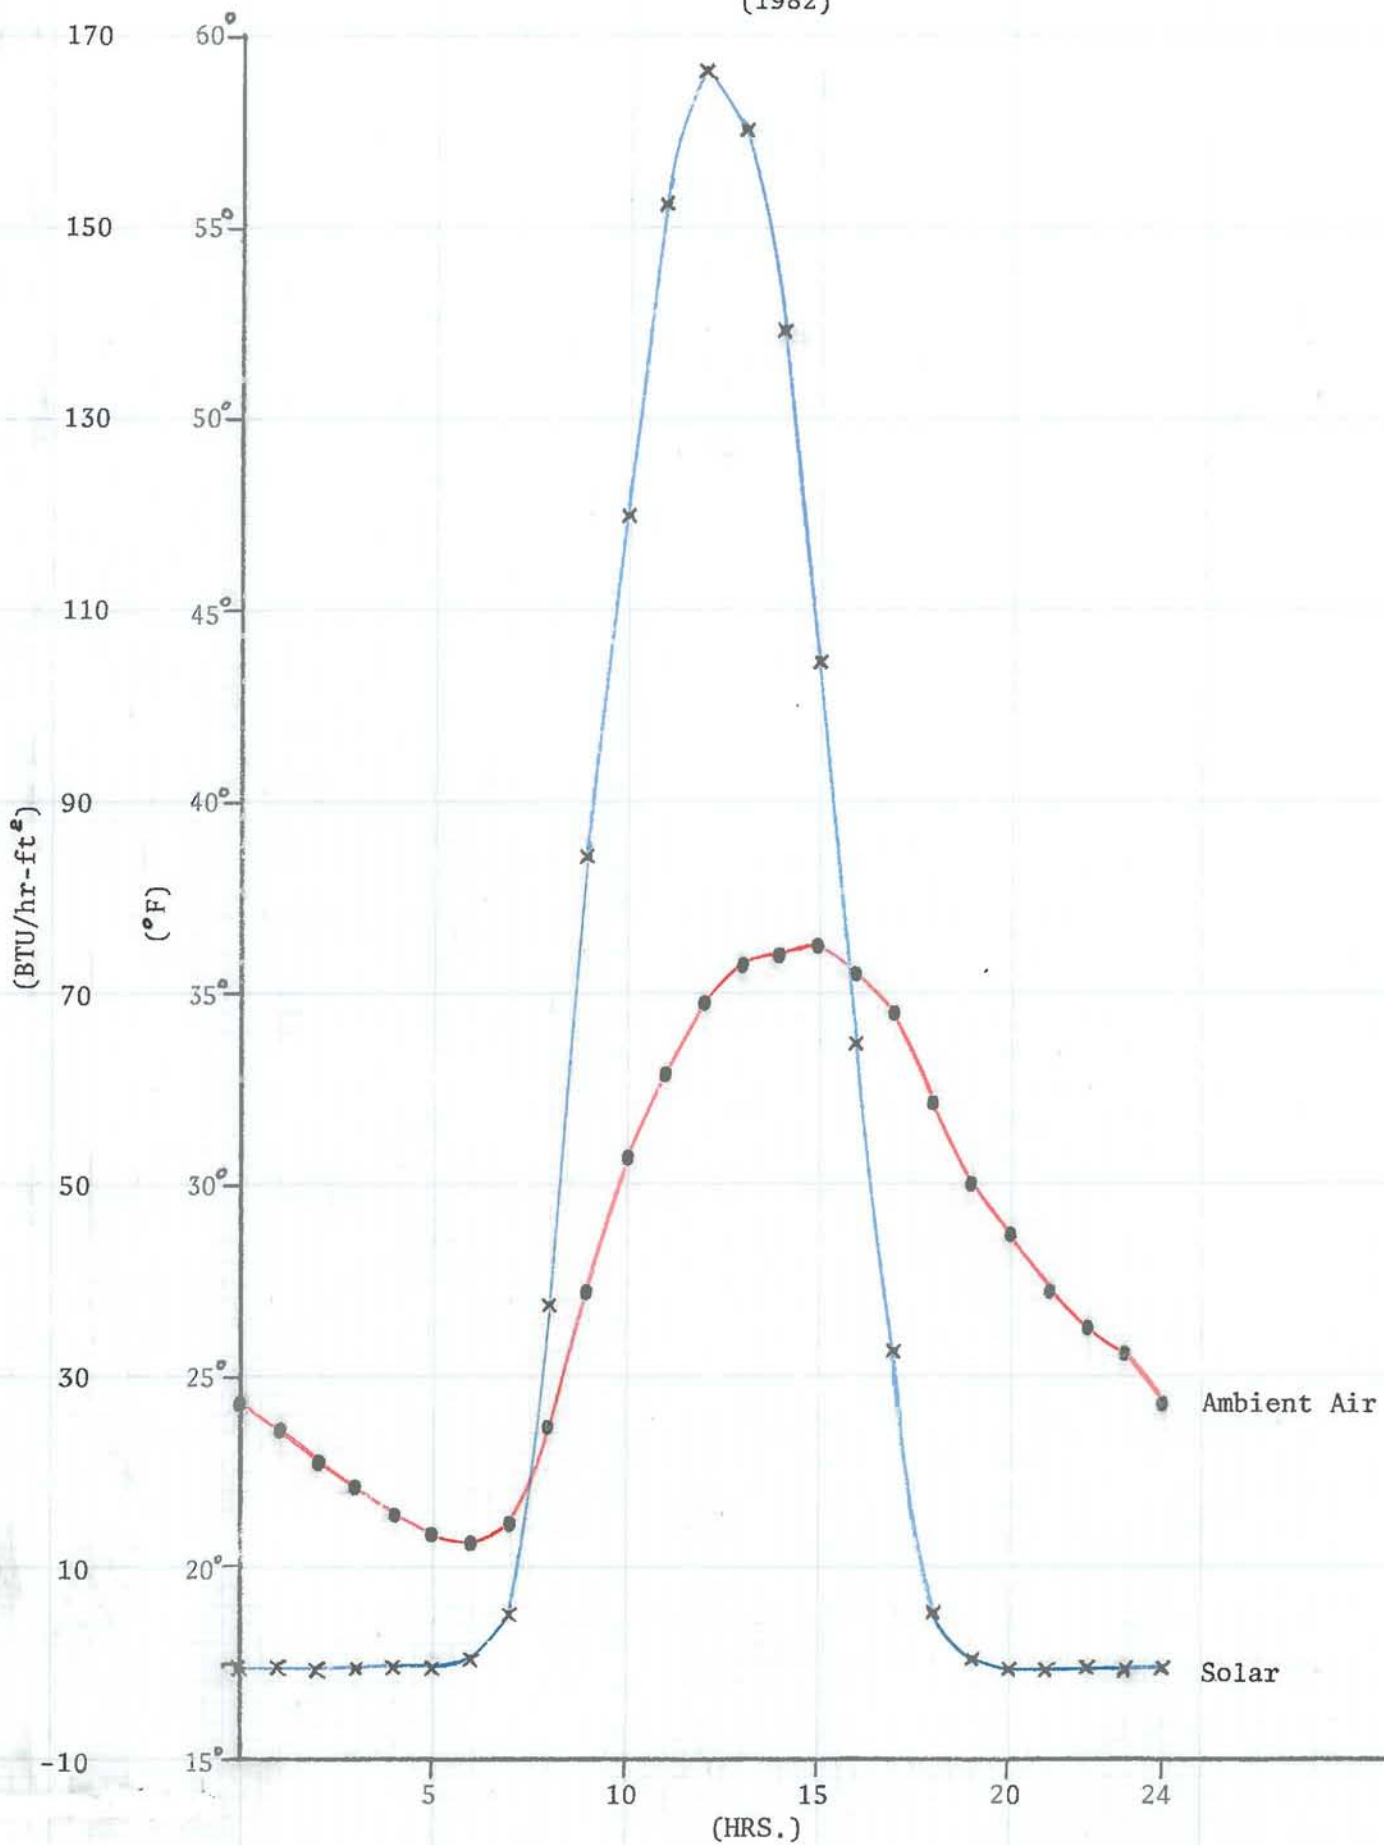
DOWD JUNCTION BRIDGE  
 SOLAR AND AMBIENT AIR VS. TIME  
 (1982)

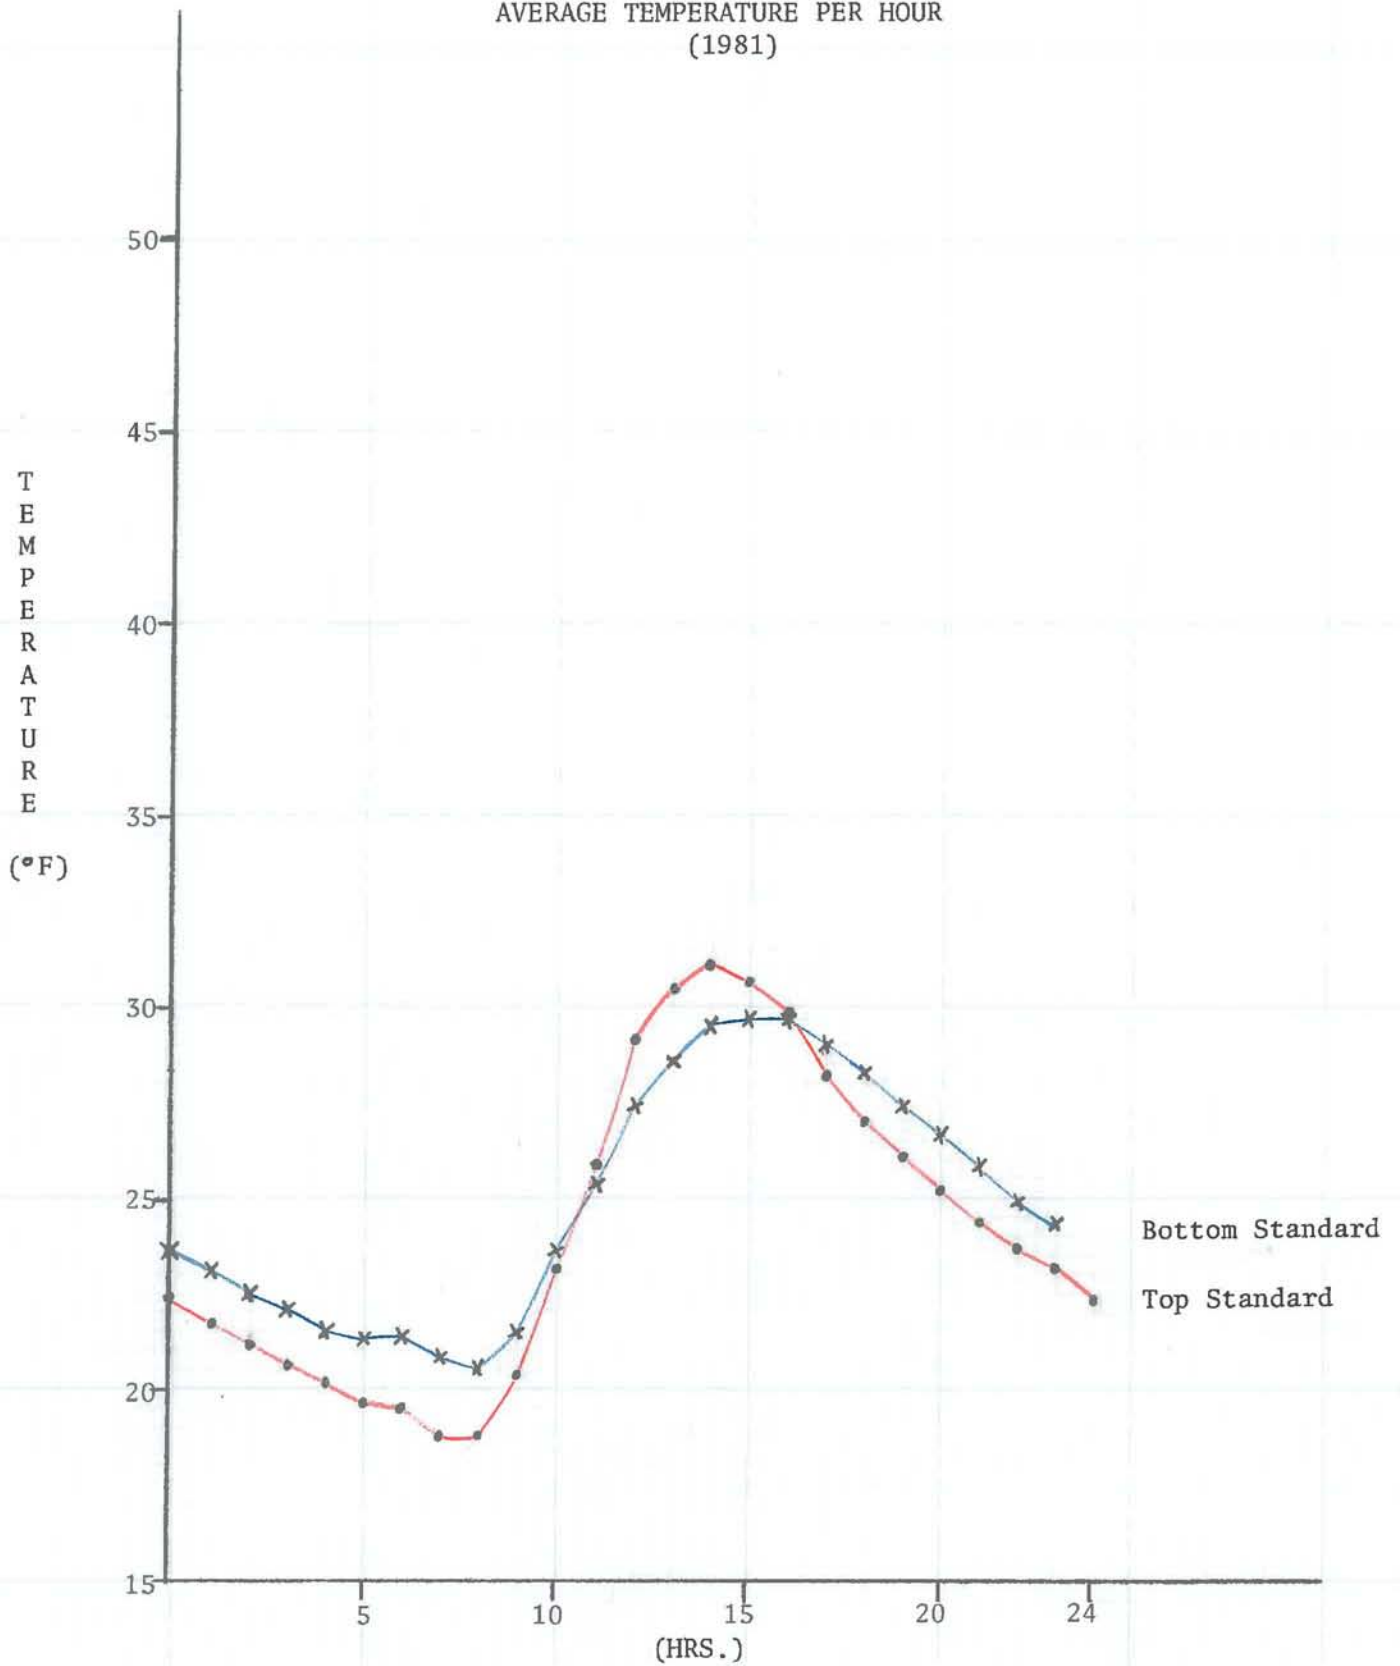
DOWD JUNCTION BRIDGE  
TOP STANDARD AND BOTTOM STANDARD  
AVERAGE TEMPERATURE PER HOUR  
(1981)
