Report No. CDH-DTP-R-82-8

# THERMAL INSULATION AND PREFERENTIAL ICING OF BRIDGE DECKS

Final Report  
December, 1982

Prepared in cooperation with the  
U.S. Department of Transportation  
Federal Highway Administration

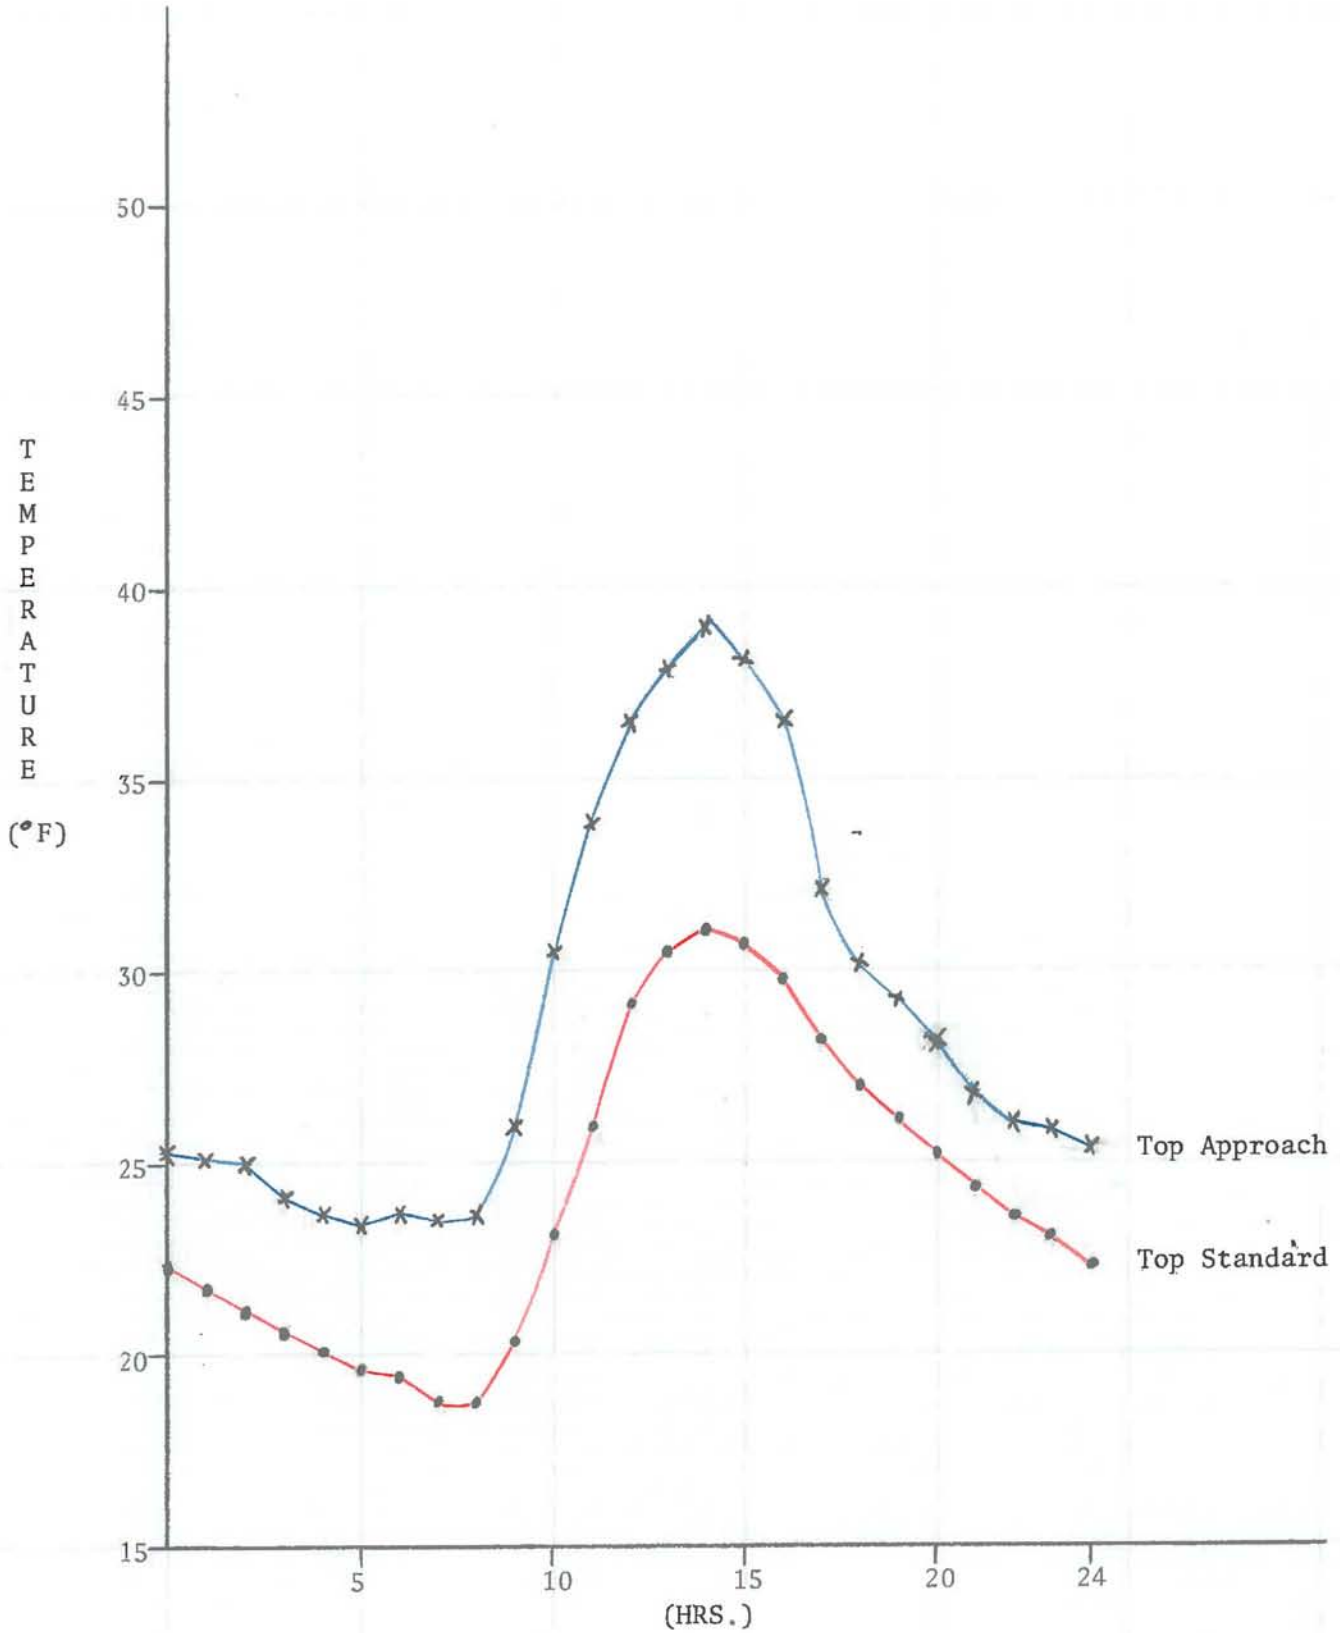
DOWD JUNCTION BRIDGE  
TOP STANDARD AND TOP APPROACH  
AVERAGE TEMPERATURE PER HOUR  
(1981)

Dowd Junction. For Dowd Junction the insulation reduced the potential for preferential icing from 83% to 73% in 1981 and from 47 to 39% in 1982. Overall this corresponds to a reduction in preferential icing potential from 58.2% to 50.4%. For this analysis it is assumed that the lower temperature of the bridge was the predominant cause of the accident; i.e. if the bridge temperature was as warm or warmer than the approach, the accidents would not have happened. This assumption will result in calculating the upper limit of benefit/cost of the insulation. Since the economic loss due to icy bridge accidents for three years was \$62,370, the average cost for one year (1980) should be one-third of this or \$20,790. Based on the 1980 Traffic Volume Study (Reference 3), the year 2000 traffic will be 18 times 1980 traffic. Similarly, the accidents and costs will increase at the same rate which is \$875 per year. By the end of 1983 (the earliest date bridge insulation could be complete), annual accident costs will have increased \$875 per year to \$23,415. If we assume a 4% interest rate over and above inflation\* and a life expectancy of the insulation system for 20 years, present value of these accident costs can be computed as follows:
