Rockfall in Colorado

Rockfall incidents will happen in Colorado, but in some cases rockfall can be avoided or mitigated. This issue of *RockTalk* covers the wide-ranging issues related to this geologic hazard.

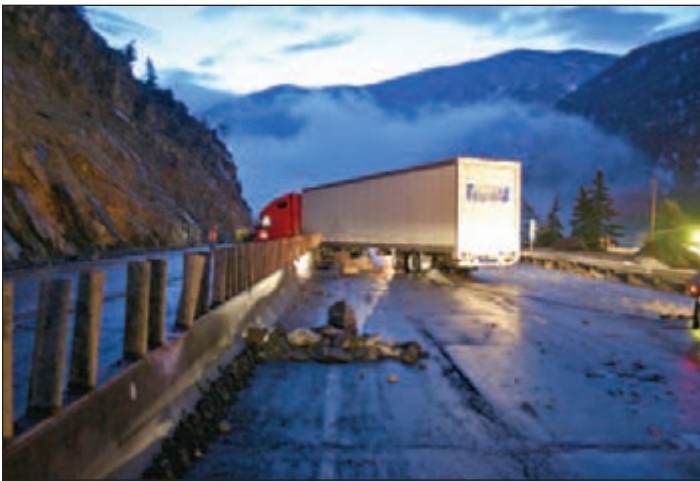
A semi-truck collided with a fallen rock on Interstate 70 near Georgetown in April, 2004. Fallen rocks around bends in the highway or night-time rockfalls may not be visible to drivers, and can lead to accidents. (Photo by CDOT, 2004)

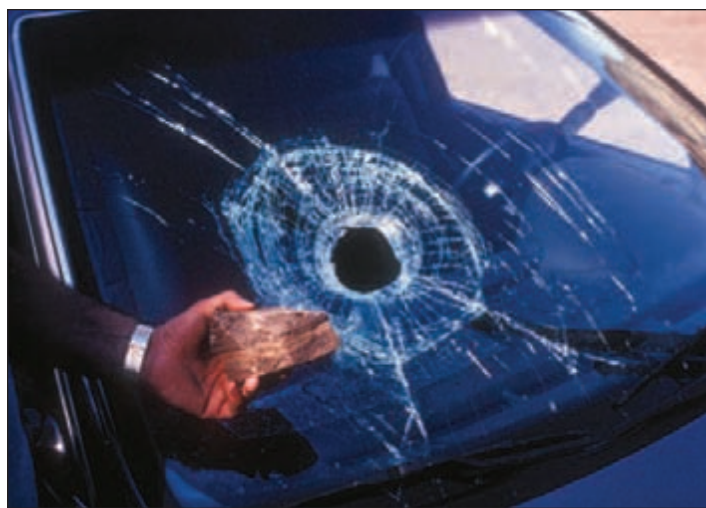
Figure 1: Rockfall accident in Glenwood Canyon. This hand-sized rock free fell 300 feet before striking the vehicle. The driver was unhurt and, luckily, there was no front seat passenger. (Photo by Jon White.)

By their very nature, rocks are heavy—and when traveling at 60 feet per second or more, their energy upon impact is frightful to consider. Rockfall events can instantly demolish structures and kill people unfortunate enough to be in their way. Even a single baseball-sized falling rock has the potential for deadly consequences (Figure 1).

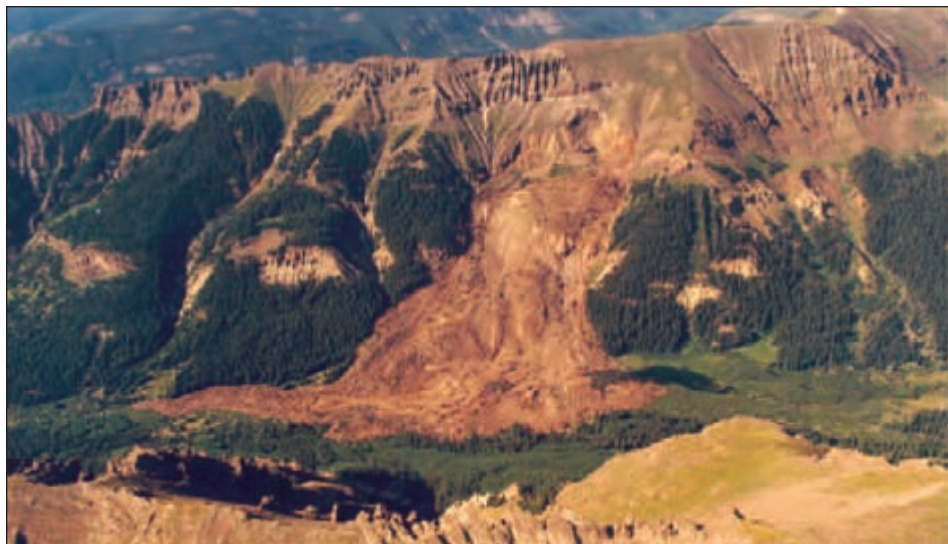
Figure 5: The July 1991 West Lost Trail Creek rockslide in Hinsdale County, Colorado. This estimated 10 million cubic-yard rock and debris avalanche began as a massive rockslide. (Photo from CGS archives.)

Rockfall in the extreme form is a **rock avalanche** that completely buries the existing ground. When a rockslide occurs with enough mass and long steep slopes, such as a flank of an entire mountain, it quickly becomes a catastrophic landslide. Figure 5 shows the 1991 West Lost Trail Creek landslide in the San Juan Mountains. This gigantic landslide began as a rock avalanche on the flank of Pole Creek Mountain and quickly grew into a large avalanche as it accelerated down the steep slopes to “flow” onto the valley floor.

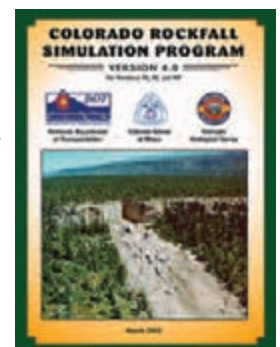
Figure 6: Documentation and user's manual for the Colorado Rockfall Simulation Program, version 4.0, available from the CGS.

CRSP has been revised and re-calibrated in later versions. Today, CRSP Version 4.0 is the current version available. CGS sells the program and a user's manual for \$25 through the CGS online bookstore (<http://dnr.state.co.us/geostore/Search.aspx?Keyword=CRSP>) (Figure 6). Stay tuned, though. The CDOT Rockfall Program is financing the development of a wholly revised CRSP that should be available within a couple of years.

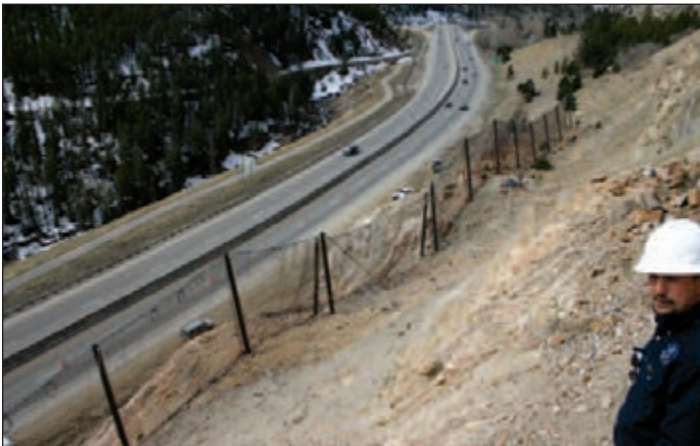
Figure 11: Wire rope rockfall fence installed on a rock slope at Georgetown Hill above Interstate 70. Exit ramps shown in the upper part of the photo are for the Silver Plume Exit. (Photo courtesy of Ty Ortiz, CDOT.)

Protection concepts accept that rocks will fall in a hazardous area, but structures and roadways can be acceptably shielded from rockfall, or sufficiently reinforced to withstand the impact without adverse damage or loss of functionality. Rockfall protection designs come in many forms. Rockfall barriers are designed to stop falling or rolling rocks. They can be constructed in the form of a large earthen wall or berm, or specialty fences built with strong, steel cable netting. Earthen barriers often include a ditch in back to provide extra space to accommodate falling and rolling rocks and associated debris. A good example of both earthen rockfall berms and impact walls is at the Booth Creek rockfall site in Vail. Photos of these barriers are shown in the case history article. Rockfall fences can be seen at many locations around the state, the most notable of which can be seen alongside and above Interstate 70 on the Georgetown Hill (Figure 11). Rockfall fences are well suited in rugged terrain and very steep slopes where impact walls and rockfall catchment ditches are not feasible. Another method of protection from rockfall is constructing a rockfall shed over the road or structure, similar to an avalanche protection shelter. This technology is the most expensive protection option, but is well suited to locations where rockfall is consistently severe, and where other protection devices would likely fail under repeated rockfall events.

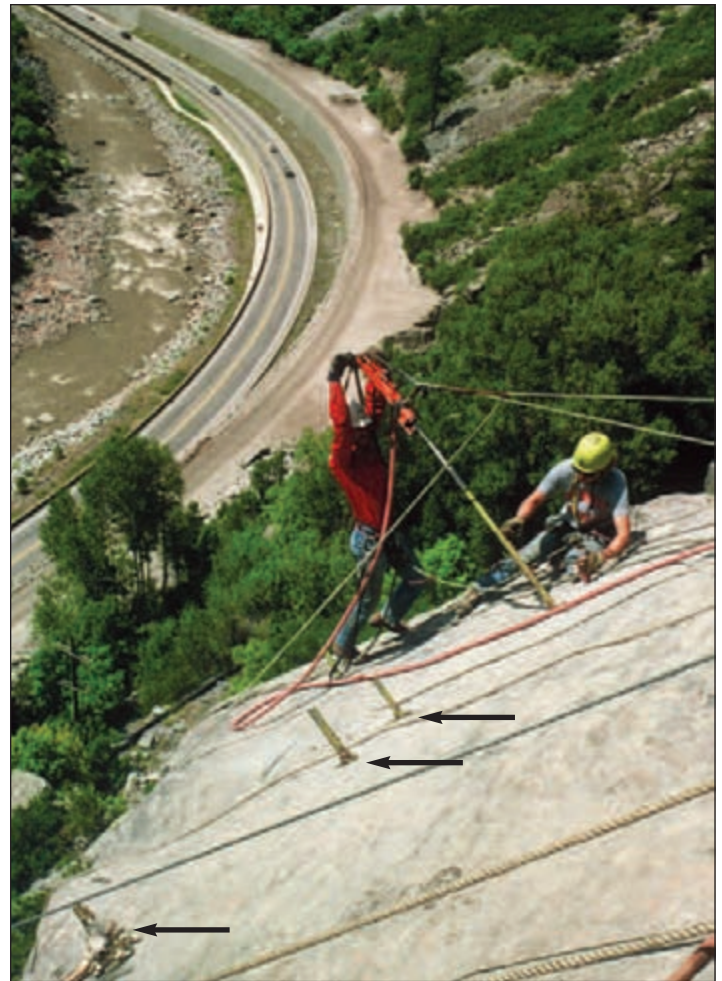
Figure 12: Installation of rockbolts on the rocky slope of Glenwood Canyon during the Interstate 70 highway construction project in 1991. The worker is spinning an epoxy-coated steel bar into the drill hole using a pneumatic drill. The protruding bars in the foreground (shown by arrows) are installed rockbolts. (Photo by Jon White.)

Rock bolts, or dowels, are long steel bars that are cemented into drill holes in the rock with a concrete or epoxy-like mortar (Figure 12). Many times these rock bolts are tensioned with a hydraulic ram and then a nut is tightened at the surface to lock the bolt, which puts the rockmass in compression (forces the rock together) and applies additional frictional forces at the discontinuity surfaces they cross, which counteract gravitational forces and hold critical planar or wedge

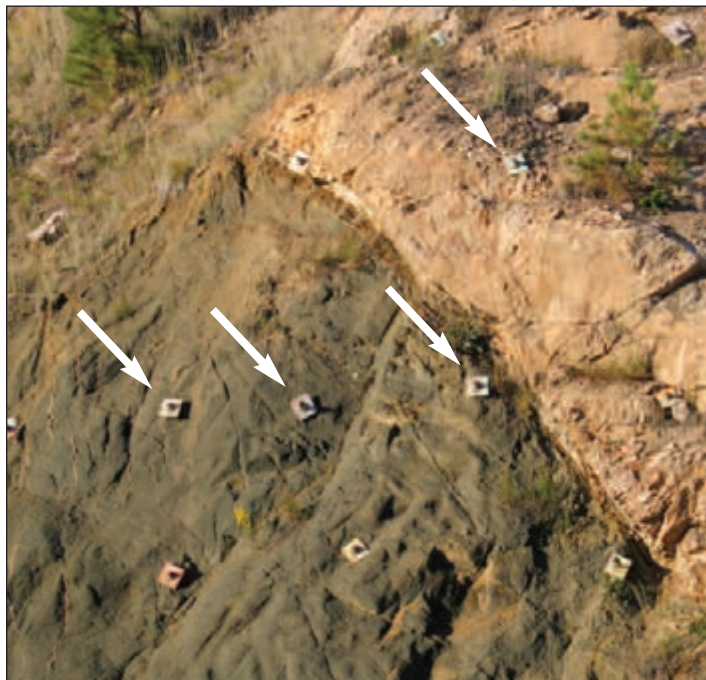
Figure 13: Pattern rock bolting to reinforce the rock cut along Highway 285. The threaded steel bars have been cemented into drill holes. The external evidence of rock reinforcement is shown by the steel plates and large nuts, four of which are indicated with arrows. (Photo by TC Wait.)

“key blocks” in place. Many highway rock slopes have rock bolts in them. The only evidence at the surface is a small steel plate and a nut exposed on the rock face (Figure 13).

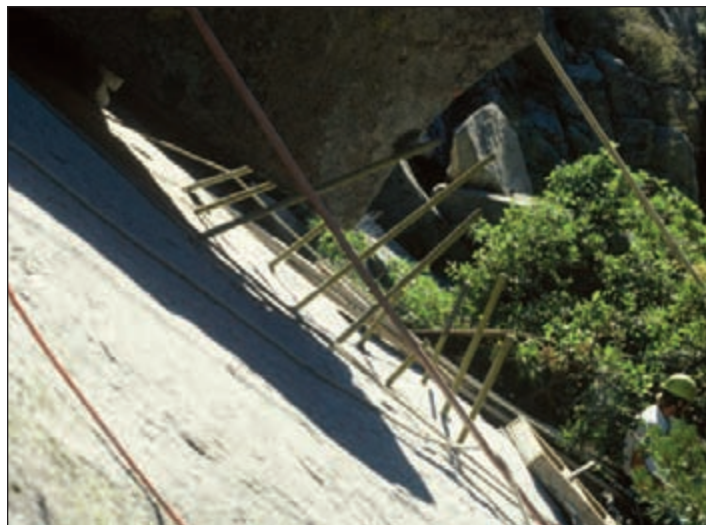
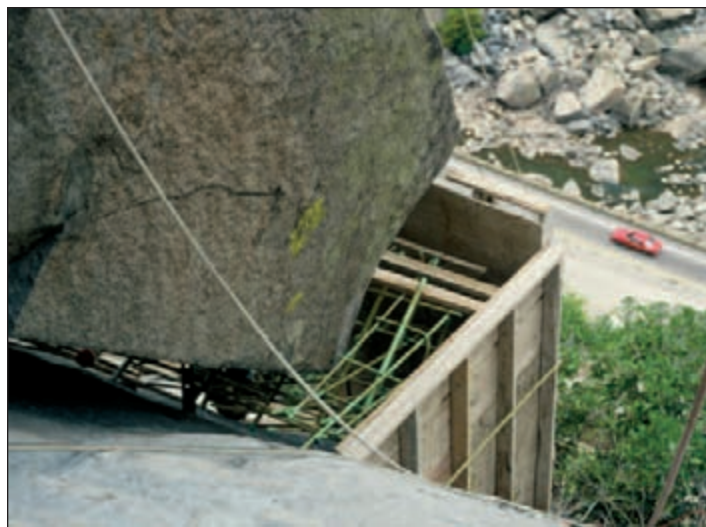
Figure 14: Smaller, upslope concrete buttresses are anchored to the rock face with rockbolts. Then, concrete rebar and wood forms are wired to the anchors in Glenwood Canyon. The concrete is carried in mud buckets by helicopter. The three photos show the progression of the installation. (Photos by Jon White.)

Surface retention of an unstable rockmass includes anchored concrete buttresses (Figure 14), and wire mesh (similar to chain-link fencing) or cable netting, either anchored to the rock face or draped down on a rock slope (which serves to redirect a falling rock into a ditch). Occasionally, large rocks can be stabilized by cable lashing, which also serves to hold the rock in place. Cable lashing is often employed to protect existing structures and roads from precariously balanced rocks that are too dangerous to remove or too unstable to drill into (Figure I, page 17). Another form of surface retention of rock is shotcrete, which is the pneumatic spraying of concrete onto a rock face or cut slope. Shotcrete can be very effective when applied on cut slopes in rocky soils (Figure 15) and in poor rock conditions such as slaking shale slopes that are undermining more resistant rock above.

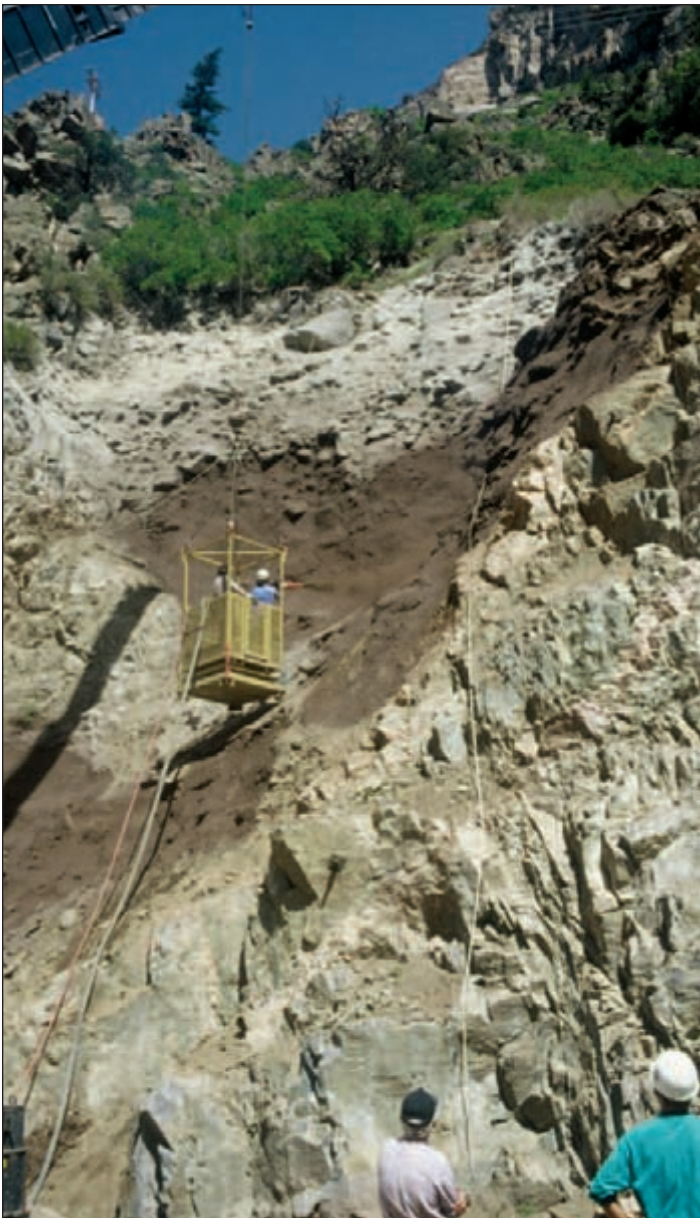
Figure 15: Application of shotcrete at a raveling cut-slope exposed in a rocky talus chute. The concrete has been dyed dark brown to better match the surrounding area. (Photo by Jon White.)

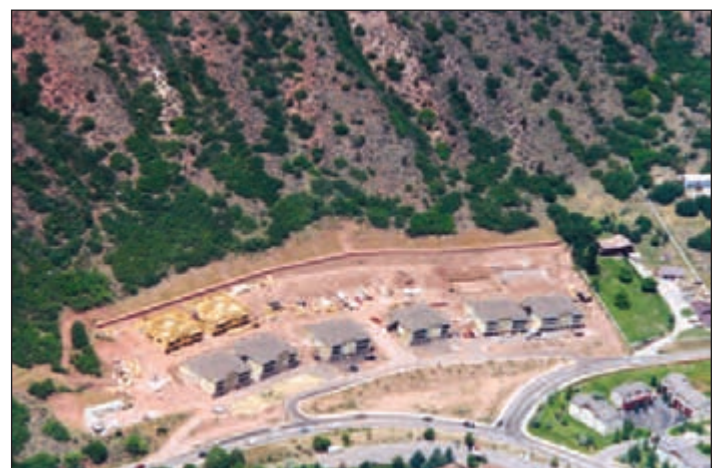
Figure C: This newer development in west Glenwood Springs constructed a rockfall impact wall above their townhomes to protect against both rockfall and mudslides (debris flows). (Photo by Jon White.)

The town of Glenwood Springs in west-central Colorado lies at the confluence of the Roaring Fork and Colorado Rivers. The town is tightly constrained by the steep river valleys so land-development pressure is causing more residential growth to advance into rockfall hazard areas. In West Glenwood, on the west side of the Roaring Fork River, the valley is rimmed with sandstone outcrops (Figure A). The sandstone layers are being undercut by the erosion of underlying softer siltstone and shale so that large sandstone blocks are being actively undermined and destabilized. In this area, there have been several large rockfall events from the valley rim; some that have severely damaged homes on the valley floor, 1,100 vertical feet below (Figure B). Fortunately, there have been no injuries or fatalities. Rapids in the river are evidence of continuous rockfall over many centuries. While there has been rockfall mitigation in some locations (Figure C), the threat remains in other areas.

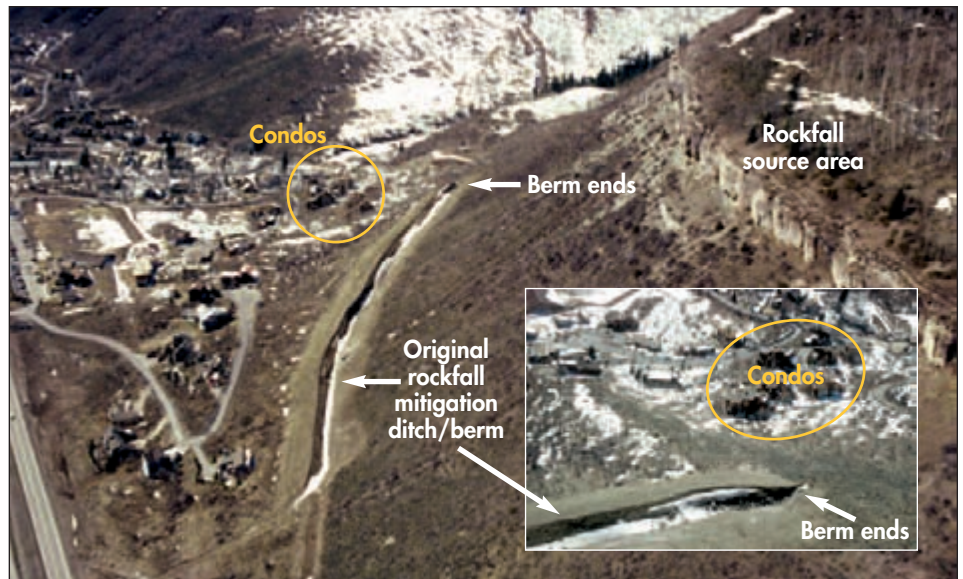
Figure D: Oblique aerial view, looking west, of Booth Creek debouching onto the Vail Valley floor. Interstate 70 highway is shown on the far lower left of the photo. The ditch and berm completed in 1990 is shown left of center. The termination of the berm and continued rockfall-hazard exposure of the condos (circled in yellow) is shown in the inset photo. (Photos by Jon White.)

Another example of a rockfall hazard and high risk affecting a neighborhood is in East Vail at Booth Creek. The north valley wall of Gore Creek is benched with two high rock cliffs. Above the two cliffs, the 1,100-foot high valley rim is composed of an eroding slope of glacial till, which is also composed of very large rocky material. All three of these areas periodically release large rocks. After several repeated, potentially lethal, rockfall events that damaged several homes in the early to mid 1980s, CGS was asked to provide assistance to the Town. The neighborhood created a special Geologic Hazards Abatement District (GHAD) affiliated with the Town of Vail. The GHAD funded a rockfall hazard study that included a mitigation design. The construction of a rockfall catchment ditch and berm above the homes on the valley slope was completed in 1990 (Figure D). Owners of adjacent condominiums elected to not participate in the GHAD, and that poor judgment was brought into sharp focus in March, 1997. Another large rockfall event fanned down the slope toward the residential areas at the property line between the homes and condominiums. The existing rockfall ditch and berm was 100% effective in catching the rocks, but several rocks impacted the unprotected condos (Figure E). After that incident, which luckily resulted in no fatalities, the condominium homeowners association petitioned the town for their own mitigation. In 2001, specially designed impact barriers (Mechanically Stabilized Earth wall) were constructed on the slope behind the condos to provide a similar level of protection (Figure F).

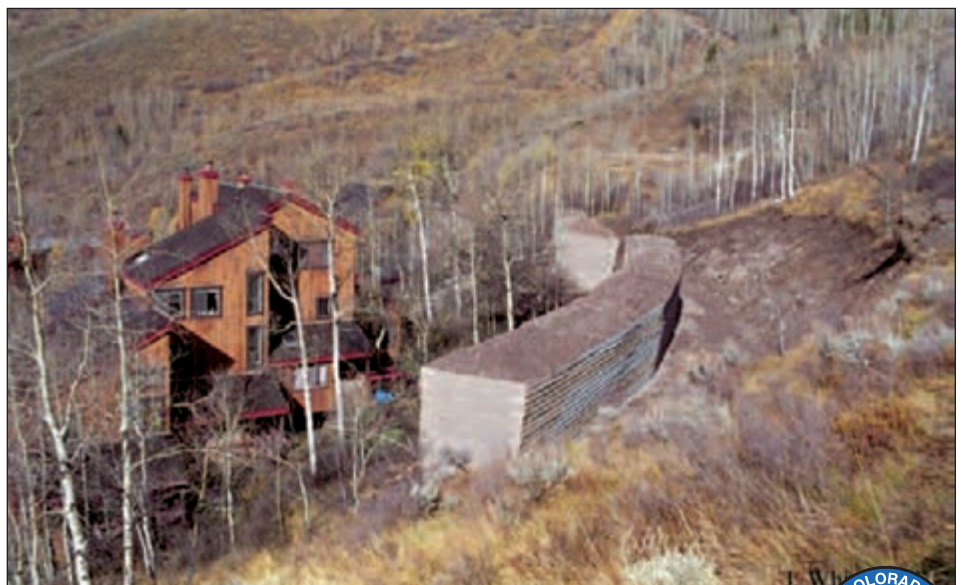
Figure F (right): Three impact walls were built after the 1997 event to mitigate the threat of future rockfall at the condominiums. (Photo by Jon White.)

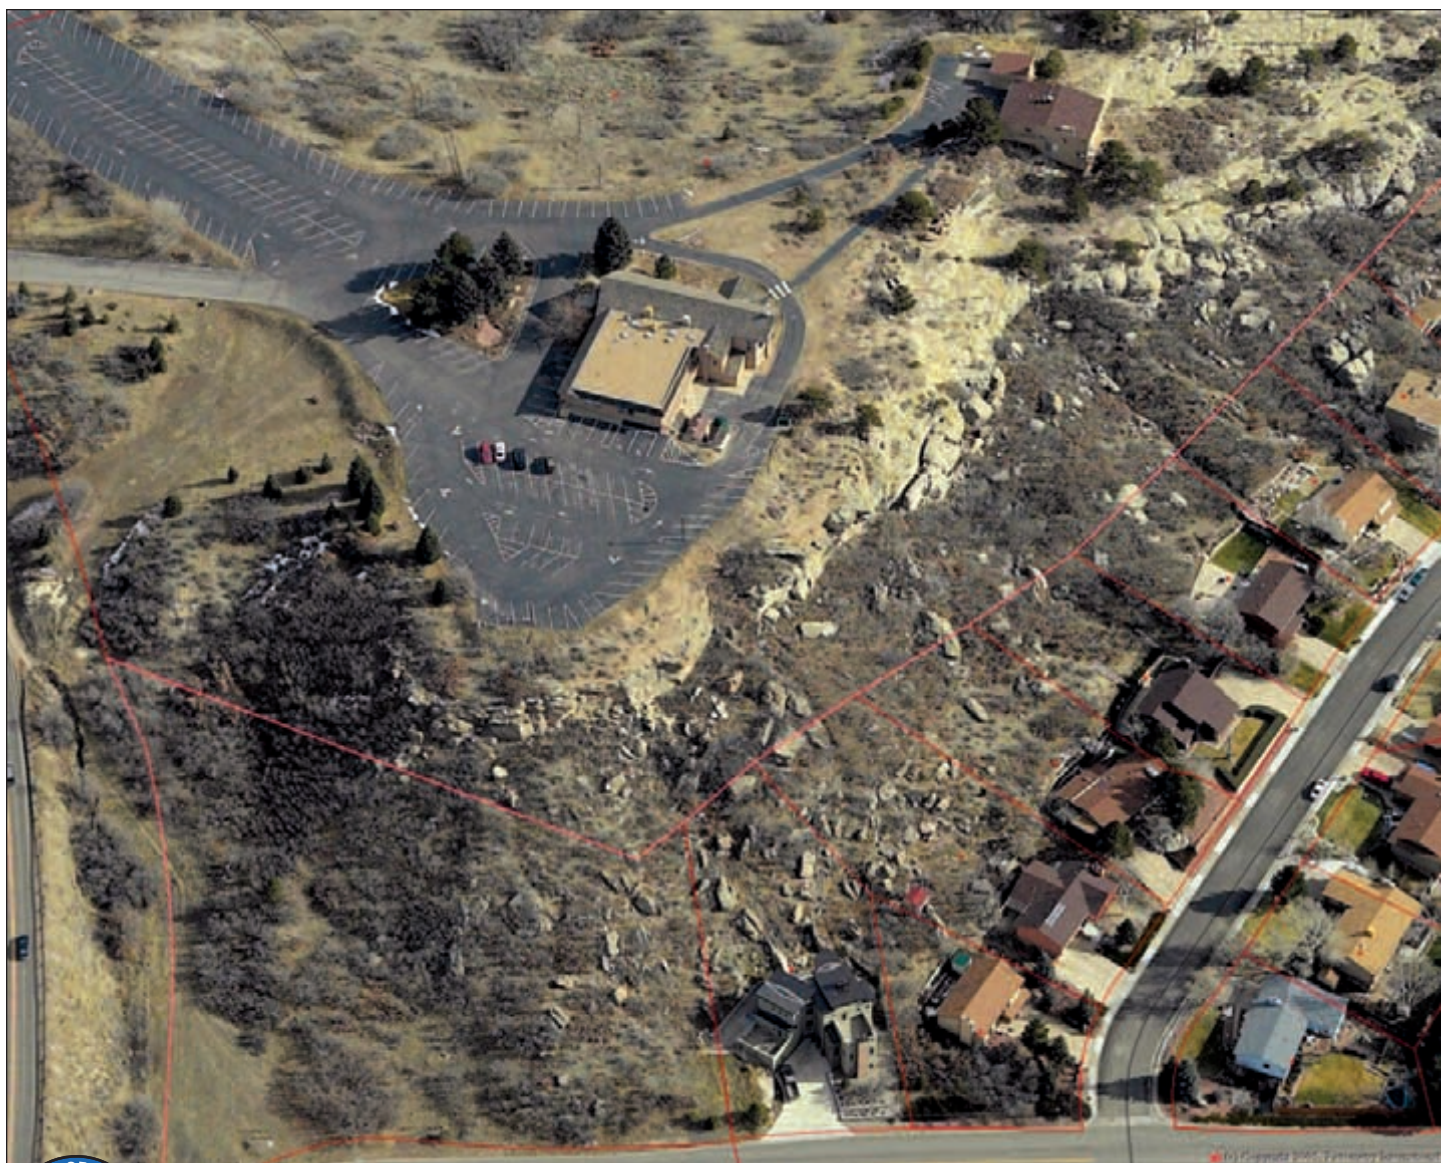
Figure G: St. Francis of Assisi Church in Castle Rock. Fractures in the cliff and large fallen blocks on the slope above these homes indicate an active rockfall zone. Red lines are property boundaries. (Photo from Douglas County Planning Department.)

A rockfall mitigation plan was developed for the site. The mitigation plan included (1) constructing a rockfall catchment trench, (2) cable-lashing a large pillar, (3) scaling unstable rocks, and (4) using rock bolts with wire mesh and shotcrete to anchor the larger areas of unstable rocks. The mitigation was completed in September 2008.

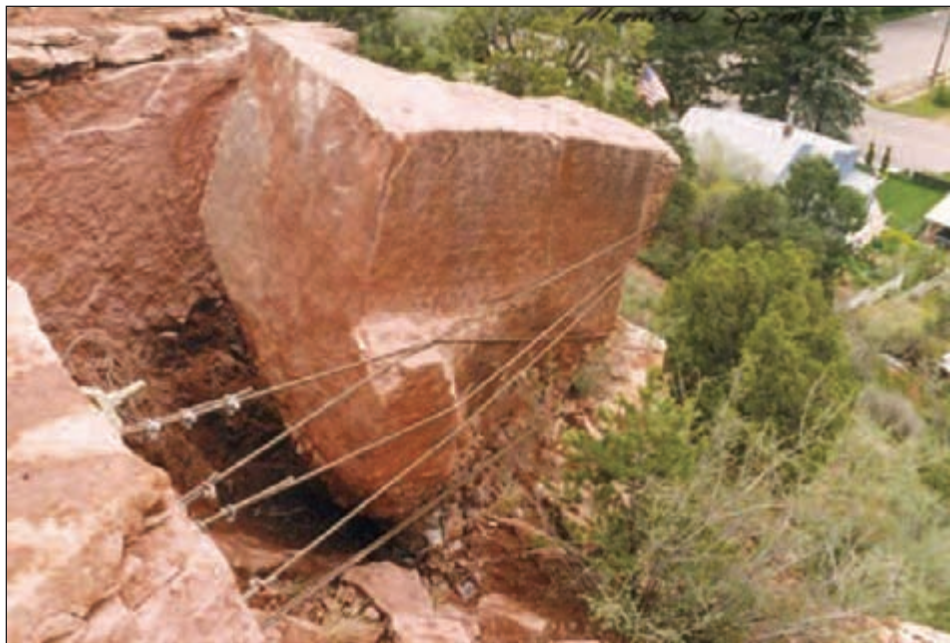
Figure H: A precarious rock above Manitou Springs started to move in 1995 after a period of wet weather. As an emergency measure, high-strength steel cables were wrapped around the rock and anchored to the surrounding ledge to arrest the movement. (Photo by Jon White.)

imity of homes directly below, so high-strength steel cables were wrapped around the rock and anchored to the surrounding ledge (Figure H). Once the block was safely restrained, additional cables were

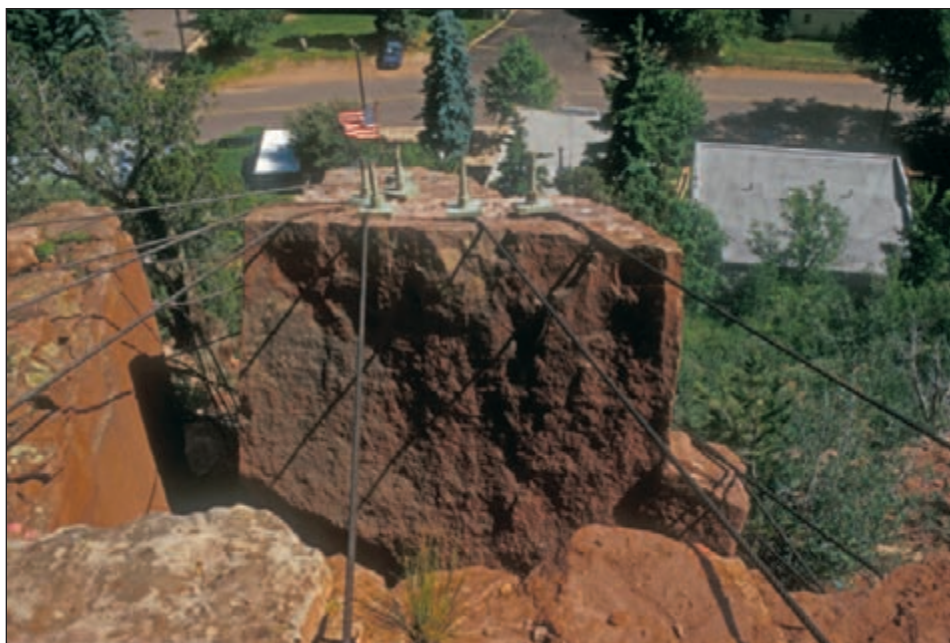
Figure I: After the rock was stabilized, additional cables were physically attached to the top of the rock block and secured to surrounding stable rock. (Photo by Jon White.)

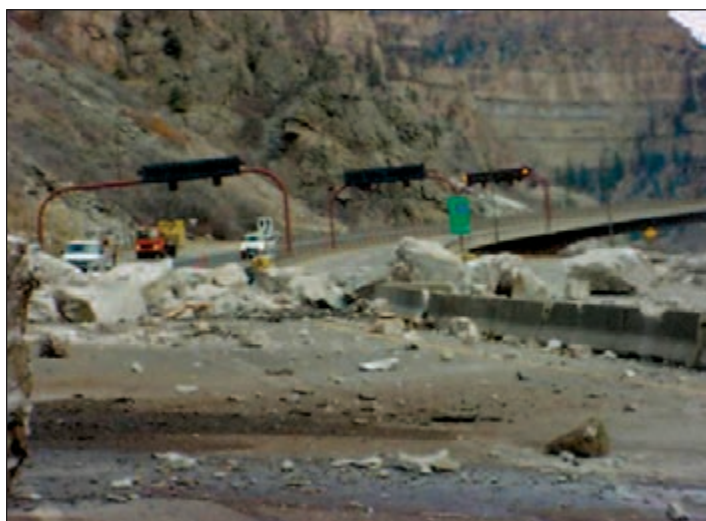
Figure E: Huge blocks of sandstone litter both east and westbound I-70.

When the dust cleared, the highway was littered with boulders of all sizes (See Figure E). Upon closer inspection, the true nature of the damage became apparent as large holes were punched through the concrete deck and the westbound retaining wall, demolishing a section of the bicycle path below, as well as damage to the bridge girder of the adjacent eastbound bridge (Figure F). Fortunately, no one was caught in this major rockfall event.

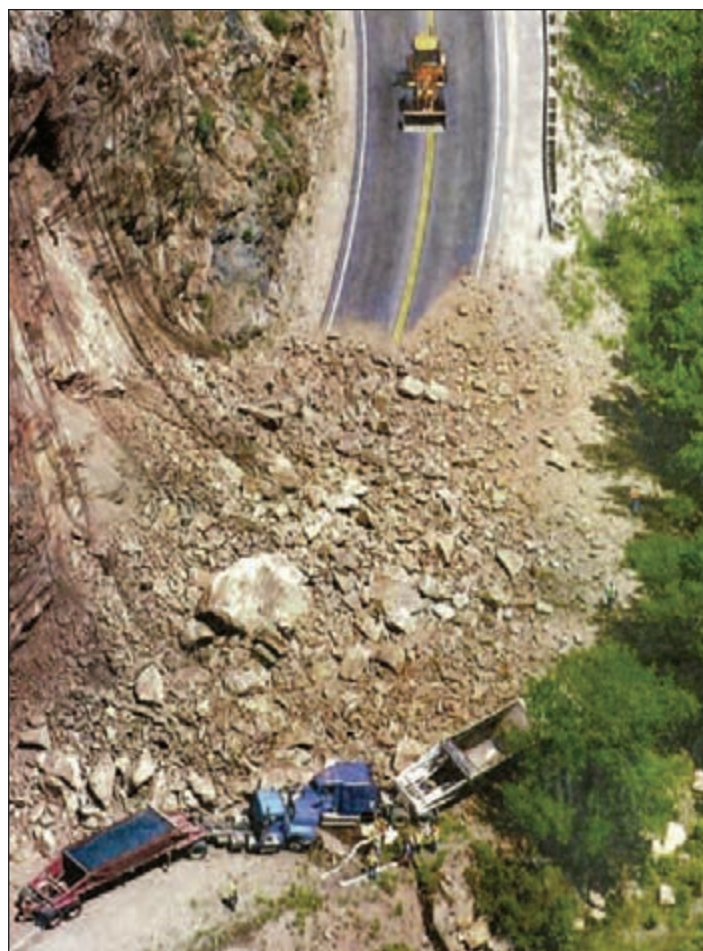
Figure G: Aerial view of the Clear Creek Canyon rockslide. Note how fallen rock pushed the blue and white haul truck across the roadway to hit, head on, with another haul truck (blue and red). Luckily the blue and white truck was not buried and crushed in the debris. Draped wire mesh shown hanging from the outcrop (upper left of photo) was not designed for such a massive rockslide. (Photo courtesy of the Denver Post.)

A high-profile rockslide event occurred on June 21, 2005 along U.S. Highway 6 in Clear Creek Canyon, approximately 10 miles west of Golden, CO. Around 11 AM, 2,000 cubic yards of rock slid from a pre-existing road cut on the north side of the road and completely covered the road (Figure G). Two tractor-trailers were caught in the rockslide and were pushed off the road by the debris. The tractor-trailers were totaled, but only minor injuries were sustained by the drivers.

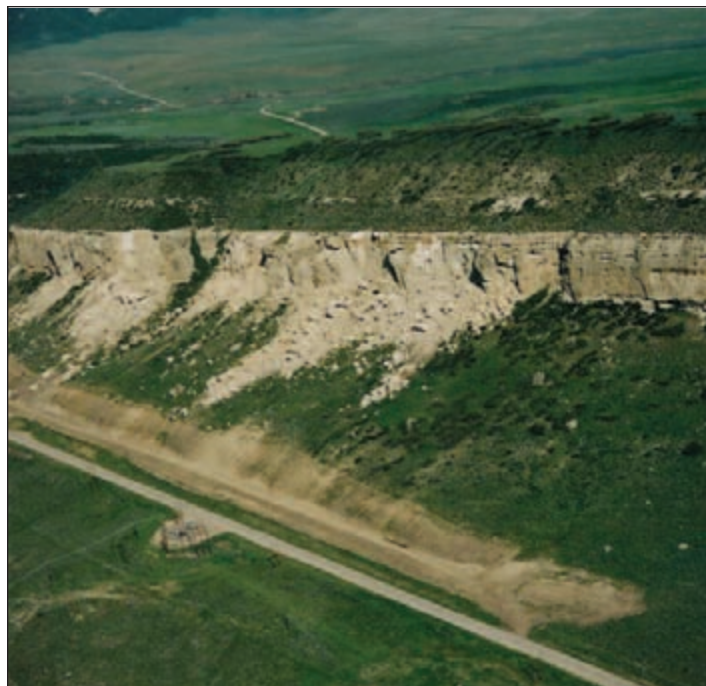
Figure J: Subsidence of the Foidel Creek Mine resulted in rockfall in the Twentymile Sandstone cliff face. Note rockfall ditch and berm above roadway. (Photo courtesy of Colorado Division of Reclamation, Mining, and Safety.)

A mile long stretch of rockfall-prone land in Colorado is entirely due to human activity! In the coal mining areas of Routt County in north-central Colorado, a technique called “long-wall mining” is often the most economical and preferred method for underground extraction of coal. Depending on thicknesses of the overburden (the rock and soil overlying the coal), long-wall mining and resulting collapse of the mined-out cavern can result in several feet of subsidence at the ground surface. At the Foidel Creek Mine in the mid to late 1990s, long-wall mining was extended below the surface exposure of the Twentymile Sandstone, a 100-foot thick, massively bedded, sandstone cliff that is exposed on the slope above Routt County Road 27. The strain from the ground subsidence fractured and broke almost 1½ miles of the exposed sandstone cliff, which resulted in several large rockfall events with some rock blocks the size of small homes (Figure J). The potential of rockfall was anticipated by the mine operator, the Colorado Division of Reclamation Mining and Safety, and the Colorado Geological Survey. A mile-long span of ditches and berms were constructed on the slope above Routt County Road 27 to mitigate the anticipated rockfall. Individual rock blocks in these rockfalls that rolled to the ditch have been completely contained by this mitigative design.

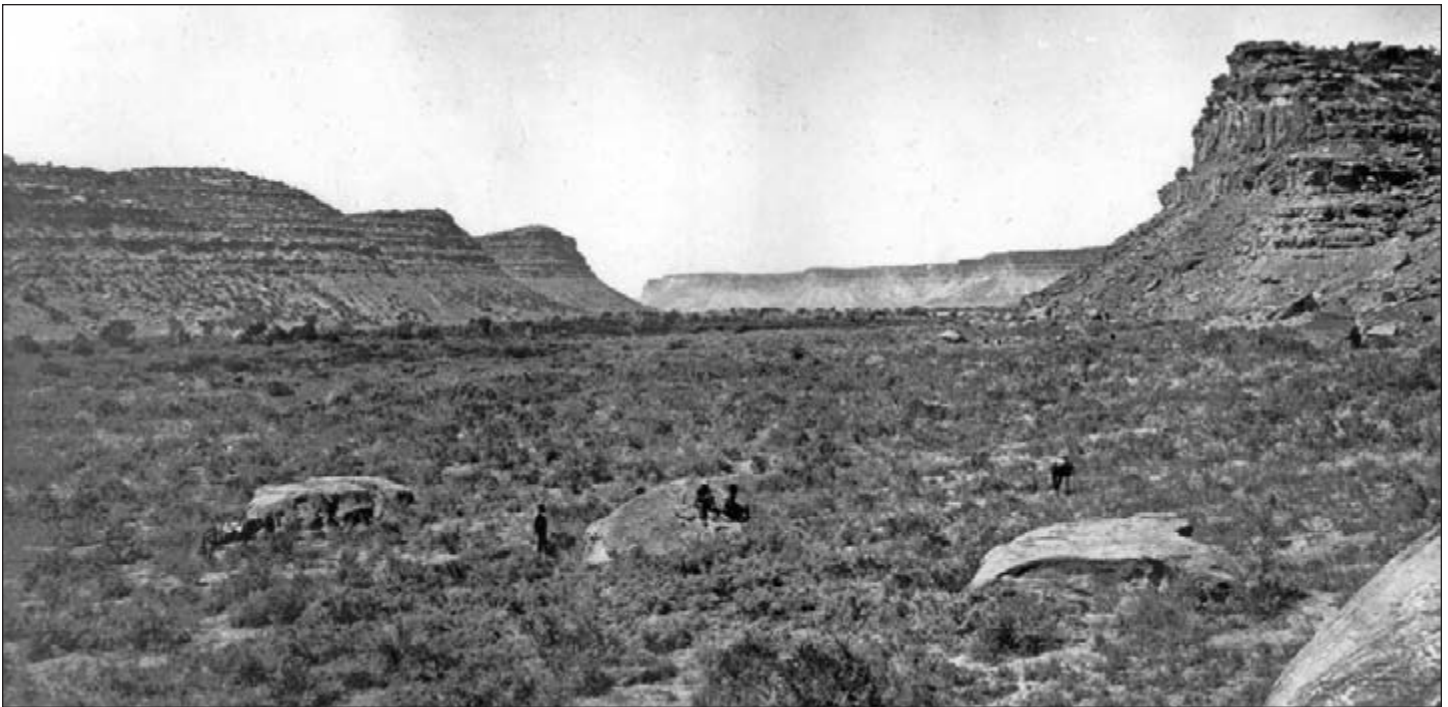
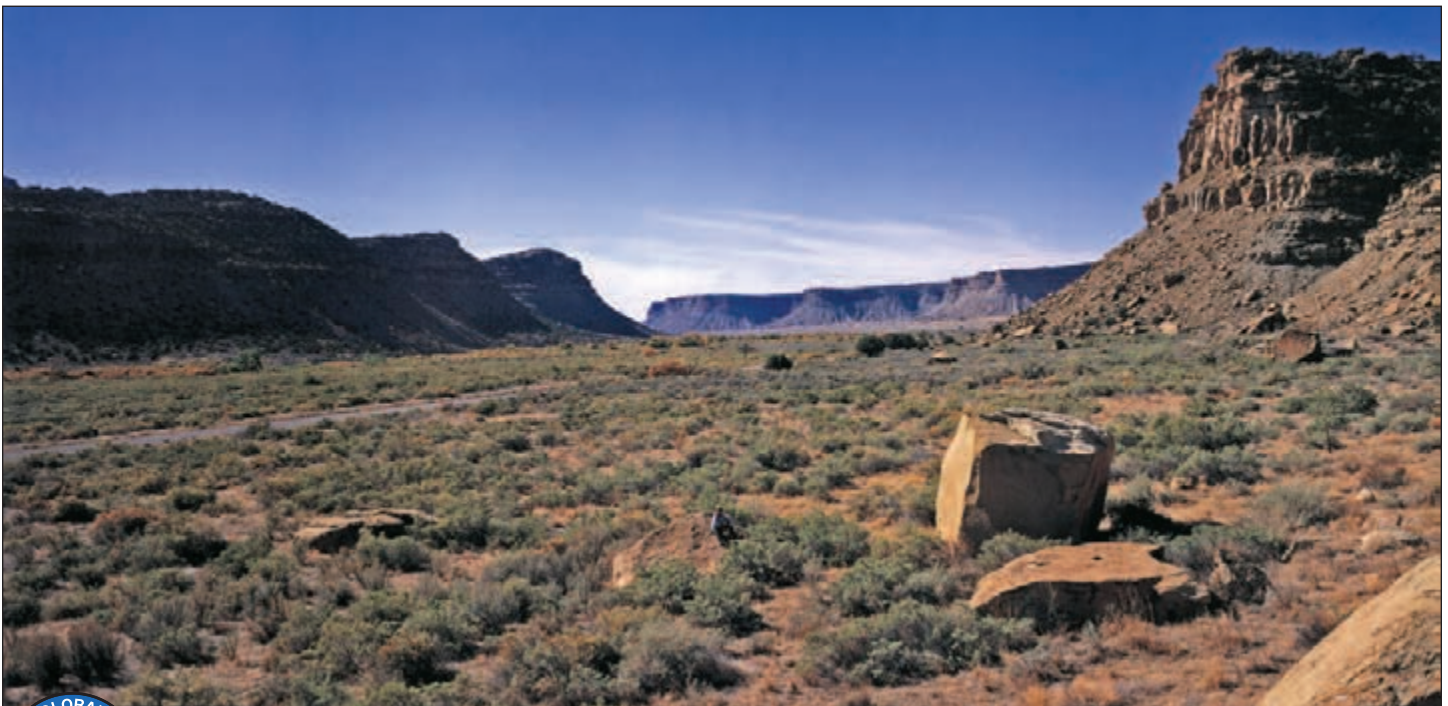
The Mancos Valley of Southwest Colorado. Top photo by William Jackson circa 1870s; bottom photo by John Fielder© 1999. Note the new rockfall block (right foreground) in the more recent picture.

1870 and Fielder's recent color images. In one pair from Mancos Valley in Southwest Colorado, Fielder, with keen observation, comments on a new addition to a group of very large boulders. These images illustrate that in locations where very large blocks of rock litter a valley beneath steep slopes, they will in time be joined by others through continuing erosion and rockfall.

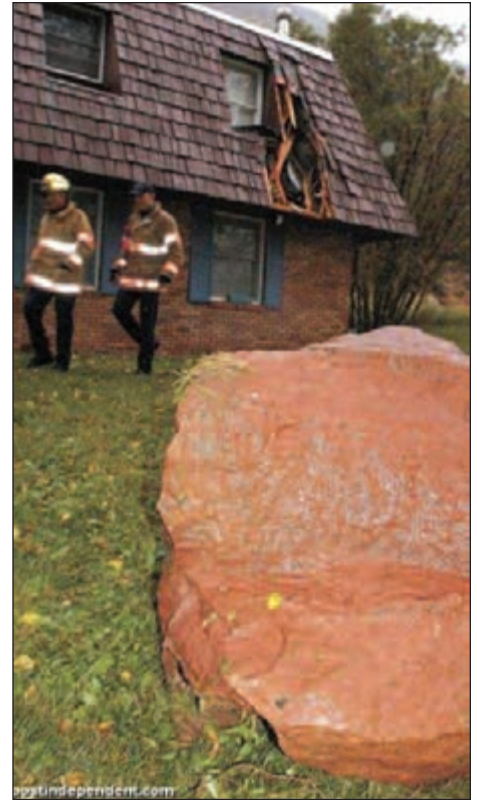
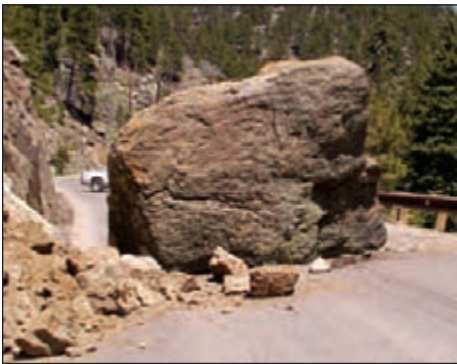
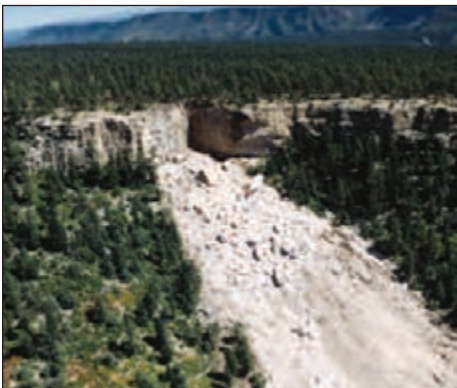
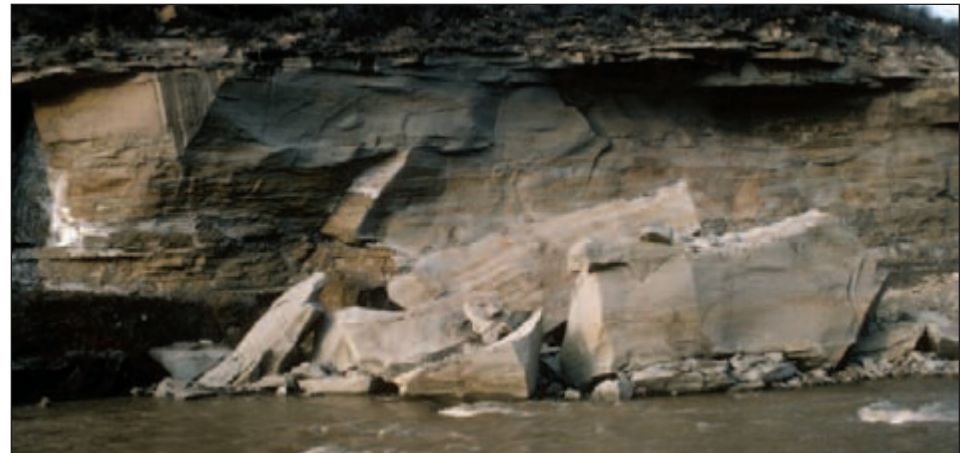
Clockwise, from upper left: Rockfall debris on Highway 133 near Paonia that occurred in the spring of 2007 (Photo by Jon White); Large boulder that fell through an apartment in Glenwood Springs in the fall of 2005 (Photo courtesy of the Glenwood Springs Post Independent); Rivers can undercut banks and create rockfall hazards; Large rockslide on Missionary Ridge near Durango that occurred in 1998 (Photo by CDOT); Boulder that fell on a county road in Jefferson County in the spring of 2007 (Photo by Inter-Canyon Fire Department).
