DAM SAFETY MANUAL

**State Engineer's Office
State of Colorado
January, 2002**

STATE OF COLORADO DAM SAFETY MANUAL

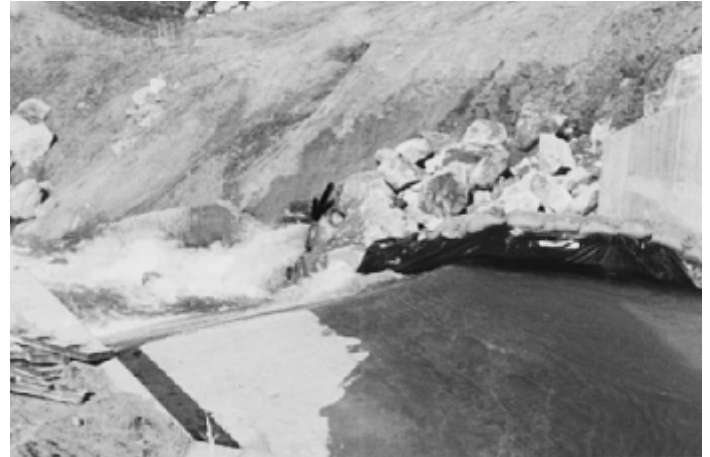
PHOTO 1.4-1
RUNOFF DAMAGE

FLows ERODING UNPROTECTED SPILLWAY CHANNEL. Sandbags and plastic sheet placed on right side to divert flow. Note full outlet discharge to minimize flow through spillway.

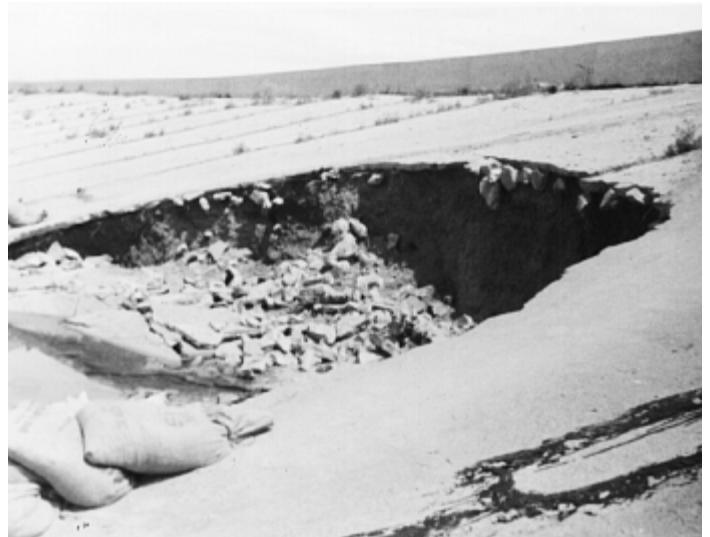
PHOTO 1.4-2
WINDSTORM DAMAGE

Large cavern eroded into embankment after wave action destroyed concrete protective coating on the upstream face.

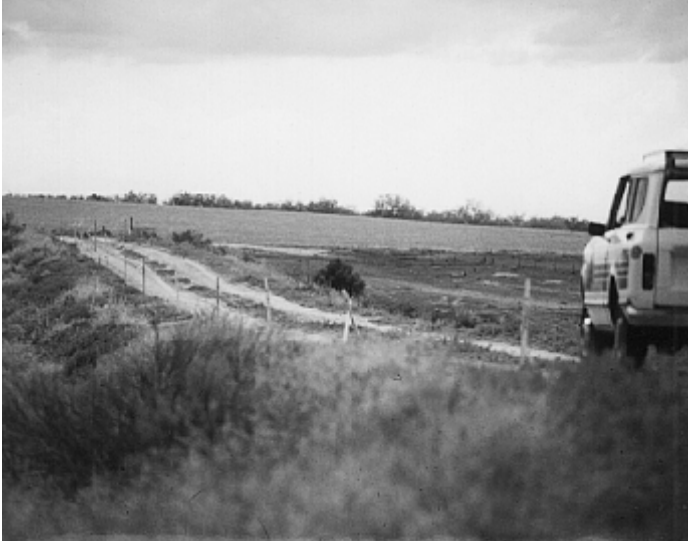
**PHOTO 1.4-3
EARTHQUAKE DAMAGE**

Settlement of 2.5 feet on dam crest first noted about 2 weeks after an earthquake in the area.

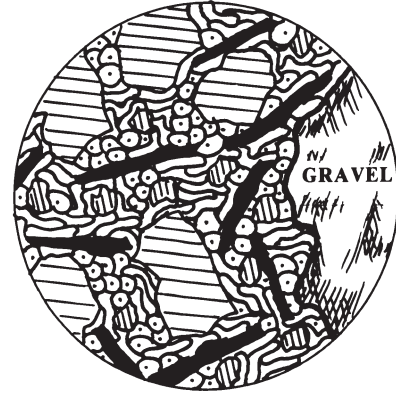
MAGNIFIED VIEW
FIGURE 2.4-5 STRUCTURE OF NATURAL DEPOSIT

A sample of a natural deposit of soil can contain a combination of rock, gravel, sand, silt, and clay. It can also include some organic material and of course will contain air and water.

These examples show that any soil deposit contains water and air in addition to the solid soil particles. The voids that are filled by the air and water provide pathways for water to flow through the soil. By reducing the number of voids, the soil will contain fewer pathways for flow.

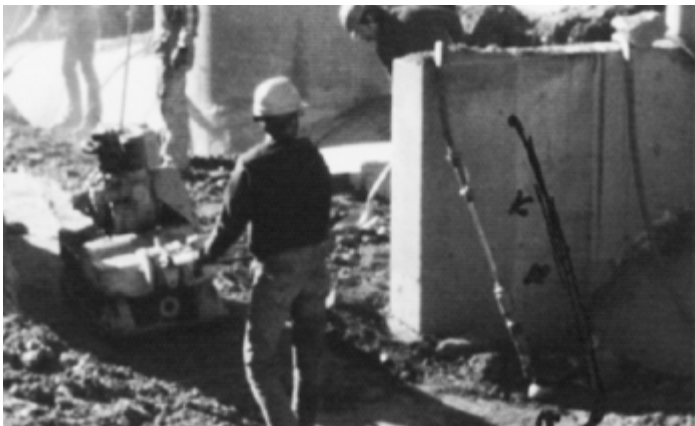
FIGURE 2.5-7—POGO STICK, SIMILAR TO TAMPING TOOL.—Is used in tight spots not accessible to larger equipment.

As can be seen, the pogo stick and wacker are much smaller and lighter than the sheepfoot and self-propelled roller. Soils compacted with the lighter equipment must be placed in thin layers not exceeding 4 inches, while soils compacted by the heavier equipment can be placed in layers up to 12 inches.

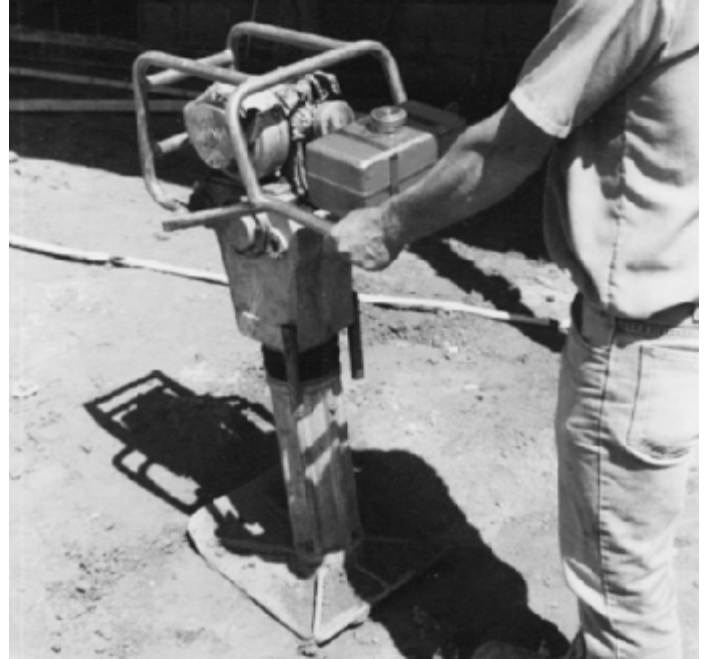
FIGURE 2.5-8—WACKER.—Is used in areas larger equipment cannot reach.

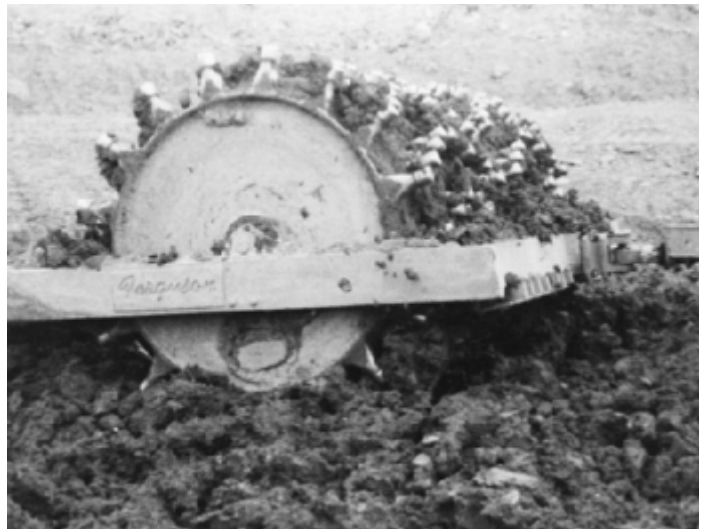
FIGURE 2.5-9—SHEEPSFOOT ROLLER.—Used in open areas.

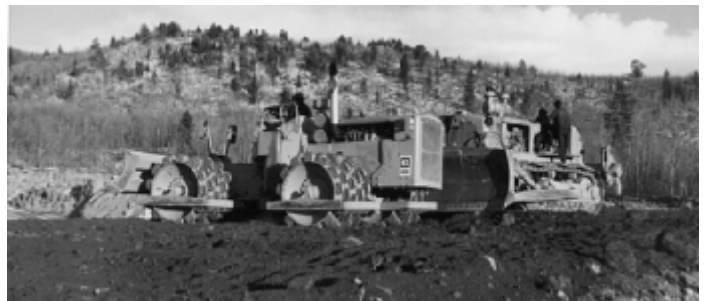
FIGURE 2.5-10—SELF-PROPELLED ROLLER.—Used in open areas.

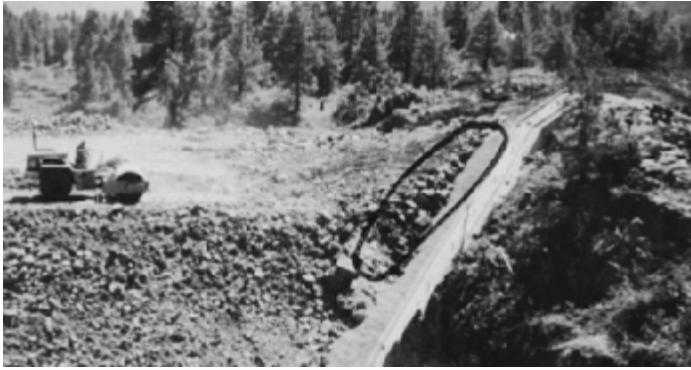
FIGURE 2.5-11—VIBRATORY ROLLER.
Drums vibrate as roller moves.

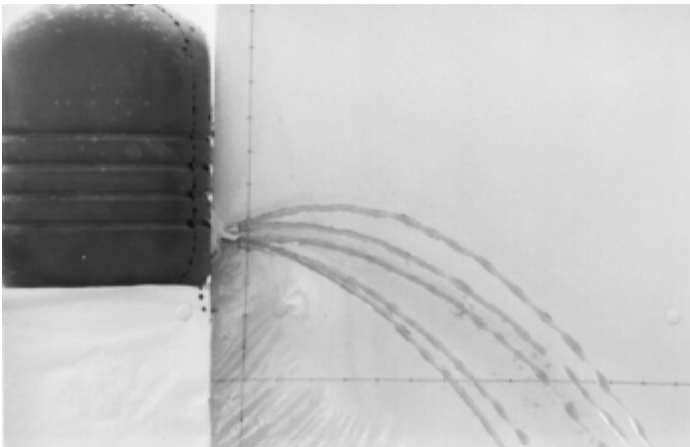
Figure 2.8-2 shows several small pipes originating at approximately the same point. The water flows in the various directions. This illustrates that water pressure at any point can cause flow in any direction if a path is available.

FIGURE 2.8-2 WATER PRESSURE AT ANY POINT ACTS IN ALL DIRECTIONS

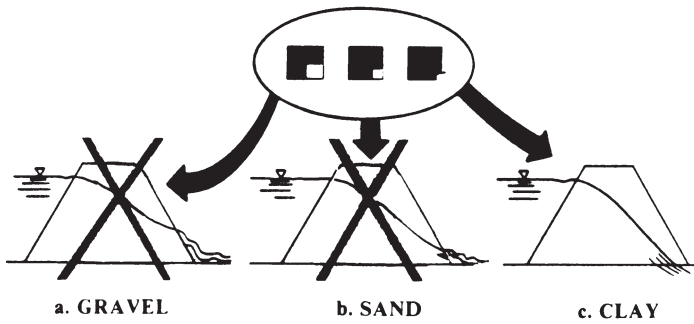
FIGURE 3.4-3 MATERIALS INFLUENCE FLOW PATH

The first two sketches represent undesirable conditions because uncontrolled seepage is exiting on the downstream slope of the dam. The situation develops because the structure does not provide sufficient resistance to the flow of water. Gravel and sand, because of their larger grain size, have more area available for flow than finer-grained material such as clay. Compacting clay soils further reduces the area available for flow. As the water moves through the soil structure, some of the pressure which is pushing it through the dam is dissipated. The path of the water must be made long enough to use up all the pressure pushing on the drop at point A by the time the drop reaches point B.

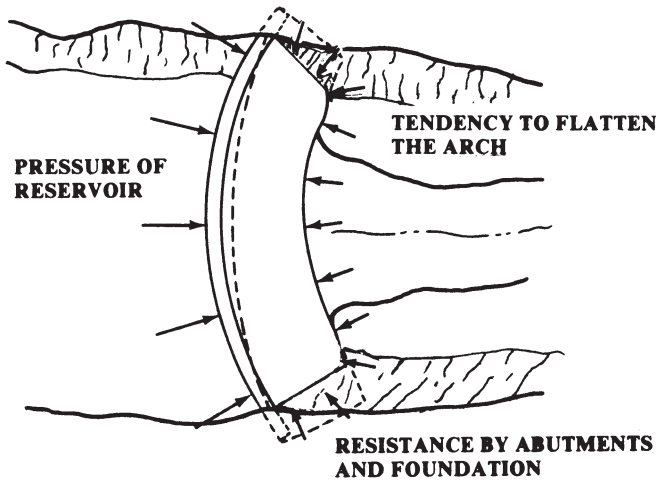
FIGURE 3.6-4
OVERHEAD VIEW OF ARCH DAM

The view above shows how the pressures from the reservoir tend to flatten the arch and how the action is resisted by the abutments and foundation. The failure of an arch dam can occur if one abutment releases its support.

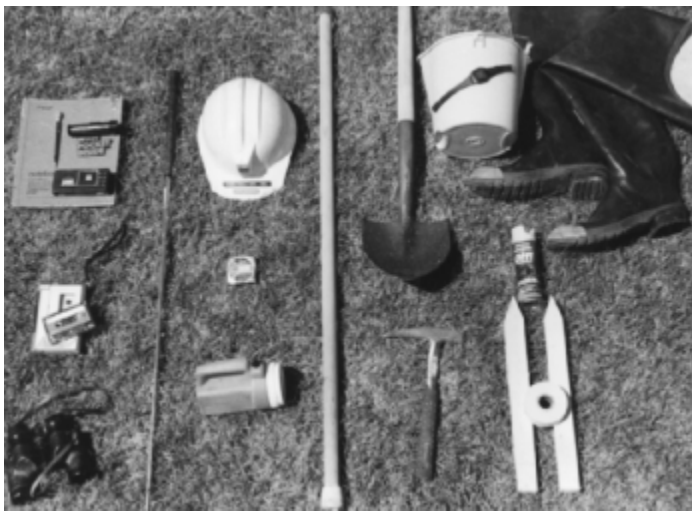
figure 4.2-1 inspection equipment—Notebook, pencil, hand-level, camera, tape recorder and tape, binoculars, probe, hard hat, pocket tape, flashlight, bonker, shovel, rock hammer, bucket and stopwatch, bug spray, flagging tape and stakes, waterproof boots.

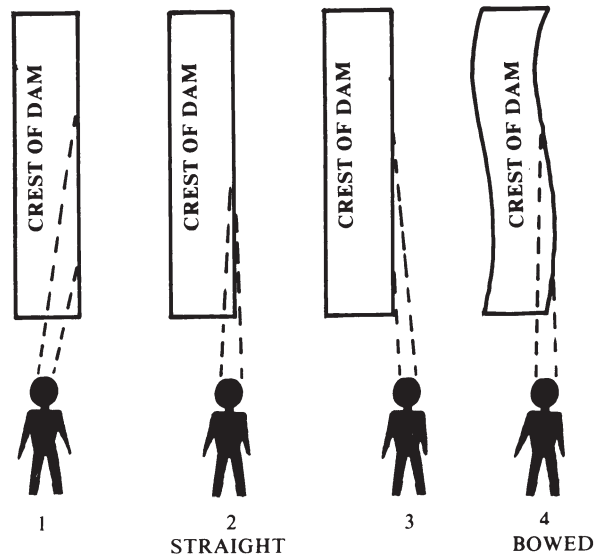
FIGURE 4.4-2 SIGHTING ALONG CREST

Looking through a pair of binoculars will help to make changes more obvious.

The items of particular concern noted above are usually visibly detectable during a thorough and complete inspection of the dam, as described in Chapter 4. While detection of longitudinal cracking, vertical displacement, or transverse cracking depends on a careful, thorough, and methodical visual inspection of the crest surface, misalignment may only be detectable by a general overview of the dam from either abutment. (See Figure 4.4-2.)

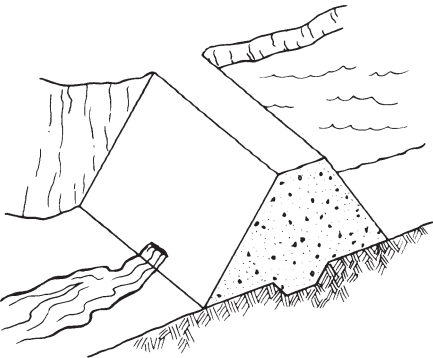
5.4-2

EXCESSIVE AMOUNT OF WATER EXITING FROM A POINT SOURCE

Water has created an open pathway or pipe through the dam.

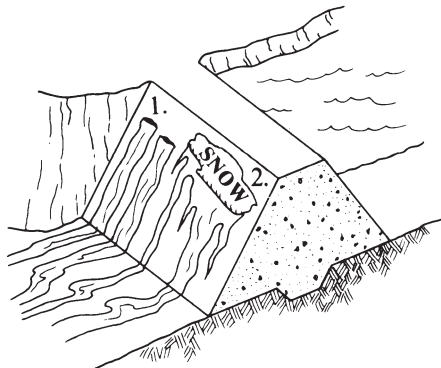
5.4-12

LARGE AREA SATURATED FROM ABOVE

1. Water flowing through the embankment.
2. Snowdrifts melting slowly during mild spring temperatures.

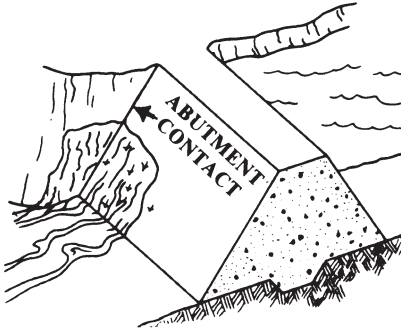
5.4-13

SEEPAGE EXITING AT ABUTMENT CONTACT

1. Water flowing through pathways in the abutment.
2. Water flowing through the embankment.

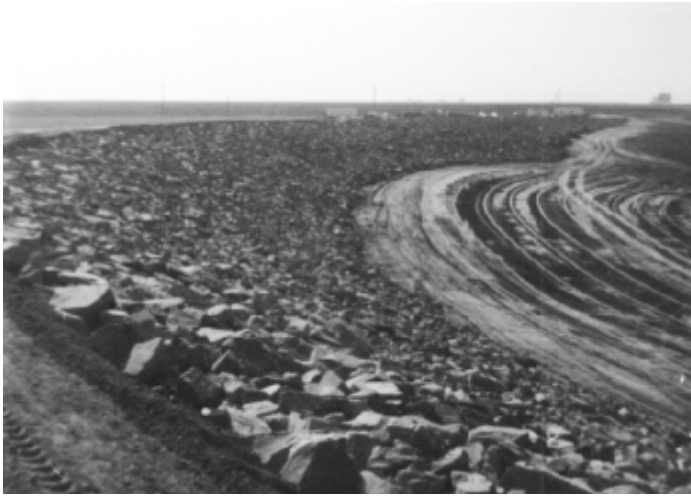
PHOTO 6.1—EXCELLENT UPSTREAM FACE. Note uniform surface or riprap protection.

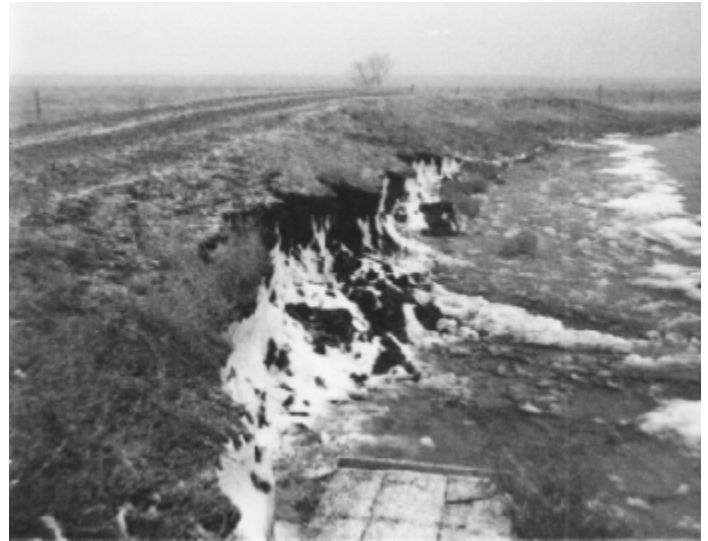
PHOTO 6.2—EROSION OF UPSTREAM FACE DUE TO LACK OF PROTECTION AGAINST WAVE ACTION.

The lack of protection against wave action on the upstream slope leads to erosion, and the decrease of the embankment width and/or elevation which could allow water to overflow the crest.

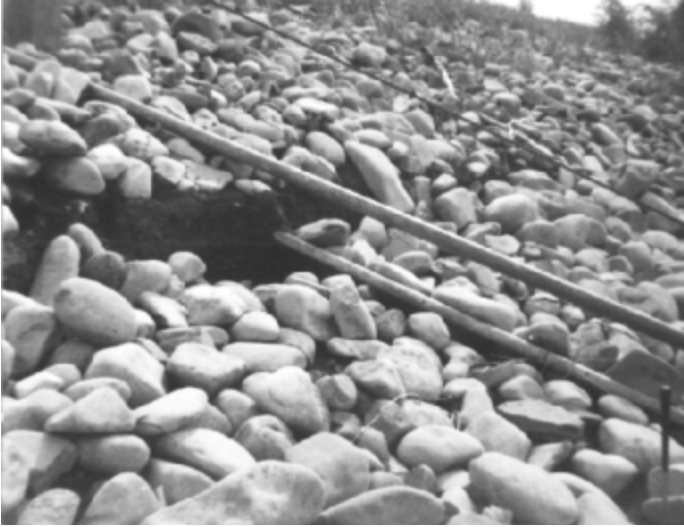
PHOTO 6.5-1—UNIFORM POORLY SIZED RIPRAP LEADS TO EROSION OF SOIL BEHIND RIPRAP.

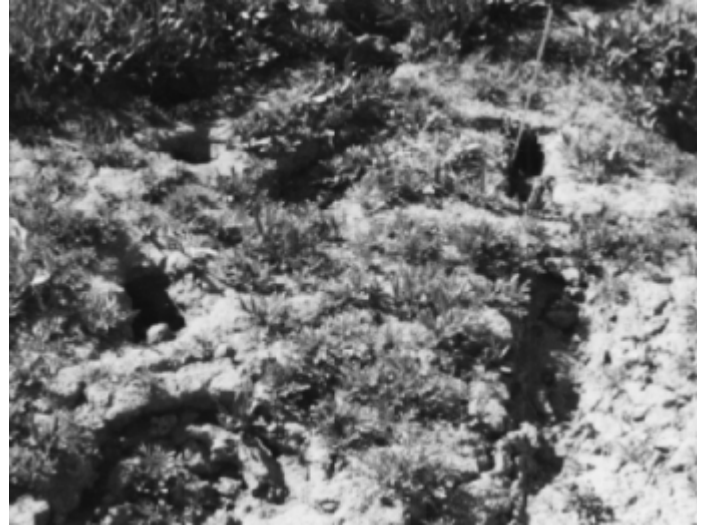
PHOTO 6.5-4—MUSKRAT DAMAGE

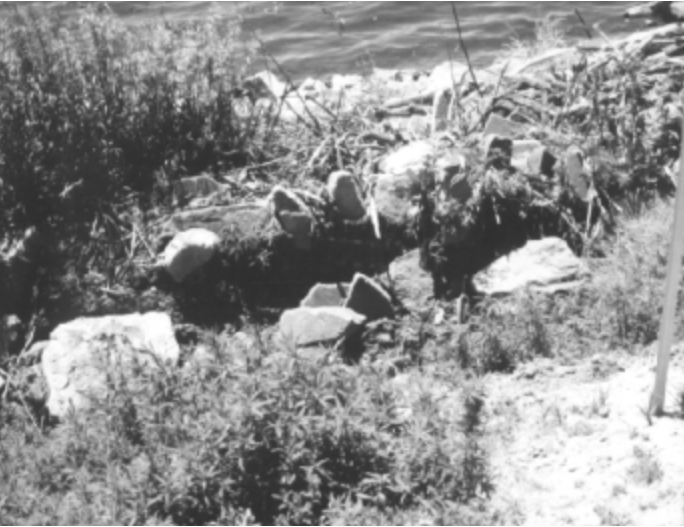
PHOTO 6.5-2—CRACK IN UPSTREAM SLOPE

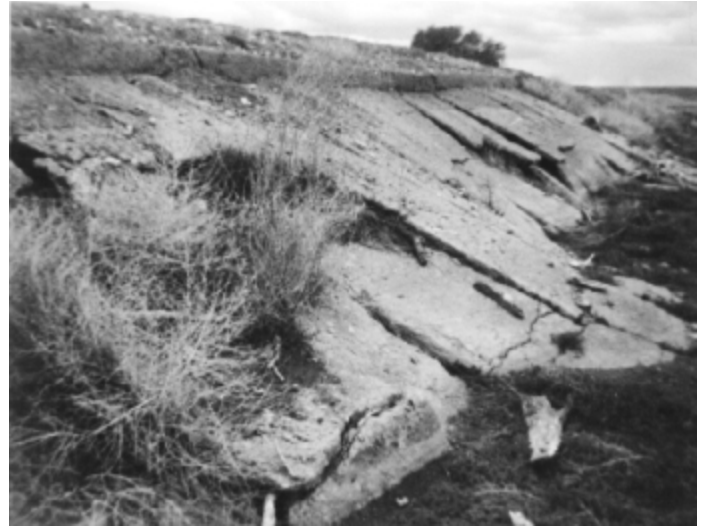
PHOTO 6.5-5—BADLY DETERIORATED CONCRETE FACE

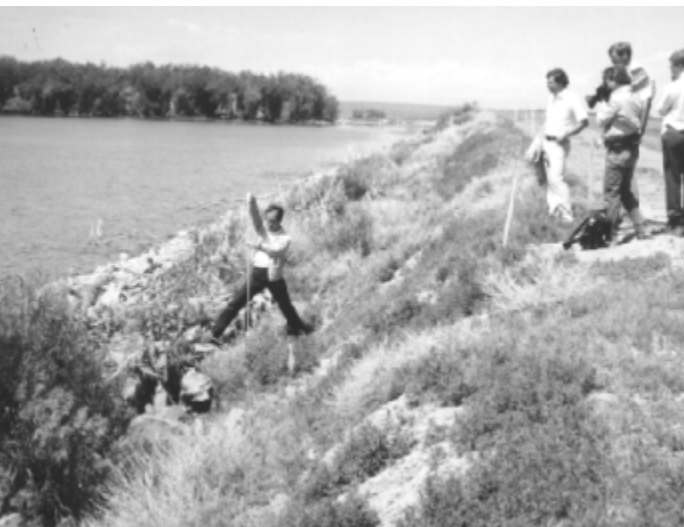
PHOTO 6.5-3—CRACK IN UPSTREAM SLOPE

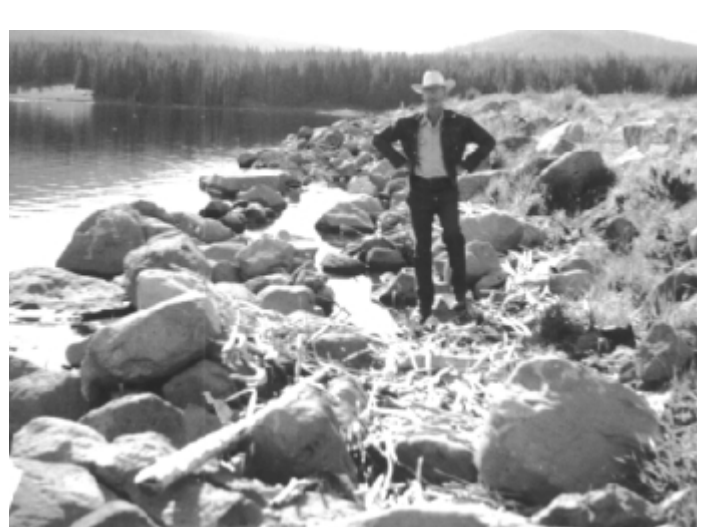
**PHOTO 6.5-6—SLIDE AT UPSTREAM SLOPE.
Note water line alignment**

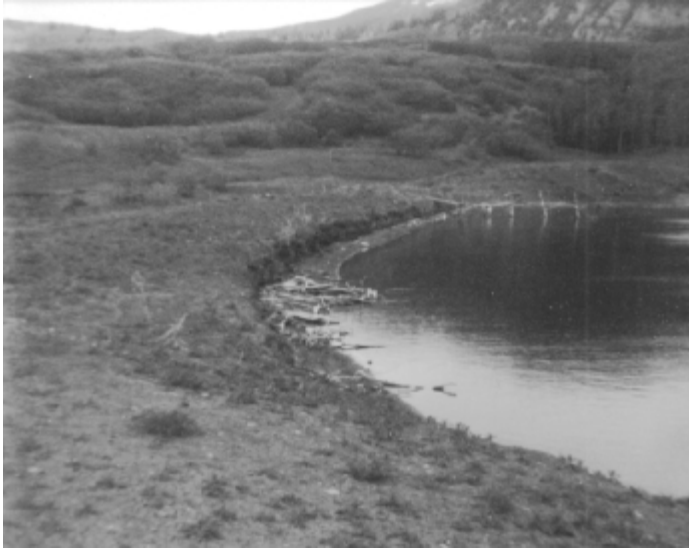
PHOTO 6.5-7—EROSION AT UPSTREAM FACE

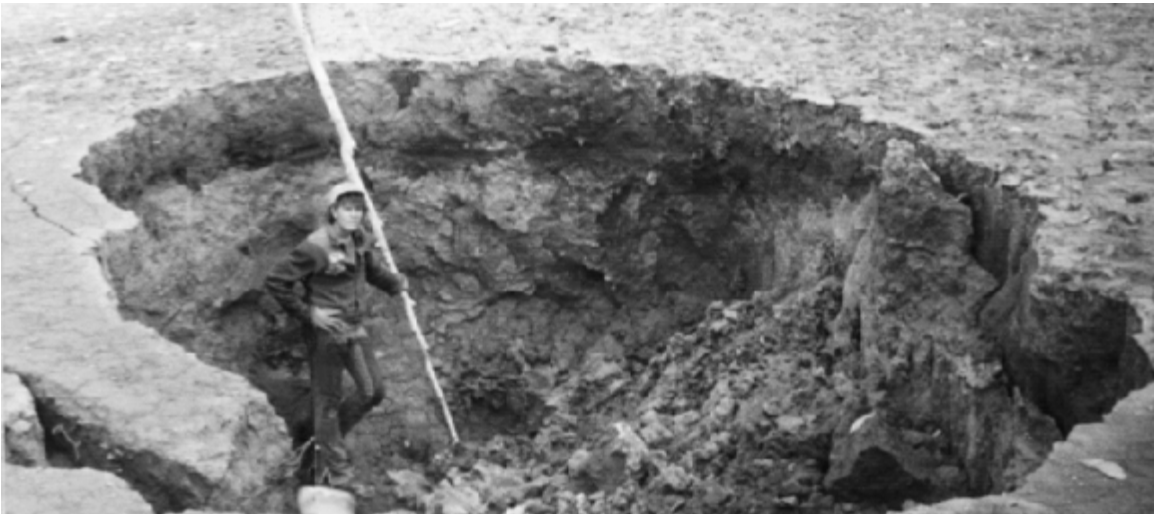
PHOTO 6.5-8—21'X21' SINK HOLE IN RESERVOIR BASIN

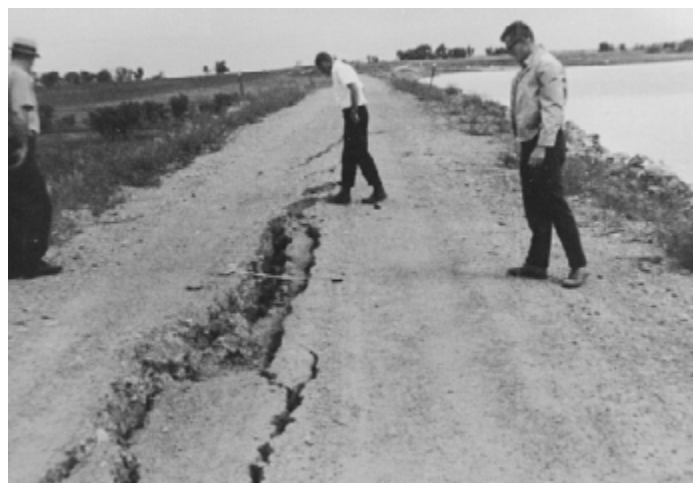
PHOTO 7.3-1—SEVERE LONGITUDINAL CRACKING. Cracking pattern indicates horizontal movement between adjacent sections of the dam. Note the close parallel cracks.

7.3-1 **LONGITUDINAL CRACKING** can indicate localized instability, differential settlement, and/or movement between adjacent sections of the embankment. Longitudinal cracking is characterized by a single crack or a close, parallel system of cracks along the crest in a direction more or less parallel to the length of the dam.

(See Photo 7.3-1) These cracks, which are continuous over their length and are usually greater than 1 foot deep, can be differentiated from drying cracks which are usually intermittent, erratic in pattern, shallow, very narrow, and numerous.

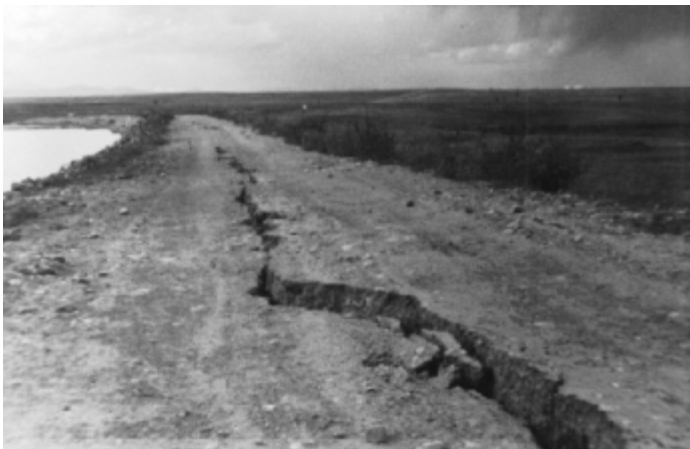
FIGURE 7.3-2

VERTICAL DISPLACEMENT ON THE CREST OF A DAM. In its initial stages, this condition was detected as a longitudinal crack.

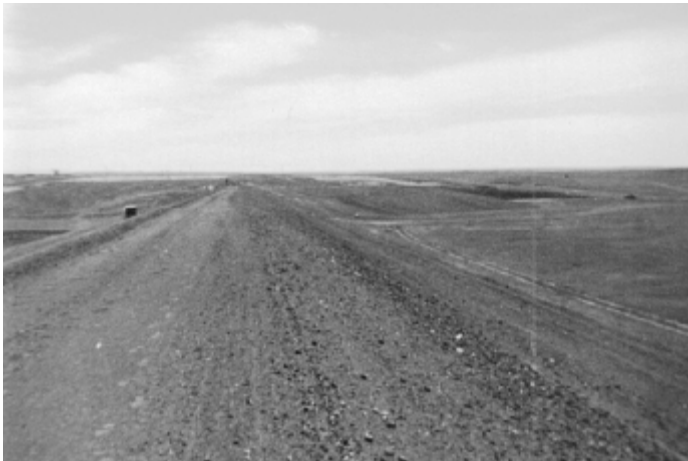
PHOTO 7.3-3—Well-graded straight crest of a newly completed dam.

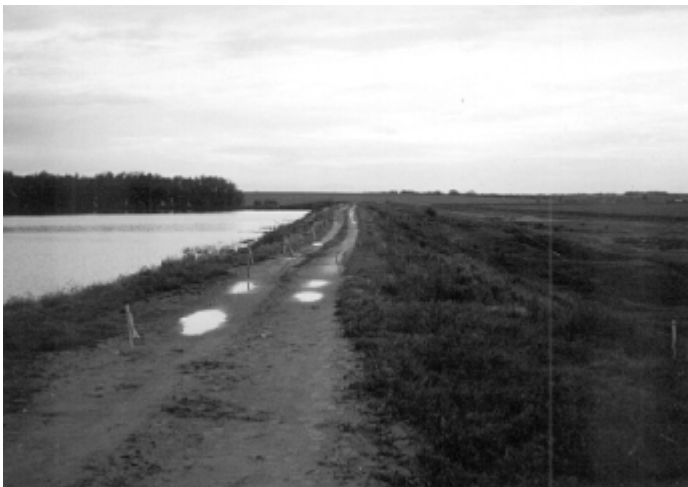
Photo 7.3-4—Crest in poor condition showing evidence of misalignment.

7.3-2 **MISALIGNMENT** can indicate relative movement between adjacent portions of the dam in directions perpendicular to the axis of the dam (See Photo 7.3-4).

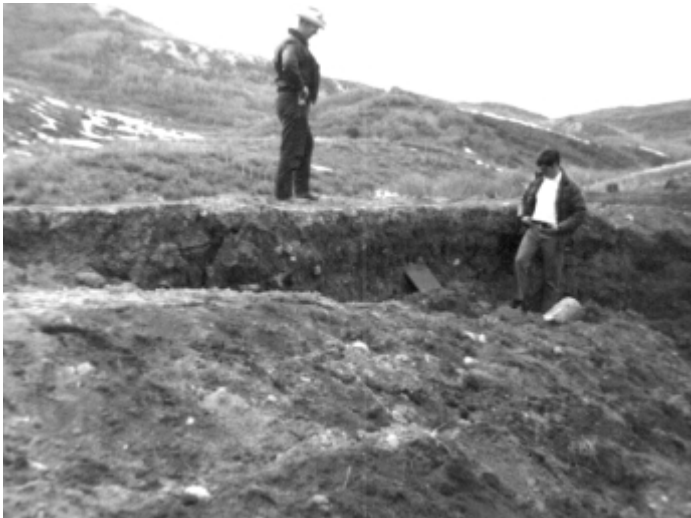
PHOTO 7.5-1.A—VERTICAL DISPLACEMENT ON CREST.

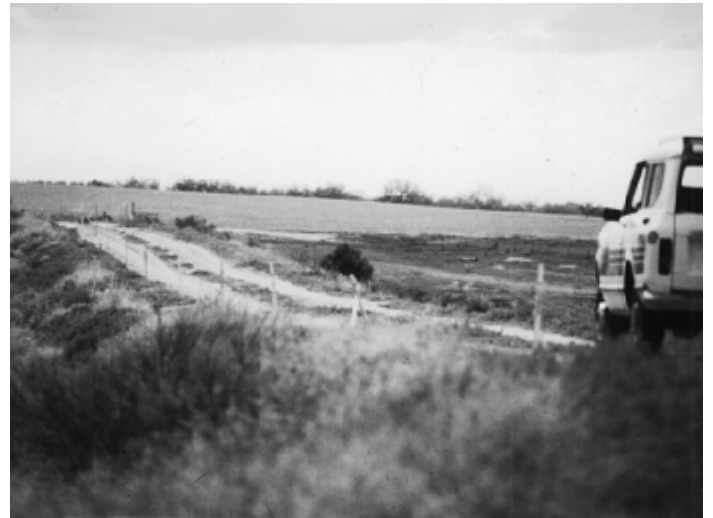
PHOTO 7.5-2—LOW AREA IN THE CREST OF A DAM, caused by a foundation failure.

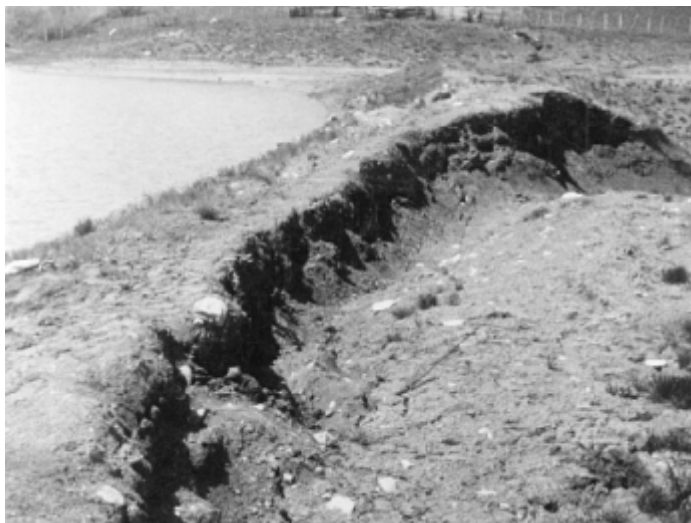
PHOTO 7.5-1.B—VERTICAL DISPLACEMENT ON THE CREST OF A DAM. This vertical movement was associated with a slip on the downstream face.

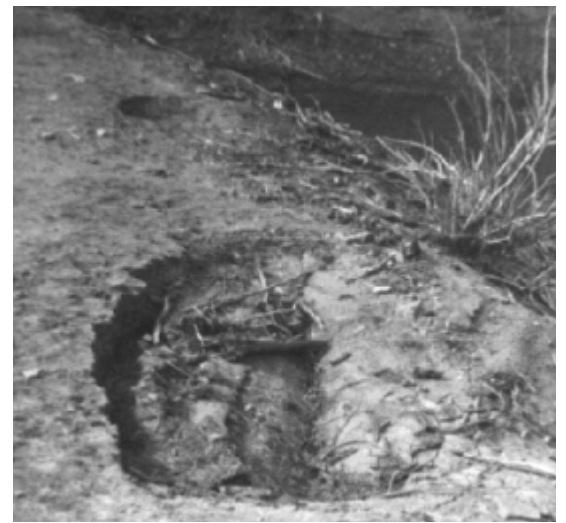
SMALL SINKHOLE

LARGE SINKHOLE

PHOTO 7.5-3—SINKHOLES IN THE CREST OF A DAM, caused by consolidation of low density embankment material.

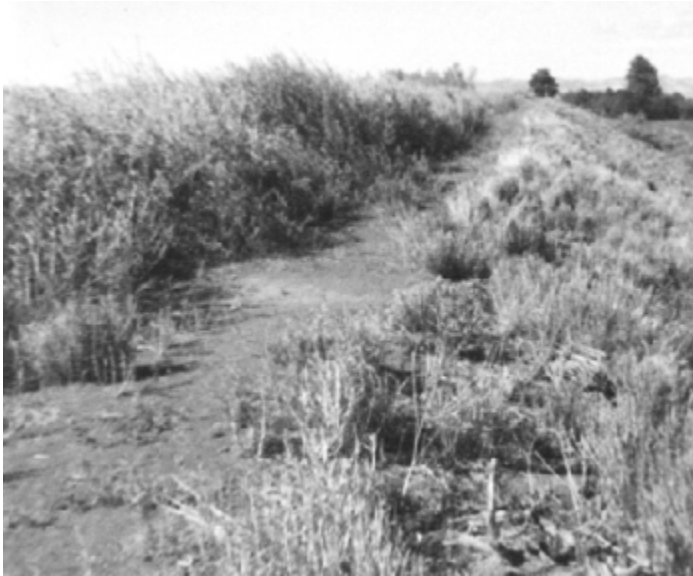
PHOTO 7.5-4—THE CREST OF A DAM PARTIALLY OVERGROWN AND OBSCURED DUE TO EXCESSIVE BRUSH GROWTH.

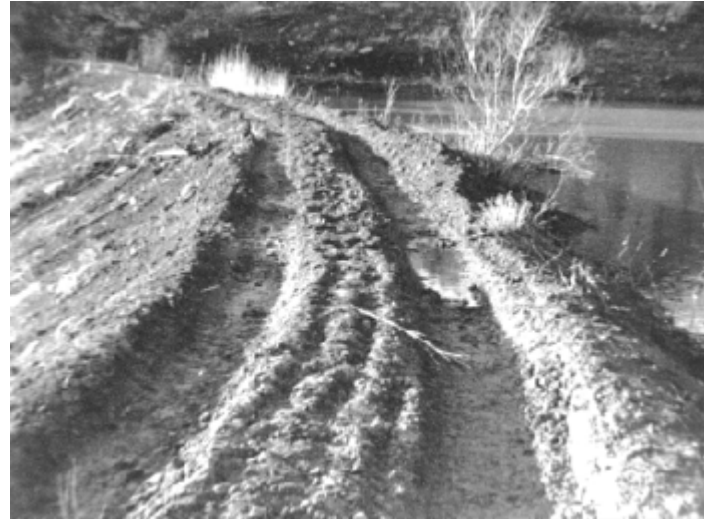
PHOTO 7.5-7—RUTS IN THE CREST OF A DAM

**Also see Photo 7.5-7.****CAUSES & HARM DONE****Cause:**

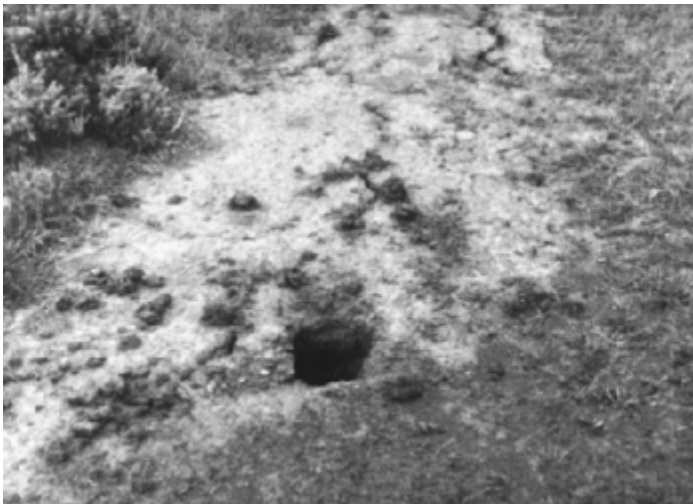
PHOTO 7.5-5—RODENT HOLE FOUND ON THE CREST OF A DAM

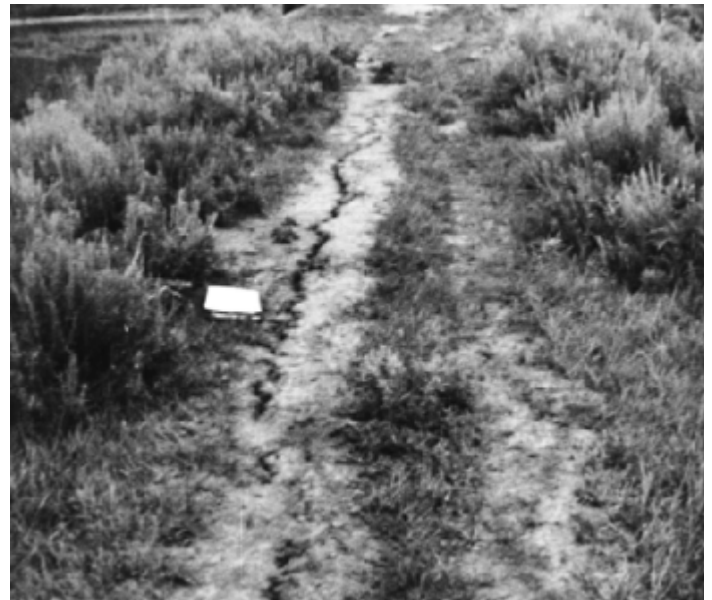
PHOTO 7.5-8—LONGITUDINAL DRYING CRACKS ON THE CREST OF A DAM. These cracks are caused by drying of the crest surface and are only 6-8 inches deep.

**Also see Photo 7.5-8.****Cause:**

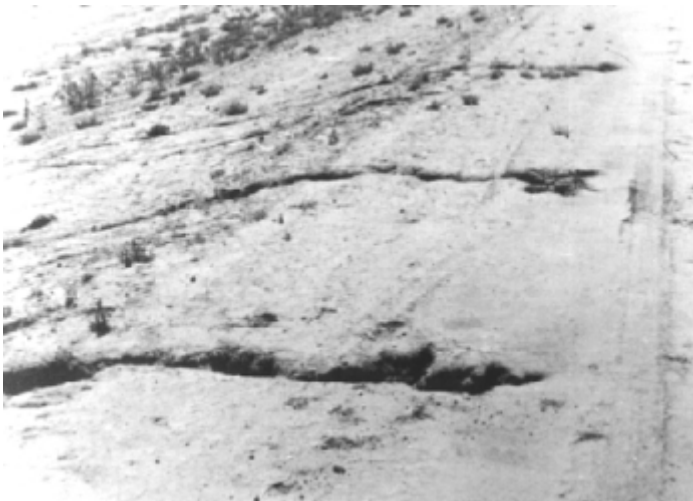
PHOTO 7.5-6—RUNOFF GULLIES FORMING ON THE DOWN-STREAM SHOULDER OF THE CREST

**Also see Photo 7.5-6.****Cause:**

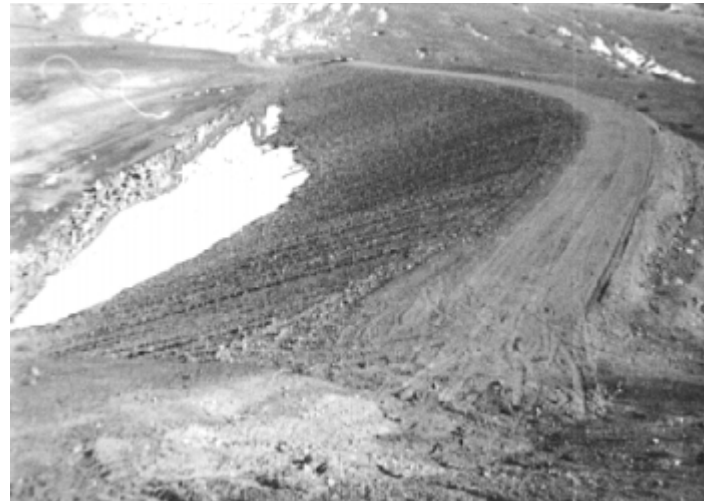
PHOTO 7.5-9—CAMBER INCORPORATED INTO CREST DURING CONSTRUCTION. Camber is greatest over highest section of the dam

Also see Photo 7.5-9.

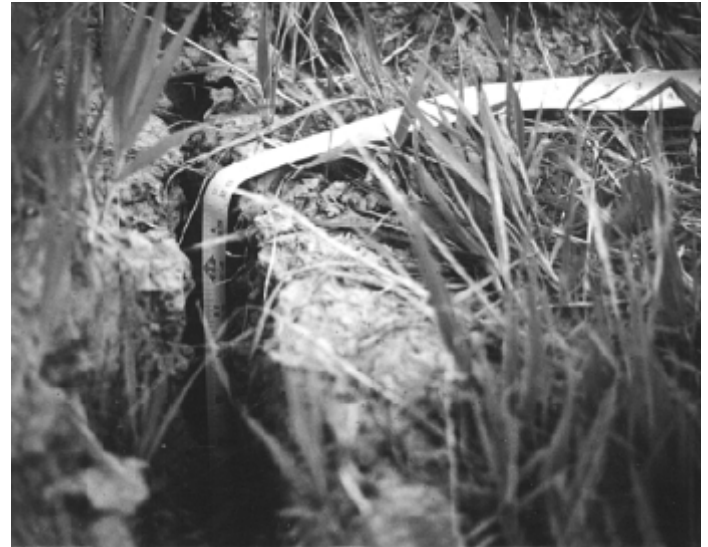
PHOTO 8.3-1—Three-fourth-inch-wide crack, well hidden in grass cover.

green grass on the slope usually indicates a seepage area. A crack such as the one shown in the photo below is difficult to locate. To help distinguish drying cracks from other types, the ground surface adjacent to the dam should be examined for similar cracking patterns.

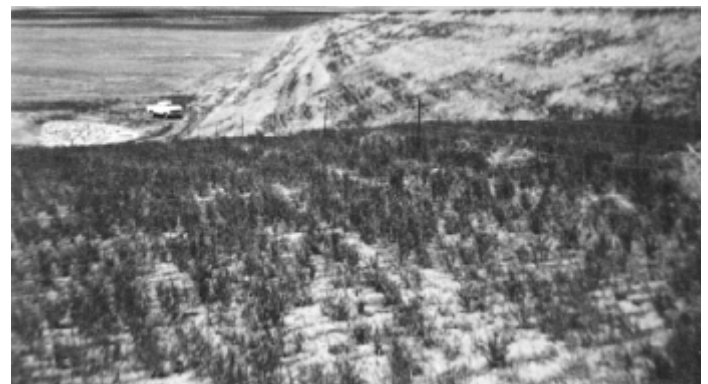
Photo 8.4-1—Early stage of growth for grass slope protection.

Embankment or compacted fill is usually covered with grasses to prevent erosion. An example is shown in the photo below.

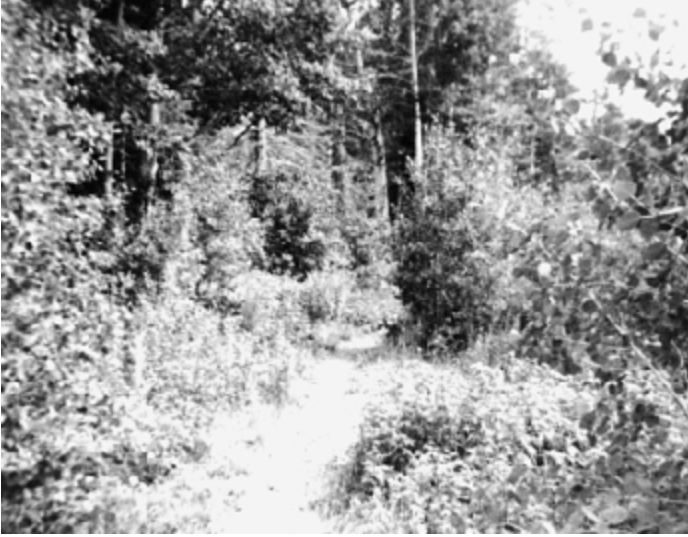
PHOTO 8.4-2—UNDESIRABLE AMOUNT OF VEGETATION

A thick stand of vegetation such as that shown below is not recommended because it obscures visual inspection of the surface.

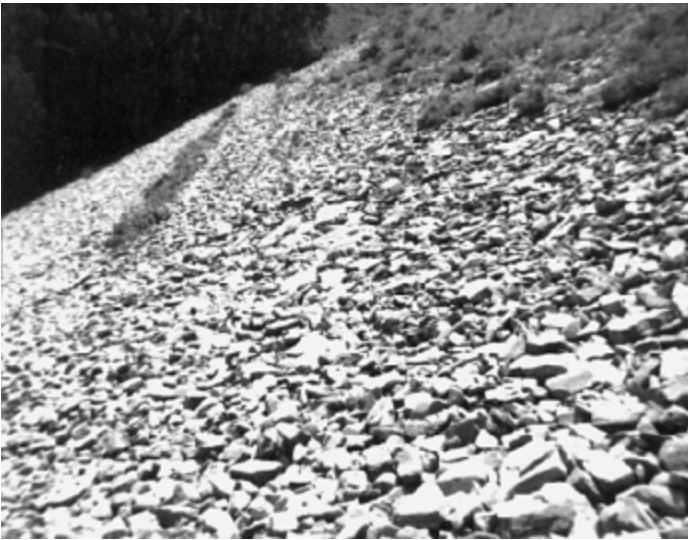
PHOTO 8.4-3—Example of well-placed riprap on the downstream slope.

Rock is placed on the compacted fill for erosion protection and is the preferred method of protecting the slope from erosion.

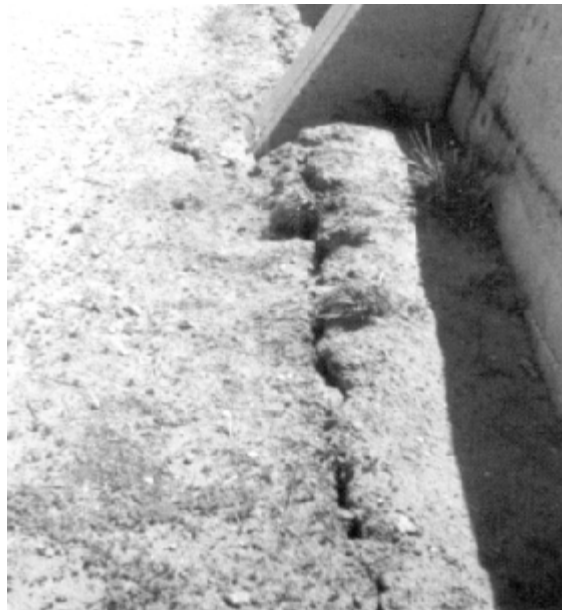
PHOTO 8.5-3—LONGITUDINAL CRACKING

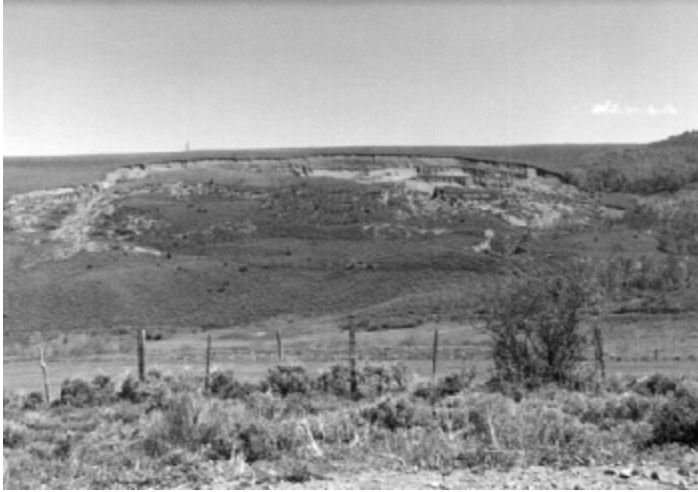
PHOTO 8.5-4—SLIDE/SLOUGH

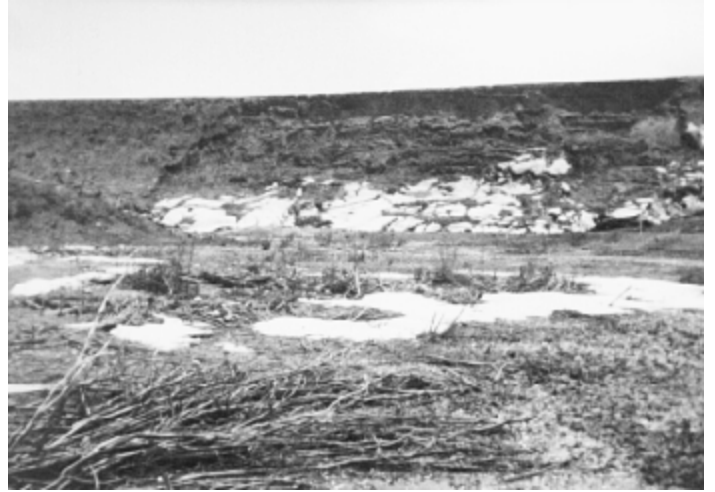
PHOTO 8.5-5—SLUMP

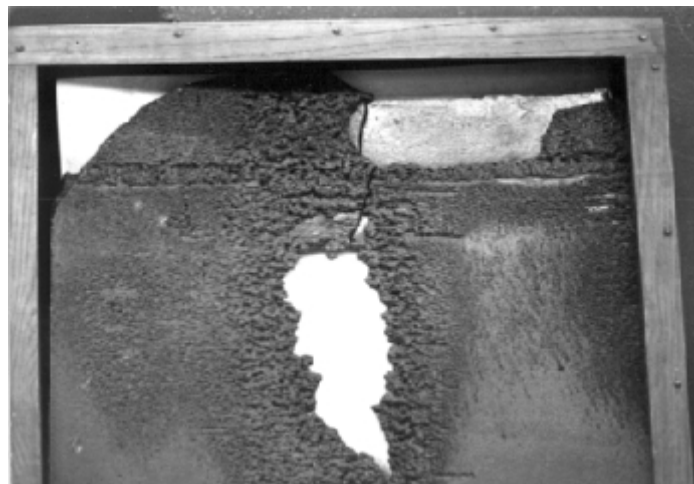
PHOTO 9.3-2—CAVITATION DAMAGE TO STEEL PIPE LINER. Cavitation has eaten through steel to expose concrete behind liner.

9.3-1 **Cavitation:** When water flows through an outlet system and passes restrictions (e.g., valves), a pressure drop may occur. If localized water pressures drop below the vapor pressure of water, a partial vacuum is created and the water actually boils, causing cavities of water vapor within the flowing water. These cavities later collapse, causing shockwaves, which can damage the outlet pipe or control valve. This process, called cavitation¹, can be a serious problem for tall dams where discharge velocities are high. Two typical examples of cavitation damage are shown in photos 9.3-1 and 9.3-2 below.

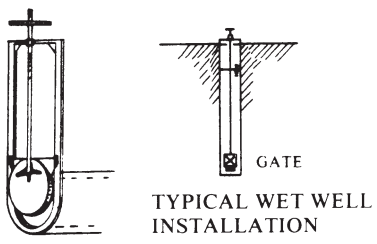
TYPE	DRAWING OR DESCRIPTION	USES AND DISCUSSION
SLIDE GATE OR SLUICE GATE (Ref. 2)

The most common type of valve. Used as regulating or guard valve at upstream end of outlet pipe, or in wet well. Mechanically simple and available in a variety of sizes and shapes. Suitable for dams of low to moderate height. If used to regulate flow, an airvent is recommended just downstream of the valve.
GATE VALVE (Ref. 1)

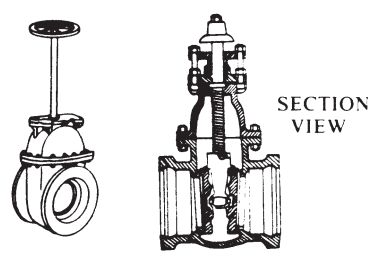
Typically used as a regulating valve or guard valve at the upstream end of the conduit or in an outlet well. Since the valve is watertight, the outlet well remains dry. The gate leaf is wedge-shaped and seals into a tapered seat. If a gate valve is used for regulation, an airvent is recommended just downstream of the valve.
BUTTERFLY VALVE (Ref. 2)

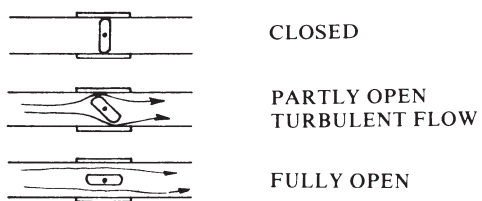
Performs best as an upstream guard gate. If used for regulation, certain valve openings cause turbulence and cavitation. Airvent required downstream of valve, if used for regulation.

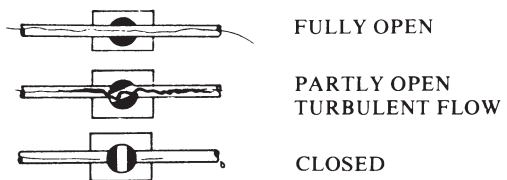
BALL VALVE, PLUG VALVE, OR CONE VALVE. (Ref. 1)

Used in low head situations or as a guard valve. Intermediate valve settings may result in turbulence and cavitation (airvent recommended).
FREE DISCHARGE VALVE (HOWELL-BUNGER, OR HOLLOW JET) (Ref. 3)

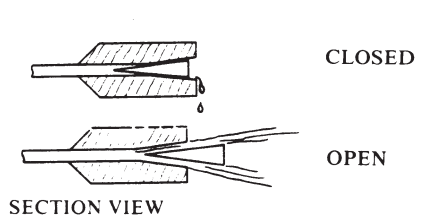
Located at downstream end of outlet conduit, discharging into the air (free discharge). Excellent regulating valve; functions well in a wide range of release rates. Used primarily on high dams where outlet pressures are great. Upstream guard gate required.
FLAP GATE (Ref. 2) SHEAR GATE (Ref. 1)

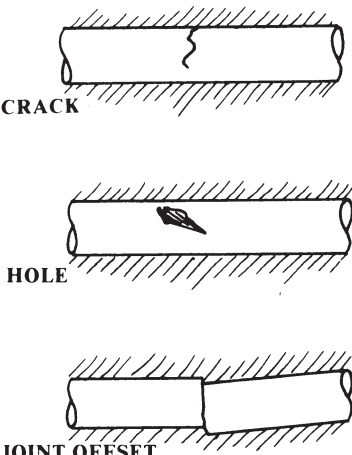
CONDITION FOUND	CAUSES & HARM DONE	ACTION REQUIRED
<p>9.8-1</p> <p>OUTLET PIPE DAMAGE</p>

<p>CRACK</p> <p>HOLE</p> <p>JOINT OFFSET</p>	<p>Cause: Settlement; impact. (See Photo 9.8-2).</p> <p>Cause: Rust (steel pipe) Erosion (concrete pipe) Cavitation (See Photo 9.8-1.)</p> <p>Cause: Settlement or poor construction practice.</p> <p>Harm: Provides passageway for water to exit or enter pipe. (Refer to Section 9.4.)</p>	<p>For all conditions: Check for evidence of water either entering or exiting pipe at crack/hole/etc.</p> <p>Tap pipe in vicinity of damaged area, listening for hollow sound which indicates a void has formed along the outside of the conduit.</p> <p>If a progressive failure similar to those shown in Section 9.4 is suspected, request engineering assistance.</p>
<p>9.8-2 VALVE LEAKAGE</p> <p>DEBRIS STRUCK UNDER GATE</p>

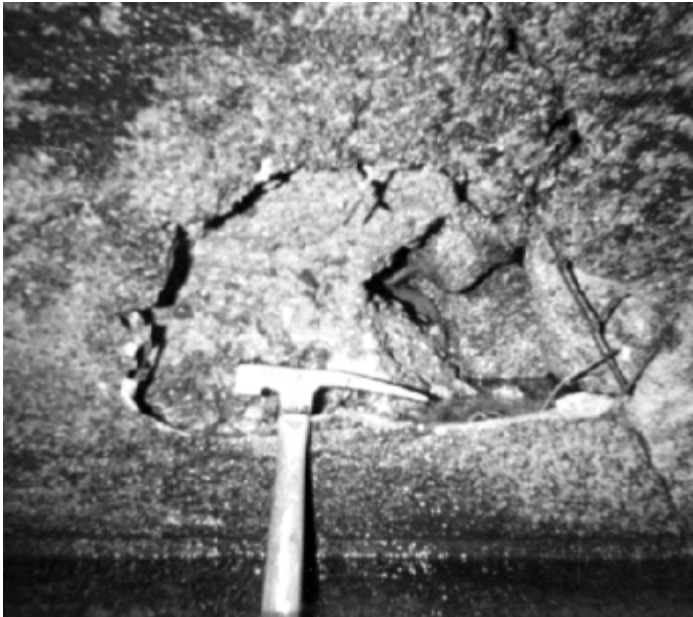
PHOTO 9.8-1—OUTLET—INTERNAL EROSION
Hole in cast-in-place concrete lining, caused by turbulence and erosion.

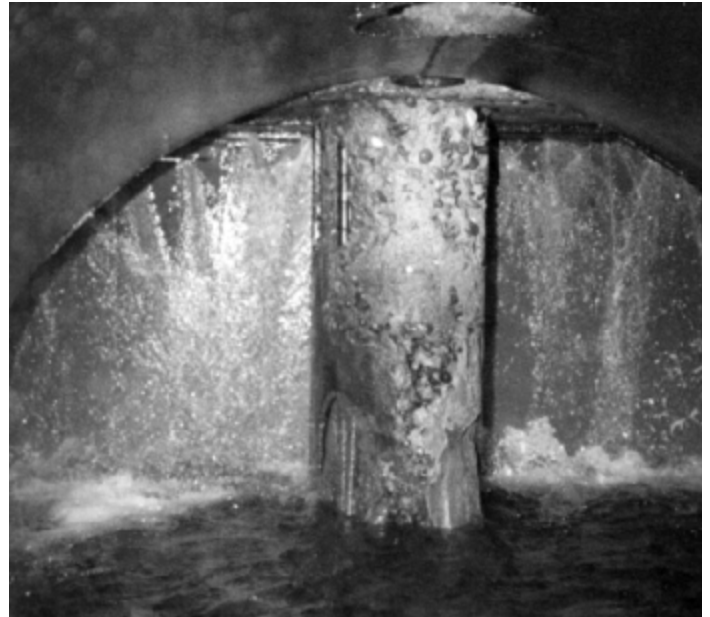
PHOTO 9.8-3—SIDE BY SIDE SLIDE GATES
Gate leakage and cavitation damage to bull nose pier. Note exposed reinforcing steel. Air vent pipe at top of photo.

<p>AIRVENT</p>	<p>Cause: Rust, erosion, cavitation, vibration, or wear.</p> <p>Harm: Leakage and loss of support for gate leaf. Gate may bind in guides and become inoperable.</p>	<p>Minimize use of valve until guides/seats can be repaired. If cavitation is the cause, check to see if air vent pipe exists, and is unobstructed. (See Photo 9.8-3.)</p>

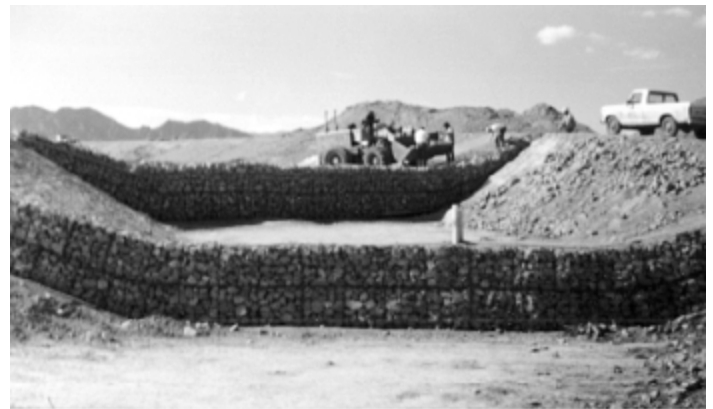
PHOTO 10.4-1—GABION DROP STRUCTURE. A special type of rock protection against erosion.

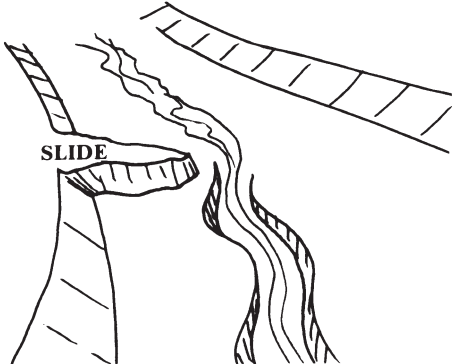
<p>Cause: Accumulation of slide materials, dead trees, excessive vegetative growth, etc., in spillway channel.</p> <p>Harm: Reduced discharge capacity; overflow of spillway; overtopping of dam. Prolonged overtopping can cause failure of the dam.</p>	<p>Action: Clean out debris periodically; control vegetative growth in spillway channel. Install log boom in front of spillway entrance to intercept debris.</p>
<p>10.5-2 Excessive erosion in earth-slide causes concentrated flows</p>

<p>Cause: Discharge velocity too high; bottom and slope material loose or deteriorated; channel and bank slopes too steep; bare soil unprotected; poor construction; protective surface failed.</p> <p>Harm: Disturbed flow pattern; loss of material, increased sediment load downstream; collapse of banks; failure of spillway; can lead to rapid evacuation of the reservoir through the severely eroded spillway.</p>	<p>Action: Minimize flow velocity by proper design. Use sound material. Keep channel and bank slopes mild. Encourage growth of grass on soil surface. Construct smooth and well-compacted surfaces. Protect surface with riprap, asphalt, or concrete. Repair eroded portion using sound construction practices.</p>

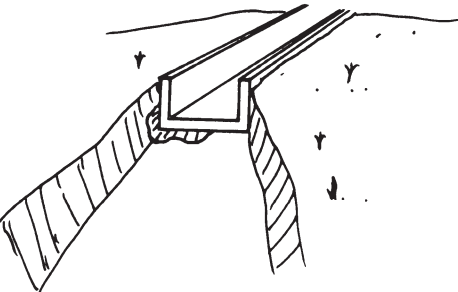
<p>10.5-3 End of spillway chute undercut</p>

<p>Cause: Poor configuration of stilling basin area. Highly erodible materials. Absence of cutoff wall at end of chute.</p> <p>Harm: Structural damage to spillway structure; collapse of slab and wall; leads to costly repair. Higher velocity flows can cause erosion of drain then embankment materials.</p>	<p>Action: Dewater affected area; clean out eroded area and properly backfill. Improve stream channel below chute; provide properly sized riprap in stilling basin area. Install cutoff wall.</p>

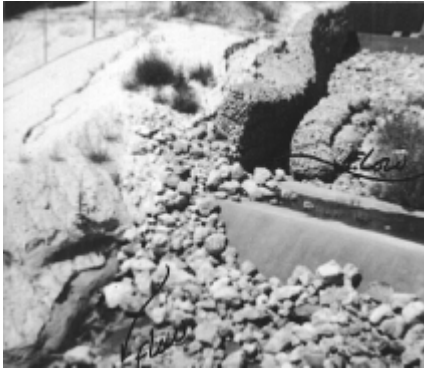
PHOTO 10.5-1—Failed spillway gabion wall

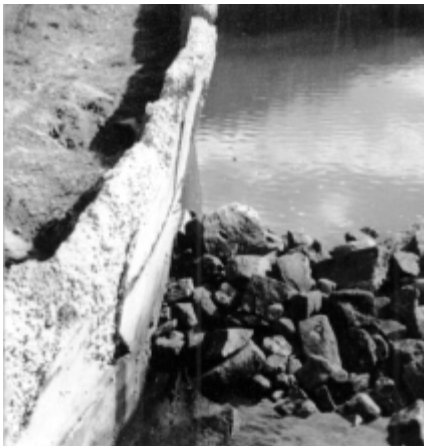
PHOTO 10.5-1—Deterioration of right D/S wingwall of spillway.

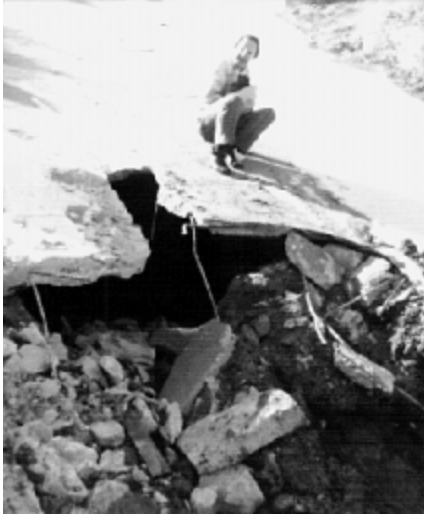
PHOTO 10.5-4—FAILED SPILLWAY
Fracturing of spillway chute slab
