DAM SAFETY MANUAL

**State Engineer's Office
State of Colorado
January, 2002**

STATE OF COLORADO DAM SAFETY MANUAL

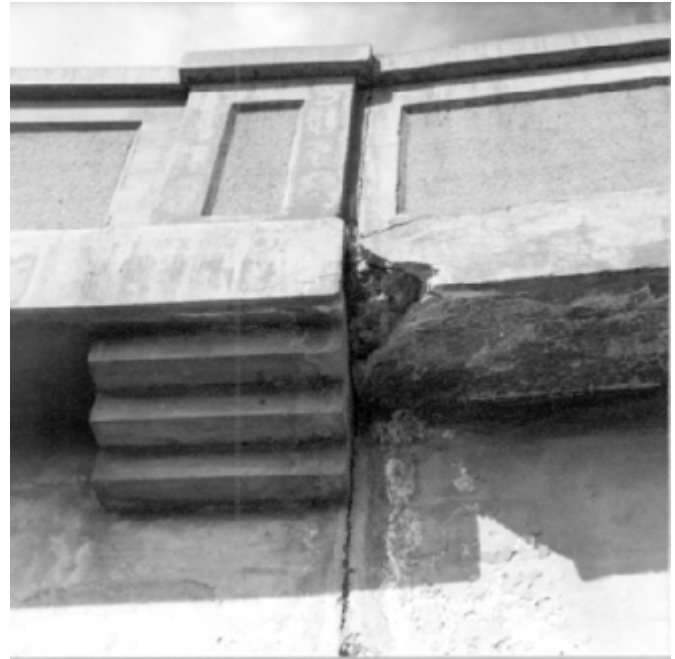
PHOTO 11.4-1
CRACK AT VERTICAL CONSTRUCTION JOINT. Note evidence of minor leakage and spalling adjacent to joint.

Construction joints are provided to accommodate volumetric changes which occur in the structure after concrete placement, and are referred to as "designed" cracks. These joints are so constructed that no bond or reinforcing, except non-bonded waterstops and dowels, extend across the joint. (See Section 11.2.a.) Examples of cracking at construction joints are shown in Photographs 11.4-1 and 11.4-2.

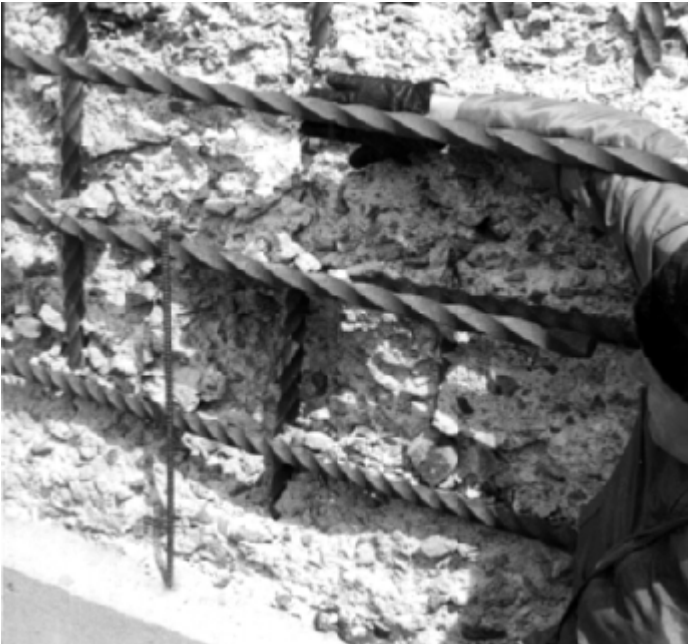
Photo 11.4-3—Structural damage. Spalling has exposed reinforcing.

In severe situations, engineering assistance is required to determine the best method of repair. Photos 11.4-3 and 11.4-4 are examples of damage due to severe spalling.

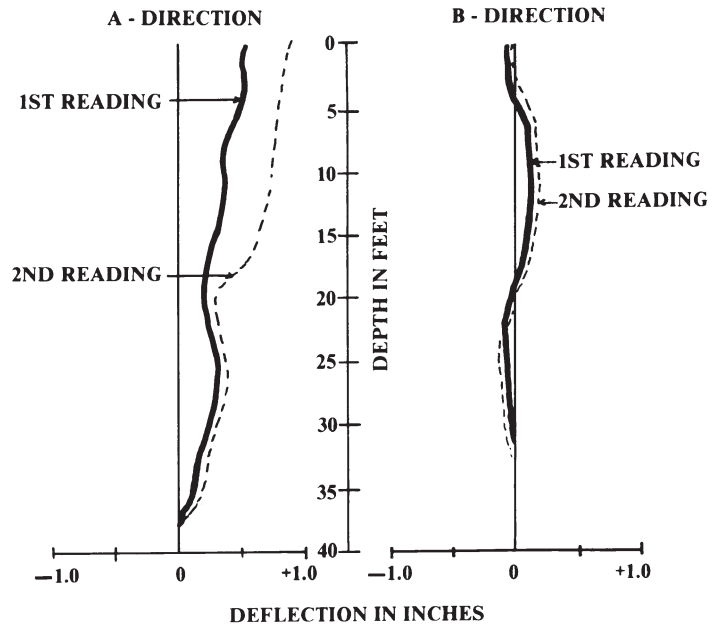
FIGURE 12.6-5—PLOT OF INCLINOMETER READINGS

All readings are compared with the initial profile to determine if changes have occurred. The results are usually presented on a graph as shown below.

In the above graph the movement that took place between the first and second reading is less than ¼ inch. The small displacement could not have been measured by conventional surveying methods on the surface. Inclinometers are most beneficial if installed before a surface movement is detected.
