Commissioners Information Meeting
Natural Gas Pipeline Infrastructure Update
Colorado

Colorado Public Utilities Commission

May 18, 2011

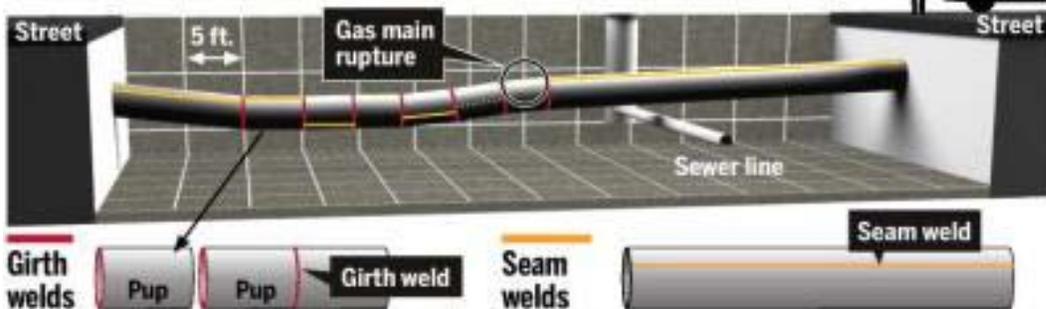
Gas pipeline construction

A report in January from the National Transportation Safety Board said that the natural gas pipeline that exploded in San Bruno in September 2010 had more than 100 spots with inadequate welds. These welds were either girth or seam welds, defined below.

Within the 44-foot section of the damaged pipeline were six smaller pieces, known as "pups," all welded end-to-end at the girth on-site in 1956.

Done at a factory, pipes were made by rolling steel sheets and welding them at the seam. Investigators found numerous welds only penetrated halfway through the steel when they should have gone all the way.

Subsequent reports indicate a longitudinal seam defect in one of the pups installed in the rupture area was the failure point of origin. The seam welds were made at a pipe mill and not by PG&E or contractor welders. The seam welds appear to have insufficient weld penetration from the outside weld and a radial offset on the inside seam joint but with no consistent internal weld.
