WATER QUALITY TECHNICAL MEMORANDUM

April 2014

EB I-70 Peak Period Shoulder Lane CATEGORICAL EXCLUSION

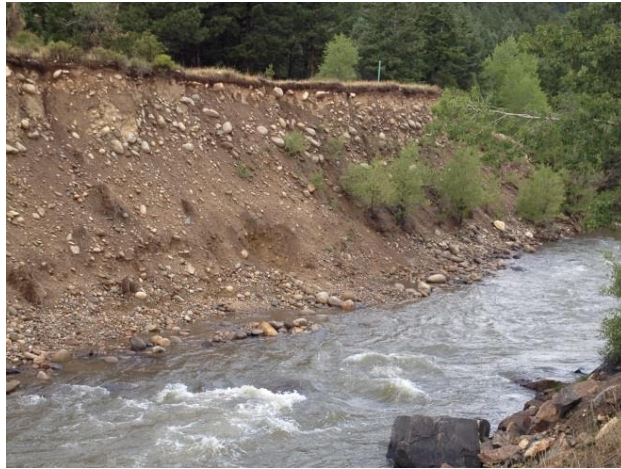
Channel bank erosion in Clear Creek, Idaho Springs.

Existing water resource conditions were documented by field surveys of drainage features, sediment deposition, and erosion conditions and through review of water quality data for the study area. Examples of existing conditions are shown on Figure 1. Potential changes anticipated during and after construction were evaluated.

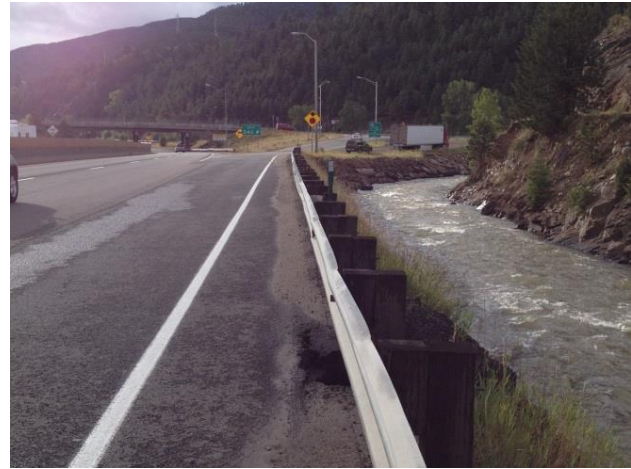
Example area where direct runoff from eastbound I-70 may flow directly into Clear Creek. (SH 103 off-ramp)

Eastbound highway runoff typically flows directly into Clear Creek. There are relatively few existing inlets and storm pipes that convey stormwater runoff from eastbound I-70 through this project reach.

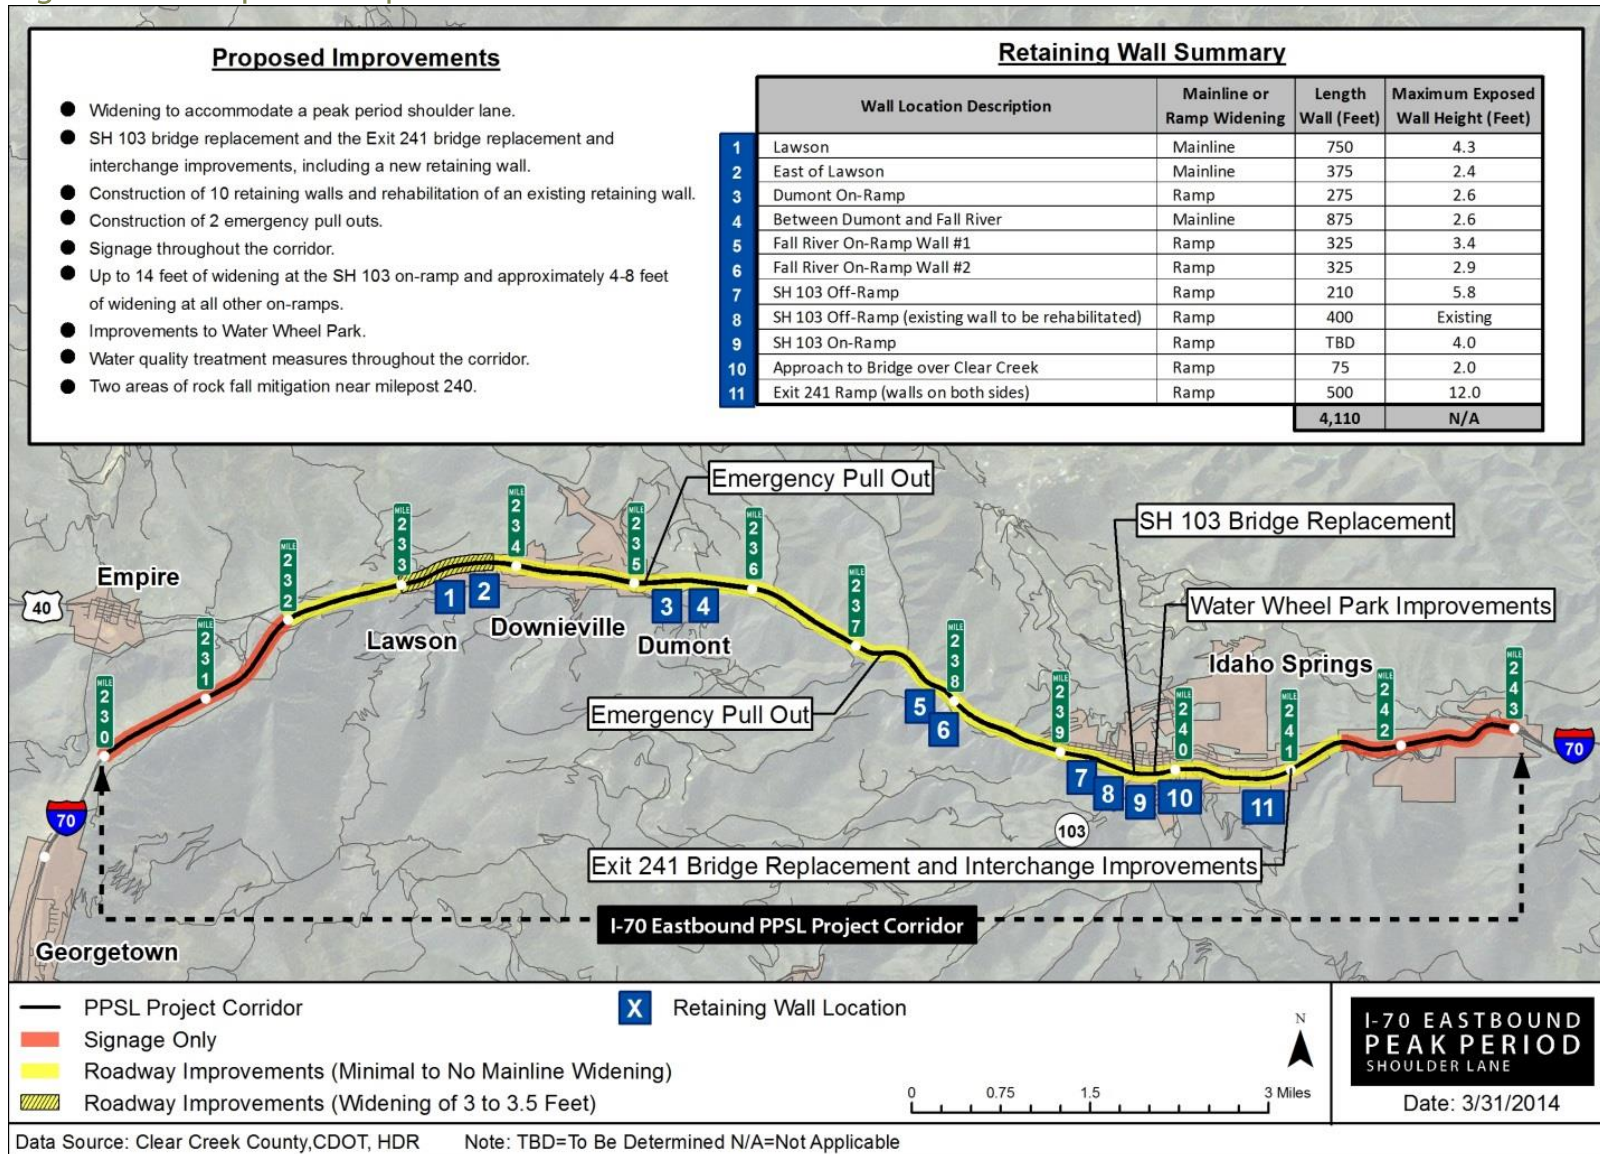
Figure 2. Proposed Improvements

- Milepost 230 to milepost 232: signage improvements only. Signage would notify motorists of the status of the managed lane, entrance and exit points, and cost.
- Milepost 232 to milepost 242: roadway improvements, including: up to 3.5 feet of widening in select areas to accommodate the managed lane, up to 14 feet of widening at the SH 103 on ramp and 4 feet to 8 feet of widening at all other on-ramps in the corridor, replacement of the existing SH 103 bridge, bridge replacement and interchange improvements at Exit 241,

See Figure 2 for an overview of the proposed improvements.

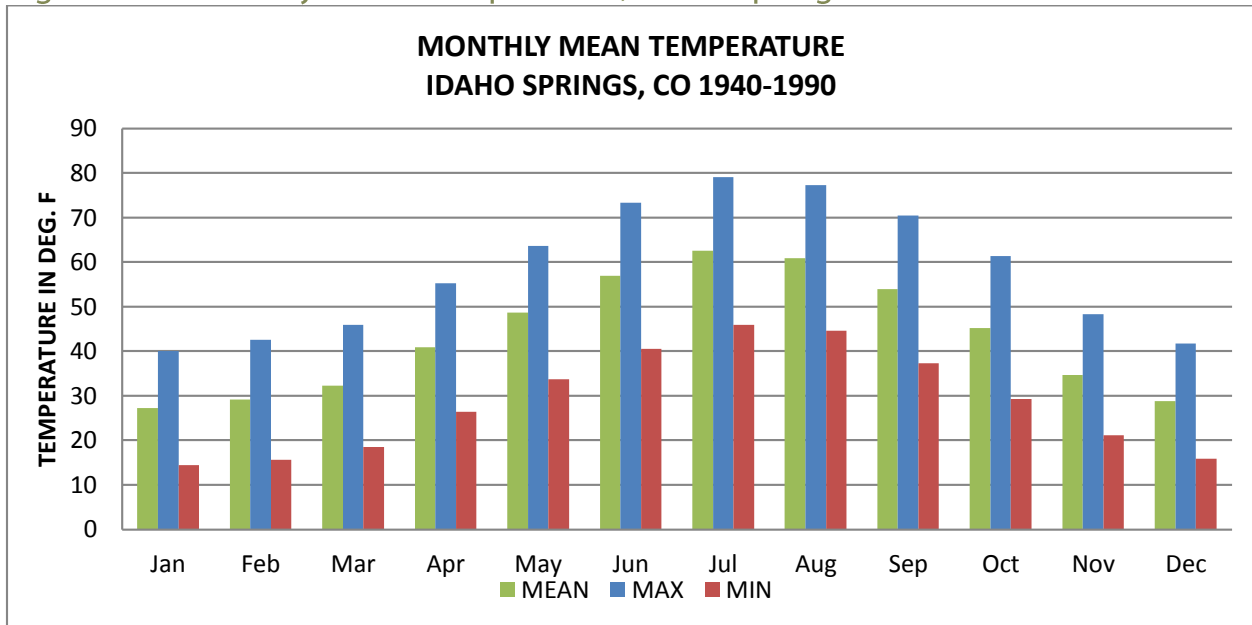
Figure 3. Monthly Mean Temperature, Idaho Springs

The study area has mean temperatures with below freezing conditions in winter (December to March). The average annual temperature and precipitation in the study area are 43° F and 14 inches, respectively, measured at Idaho Springs. Figure 3 and Figure 4 show seasonal temperature and precipitation distribution for the town of Idaho Springs.

Note: Data for temperature and precipitation in Idaho Springs are available up to 1990 through the National Ocean and Atmospheric Administration and Western Regional Climate Center.

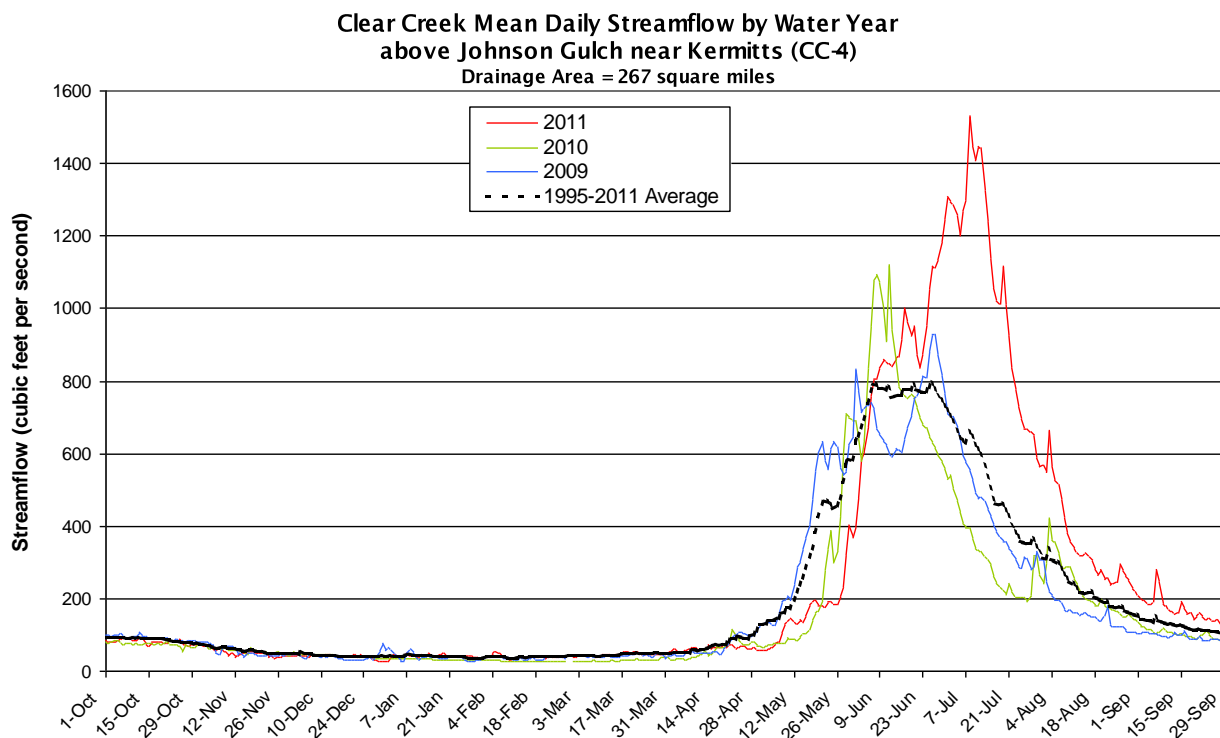
Figure 5. Clear Creek Mean Daily Discharge by Water Year

The seasonal precipitation pattern determines highway runoff and stream flow conditions in the study area. Other factors that can influence hydrology include transmountain water diversions, storage reservoirs, and increases in impervious surfaces resulting from urban, commercial, industrial, and highway development.

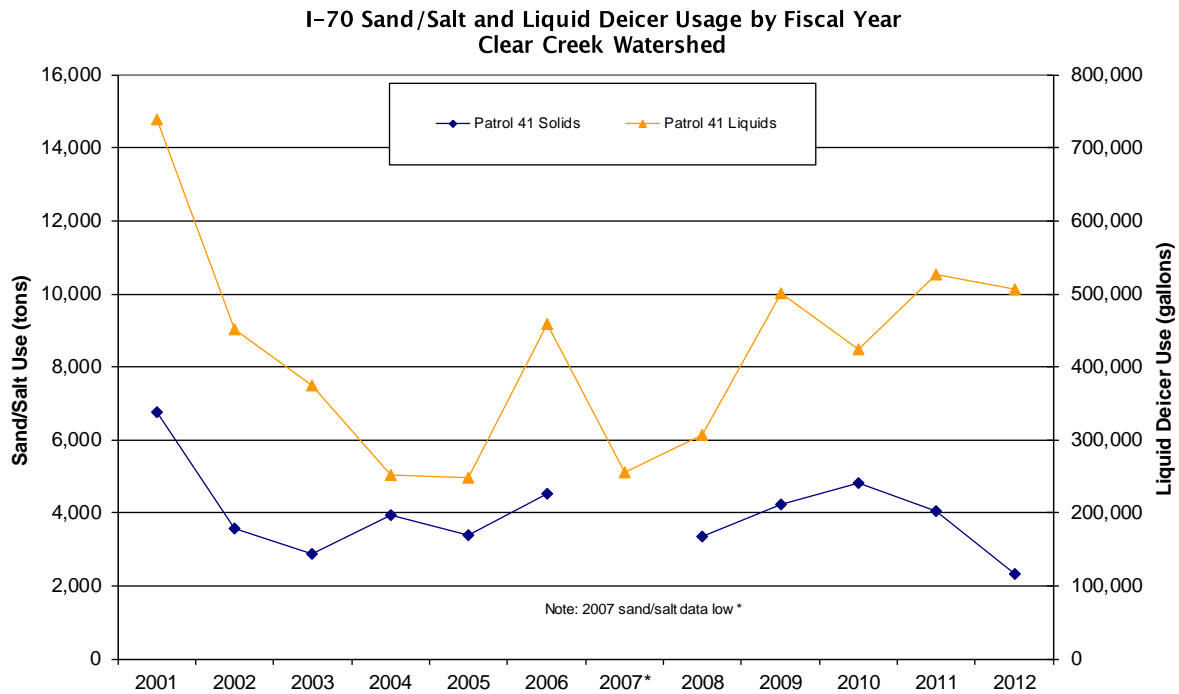
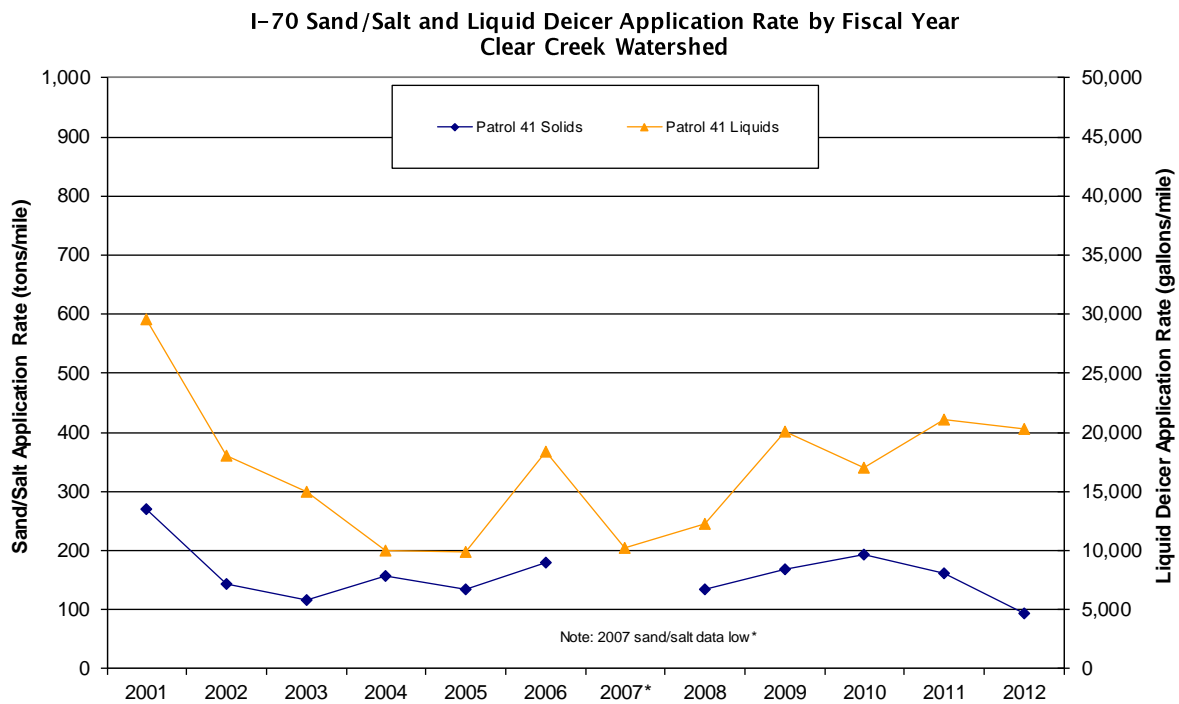
Figure 6. I-70 Sand/ Salt and Liquid Deicer Use

The highway contributes surface runoff to receiving streams during snowmelt or rainfall runoff conditions. CDOT removes snow from the travel lanes and applies traction sand or salt-based liquid deicers to maintain winter mobility. Traction sand accumulates along the highway shoulders over the winter in the study area. Snowmelt and rainfall runoff can remobilize dissolved and particulate contaminants from I-70 to receiving streams.

*Year 2007 solid volumes not used; possible under-reporting caused by CDOT transition from Maintenance Management System to the SAP

Stream water quality can be affected by highway winter maintenance material (sand and salt) that run off the highway into receiving streams. The amount and type of winter maintenance material used changes based on weather conditions and mobility demands of the traveling public. The I-70 Mountain Corridor PEIS identified sediment and chloride as the primary water quality parameters of concern for the I-70 corridor in the study area (CDOT, 2011b).

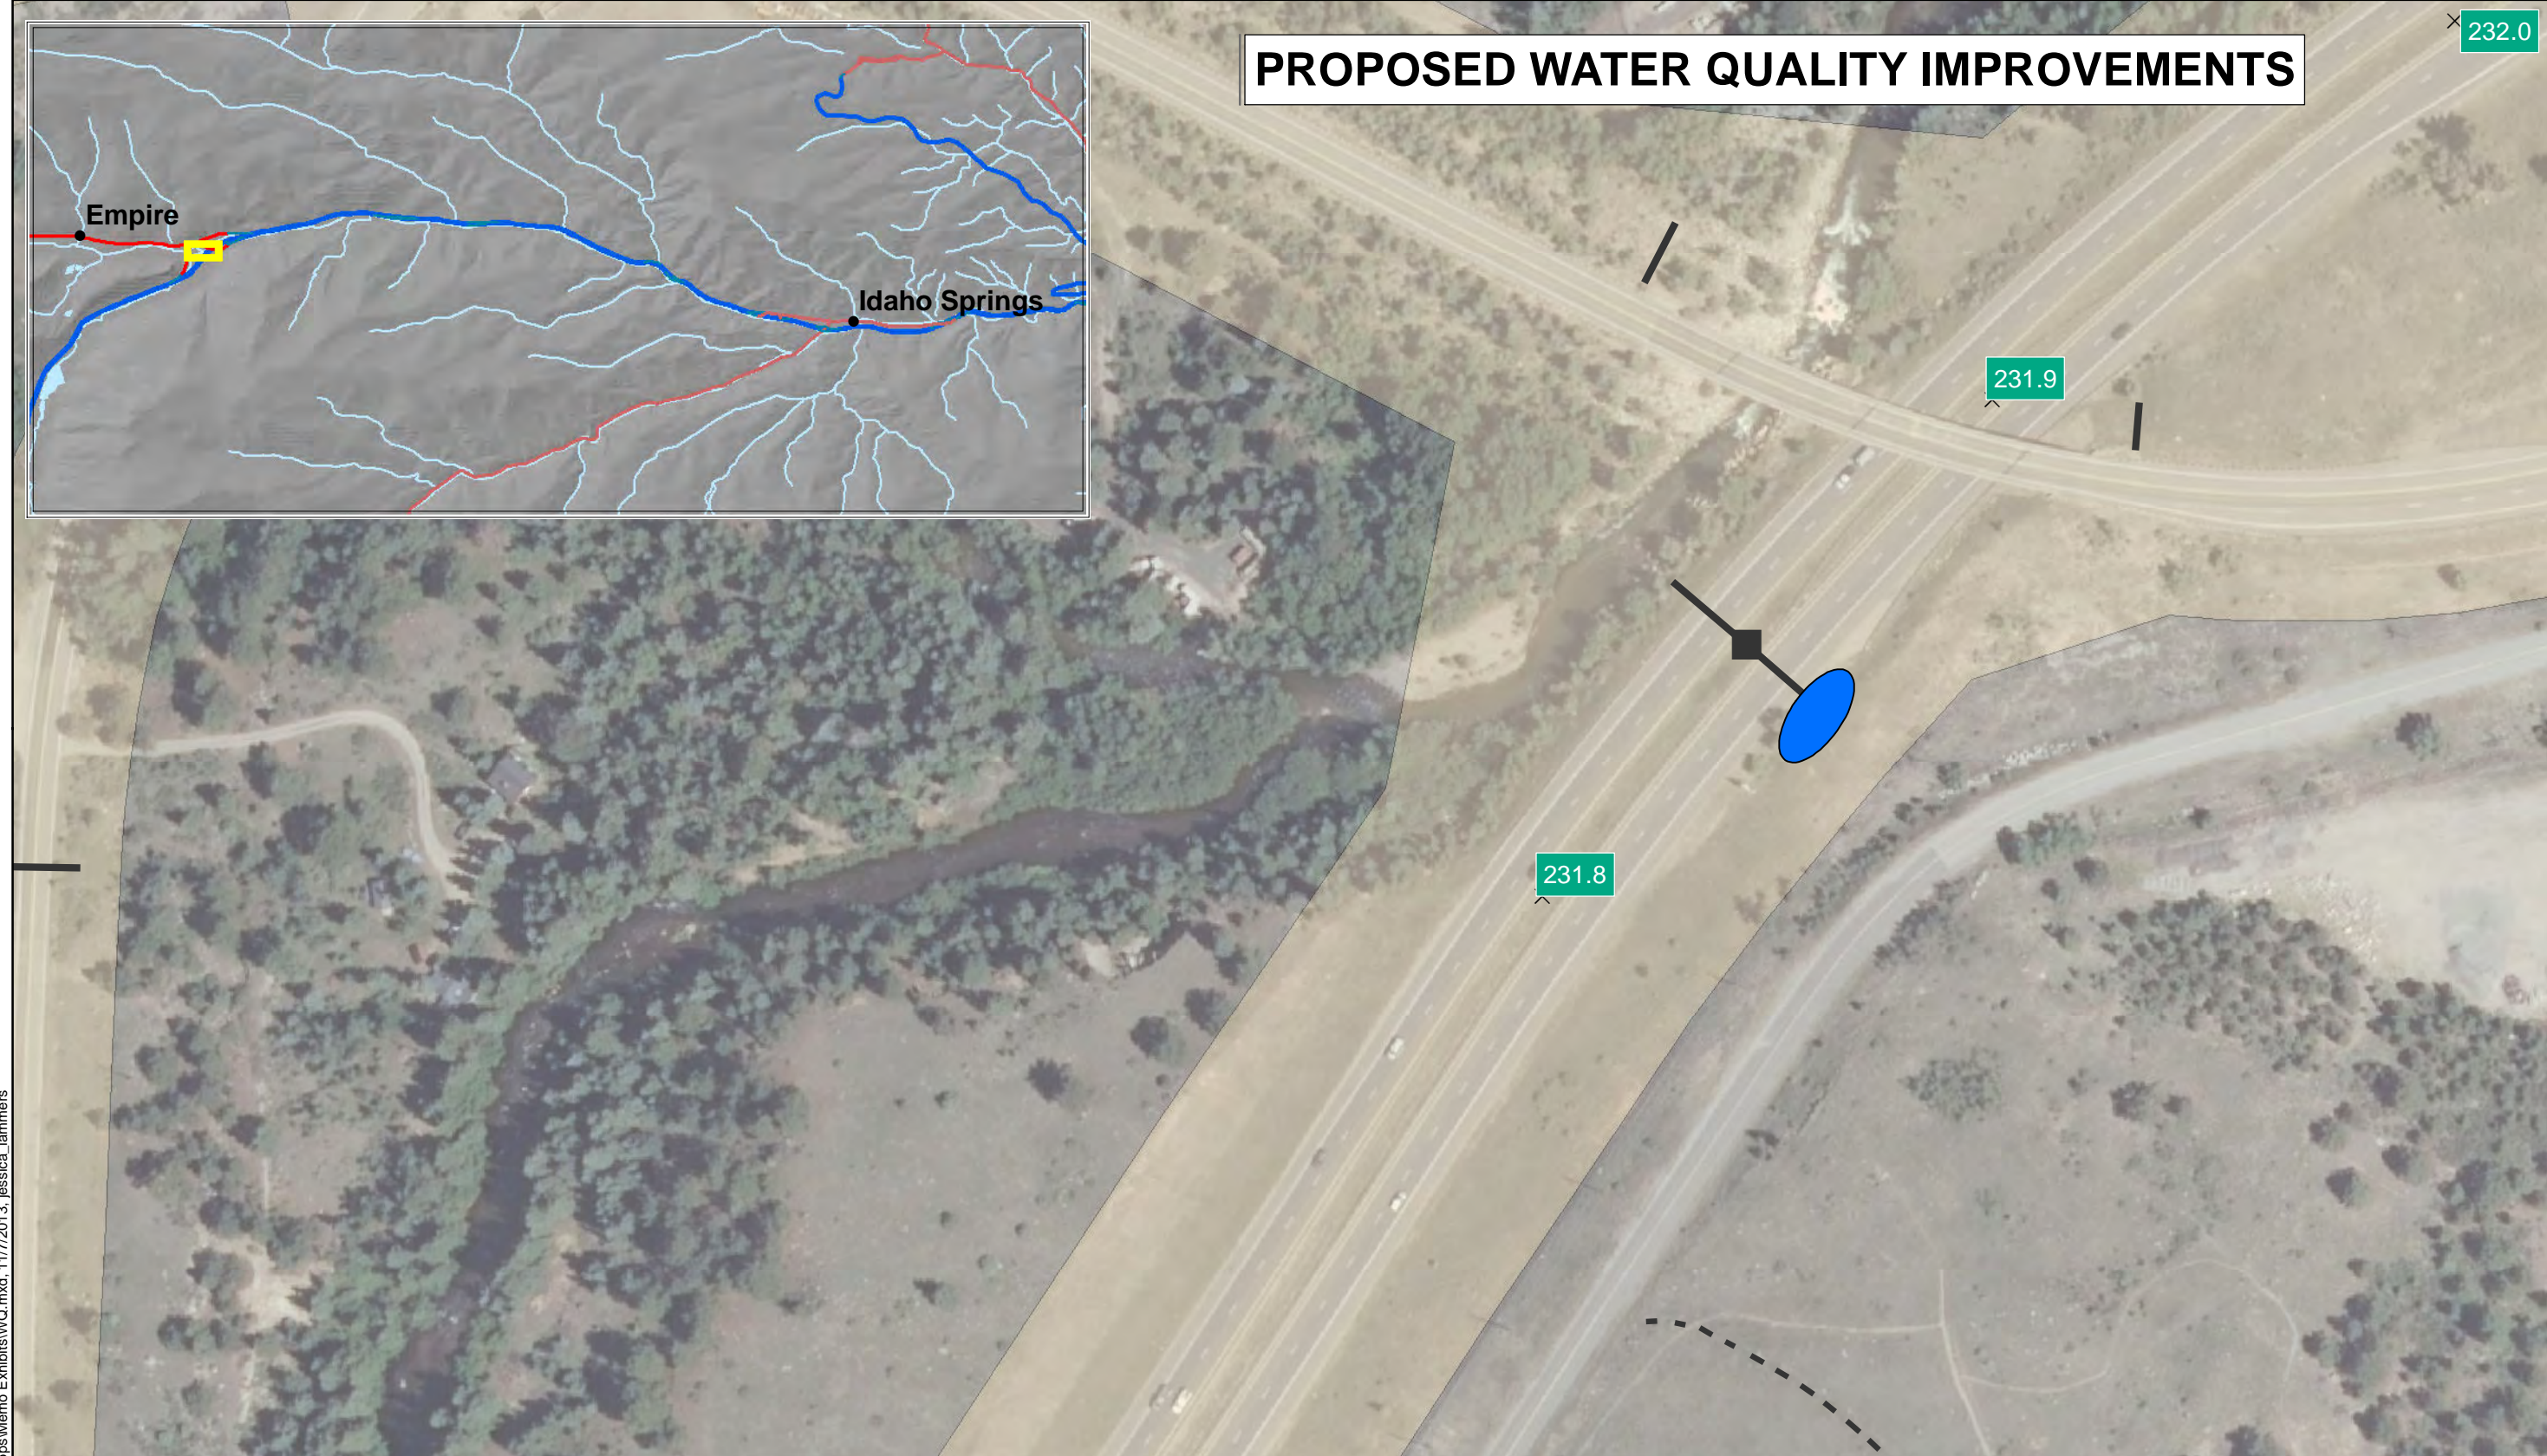
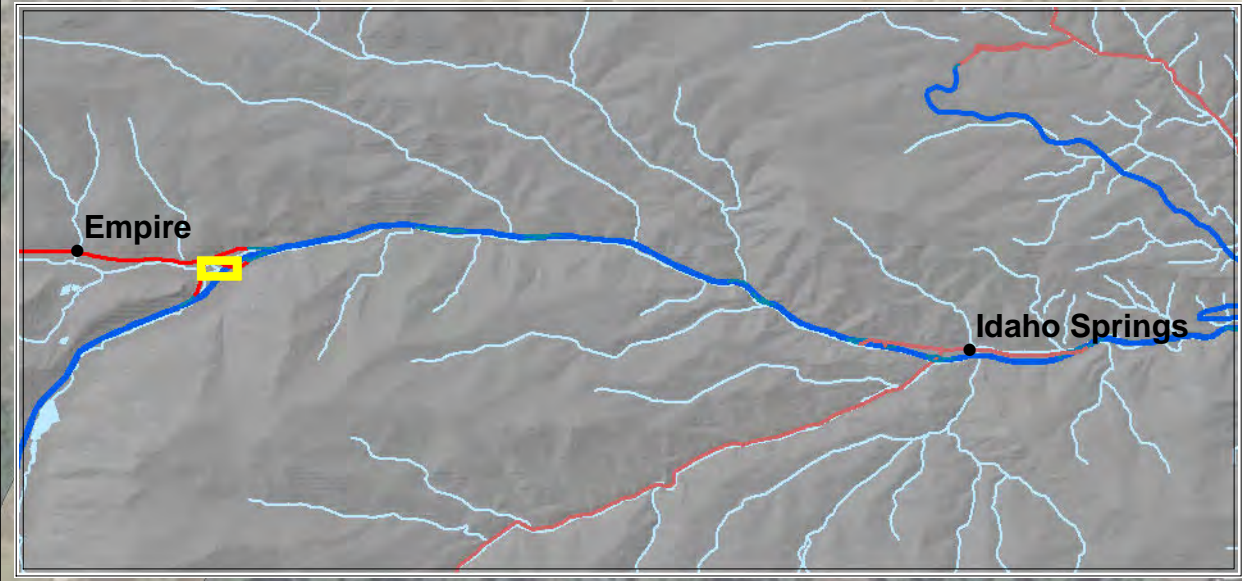
PROPOSED WATER QUALITY IMPROVEMENTS

- Proposed Sediment Basins_
- Proposed Curb & Gutter
- Proposed Rundown
- Existing Inlet
- Proposed Retaining Wall
- Existing Rundown
- Existing Channel/Ditch
- Existing Culvert
- Mile Marker
- CDOT ROW
