Nature's Building Codes

Geology and Construction in Colorado

COLORADO GEOLOGICAL SURVEY

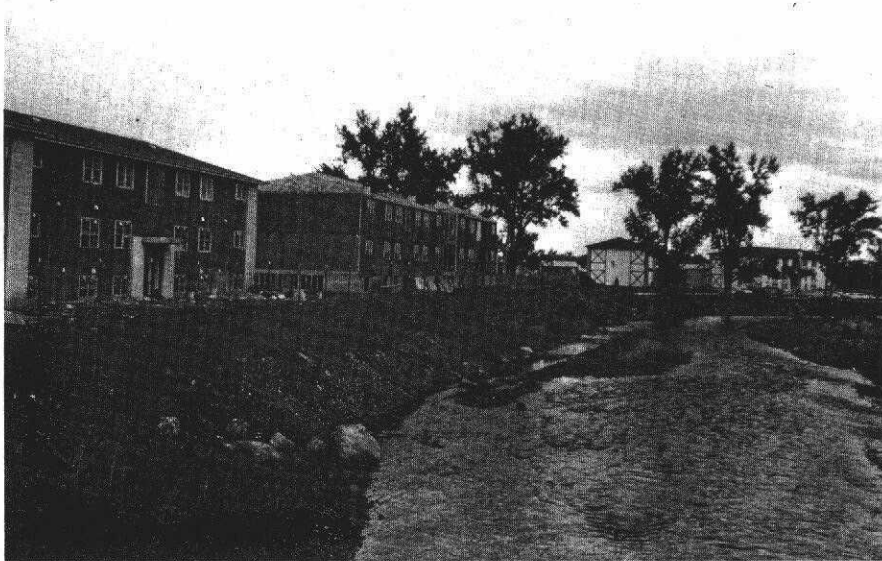
These apartment houses are within the flood plain of Bear Creek in the Denver metropolitan area. A flood control dam has been placed upstream of this development.

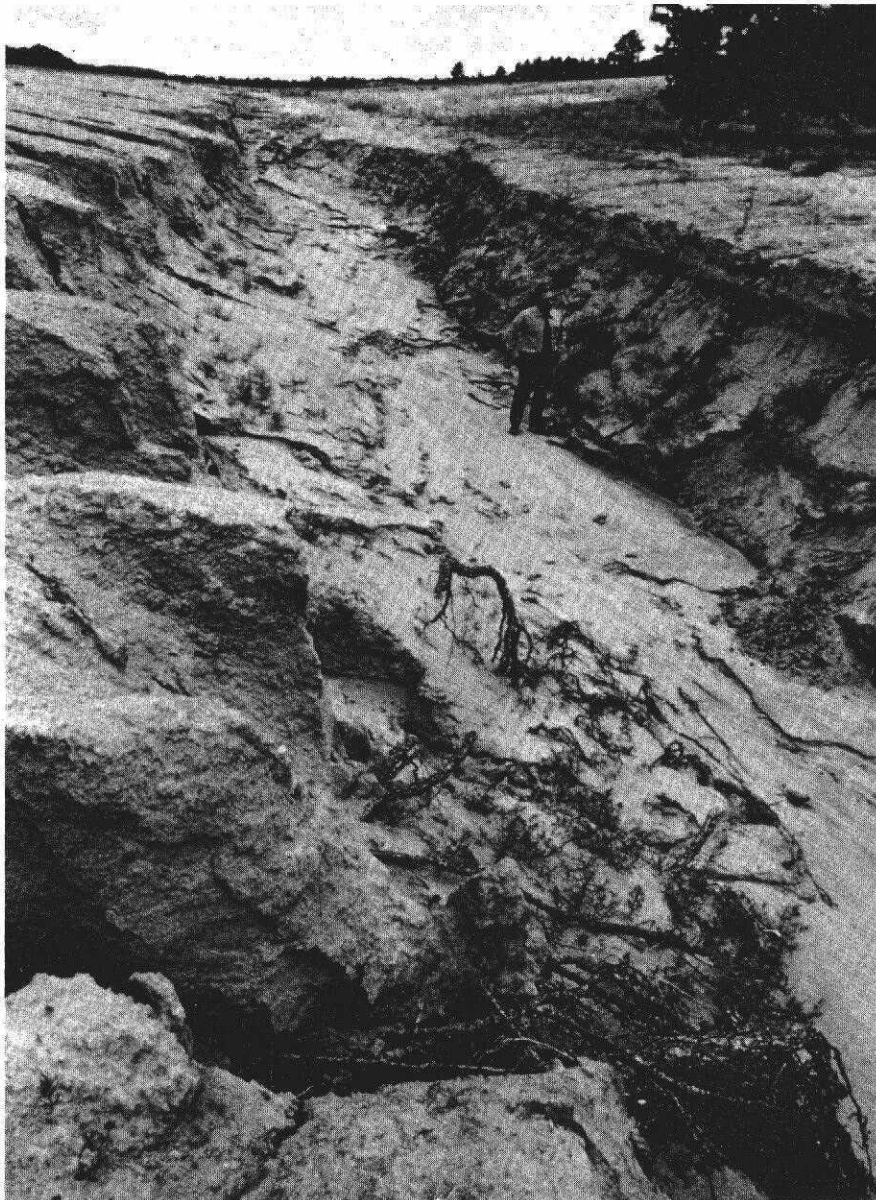
Severe erosion from man-made alterations of the natural drainage systems resulted in a large gully in Douglas County. Note man standing in the center of the picture.

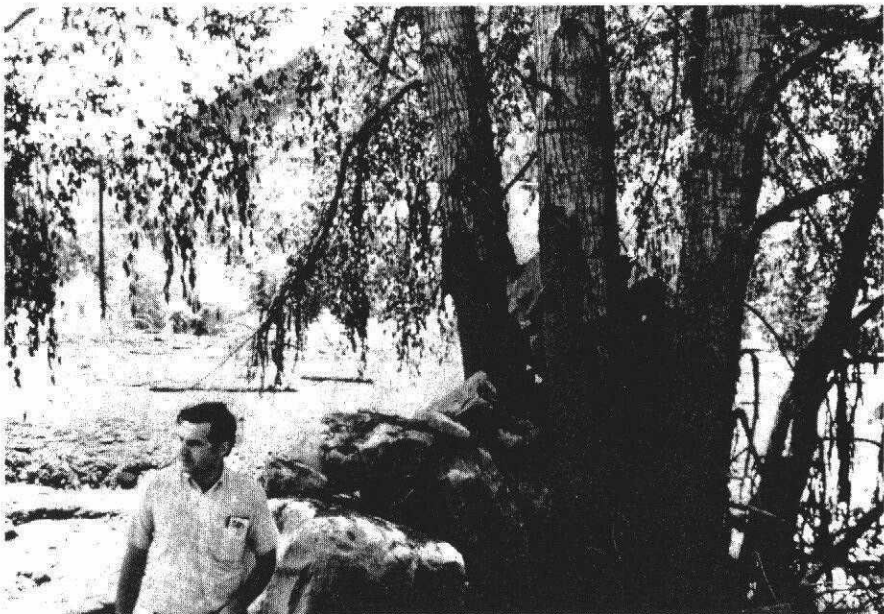
Mud and debris flows at Slate Creek near Marble lodged mud and boulders high in the trees, indicating a flow depth of at least 10 feet higher than the present ground level. This was a relatively minor event such as occurs on Slate Creek about every five years.

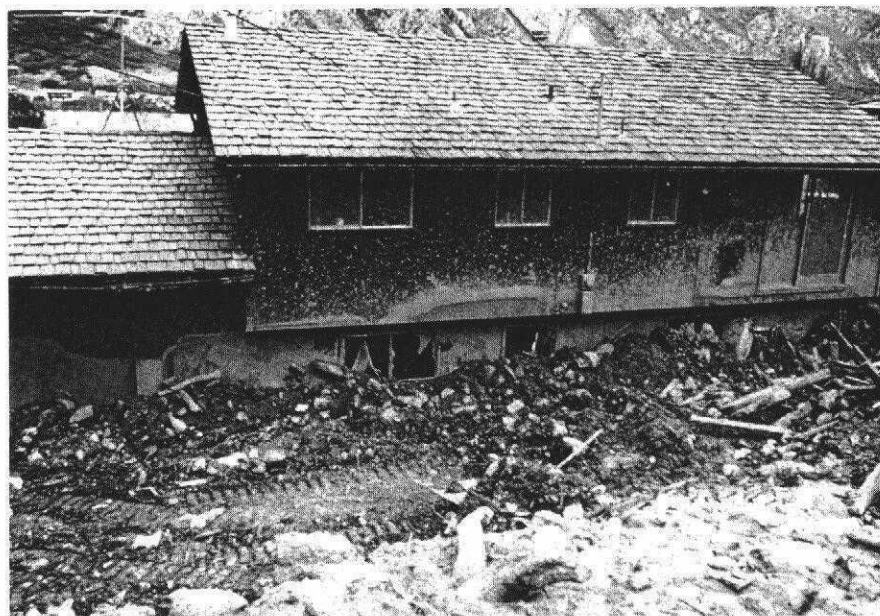
A debris flow smashed into this Glenwood Springs home in 1977. The house is a part of a residential development placed on a debris fan which had been built up over the years. Note the height of the flow as indicated by the water/mud mark at second floor level.

On July 24, 1977, an intense rainstorm drenched Glenwood Springs and the steep slopes above the town. It generated debris flows that caused a reported \$2 million in damage in the southern part of the city. Remarkably, there were no reported injuries as tons of red rock and other material, loosened by the rainfall, swept down the scenic mountainside into homes and other buildings, severely damaging them. The financial loss, much of it borne by city and Garfield County taxpayers, could have been averted with proper development planning on a known debris fan and its periphery.

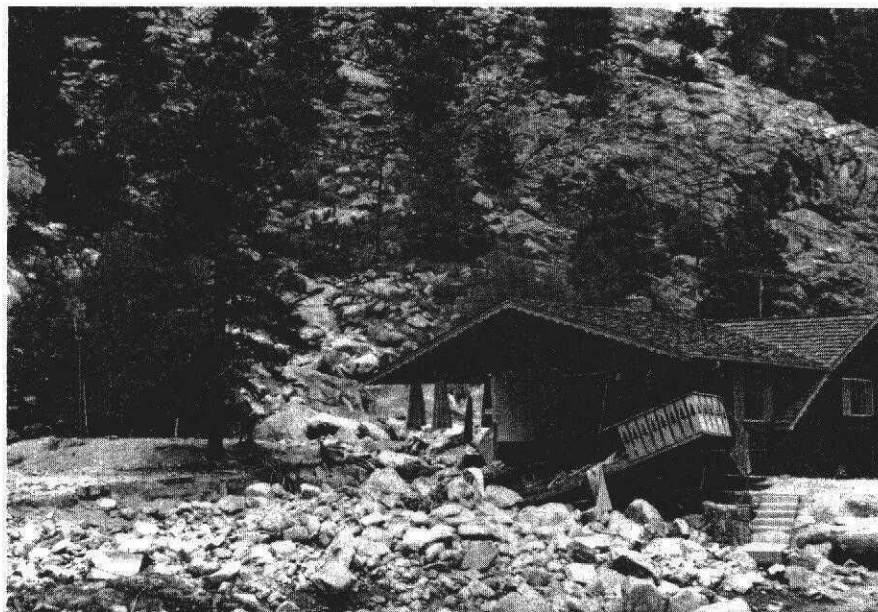
This house was located on a debris fan of a small tributary to the Big Thompson River. The house was not damaged by mainstream flooding on the Big Thompson, but by the debris flow from the small ravine behind the house.

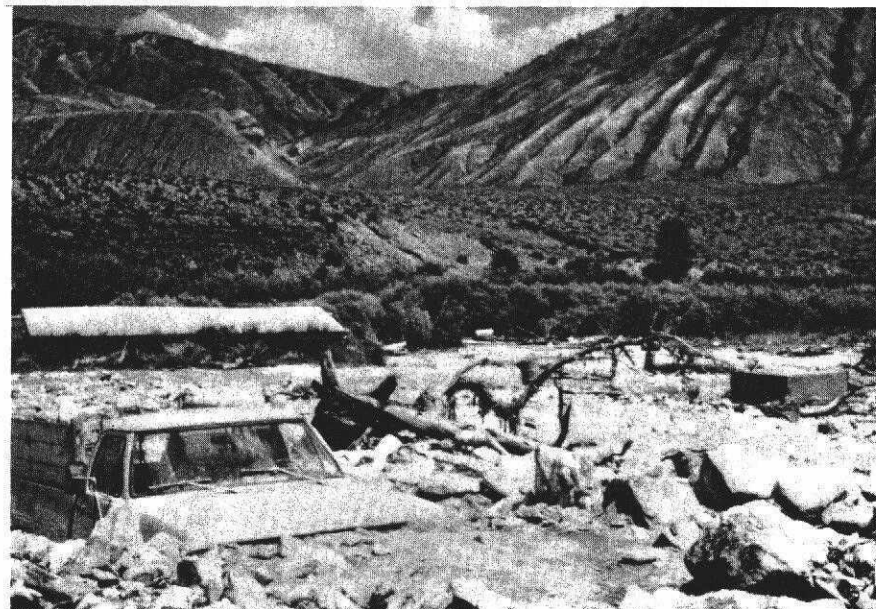
Deposits on a debris fan on Sweetwater Creek in Eagle County occurred ten days after the Big Thompson flood in 1976.

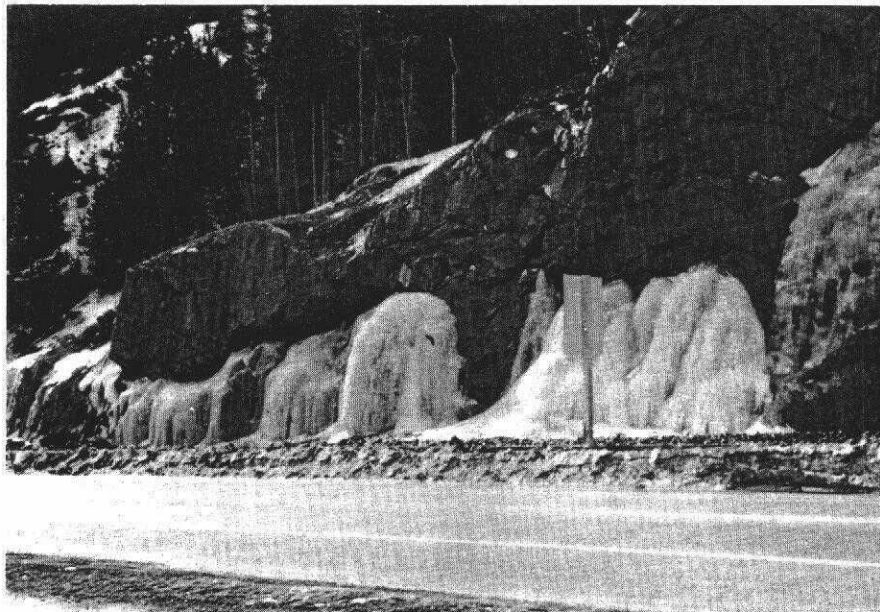
The pathways of groundwater movement through fractures in crystalline rocks in Clear Creek County are vividly shown by the formation of ice from seeping ground water at joints in the rock.

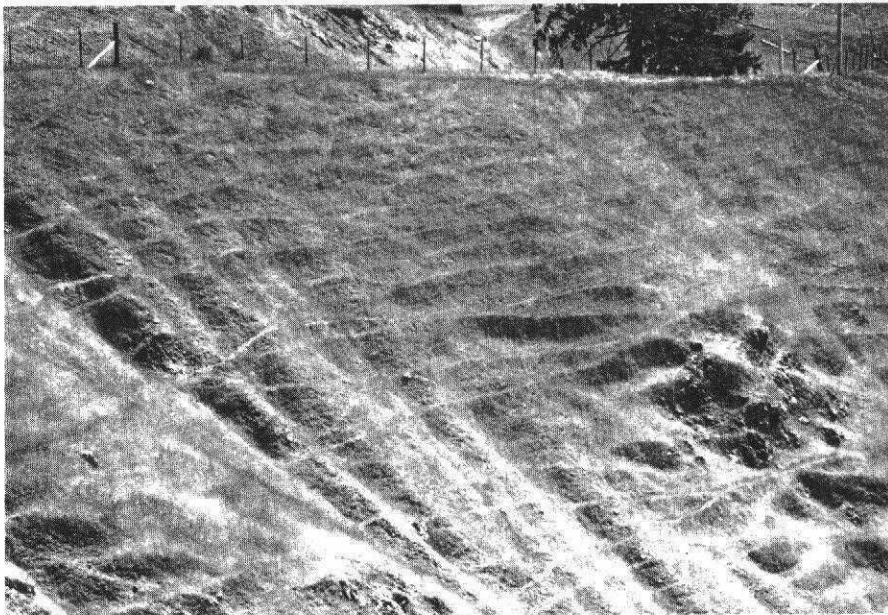
Soil creep is common on a steep slope with a thin soil cover over bedrock. Such patterns are frequently mistaken for animal trails. Soil creep can be an indicator of more serious failures in the future, especially if the area is disturbed.

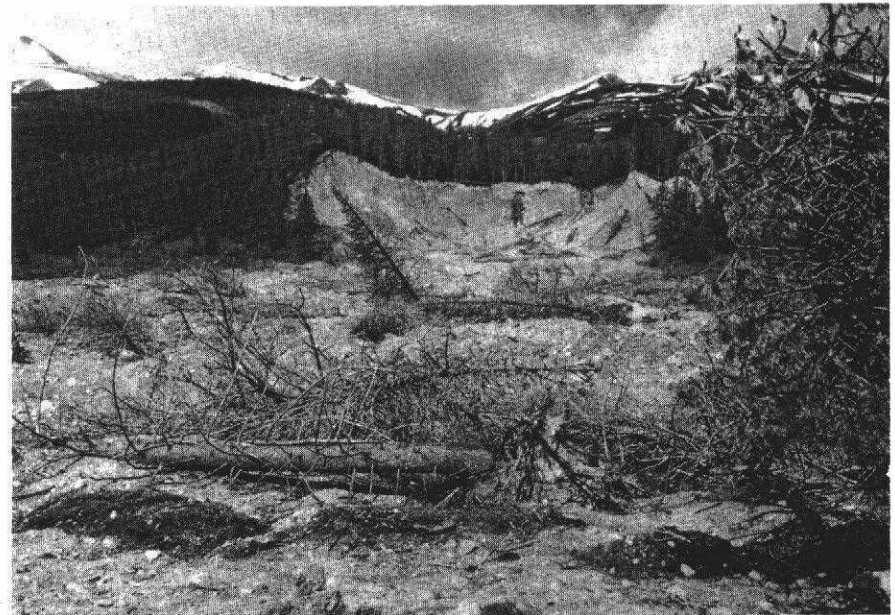
This landslide near Breckenridge occurred in an area proposed for development. The land "failed" as a result of water saturating the slope. The slide moved so rapidly and with such force that trees were uprooted with the tops falling uphill.

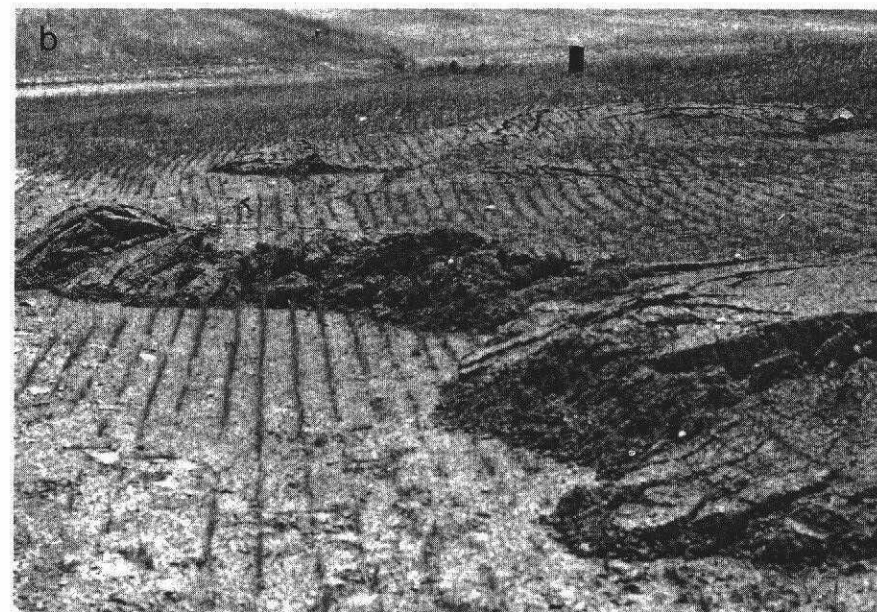
These two photos show the headscarp (a) and toe (b) of a landslide in a residential subdivision south of Denver. Fortunately, this slide occurred during utility placement and lot grading prior to construction of homes. Geologic

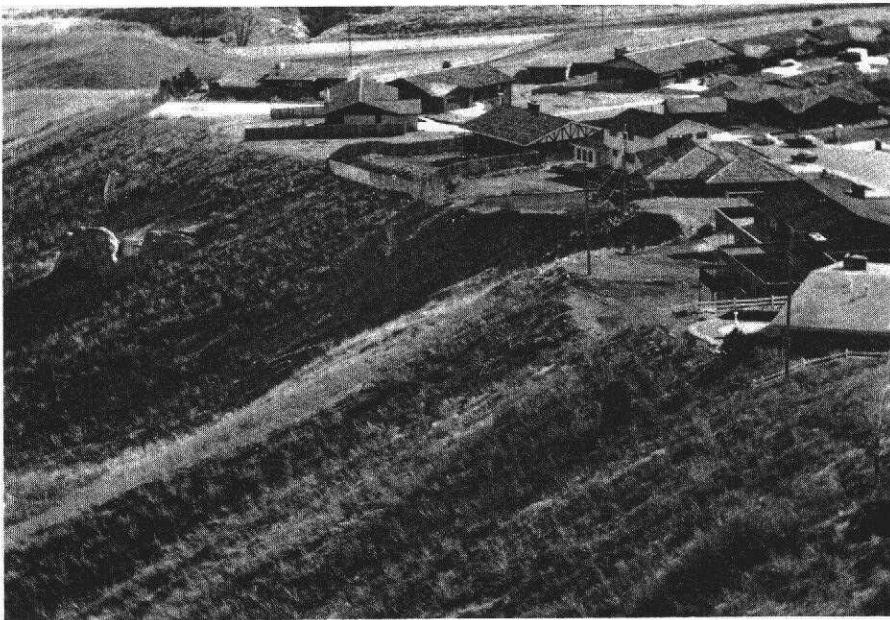
A landslide on the edge of a subdivision west of Denver is destined to "shrink" backyards unless stabilization measures are taken.

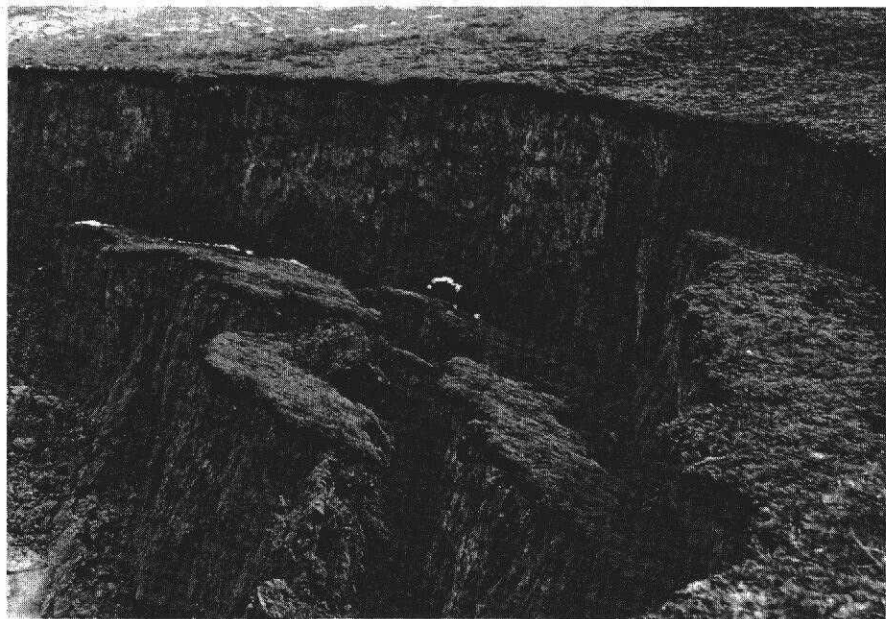
Significant landsliding can occur on almost flat terrain due to a very weak layer of material. These scenes are near Cortez in Montezuma County.

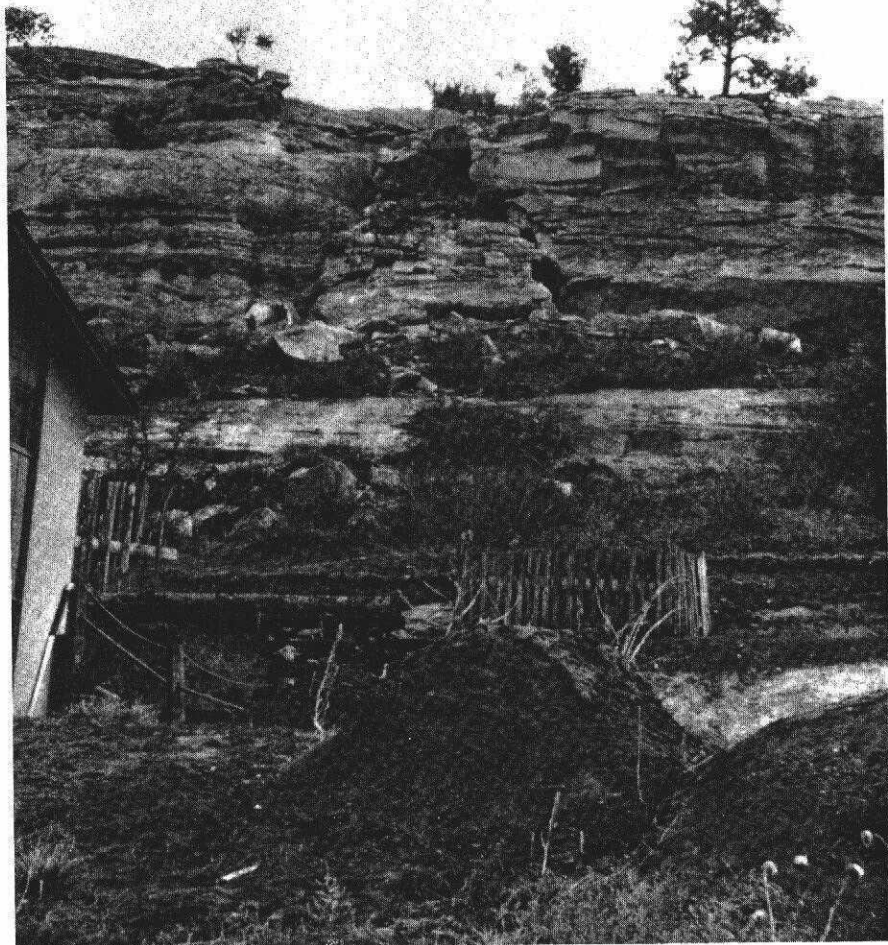
A typical rockfall hazard area on the steep west side of a hogback south of Denver. The massive sandstone blocks exposed at the top of the hogback can roll to the base of the hogback.

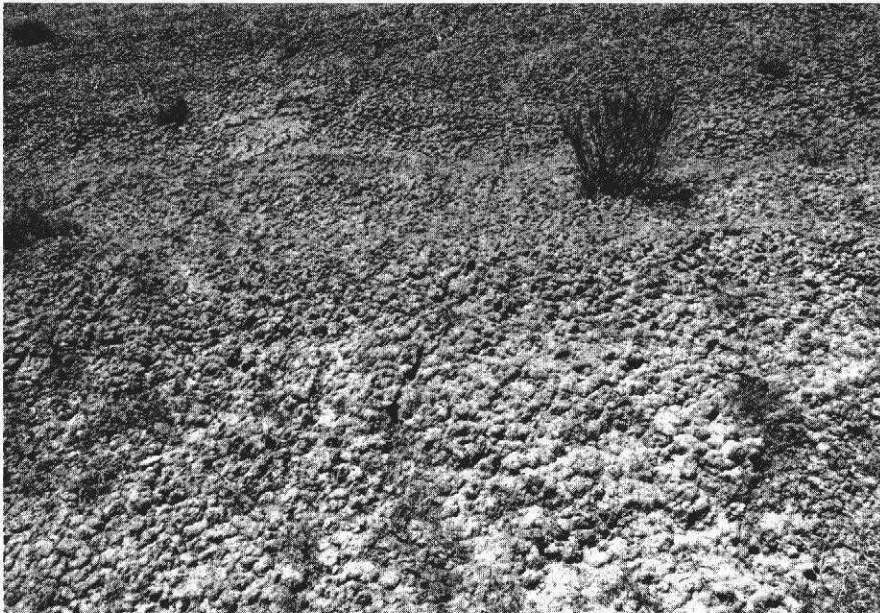
When they are dry, swelling soils often can be recognized by their "popcorn" appearance.

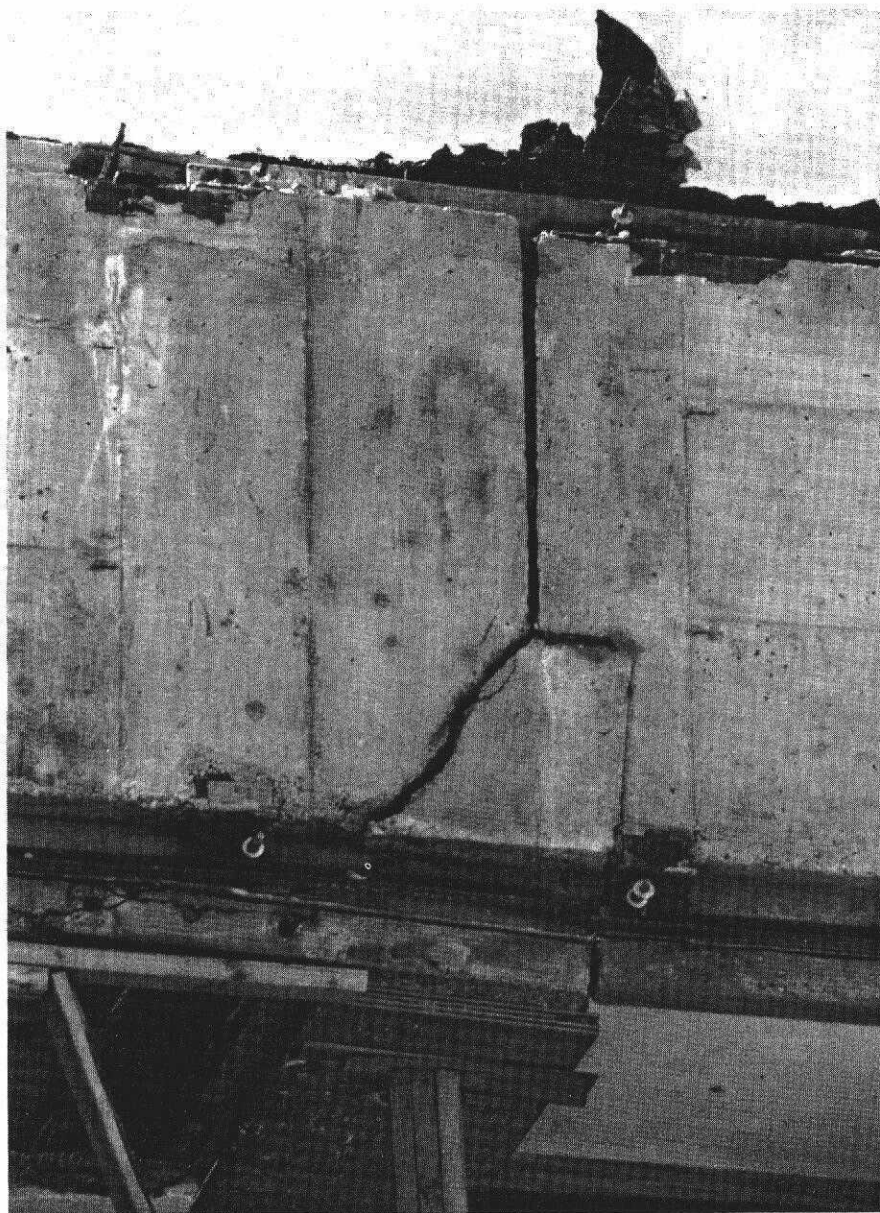
Swelling soil damaged the Life Sciences Building at the Southern Colorado State College campus near Pueblo.

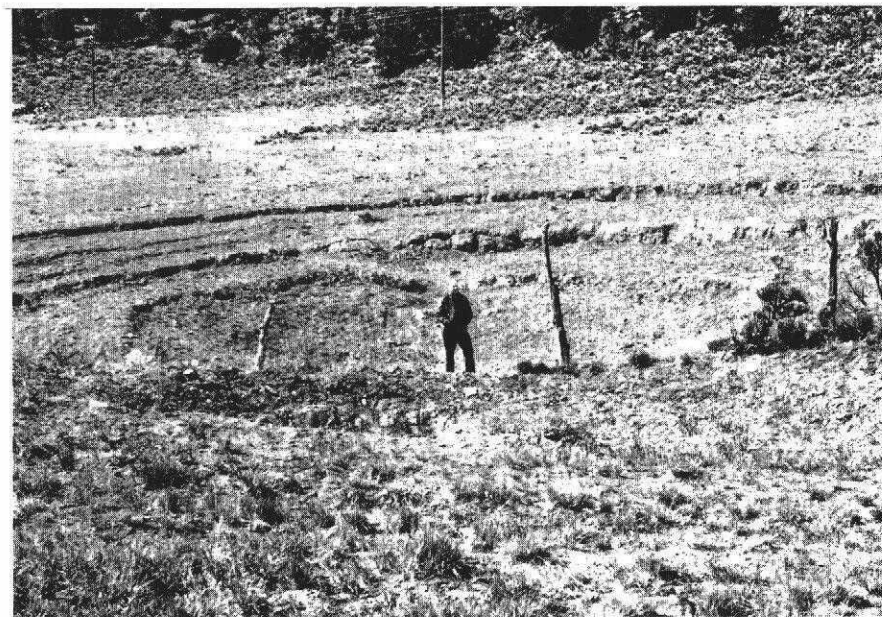
These soils in Garfield County collapsed from wetting.

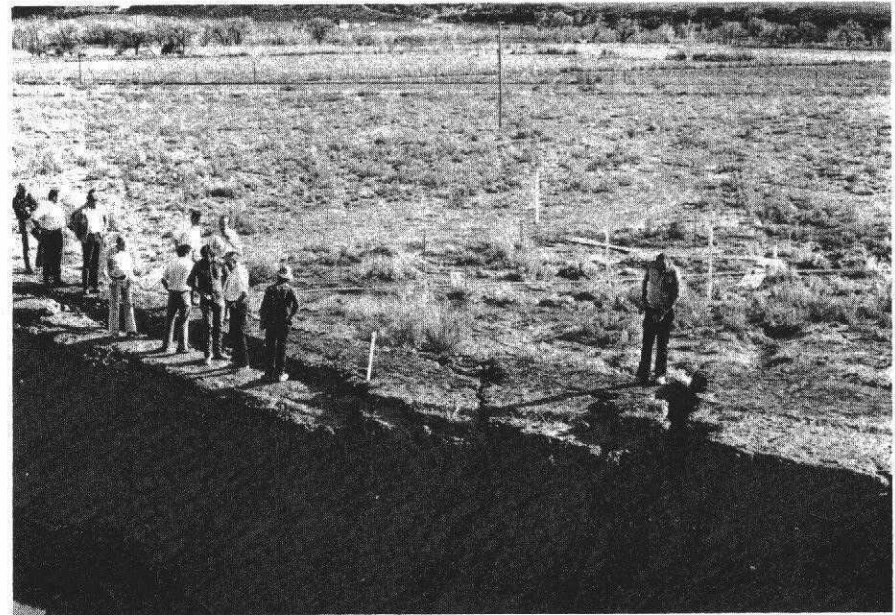
Tests permitted proper highway design and construction, avoiding future repairs.

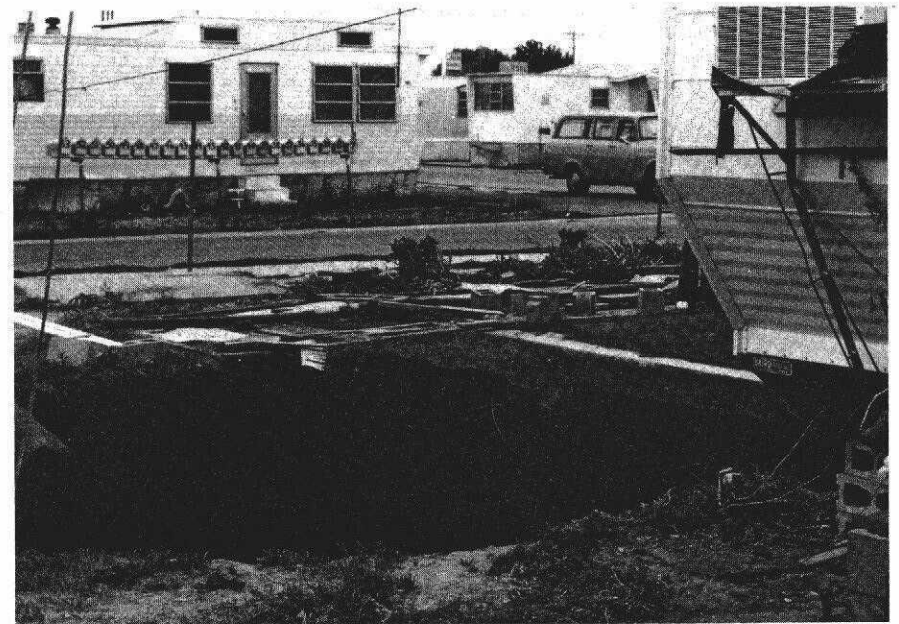
Subsidence pit in a trailer park at Lafayette. This 25 ft x 25 ft hole, 30 ft deep resulted from collapse of the overlying materials into an inclined mine shaft.

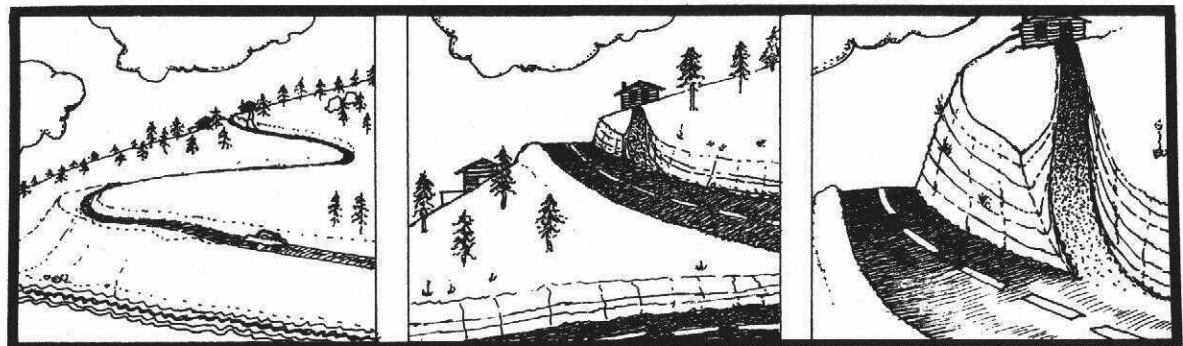
The severe constraints associated with the development of steep slopes include: 1) Subdivision roads with steep gradients which are hazardous under icy conditions, 2) Large cuts and fills which may be unstable, 3) Access roads to lots with even steeper gradients, which may not be accessible, 4) Some lots may have no reasonable access through a large cut or fill on the main subdivision road, 5) Interception of steep hillside drainages.
