# The Impact of CDOT Research

CDOT-DTD-R-2002-1

January 2002

Colorado Department of Transportation  
Research Branch  
4201 E. Arkansas Ave.  
Denver, CO 80222

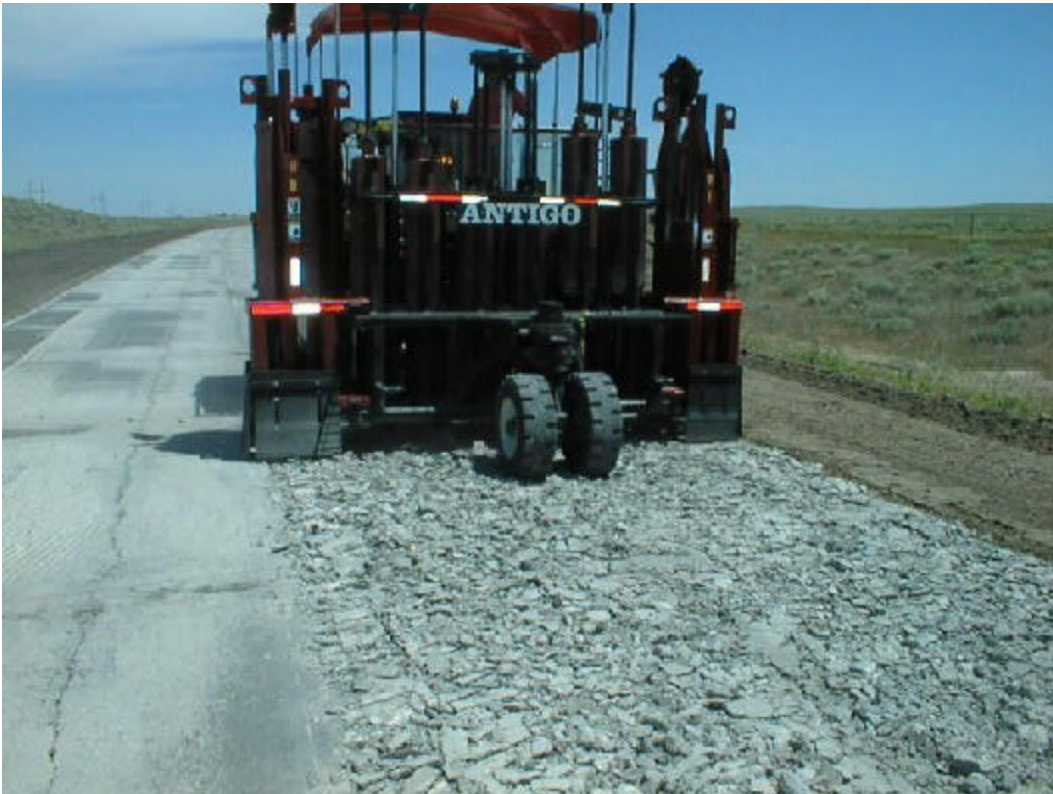
*This multi-head hammer truck is rubblizing this concrete pavement.*

Background: This report documents the design and construction of the first rubblization project built by CDOT. It will be under evaluation for five years. The project was selected to demonstrate the resonant breaker and multi-head hammer methods of concrete pavement rubblization. The project consisted of removing the existing 2-inch asphalt bond breaker, rubblizing the concrete and placing three, two-inch lifts of HBP on the rubblized concrete. Evaluations will consist of crack mapping, rut measurements, falling-weight-deflectometer measurements and observation of the edge drains. Long-term performance information provided by this study will determine the overall life cycle cost of rubblization with an asphalt overlay. Although the initial cost for HMA with rubblization is lower, the long-term performance information provided by this study will determine the overall life cycle cost of rubblization with an asphalt overlay. This comparison will establish the basis for alternate life cycle costs for the two rehabilitation techniques.

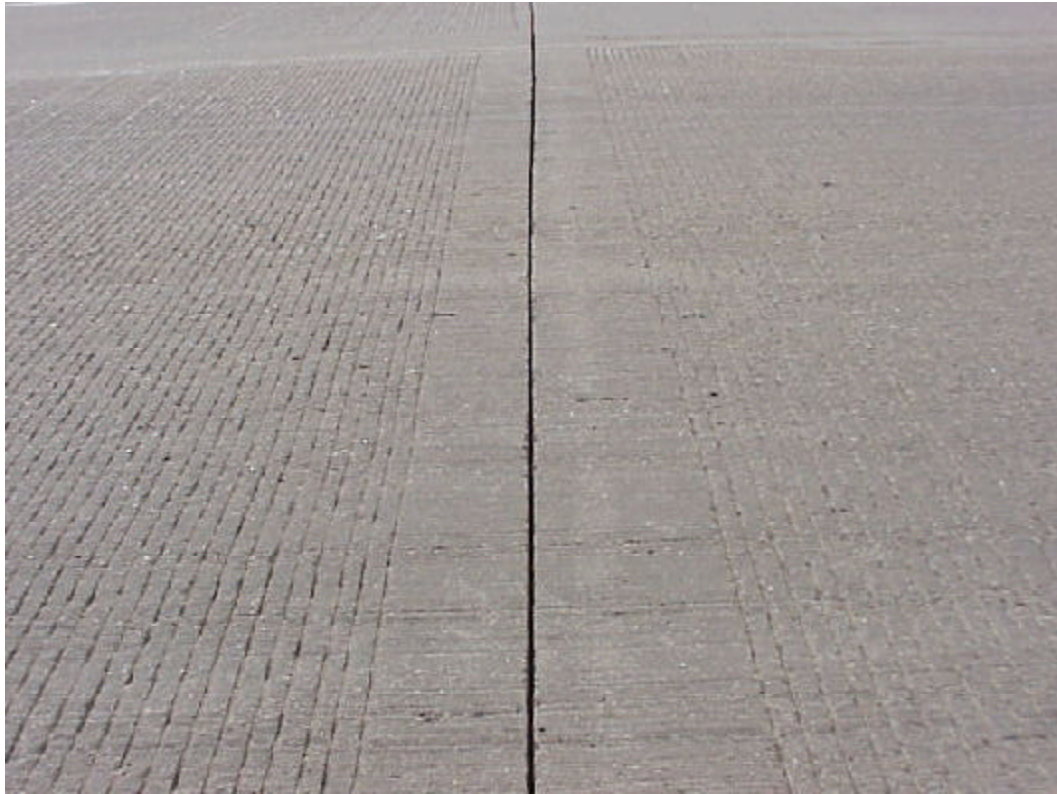
*This concrete pavement joint has been left unsealed.*

Concrete pavement, as constructed in Colorado, has transverse joints every 15 feet and longitudinal joints separating the lanes and shoulders. During construction these joints are blasted clean, dried, and sealed with one of several joint sealant materials designed to prevent moisture from penetrating to the base under the pavement. During the life of the pavement these joints are cleaned and resealed several times. Questions are now arising as to whether these seals actually prolong the life of the pavement or facilitate its demise. Not having to seal the joints could result in significant savings in time, materials, and money during construction and maintenance.

This research is evaluating 100 unsealed and 100 sealed joints along I70 between Denver and the Kansas border. Evaluations will continue through 2005.

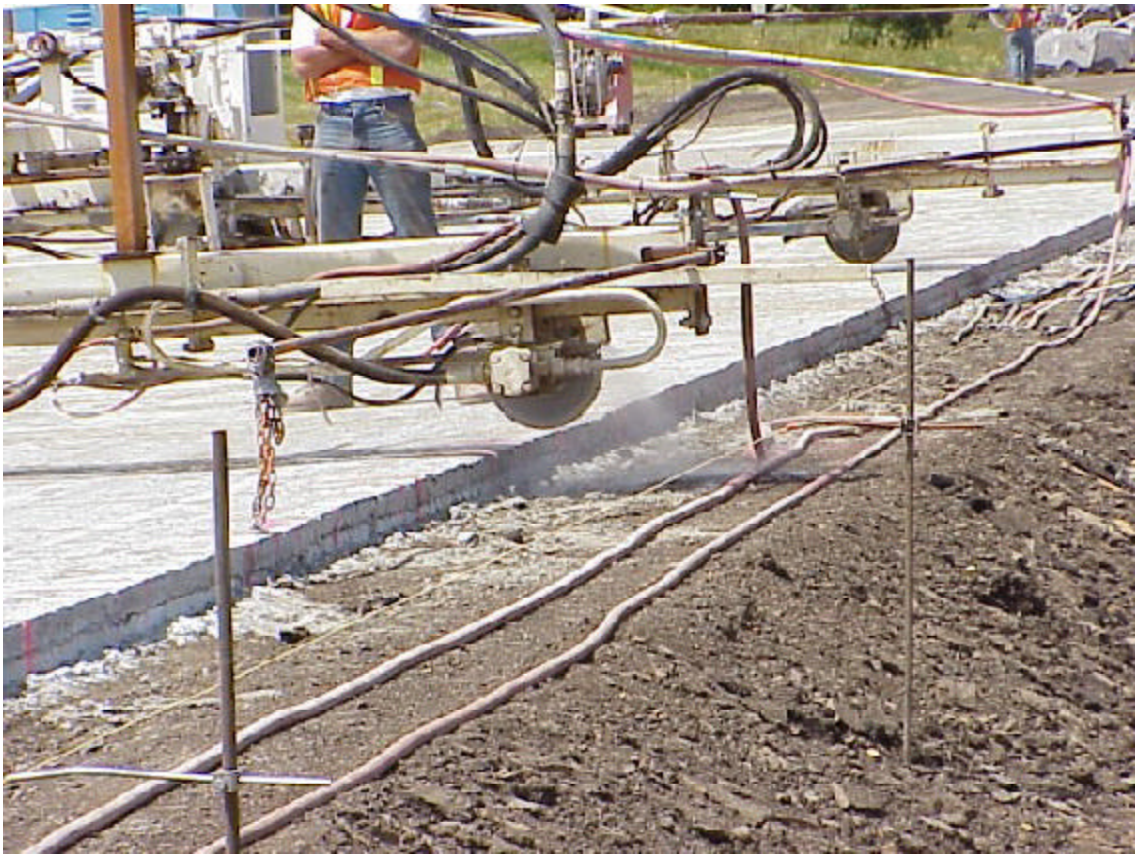
*Whitetopping is a thin concrete overlay over asphalt pavement.  
It is used as a rehabilitation method.*

Whitetopping, or putting a thin concrete overlay over a deteriorated asphalt pavement, was introduced as a rehabilitation method in Colorado in 1990. To date, several whitetopping projects have been completed in Colorado. While there are guidelines and procedures for whitetopping, this research will look at obtaining the necessary information through field and laboratory testing and analysis to validate these guidelines and procedures. This study is being conducted as part of a national effort sponsored by the FHWA and the Innovative Pavement Research Foundation. (See related photo on next page.)

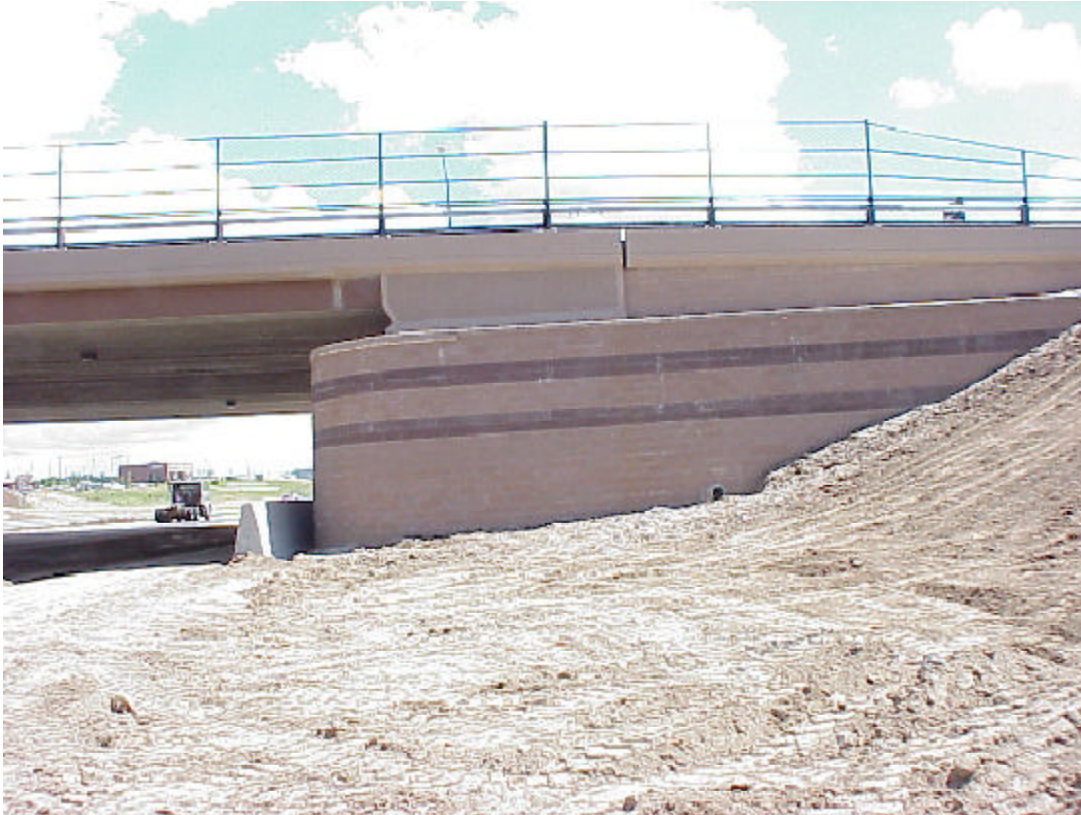
*The Founders-Meadows Parkway bridge in Colorado Springs uses geosynthetic-reinforced soil walls.*

Background: In 1999, CDOT successfully completed the construction of the Founders/Meadows Bridge structure over I25 in Castle Rock. This was the first major bridge in the United States built on footings supported directly by geosynthetic-reinforced soil (GRS) walls - eliminating the traditional use of deep foundations altogether. When compared to the use of deep foundations, this structure has the potential to alleviate the common bridge approach bump problem. It also allowed for construction in stages and a smaller work area in the vicinity of a very busy section of I25. The Founders/Meadows Bridge was considered experimental. Comprehensive material testing, instrumentation, and monitoring programs were incorporated into the construction operations. Performance data was collected for the movements of the wall facing, settlement of the bridge footing, and loads inside the reinforced soil mass and against the wall facing. This monitoring data was collected during six construction stages and while the structure was in service for more than a year.

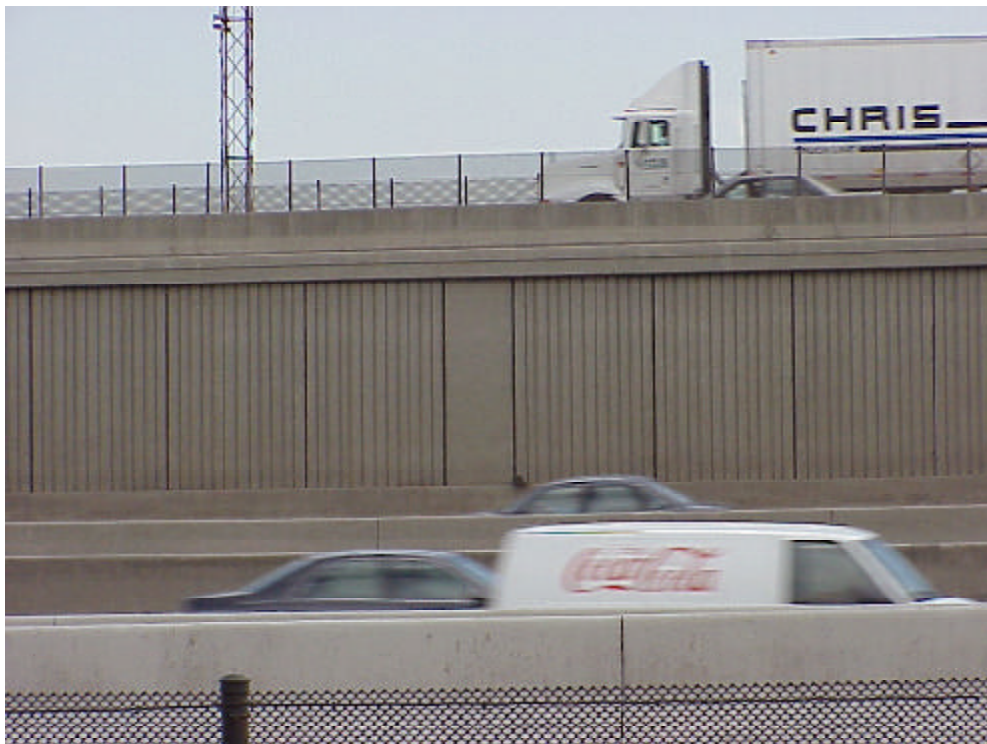
*This mechanically stabilized earth wall, with independent full-height facing, is part of the ramp connecting N.B. I25 to I70 in Denver.*

When compared to other conventional retaining walls, this new wall system requires little or no over-excavation in front and beneath the wall, costs less, and requires less construction time and maintenance work. Since this MSE wall system was the first and possibly the only of its kind, it was considered experimental. A comprehensive instrumentation and monitoring program was incorporated into the construction operations. Performance data was collected during construction for the movements of the wall facing, loads inside the reinforced soil mass and loads against the wall facing.

Recommendations from the report: The report provides insight into the details, materials, design, and construction of the I25/I70 MSE/IFF walls. The collected instrumentation results are also presented and utilized in the assessment of the design and performance of the MSE/IFF wall structure. The flexibility of the MSE/IFF wall system smoothly accommodated the wall movements and kept the lateral earth pressure against the wall facing to a low value of 32 psf. The report also provides thorough details and the basis for future standard use of MSE/IFF walls.

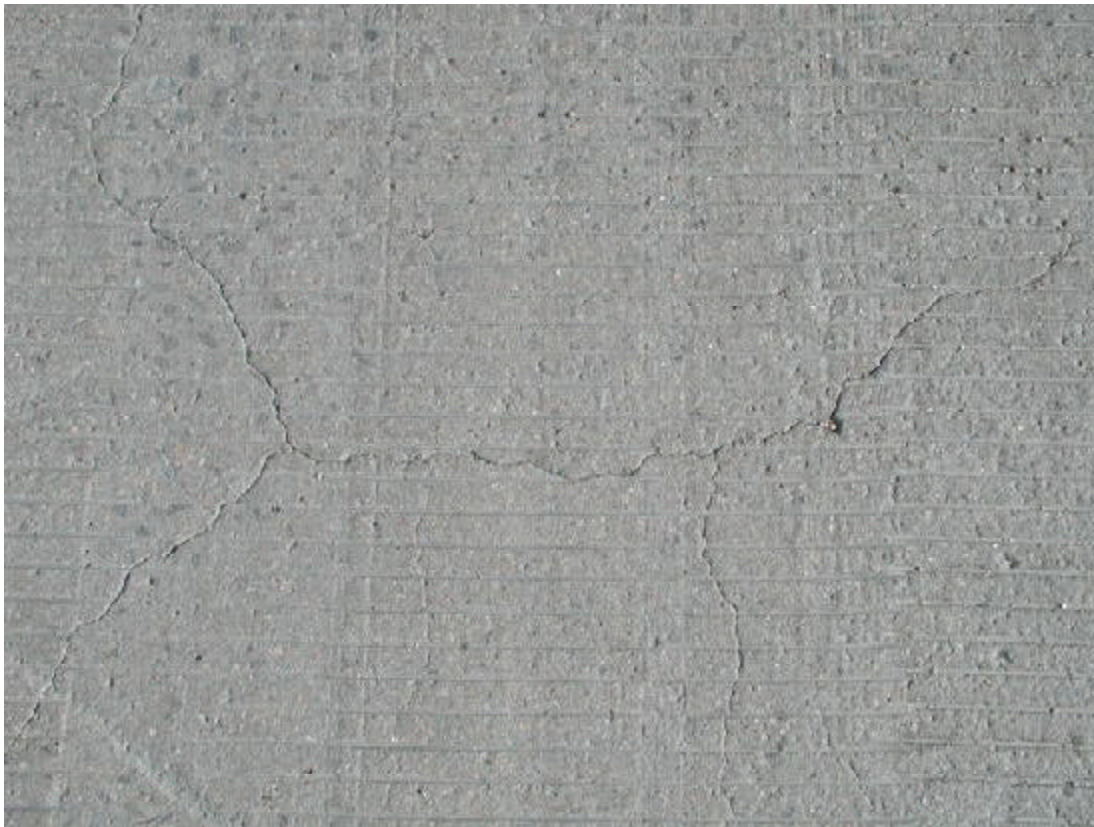
*This bridge deck is showing extensive cracking.*

Background: This study sought to determine the cause of extensive transverse cracking observed in existing bridge decks and to identify the changes in materials specifications and construction practices needed to reduce this deck cracking. The authors reviewed recent studies on bridge deck cracking and conducted a study to compare the shrinkage properties of several concrete mixes. They also reviewed current CDOT materials, construction, and design specifications to identify areas needing improvement. A survey was then conducted on seven newly constructed CDOT bridges to examine the extent of cracking in concrete decks that were constructed with different mix designs and curing procedures.

Recommendations from the report: Recommendations on the design and construction of bridge decks to reduce deck cracking were identified. Several materials factors to reduce deck cracking were also identified– using Type II cement, reducing the cement content in concrete, using Type F fly ash to reduce the heat of hydration, and the use of silica fume to reduce chloride permeability.

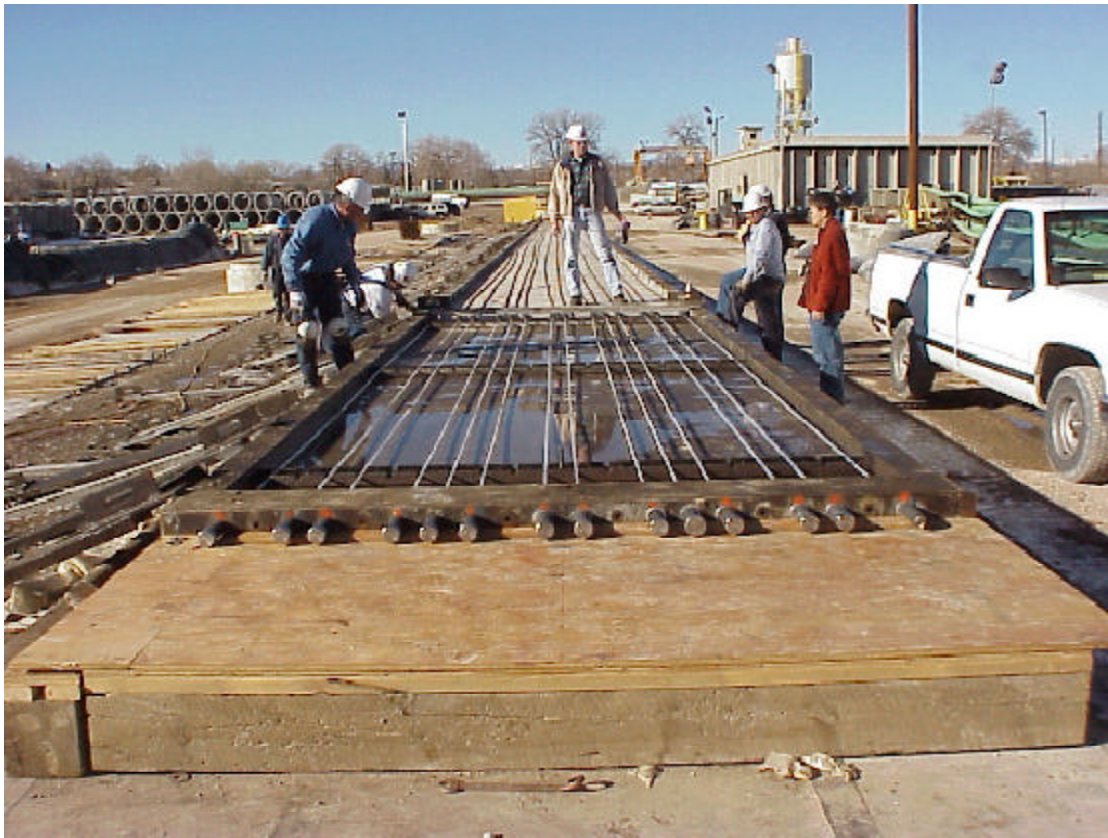
*This photo shows a prestressed carbon fiber precast bridge panel. This project is the first time that CDOT has not used steel for reinforcement.*

As part of a national experiment under the IBRC program, CDOT is participating in the evaluation of fiber-reinforced polymer (FRP) in a precast bridge deck and bridge rail for the Parker Road interchange at I225. As part of this experiment, and as an extension of previous work done on high performance concrete (HPC), CDOT will also develop an HPC mix for bridge decks to improve durability by reducing shrinkage cracking, thermal cracking, and permeability while maintaining current standards for workability and strength. With this project, CDOT is replacing the reinforced and prestressed steel in the precast panel and rails with FRP products. Evaluations are continuing. (See related photo on next page.)

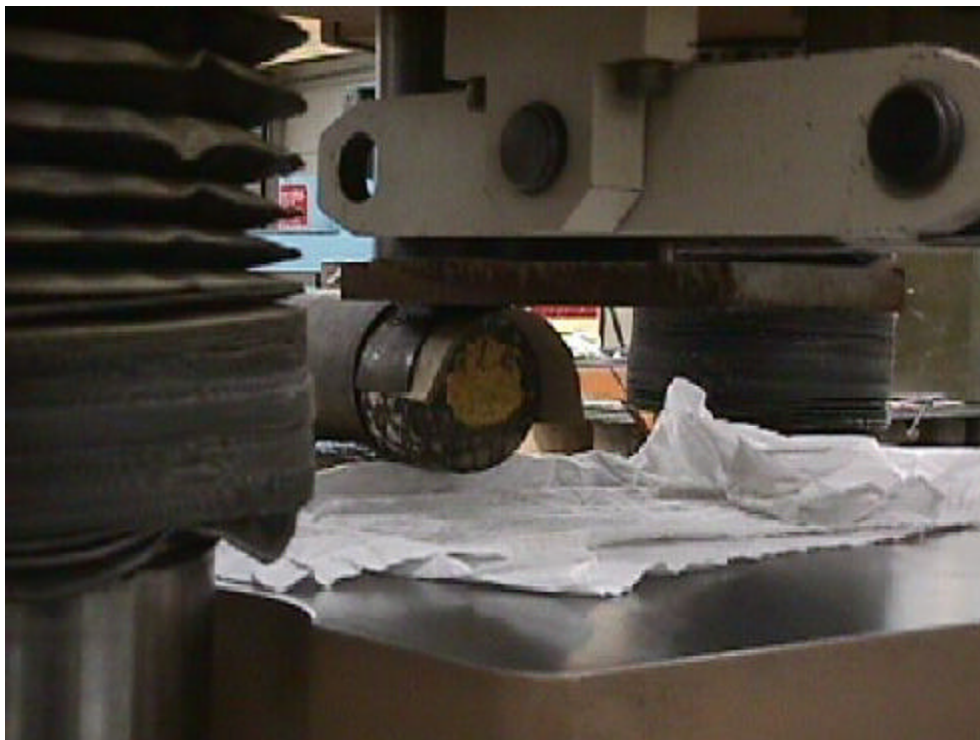
*The pavement sample being tested was soaked in magnesium chloride before an overlay was added.  
This machine is testing the sample for shear strength.*

This research report focused on the effect magnesium chloride has had on asphalt pavements. Region 6, in the Denver Metropolitan Area, had some stripping occurring on pavement surfaces and suspected it was due to magnesium chloride. It was also noted that when pavements were placed in two lifts, one in the fall and the other the following spring, the bond between the two was weaker. It was suspected that this poor bond was attributable to the magnesium chloride placed during the winter months. On a different note, but equally troubling, was the lack of adhesion of thermoplastic pavement marking to roadways treated with magnesium chloride.

Recommendations from the report: Based upon research data, magnesium chloride does not contribute to stripping of asphalt pavements, nor does it negatively affect the bonding strength in overlays. Testing of the preformed pavement marking tape PREMARK 20/20 in a controlled outdoor test shows that if the pavement is cleaned using a high pressure rinse and dried thoroughly, successful application of the preformed marking will occur. As a side note, Research also tested the metric version of PREMARK 20/20. Its use is not recommended at this writing.

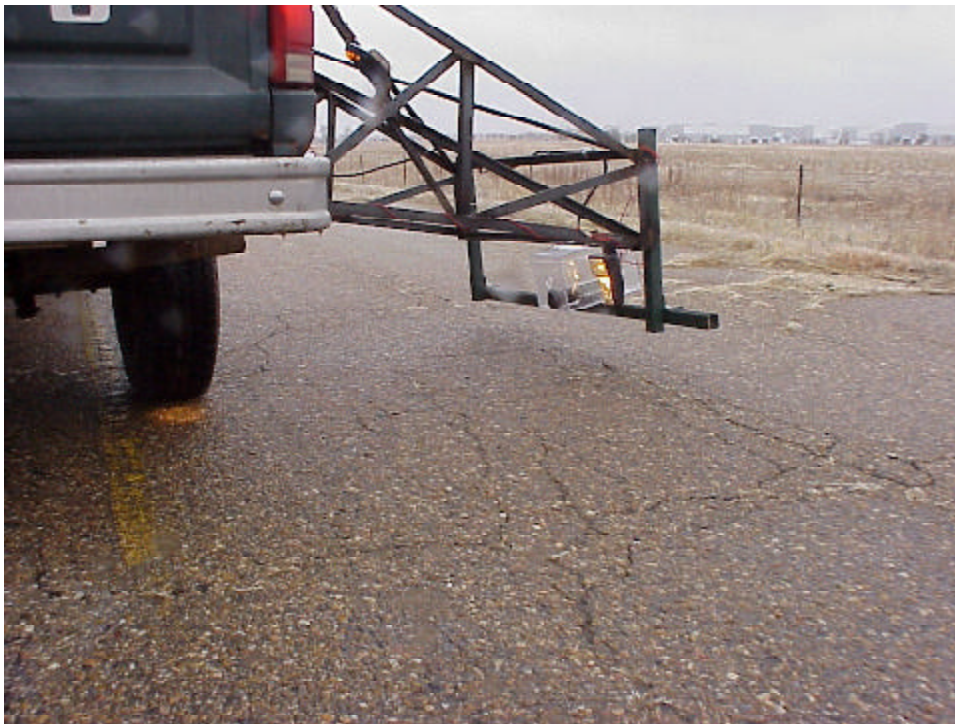
*This high speed video camera is observing sand particle movement.*

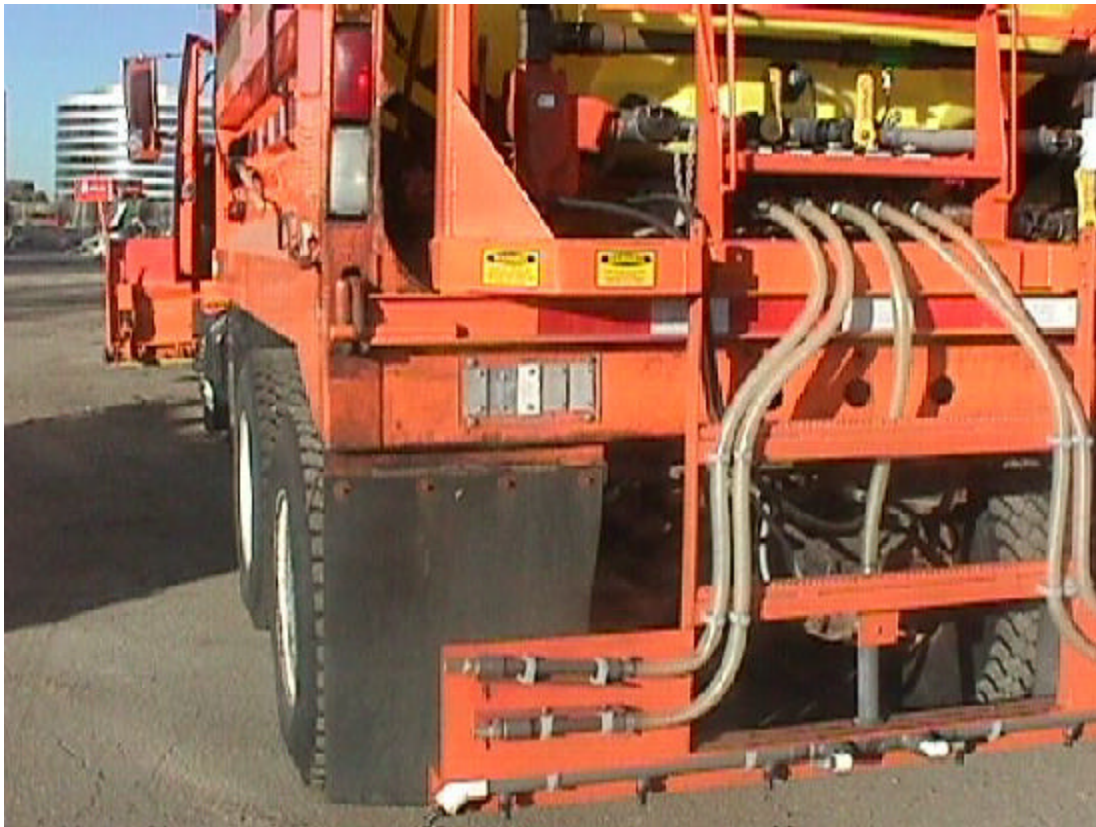
*This CDOT Maintenance chemical deicing distributor truck has five test “coupons” (steel squares) mounted on the back of the truck to determine corrosion rates due to chemical deicing.*

This study is Phase II of a previous research study, "Effects of Deicing Agents on Corrosion." Deicing agents, mainly magnesium chloride, have been used for several years by CDOT for snow and ice control. This research is looking into concerns that have surfaced regarding the chemical effects on various components of cars and trucks caused by chemical deicers. Although chemical deicers contain a corrosion inhibitor there have been questions as to whether the deicing chemical attacks aluminum and other vehicle components. When completed, these two studies will be expected to result in chemical deicer specification changes. (See related photo on next page.)

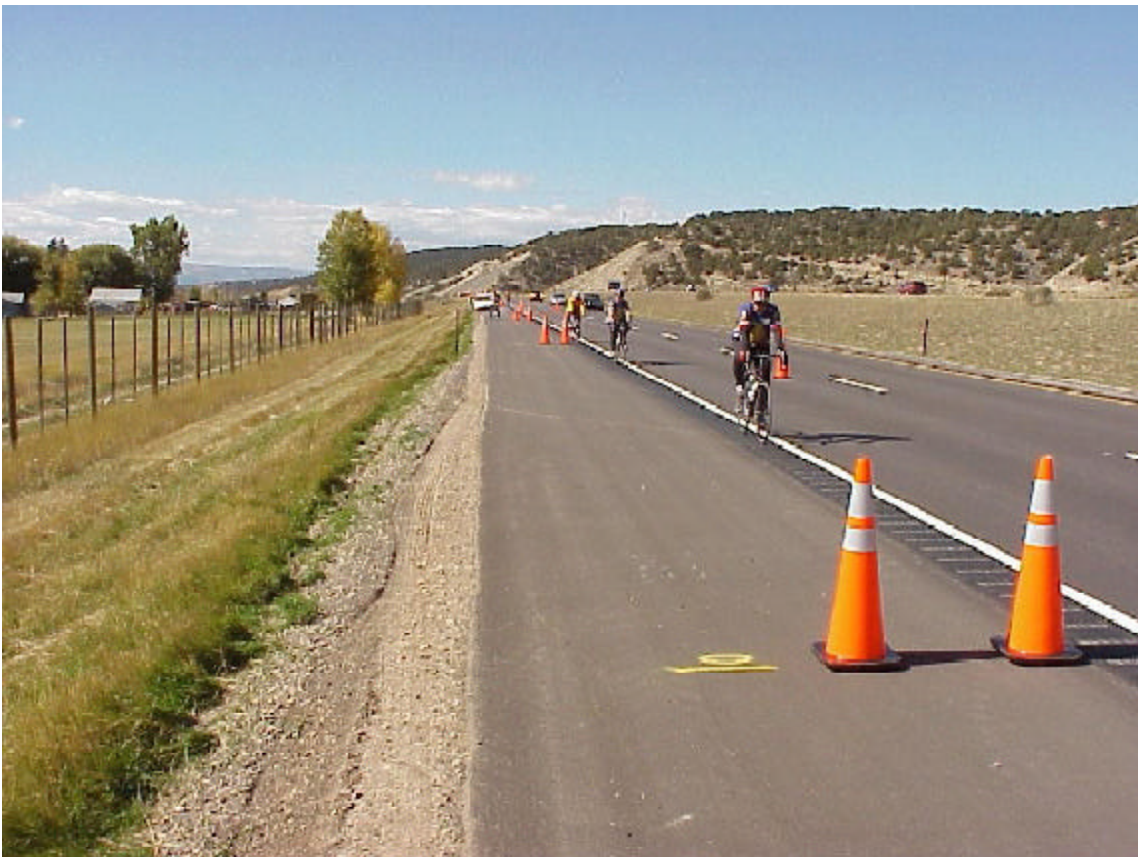
*Bicyclists test rumble strips placed along side the edge of the road.*

Recommendations from the report: Your best choice? The standard ground-in asphalt rumble strip, 12 inches wide, with a groove depth of 3/8 inch +/- 1/8 inch, ground in an interrupted pattern is the recommended configuration for asphalt strips based on the data collected for this report. No recommendations were made concerning the rolled-in concrete rumble strips.

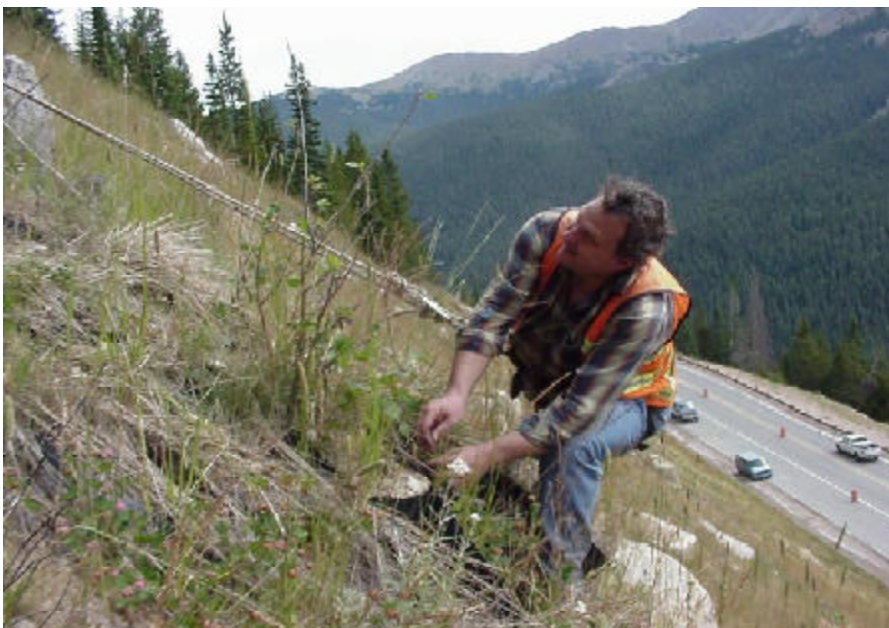
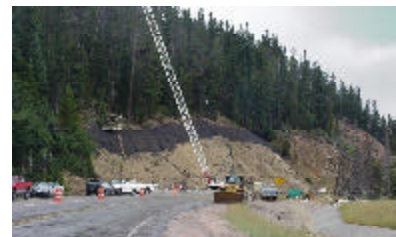
*Above: Installation of erosion control materials on SH 40, west of Berthoud Pass. Left, counting the type and number of plants that are growing on the rehabilitated slope. And yes, the man is attached to a safety line.*
