Report No. CDOT-DTD-R-2005-16
Final Report

THERMAL SEGREGATION

COLORADO DEPARTMENT OF TRANSPORTATION
RESEARCH BRANCH

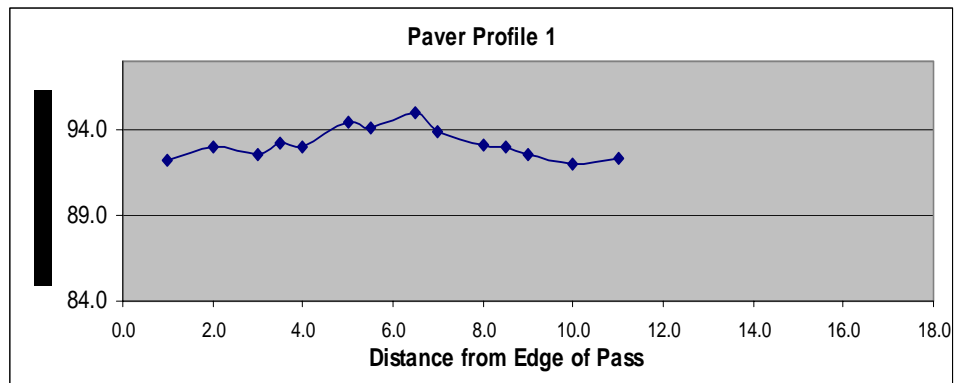
Figure 1. Transverse relative compaction profile. The outer 1 foot of each side of the mat was not measured for relative compaction.

done because in data that was collected transversely during density profiles in Colorado during the 2004 paving season, CDOT learned that readings across the width of the mat often vary with location based on the paver and rolling pattern. See Figure 1 for a typical transverse density profile that was collected in 2004. Therefore, rather than locate adjacent “hot” areas transversely to the “cold” areas, the “hot” areas were located forward of the “cold” areas when the temperature segregation was not in strips.

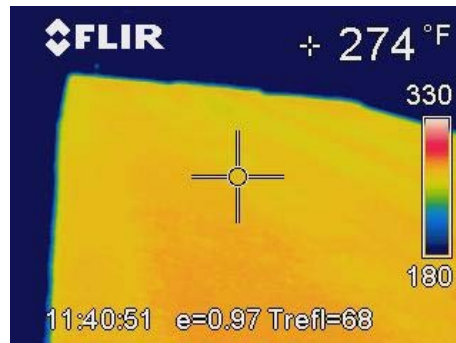
Figure 3. Contractor A with a new screed and a different windrow elevator.

the number of “cold” areas was also examined by Contractor. In Table 4, Contractor A was on three of the twenty projects that were in the study. A windrow elevator was used all three times. One of the projects had five “cold” areas and two of the projects had no “cold” areas. This Contractor attributed the five “cold” areas to problems with the screed. The screed was subsequently replaced and the “cold” areas disappeared on the other two projects. Because two different windrow elevators were used by this Contractor before and after the screed was replaced, the improvement can’t be tied solely to the replacement of the screed. Figure 2 below is from the project where the screed was old and worn. Figure 3 is from a project by the same Contractor after the screed was replaced.

Table 5 shows, by Contractor, the number of areas that actually had compactions, relative to the maximum specific gravity of the mix, below 92%. When compared to Table 4, one can see that “cold” areas may still be able to be compacted even though they were 25° F cooler than adjacent areas. Of the 31 “cold” areas, 19 of the areas were able to meet a minimum relative compaction of 92%. For example, Contractor A had five “cold” areas when paving with the worn screed. However, the mix was over 300° F and the rollers were close enough to the paver that minimum 92% relative compactions were obtained. By utilizing industry “best practices,” the temperature segregation created by the worn screed was overcome.

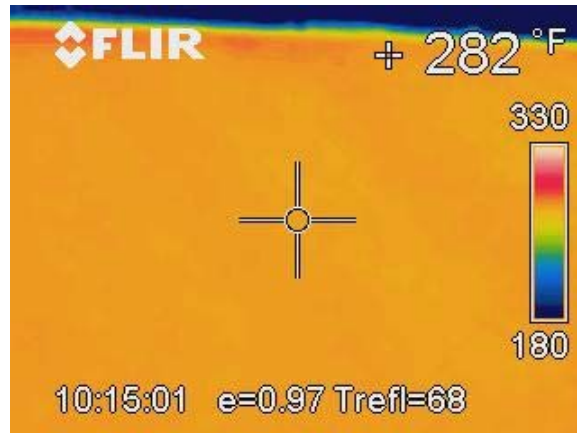
Figure 5. No temperature segregation across the mat width.

In contrast, Figure 5 is from a project that kept a constant flow of material going to the paver and used end dump trucks with an MTV.
