REPORT ON  
PHASE I  
ENVIRONMENTAL SITE ASSESSMENT

SH 96A (4<sup>TH</sup> STREET) BRIDGE OVER THE ARKANSAS RIVER

Project STA 0961-008

***HazWaste Technologies® Corporation***

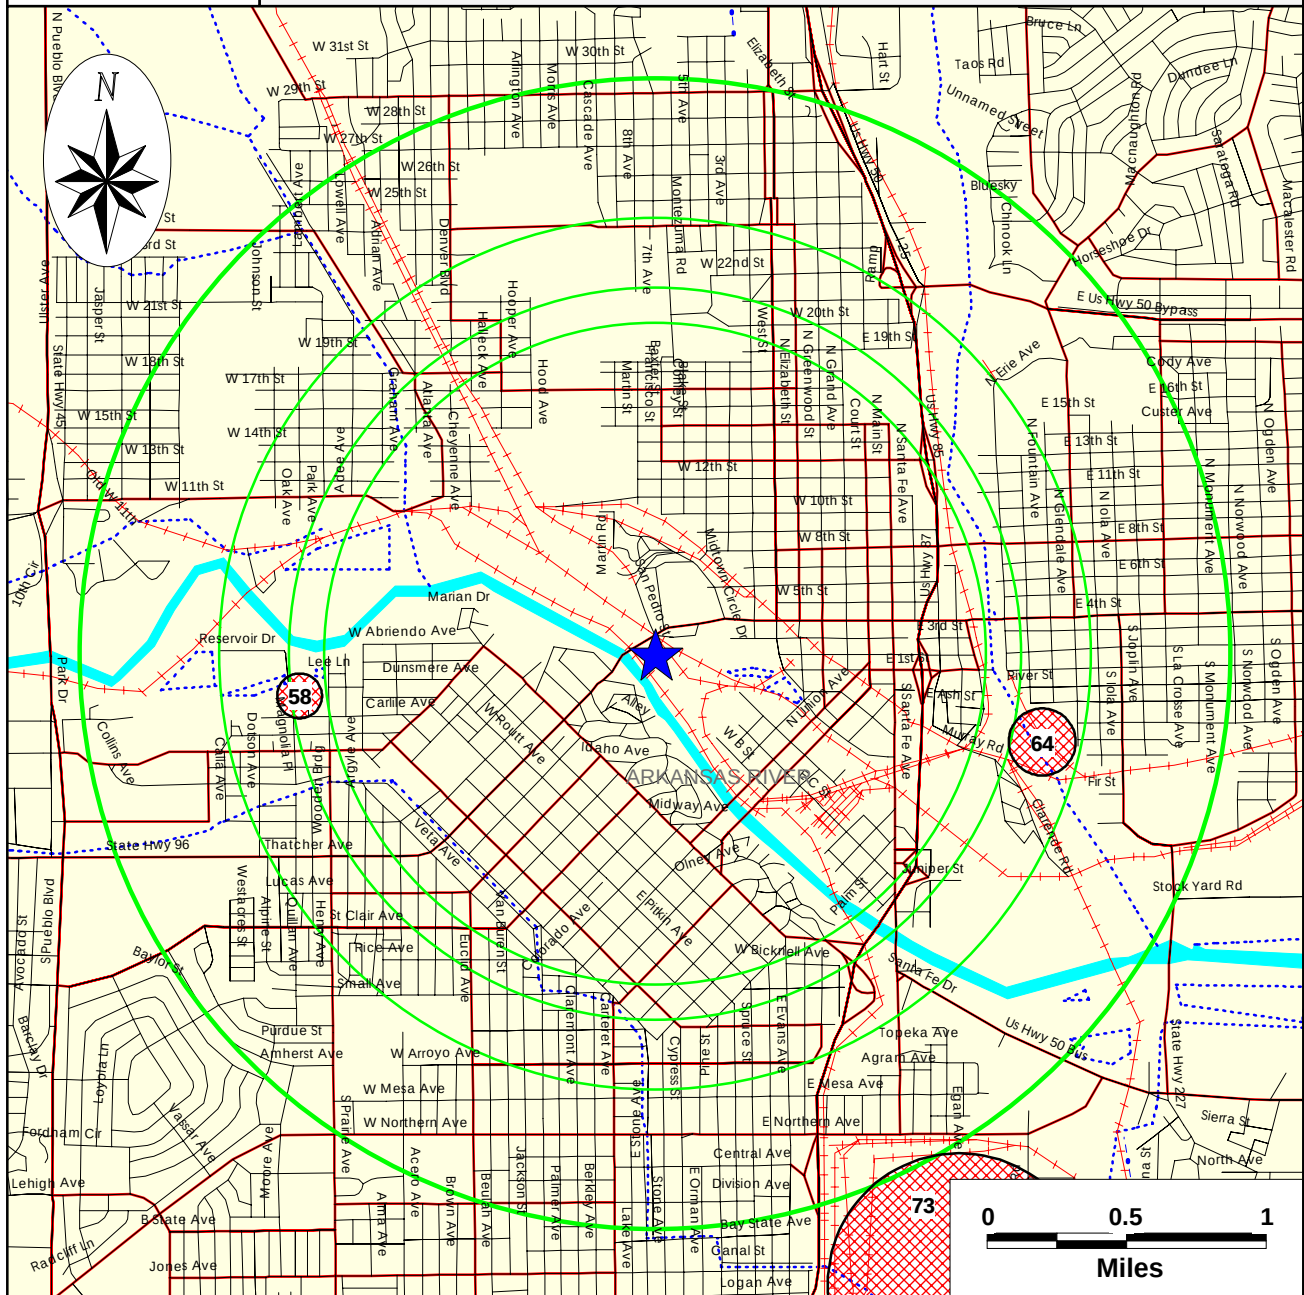
## Sites Represented as Radius Buffers

These radii are estimated from agency records or detailed street maps. The radii may be based on the furthest boundary of each property or study area from its center. For more information contact the agency referenced by source number in the site listing.
