# COLORADO STATE CAPITOL

## HISTORIC STRUCTURE ASSESSMENT

STATE HISTORICAL FUND PROJECT NUMBER  
SHF-2006-T1-001

**December 15, 2006**

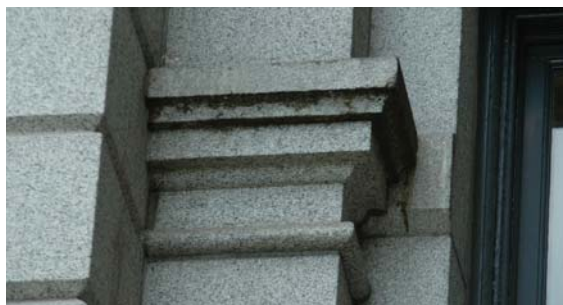
Mold growth

The entire exterior façade should be evaluated and a repair program undertaken as soon as possible. A complete understanding of the scope of the problems, as well as the causes, is critical prior to undertaking any repairs. It is important to make repairs in a historically sensitive manner using appropriate methods and materials.

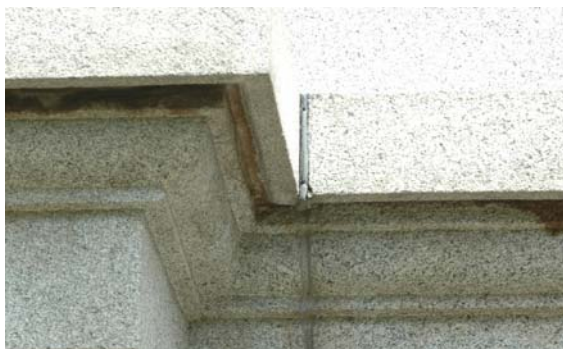
Mold growth

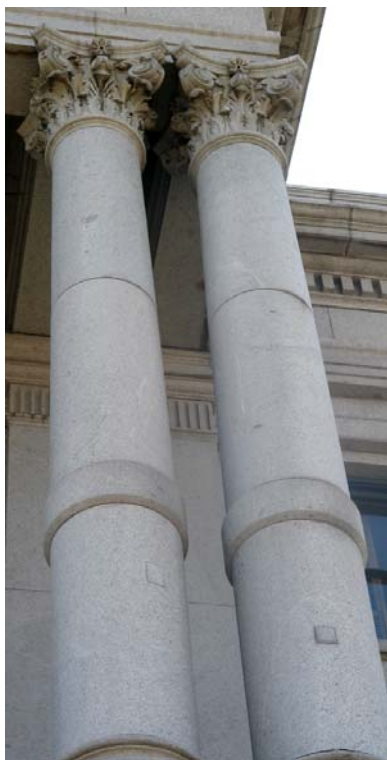
There are several poorly executed patches on the round granite columns. Water is seeping through joints and cracks on Balcony 217C, and staining the granite of the Portico. Evidence of this leakage is visible from underneath the balcony as well. The rate of decay of this feature is increasing each winter. The concrete at the vaulted ceiling is decaying from exposure to moisture. Pieces of concrete are falling to the floor and significant rust stains from exposed rebar are visible. A vent on the south side of the East Steps shows damage from exposure to moisture. The steel lintel above the vent is rusted and failing. The granite steps and granite blocks at the entry show evidence of spalling due to the presence of freezing water. The joints in the steps have failed as have the attempted repairs with synthetic caulk.

Column patches

The East Portico and Steps should be evaluated and a repair program undertaken as soon as possible. The East Portico and Steps should be given immediate attention due to the staining, spalling, open joints, rust, and settling. Refer to Section 5.3 Estimate of Probable Cost of Construction.

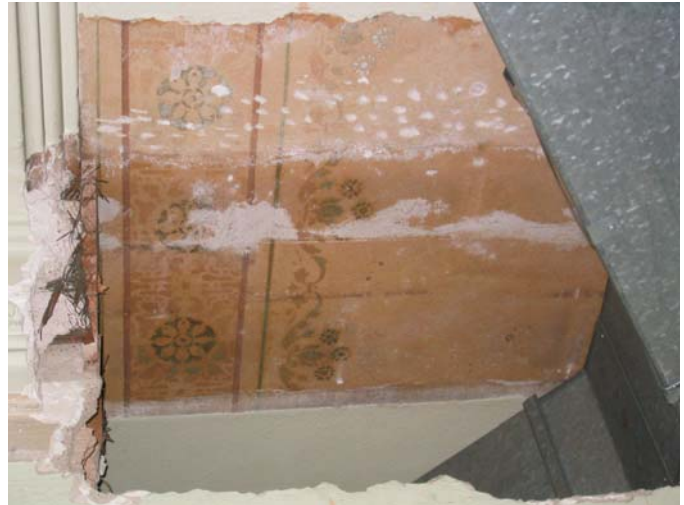
Existing original ceiling frescos in Room 357

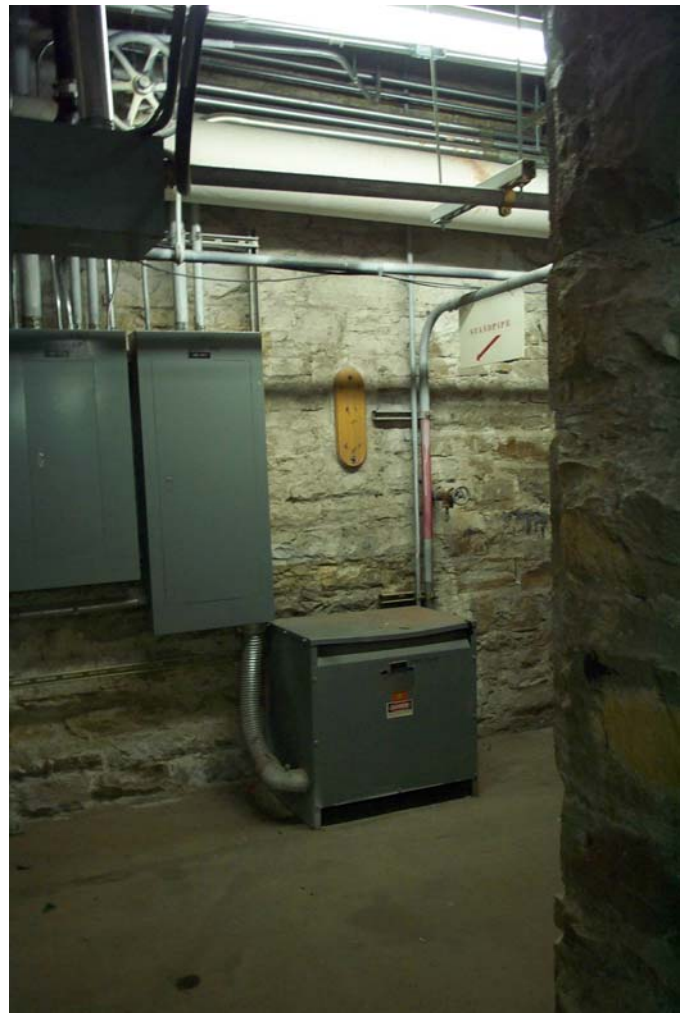
Sub-Basement transformers

Check grounding of small transformers in the Sub-Basement. Correct loose, hanging wire in elevator shaft. Develop and maintain a complete and accurate as-built drawing for the entire capitol electrical distribution system. Relocate overlooked/hidden panels in back rooms of the Attic. Remove abandoned electrical wiring. Review and correct grounding deficiencies of all home run wiring. Review and address code deficiencies in the existing electrical distribution. Relieve overloaded junction boxes. Rewire fixtures and panels that use the original DC wiring for AC circuits. Replace sub 12-gauge wiring used for 20 amp circuits. Address conditions inside electrical rooms such as 137 and 275.

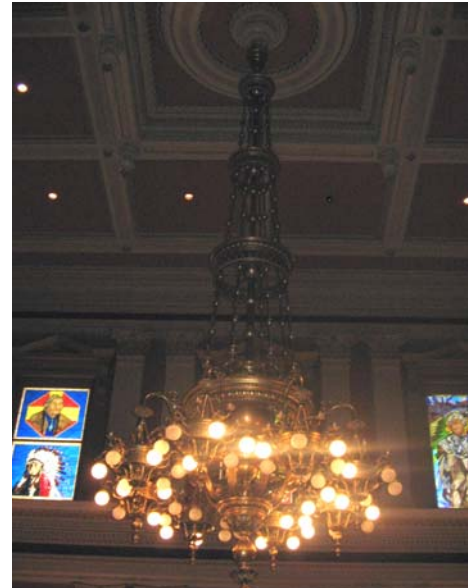
Supreme Court Chandelier

This refurbished chandelier is located in the Supreme Court Chamber. This particular chandelier, original to the building, is similar to the chandeliers in the House and Senate Chambers yet is unique in that it has round lamps and no brass reflectors with all three original tiers remaining intact. The frosted shades have been removed along with the original glass ball shades around the gas outlets. The gas outlets have been plugged, but the original gas valves remain.

*Functional Condition: Good*

No preservation work required.

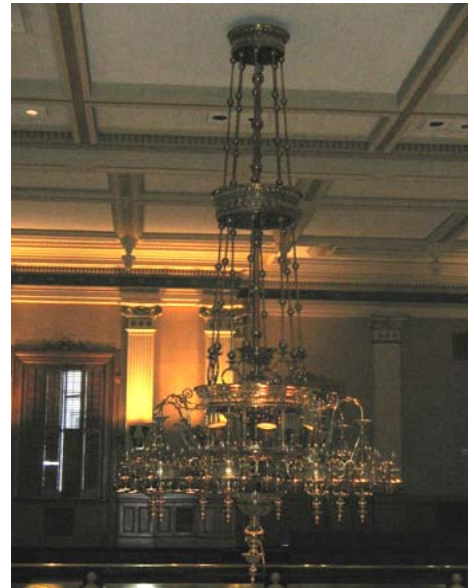
House Chamber Chandelier

This refurbished chandelier is located in the House Chamber. Although original to the building this chandelier has undergone the following changes: the original uppermost tier has been removed from the chandelier; the frosted shades around the electric lamps along with the original glass ball shades around the gas outlets have been removed; the gas outlets have been plugged; the tubing has been altered; and the entire fixture has been rewired. Additionally, brass trumpet shades have been added, eliminating the up lighting component of the fixture.

*Functional Condition: Good*

Use caution when polishing to avoid further damage. Subsequent repairs should consider impact on fixture restoration.

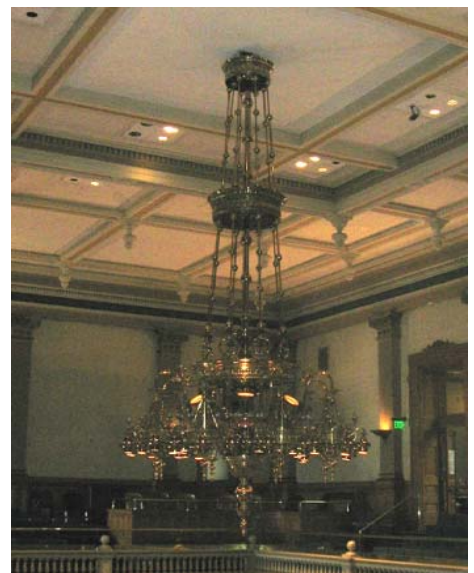
Senate Chamber Chandelier

This refurbished chandelier is located in the Senate Chamber. As with the House Chamber fixture, this fixture is original to the building and has undergone the same changes. These changes include the removal of the original uppermost tier; the frosted shades around the electric lamps along with the original glass ball shades around the gas outlets have been removed; the gas outlets have been plugged; the tubing has been altered; and the entire fixture has been rewired. Additionally, brass trumpet shades have been added, eliminating the up lighting component of the fixture.

*Functional Condition: Good*

Use caution when polishing to avoid further damage. Subsequent repairs should consider impact on fixture restoration.

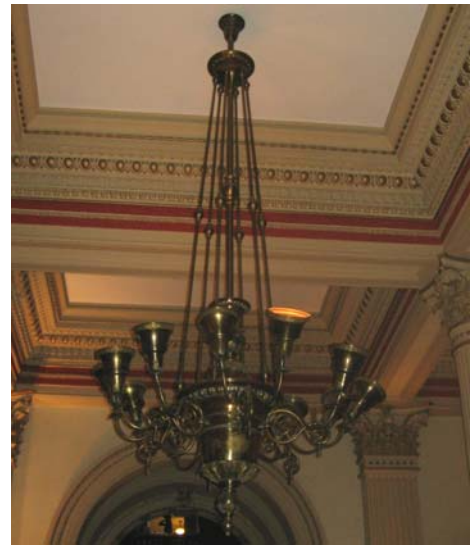
First Floor West Arcade

This refurbished chandelier is found in the West Arcade of the First Floor. Although this fixture is original to the building it has been subjected to many changes. The frosted shades around the electric lamps along with the original glass ball shades around the gas outlets have been removed; the gas outlets have been plugged; the tubing has been altered; and the entire fixture has been rewired. The down lighting component of the fixture has been eliminated by the addition of the brass trumpet shades.

**Functional Condition: Good**

Repairs should consider impact on fixture restoration.

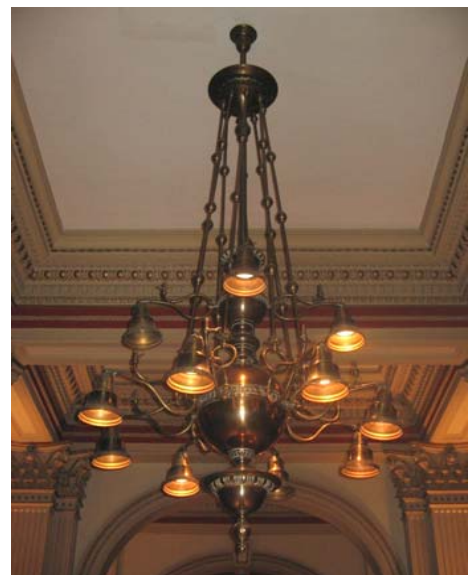
First Floor Entry Vestibule

This refurbished chandelier is found in the North and South Arcades of the First Floor. This fixture, also original to the building, has undergone the similar changes as other original chandeliers. The frosted shades around the electric lamps along with the original glass ball shades around the gas outlets have been removed; the gas outlets have been plugged; the tubing has been altered; and the entire fixture has been rewired. Brass trumpet shades have been added, eliminating the up lighting component of the fixture.

**Functional Condition: Good**

Repairs should consider impact on fixture restoration.

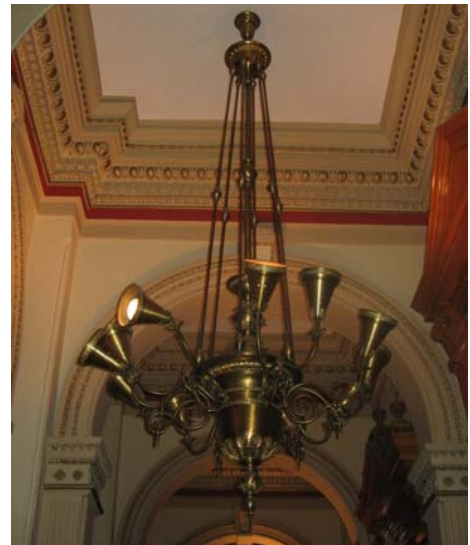
Entrance to Governor’s Office

This refurbished chandelier is found in the First Floor South Arcade at the entrance to the Governor’s Office. Original to the building, the fixture has undergone the following changes: the frosted shades around the electric lamps along with the original glass ball shades around the gas outlets have been removed; the gas outlets have been plugged; the tubing has been altered; and the entire fixture has been rewired. Additionally, perforated brass trumpet shades have been added, eliminating the down lighting component of the fixture.

***Functional Condition: Good***

Repairs should consider impact on fixture restoration.

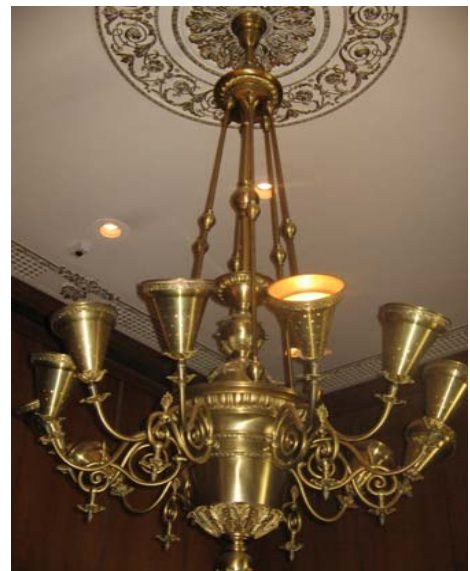
Governor’s Office Chandelier

This refurbished chandelier is found in the Governor’s Office and matches the one in the South Arcade, just outside the Governor’s Reception Office. Although original to the building, this chandelier has undergone the same changes as it’s duplicate fixture. The frosted shades around the electric lamps along with the original glass ball shades around the gas outlets have been removed; the gas outlets have been plugged; the tubing has been altered; and the entire fixture has been rewired. Additionally, perforated brass trumpet shades have been added, eliminating the up lighting component of the fixture.

***Functional Condition: Good***

Repairs should consider impact on fixture restoration.

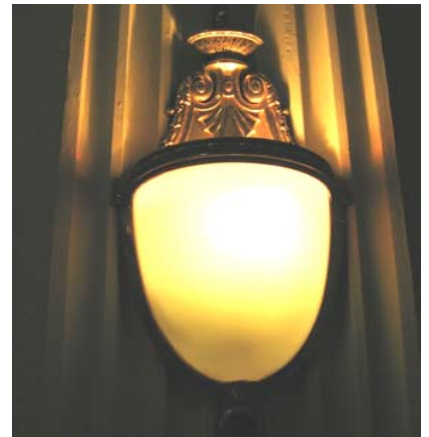
This sconce fixture is found in the original Basement Corridor space. The history of this fixture is unknown.

**Functional Condition: Good**

No preservation work required.

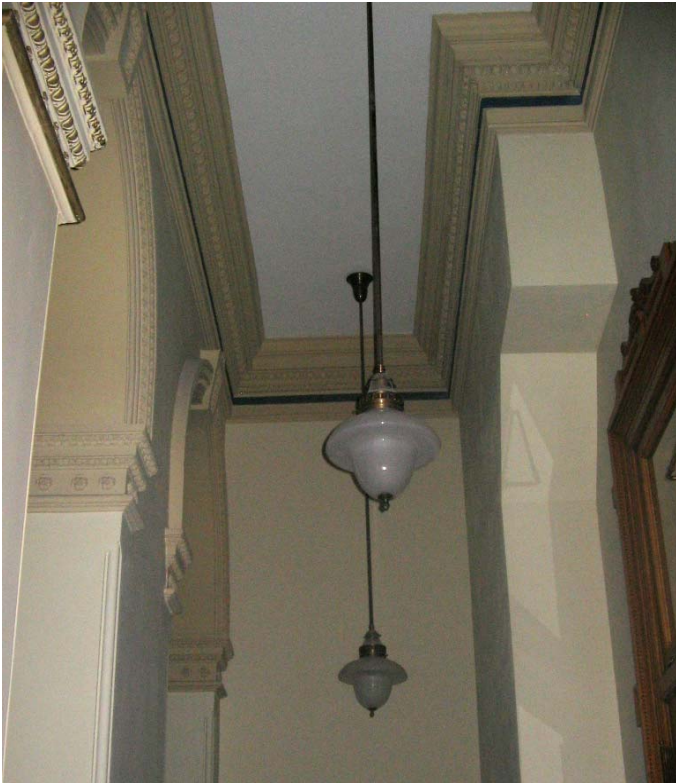
The finishes are in good condition, except as noted. The floor is in good condition and shows normal wear except at Room 225 and 226 where deep scratches are present. Some damage to the stone wainscot has occurred due to floor cleaning equipment. The condition of the door and interior window trim ranges from good to fair.

226 ceiling condition

Repair damaged wainscot.

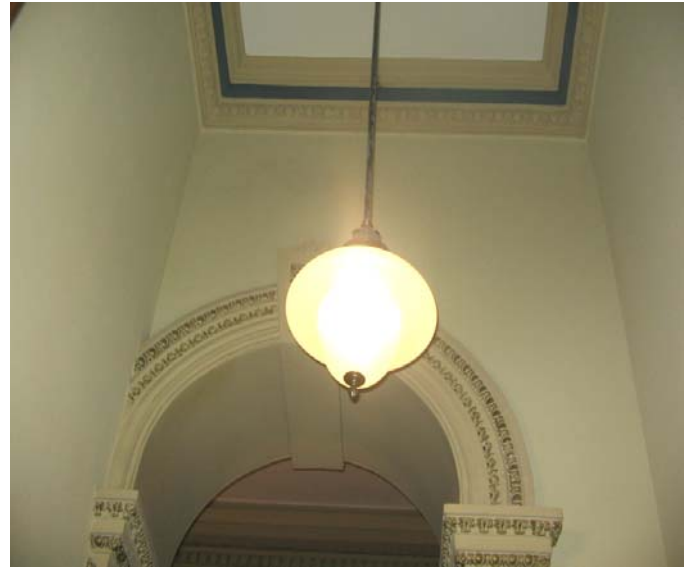
233 crowded arched opening suggesting alterations

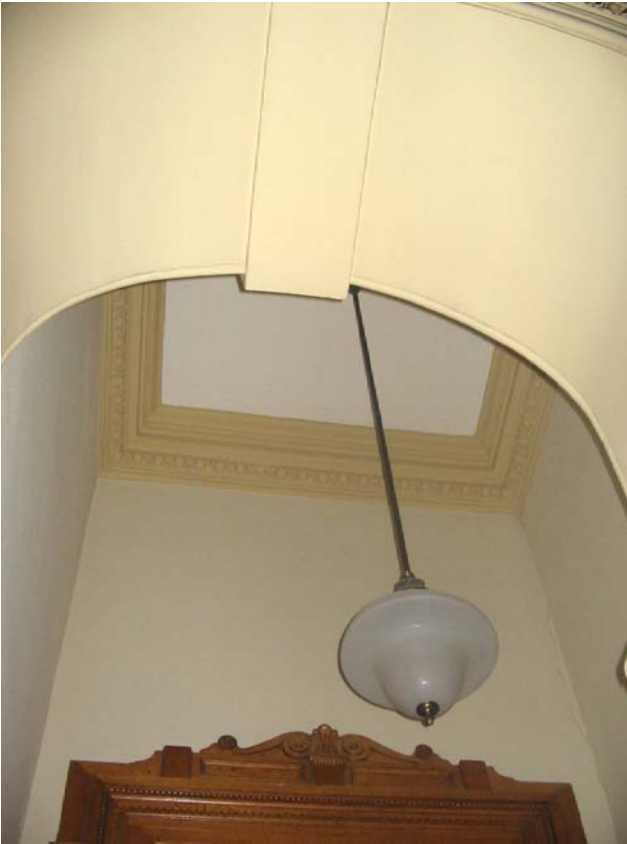
238 ceiling condition

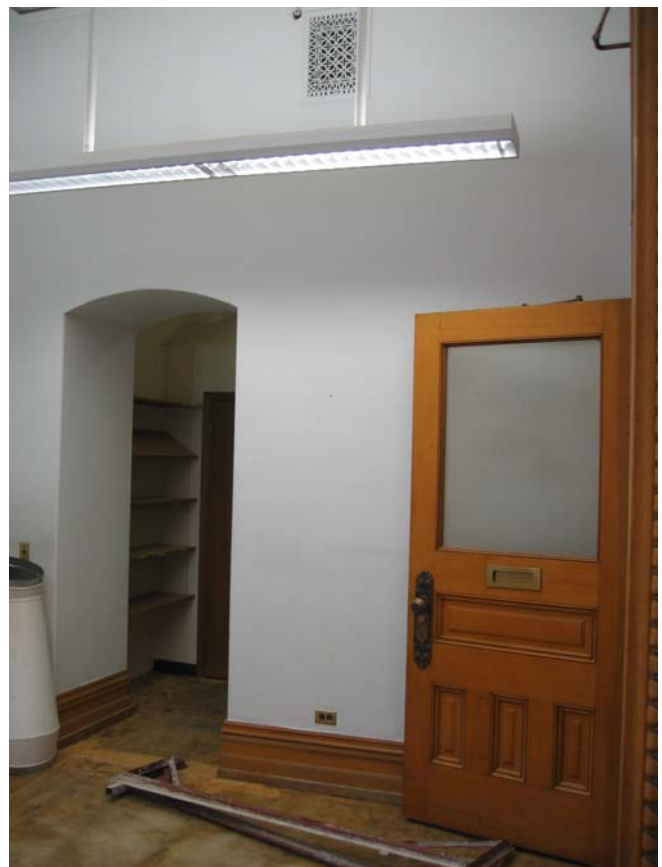
The space is in good condition and consistent with the current use; walls show signs of patching; plaster is cracking and delaminating in some areas

Repair the delaminating plaster

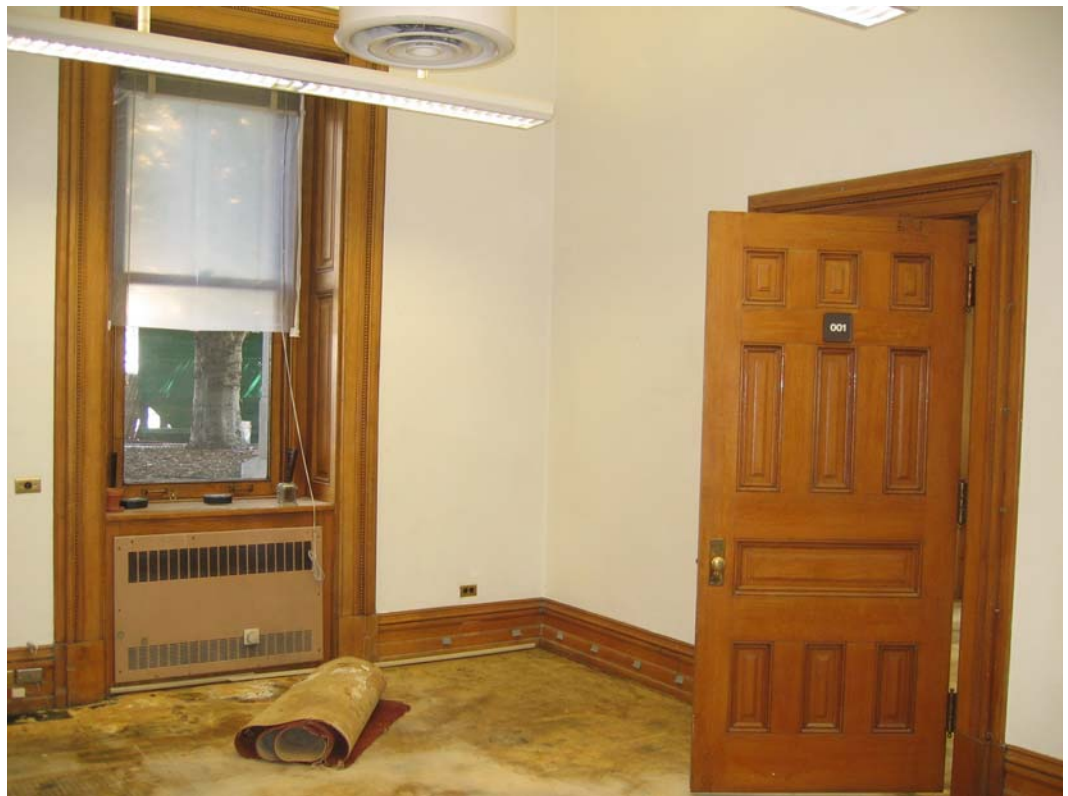
003 Corded corner detail

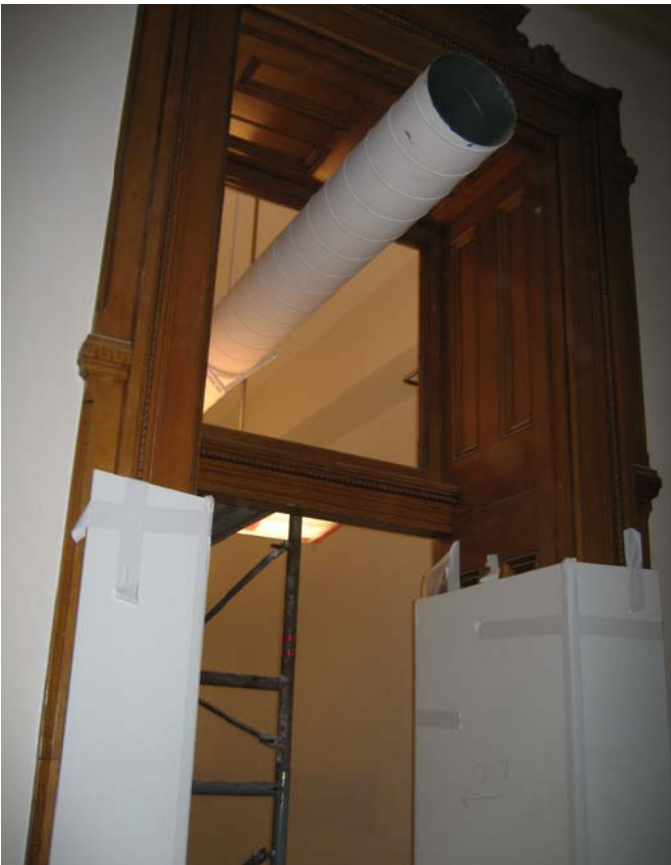
Door to 017: relocated, modified original casing, frame and transom; door missing; transom glazing removed to allow for ductwork; stone plinth base on jambs; latch plates remain; trim type T2 corridor side; trim type T3 room side; former interior window opening

007 View of room 017 door

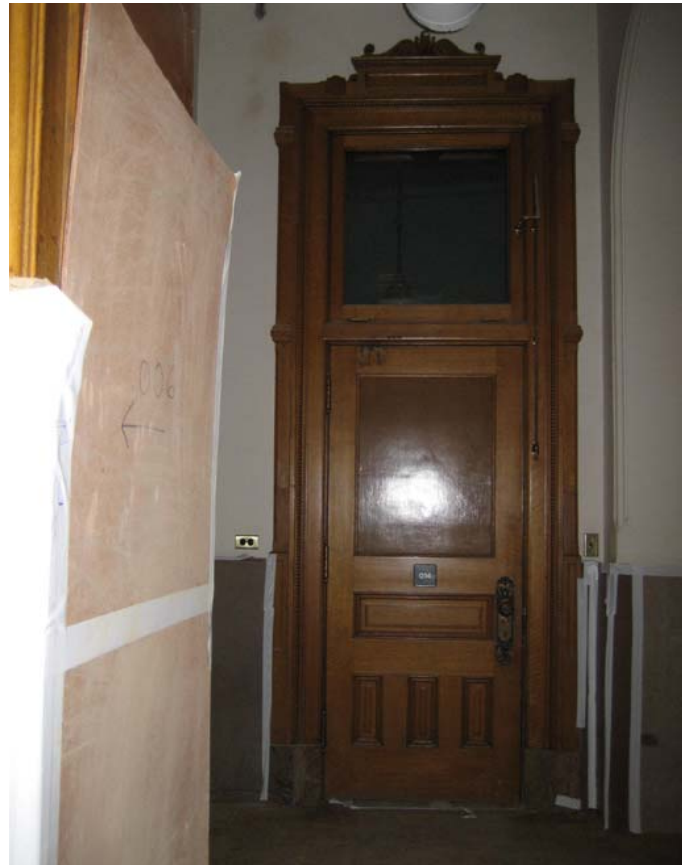
Door into 014: modified original door type D1 in poor condition; door glazing replaced with wood panel; non-original clear transom glazing, stone plinth base on jambs; columbine plate on 014 side; scroll plate on corridor side; large cast knobs; trim type T2 both sides

007 View of door 014

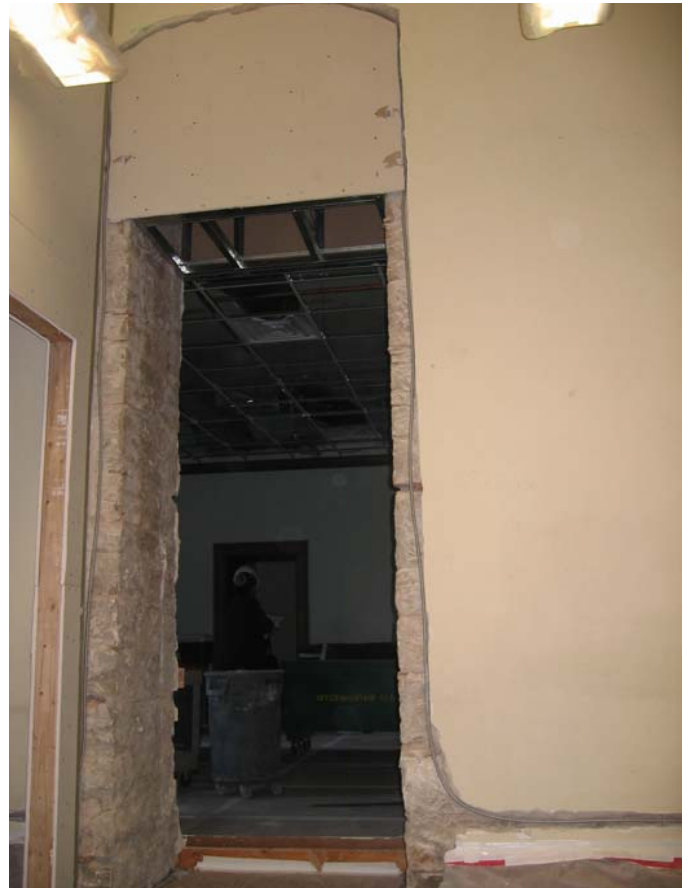
010 Reopen original opening south wall of room 011

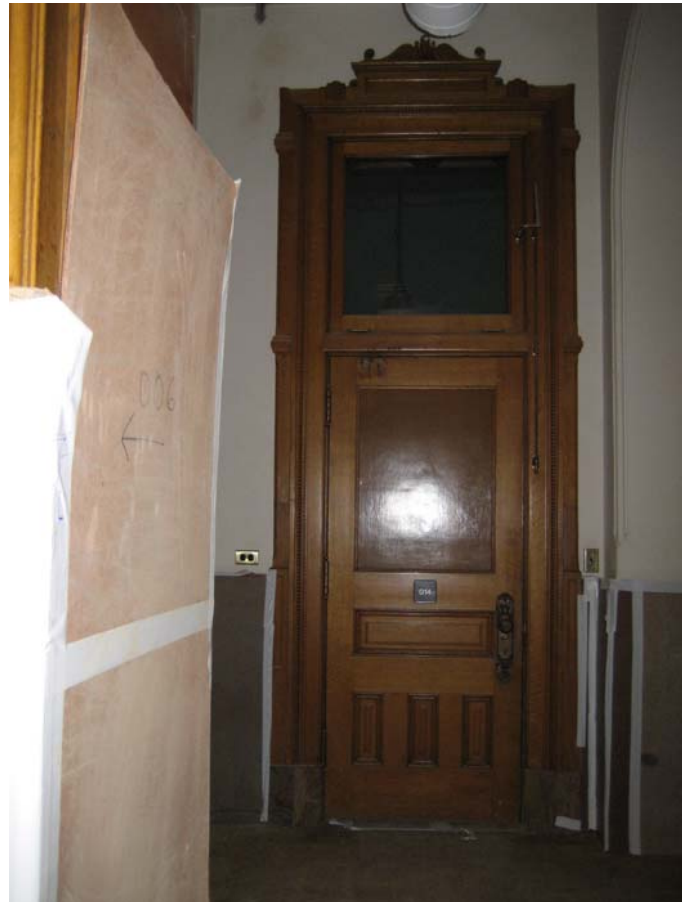
014 Entry door from Hallway 007

Determine source of water damage and repair if necessary

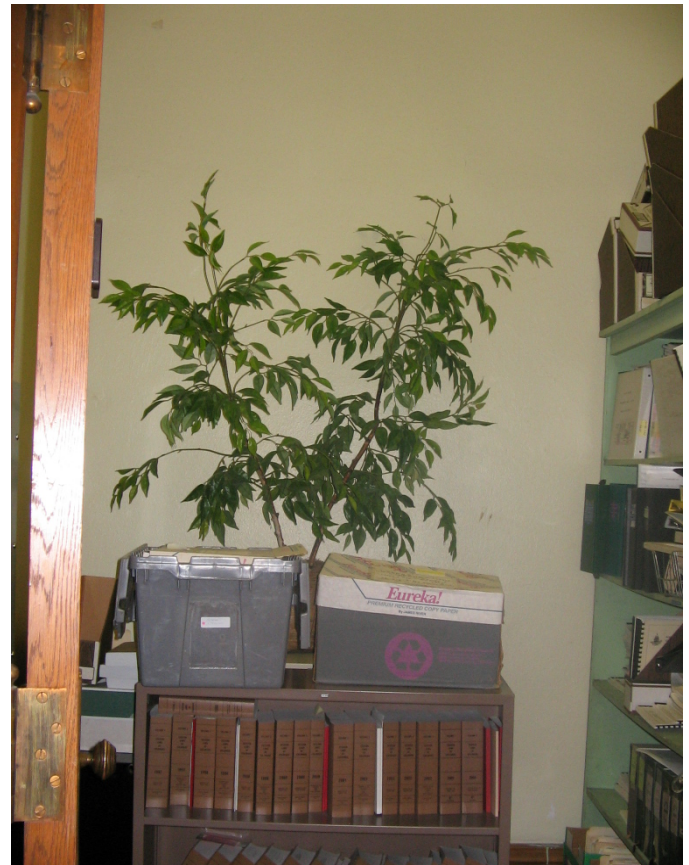
015 Existing conditions

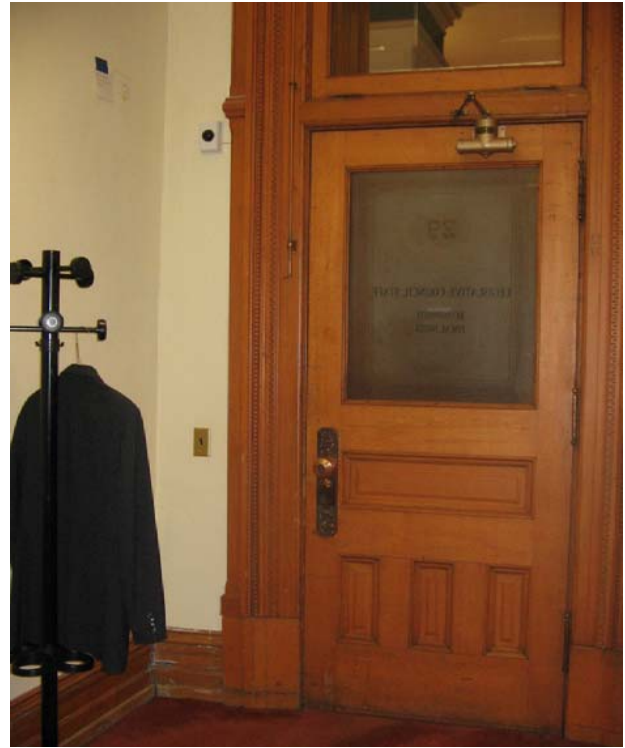
016 Entry door from Arcade

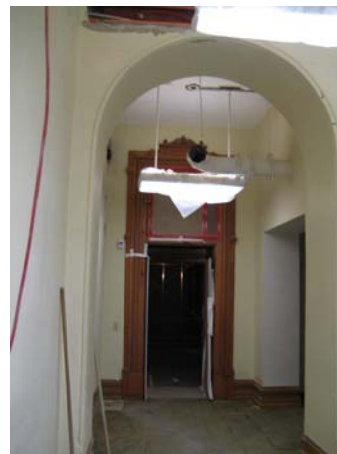
016 View from room 010

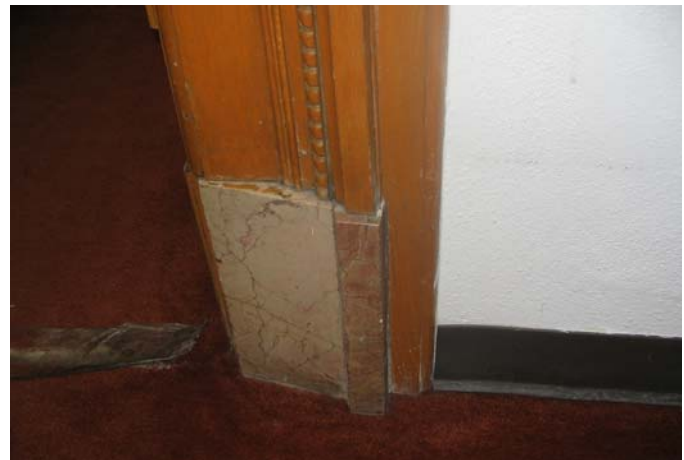
017 Stone plinth on the relocated original door

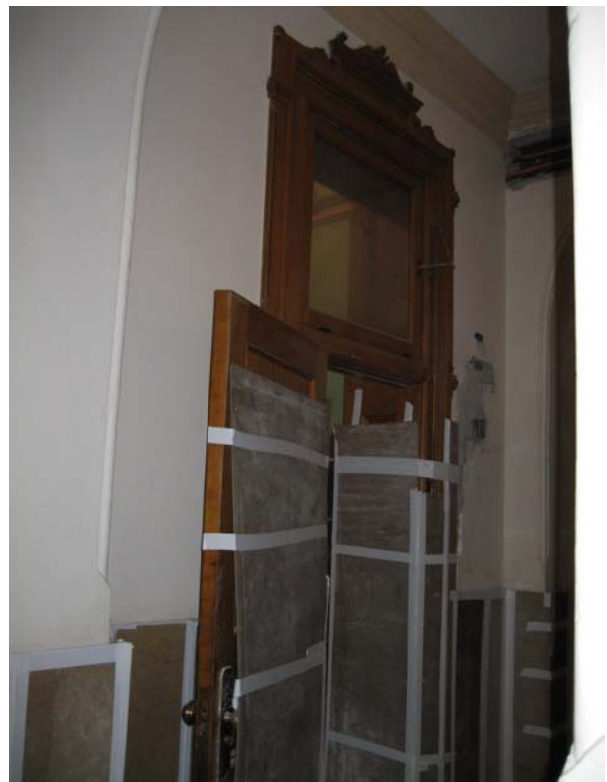
Entry from Hallway 007: modified original door type D1 in poor condition; door glazing replaced with wood panel; non-original clear transom glazing, columbine plate on room side; scroll plate on corridor side; large cast knobs; trim type T2 both sides; door in poor condition

018 original door from corridor 007

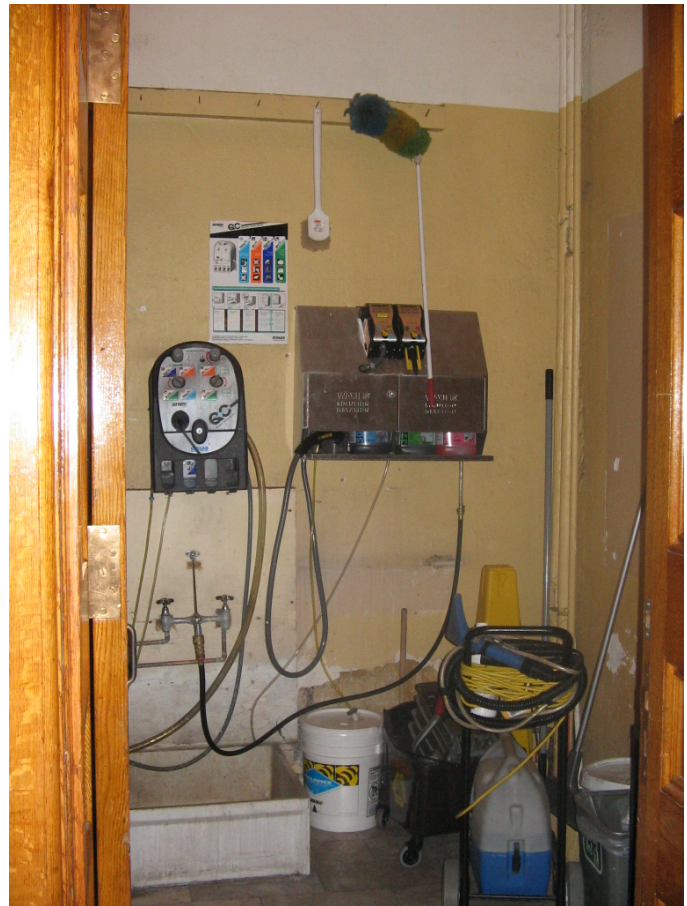
019 Janitor's closet

The space is in poor condition; walls show signs of heavy wear; paint is peeling; floor is stained and unprotected from further damage; space *is* performing its intended function

Repair walls; protect floor from further damage

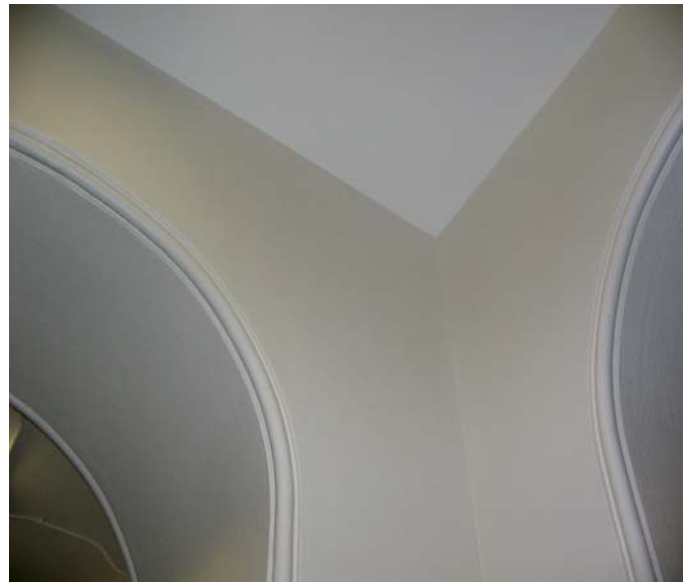
Painted plaster with sand-textured finish; two original corded plaster archways with cording in poor condition;

030 Arched openings

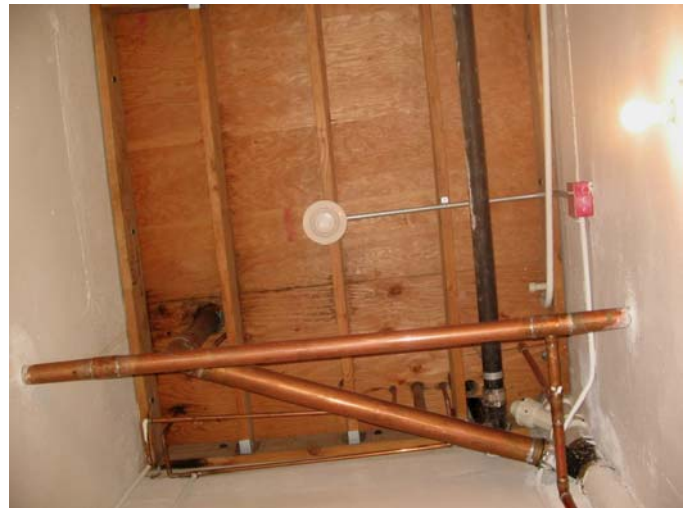
041 Framed ceiling

The space is in good condition and consistent with current use; Ceiling has not been finished; walls show signs of patching and normal wear

No preservation work required

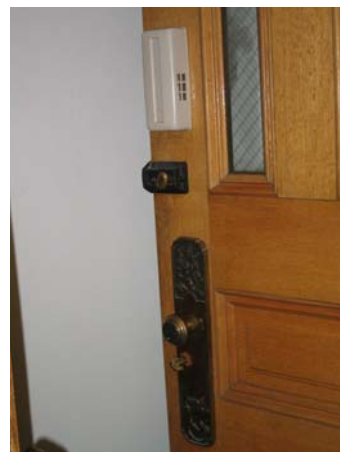
Door to 041: modified original door type D2; one door panel replaced with wire glass view panel; columbine plates both sides; small cast knobs; door bell; deadbolt with key access from outside

041 Modified door

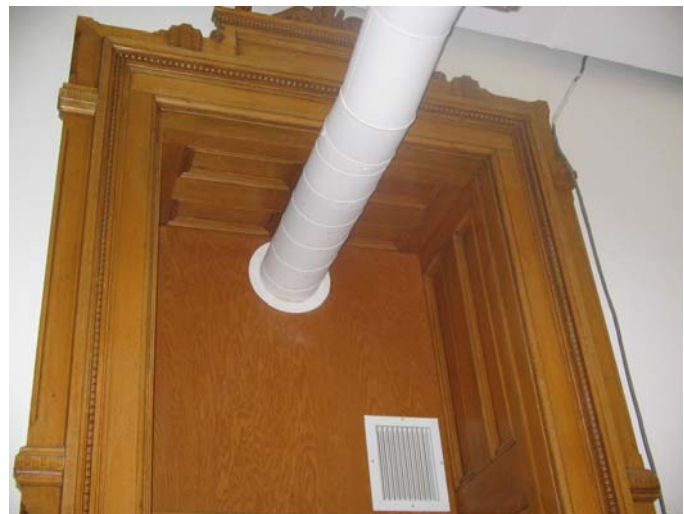
056 Non-original transom wood panel

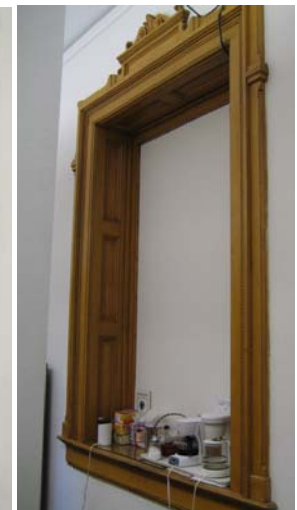
056 Painted window

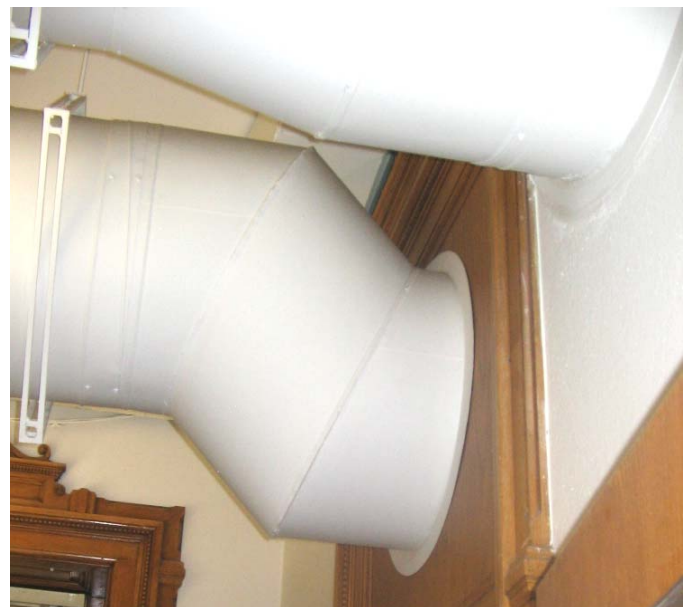
063 Transom in-fill

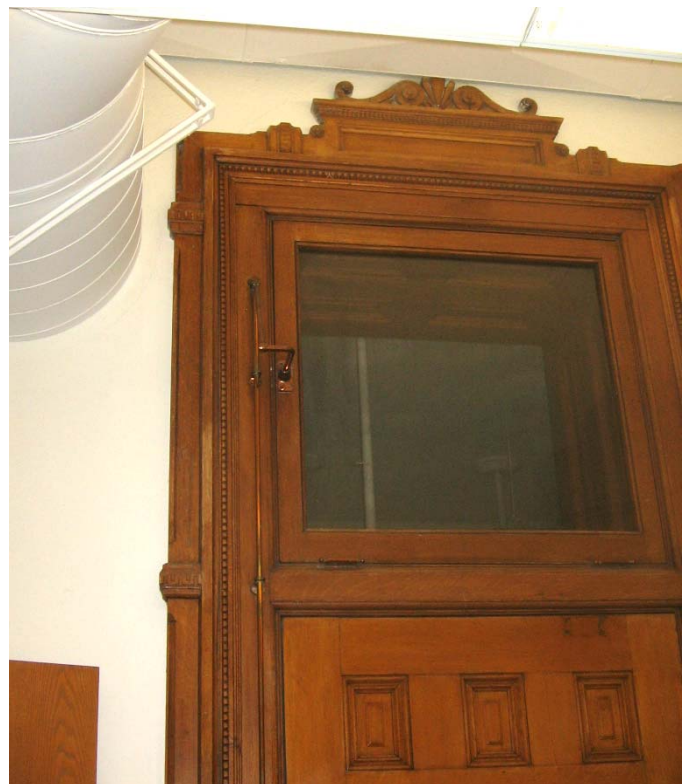
064 Transom detail to 067

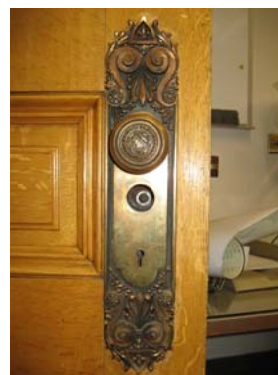
070 Unusual original door knob

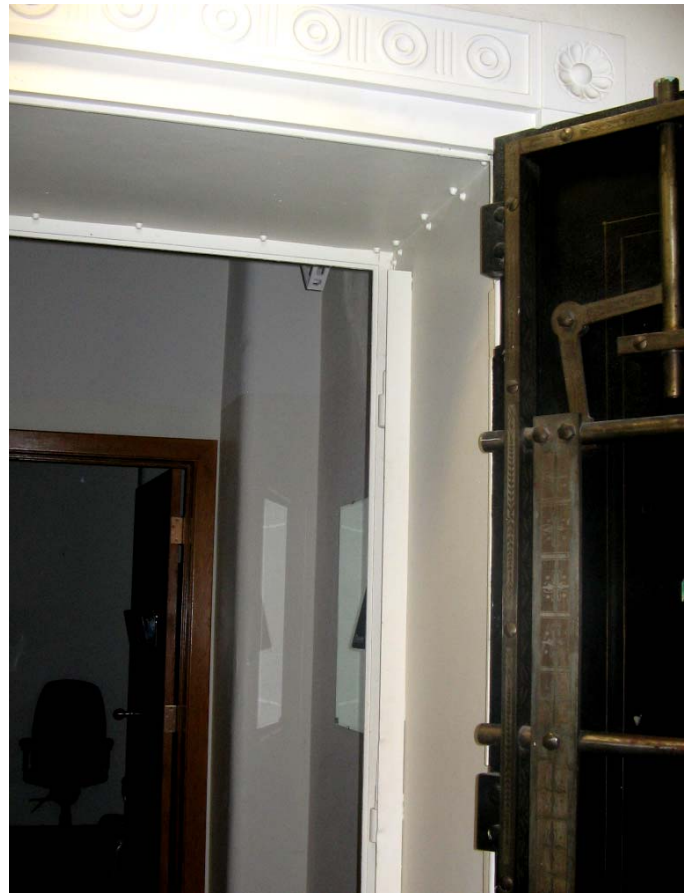
Door to 076: original vault door; painted on outside face; original interior vault door and frame; exterior door is missing; frame existing exterior door hinges have been painted over

075 Vault door

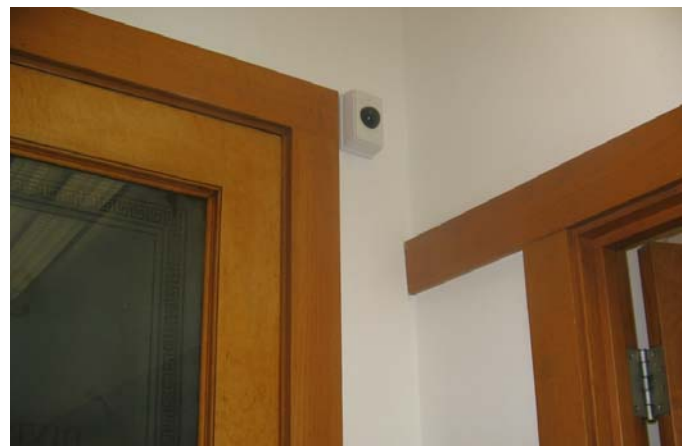
079 Relocated door to Arcade

Door from 079: original relocated frame and casing; door missing; transom missing to accommodate ductwork; trim type T2

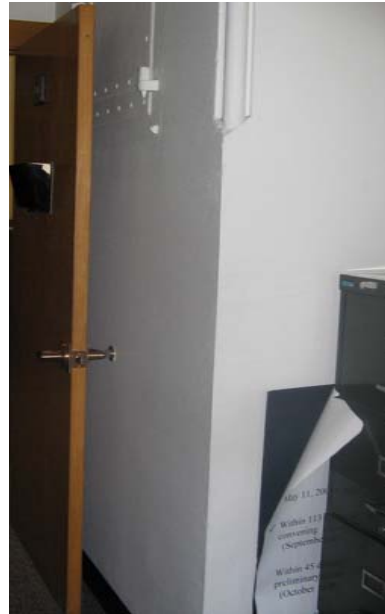
Painted plaster with sand-textured finish on original; painted gypsum board with smooth finish on non-original walls; corded arch in northeast corner; original plaster east wall removed at former South Entry Vestibule and replaced with gypsum board partition

080 Missing stone wainscot and corded plaster corner

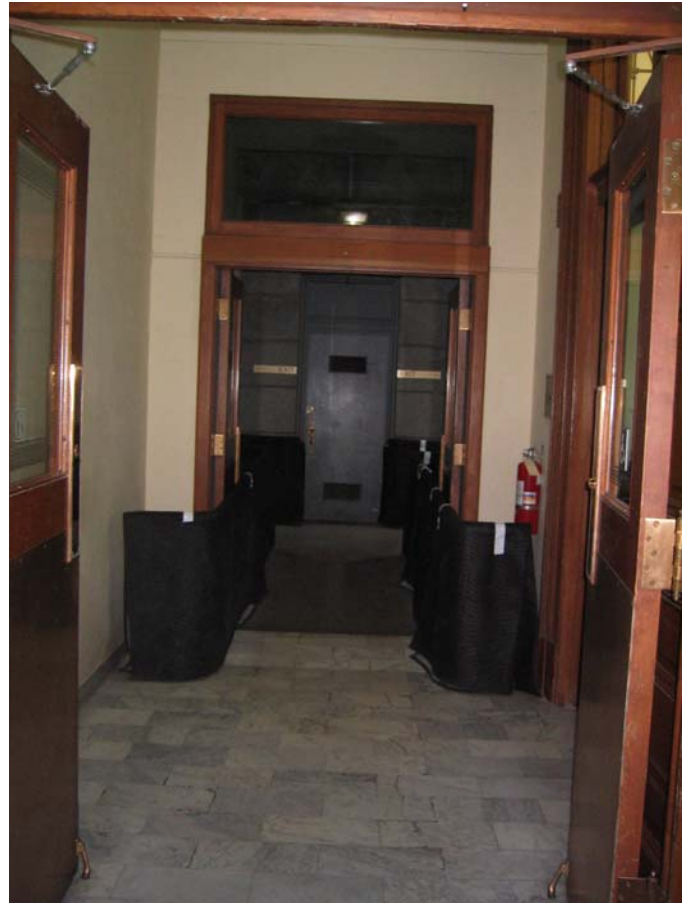
Concrete block in poor condition

View down entry 0122 looking at 082

**Functional Condition: Poor**

Repair water infiltration into this space

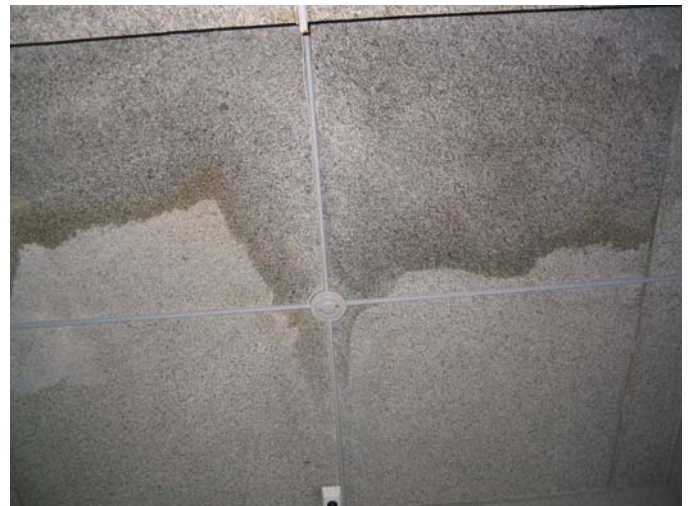
Concrete in poor condition

Ceiling outside 082

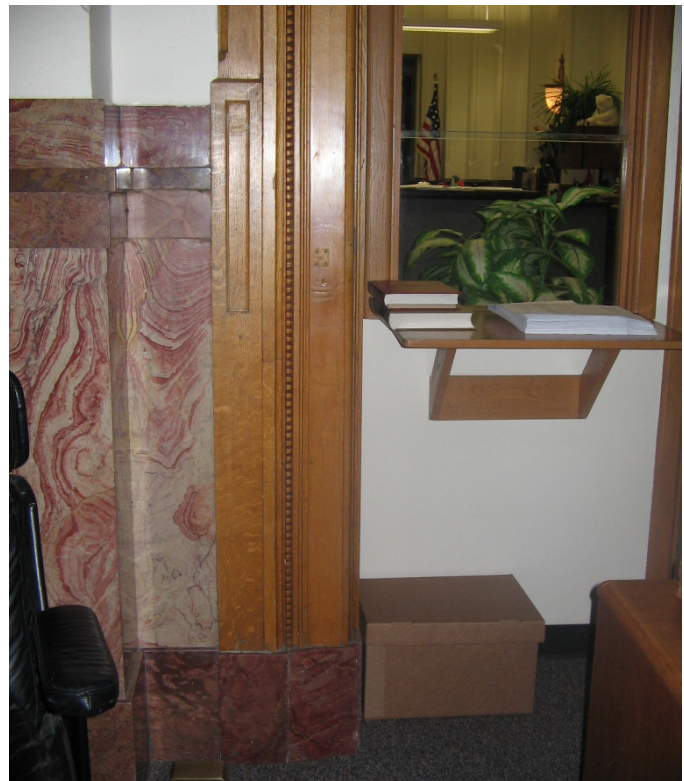
Door from 091: original double doors type D1 of former entry vestibule; original frame and casing; transom glazing removed to accommodate ductwork; west door leaf replaced with partition in-fill and pass through window; non-original clear door glazing in east door; original push plates; trim type T2 on outside; inner trim modified for partition and window

083 Doorway modification

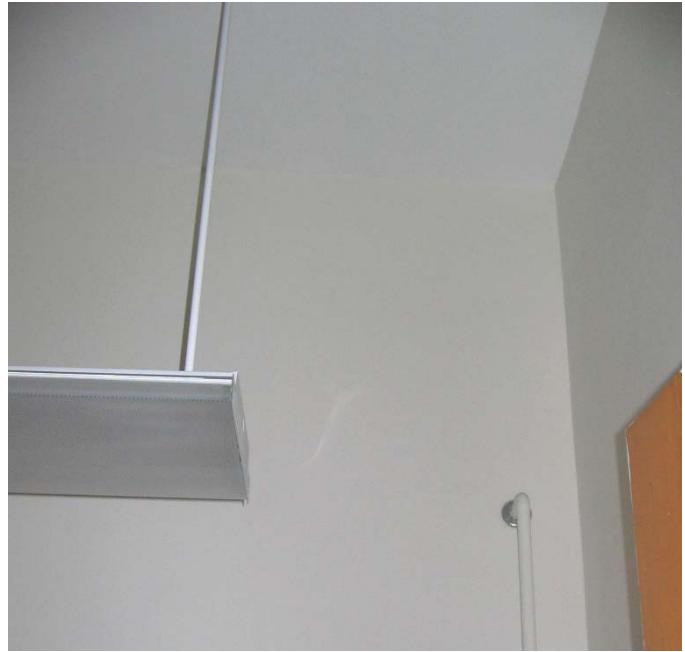
099 Existing ceiling

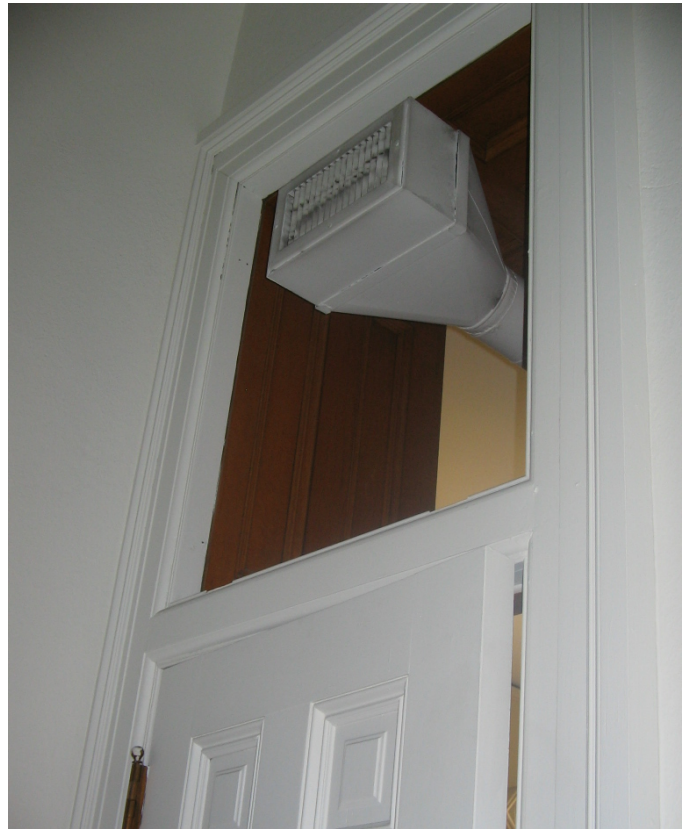
099 Door with painted finish

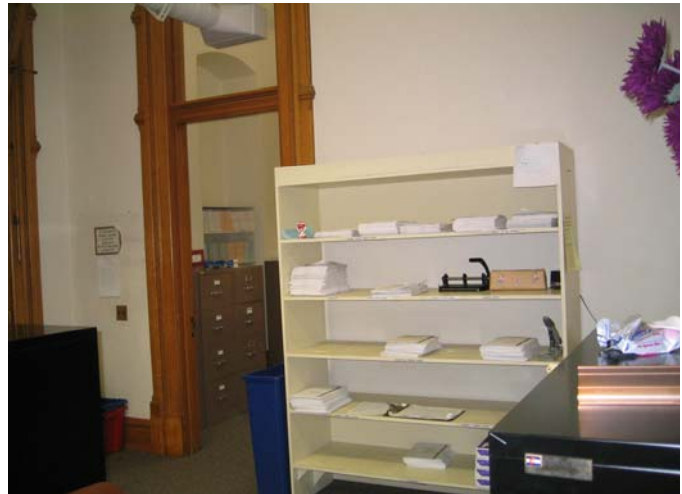
0103 View from 0102 looking into 0103

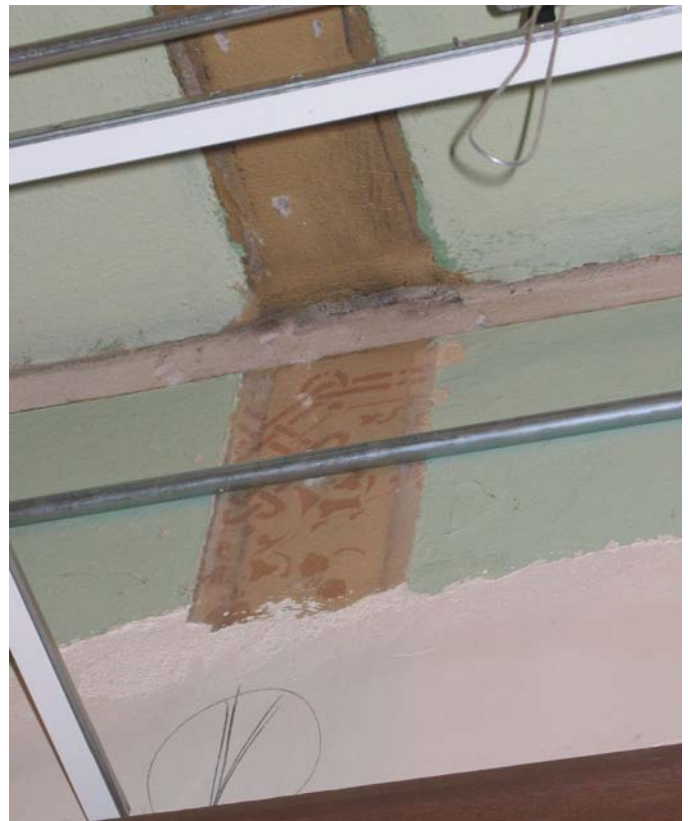
1’x1’ concealed spline ceiling scheduled to be replaced in 2006 with a 2’x2’ lay in ceiling; non-original wood crown molding; original plaster ceiling above current ceiling

0112 Detail above ceiling

No preservation work required

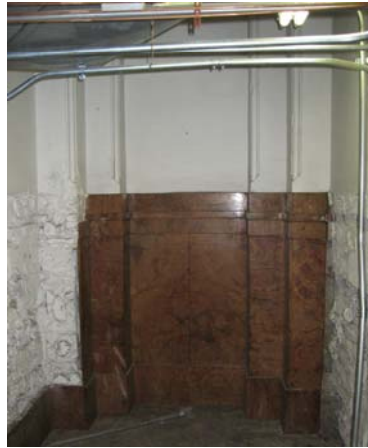
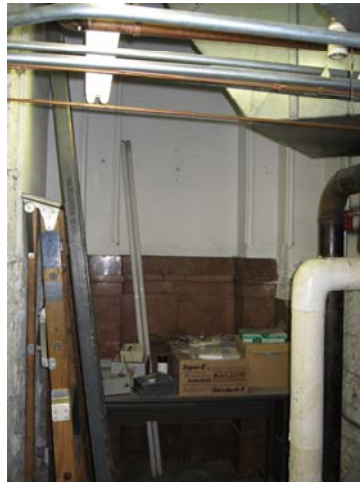
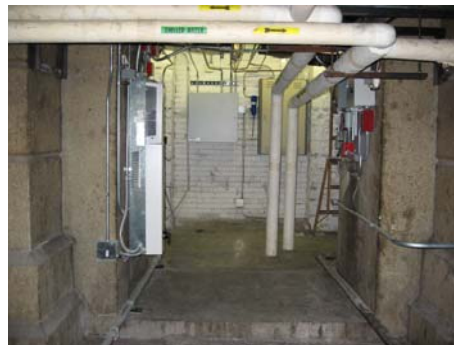
This space is in poor condition. Although it functions adequately as a mechanical room, the original finishes of the former entry vestibule are damaged beyond repair.

No preservation work required

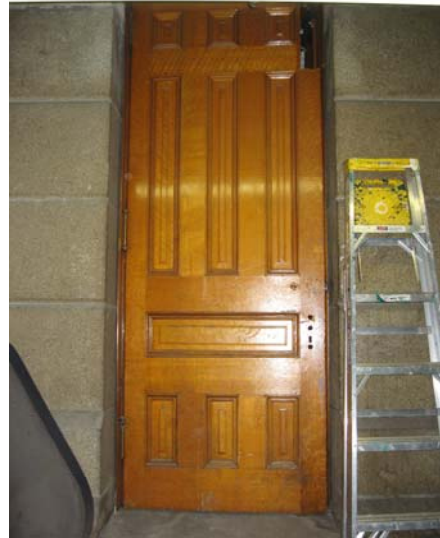
Door from 0116: Original type D2 single door; non transom frame; no hardware; door has been damaged; corner cut to fit around a duct

0117 Entry door from 0116
