# COLORADO STATE CAPITOL

## HISTORIC STRUCTURE ASSESSMENT

STATE HISTORICAL FUND PROJECT NUMBER  
SHF-2006-T1-001

**December 15, 2006**

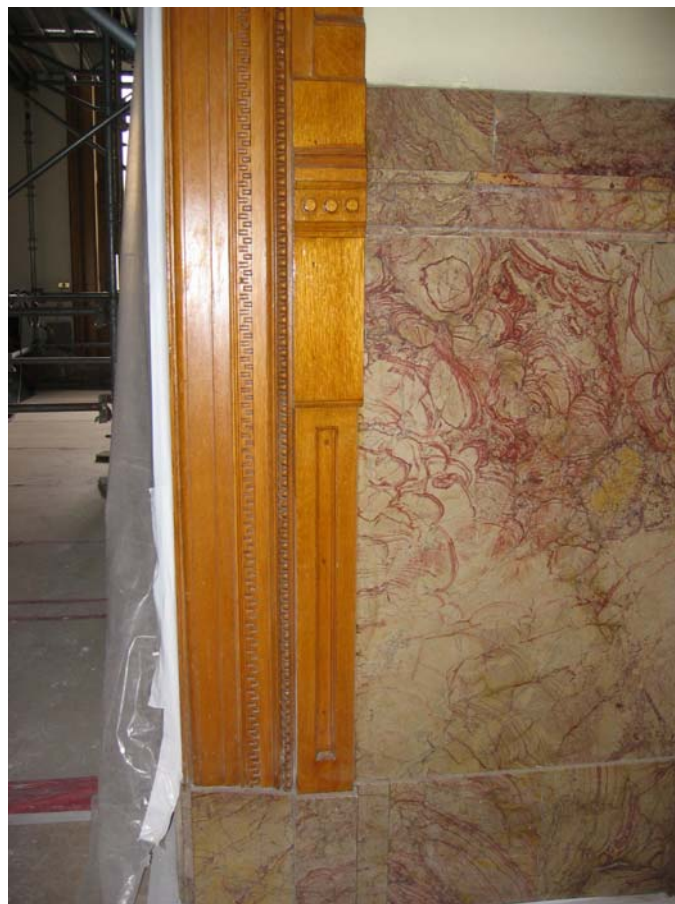
100 Rose Onyx marble wainscot and wood trim detail at entry

No preservation work required

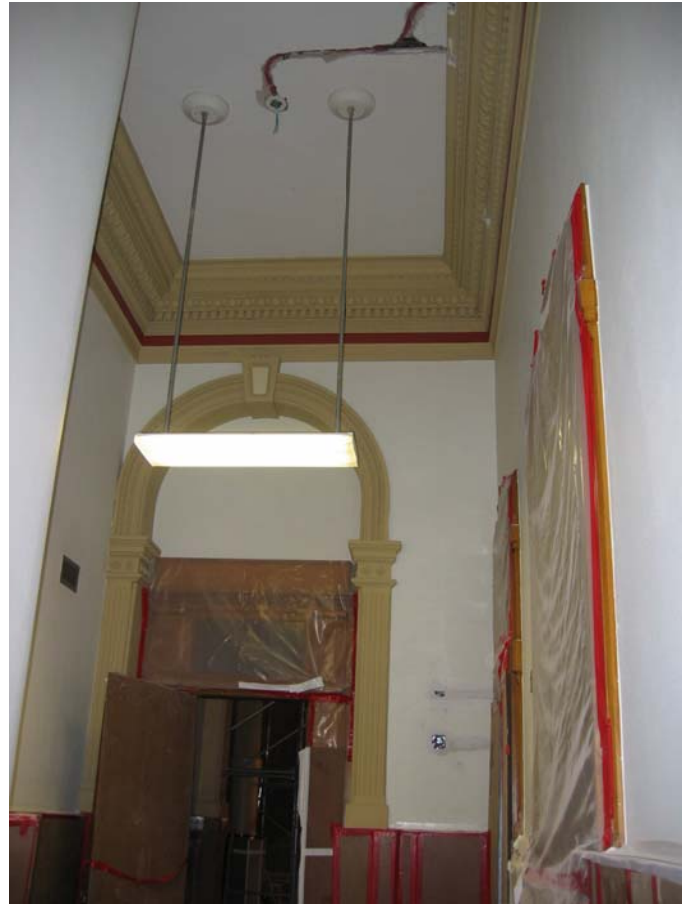
100A Looking west to Room 100B

Finishes in good condition, except as noted; walls show signs of patching and normal wear

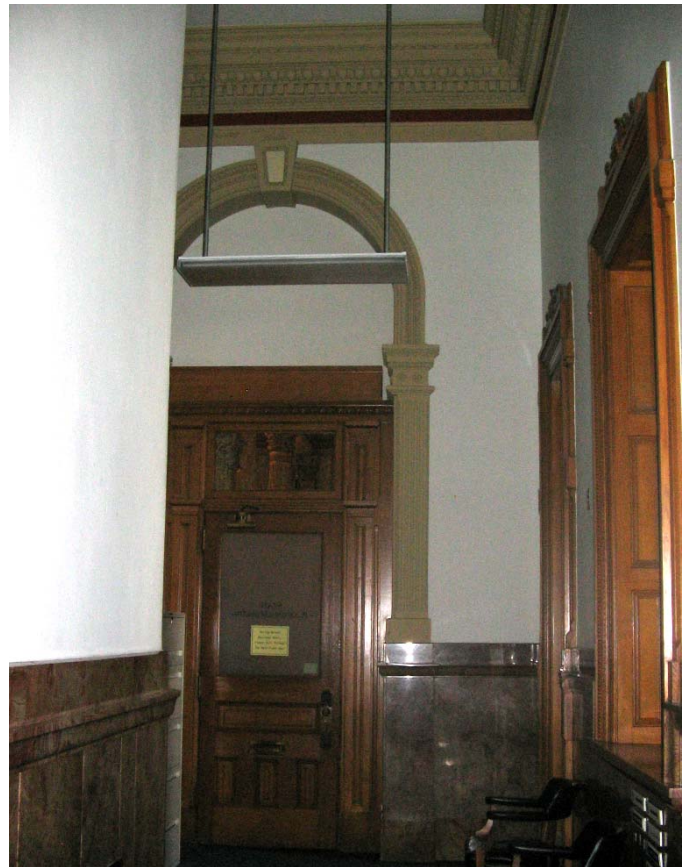
100A Looking west to room 100B

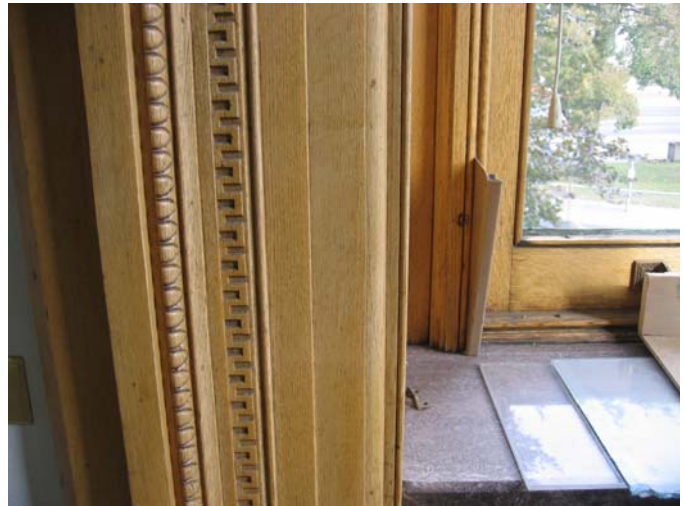
104A North window trim detail; trim type T1

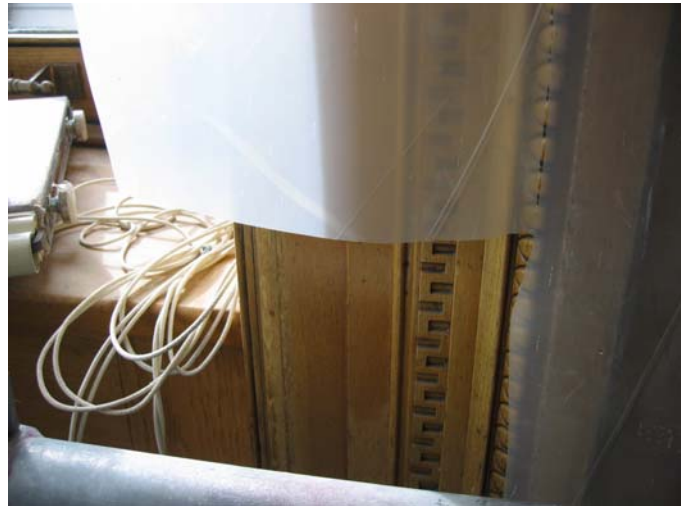
105 South window trim detail; trim type T1

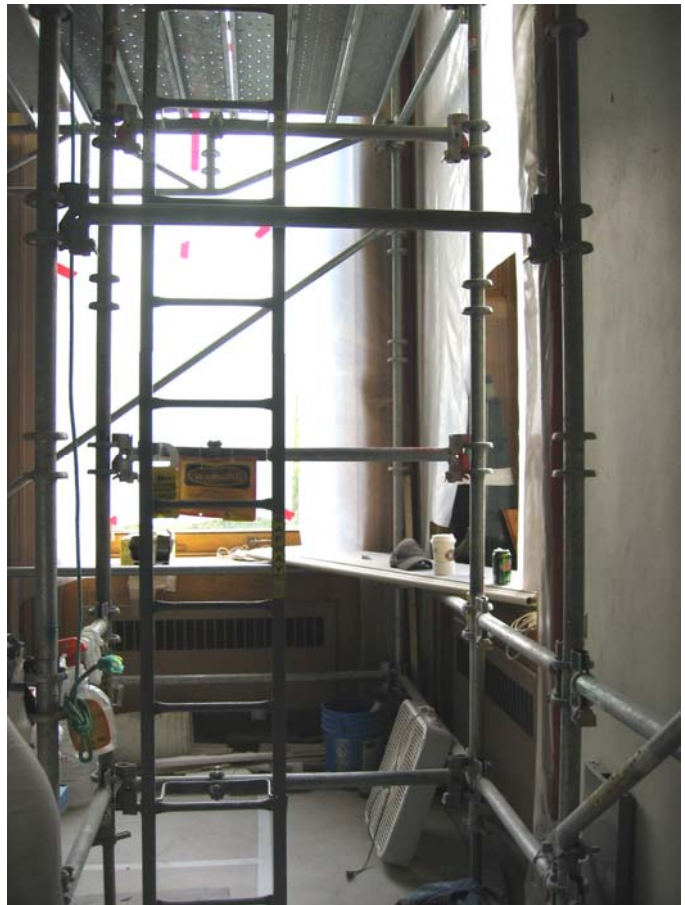
105 View looking east

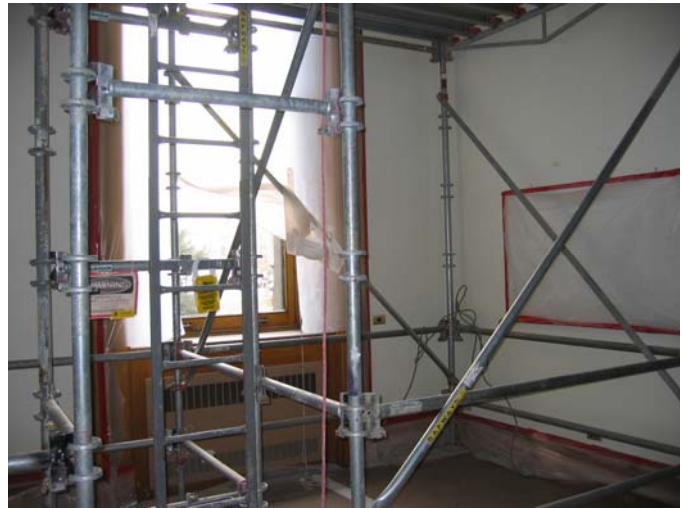
106 Exterior window on east wall

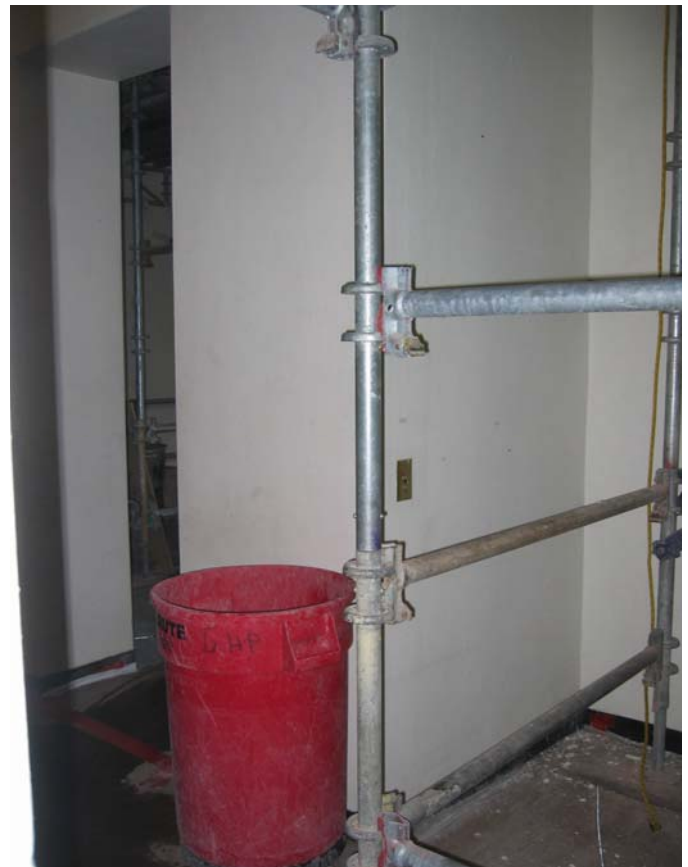
107 Looking toward 110A

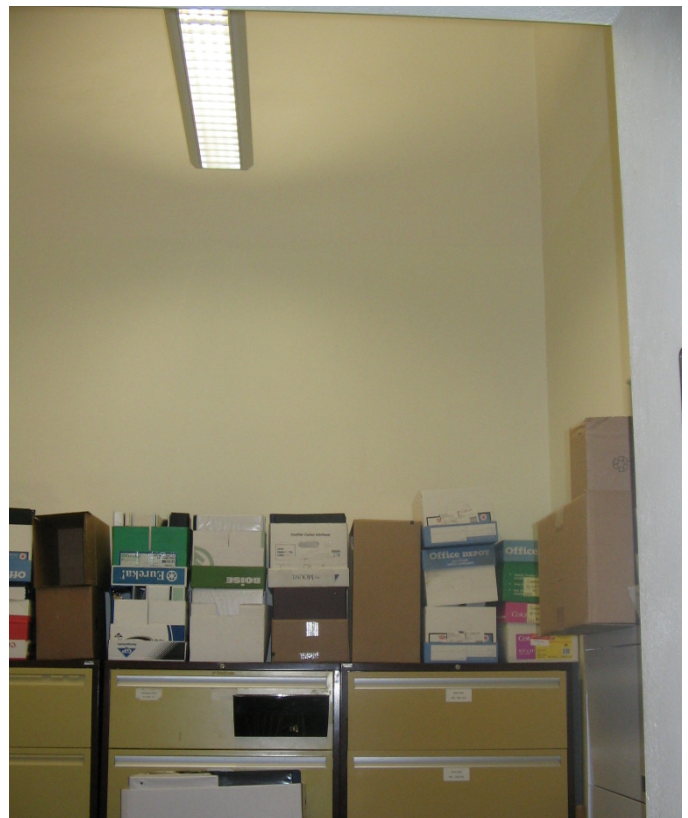
107 Existing conditions

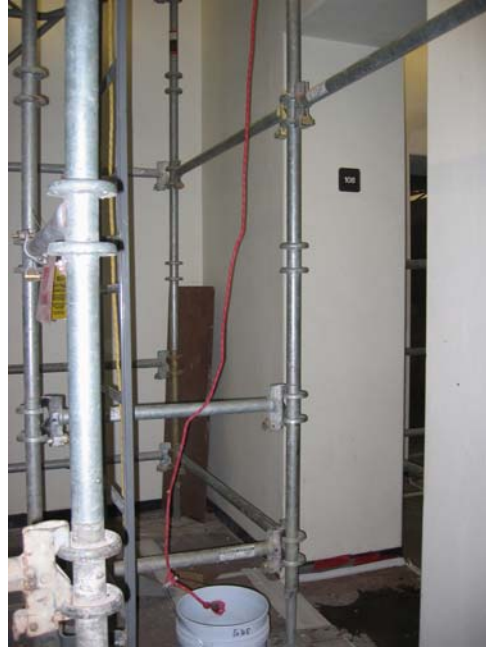
108 View from Room 107

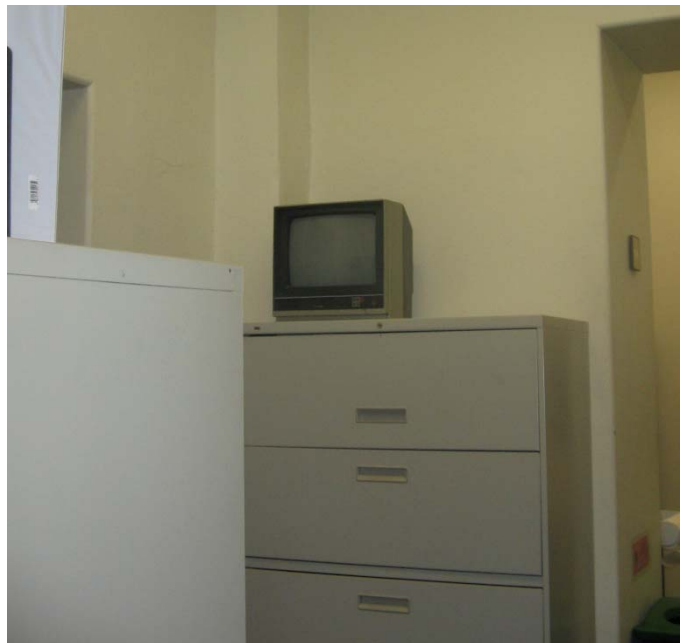
108 Northeast corner

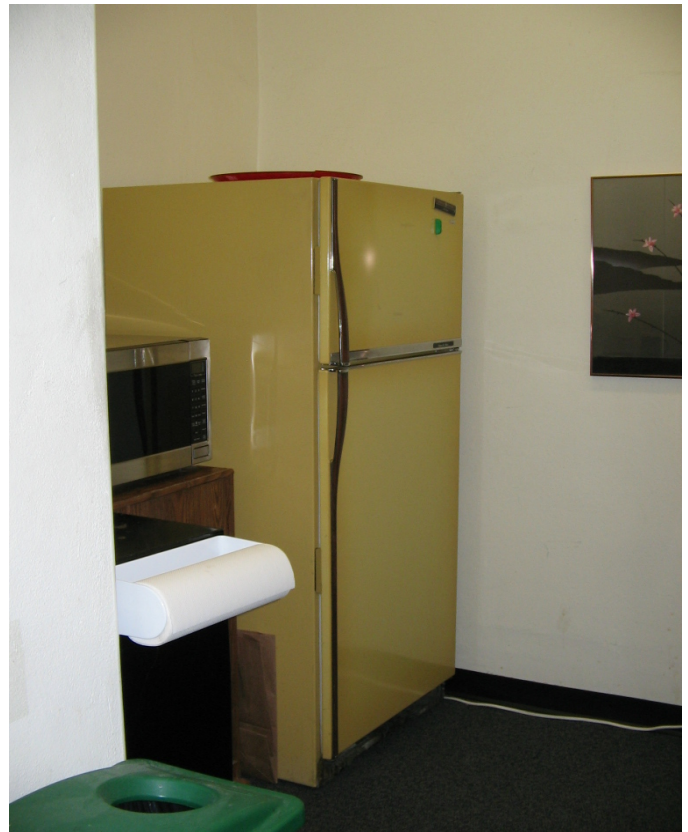
109 South view

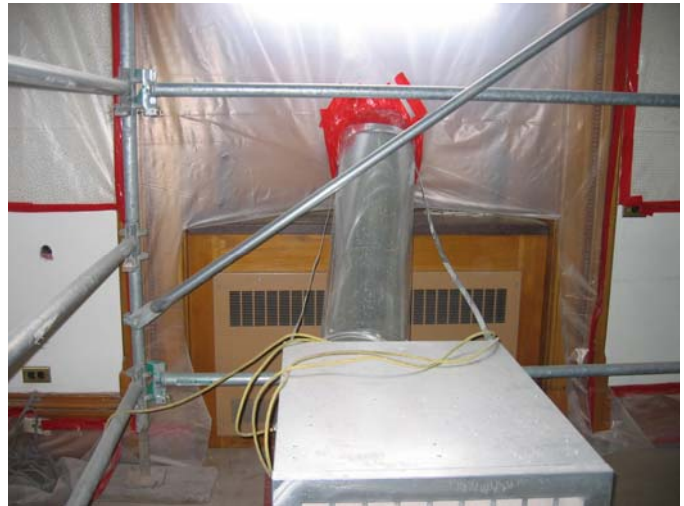
110 Non-original radiator at window

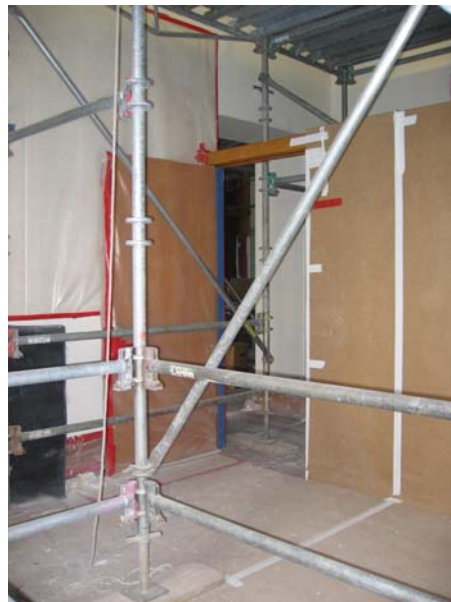
110 Southwest corner

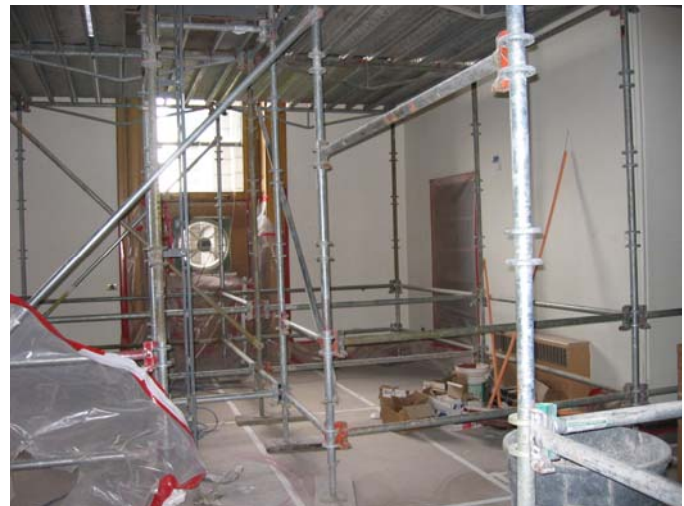
111 southeast corner with bookshelf on south wall

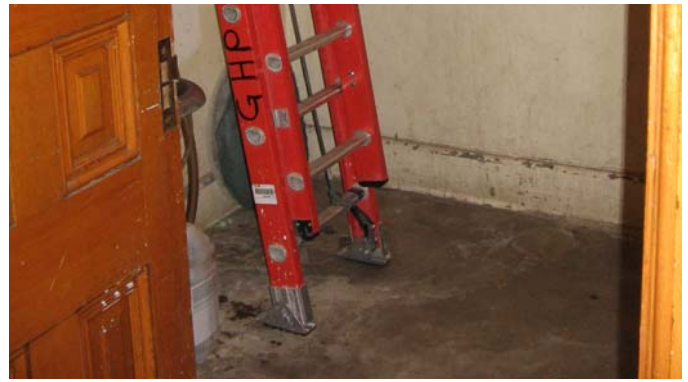
116 Concrete floor

Finishes show signs of heavy wear

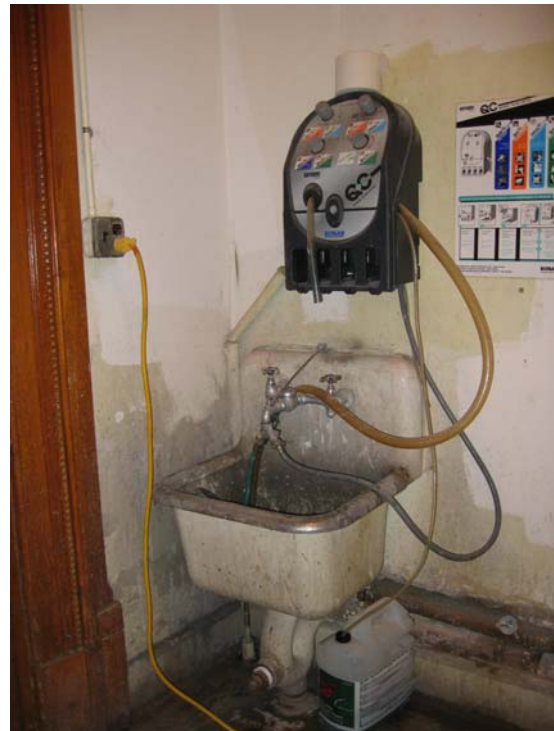
Painted plaster with smooth finish in poor condition; janitor's sink on north wall

116 Janitor's sink

No preservation work required

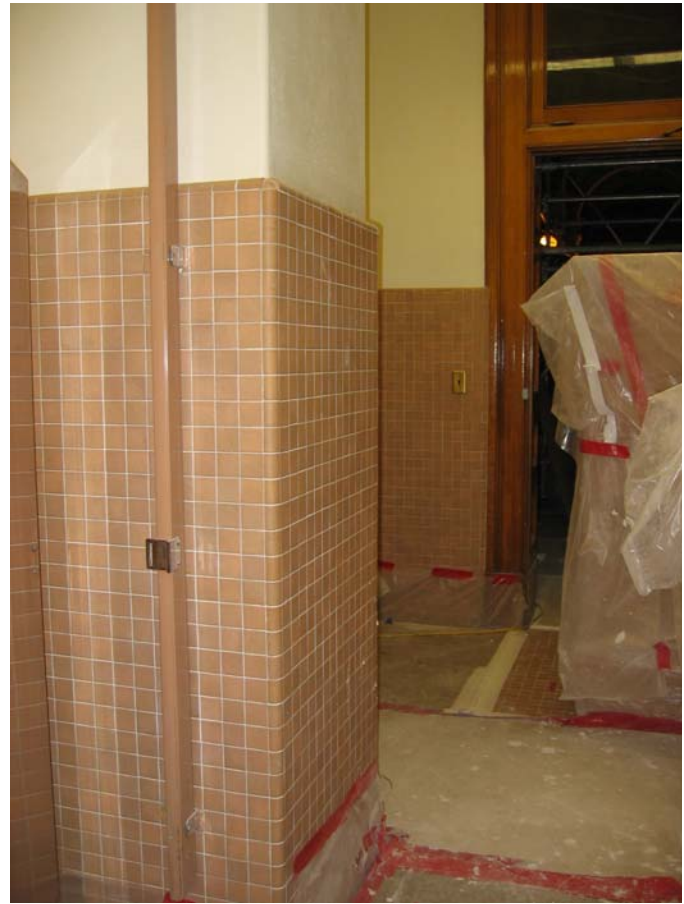
116A View from 117

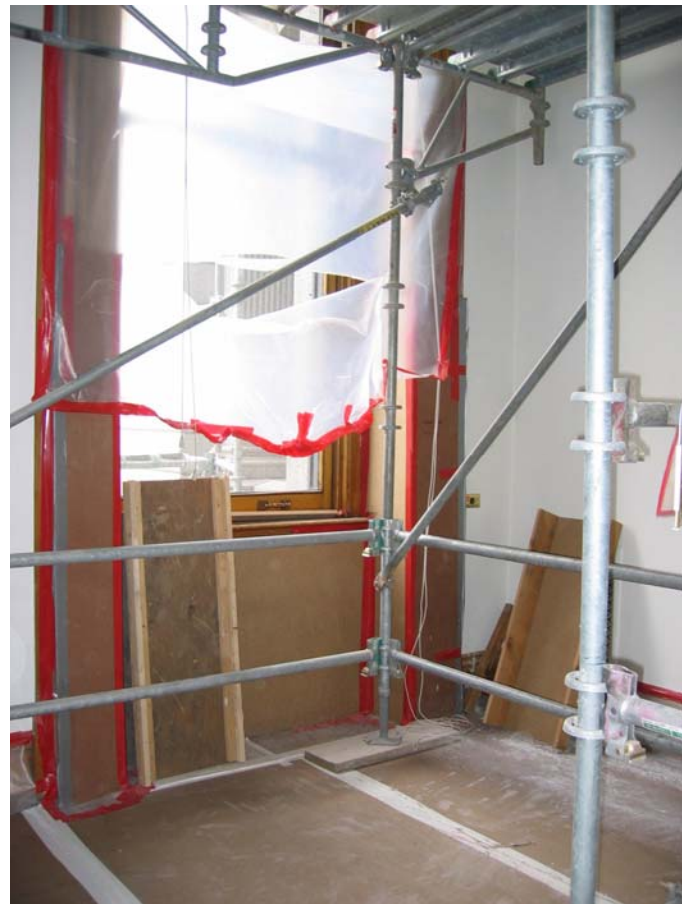
116B Southeast window

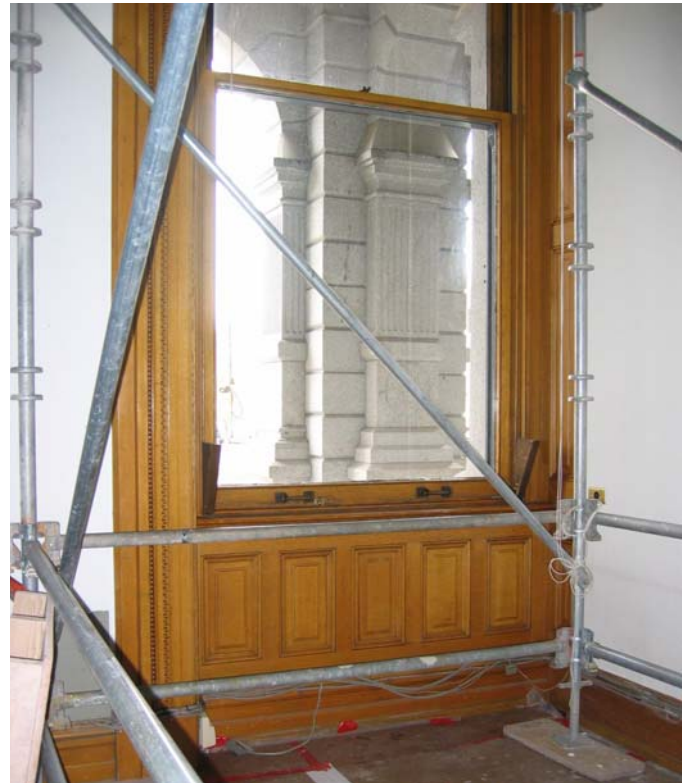
116C Southeast window

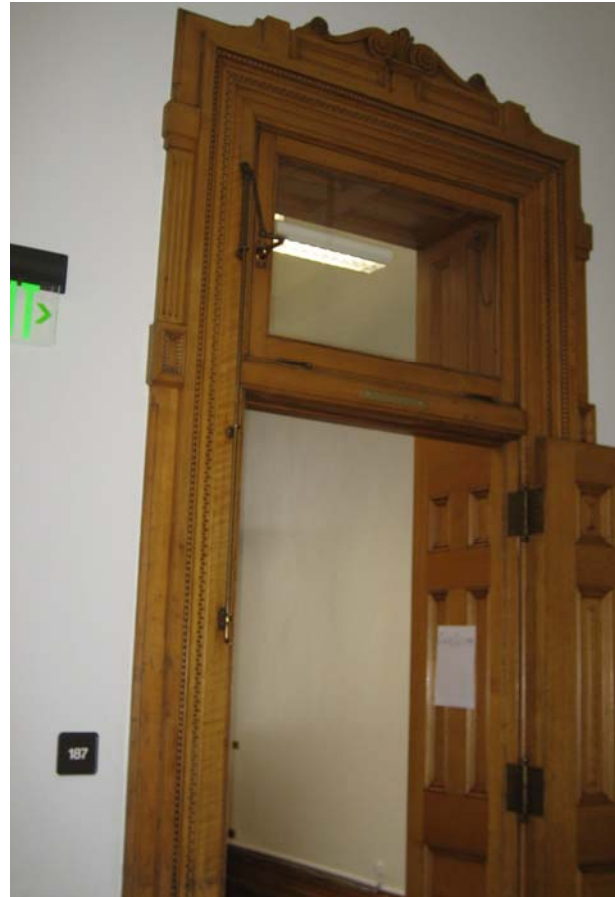
116C Entry into Room 115

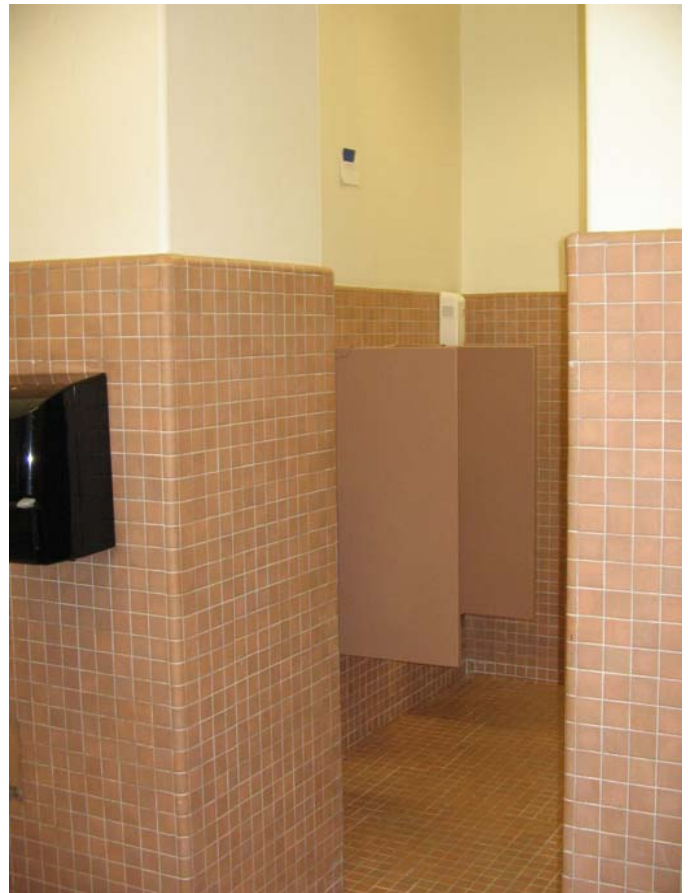
117 Looking northwest

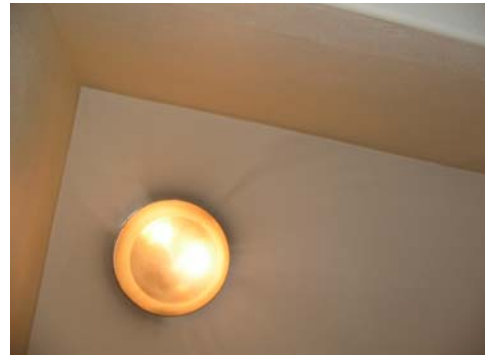
118 Lighting detail

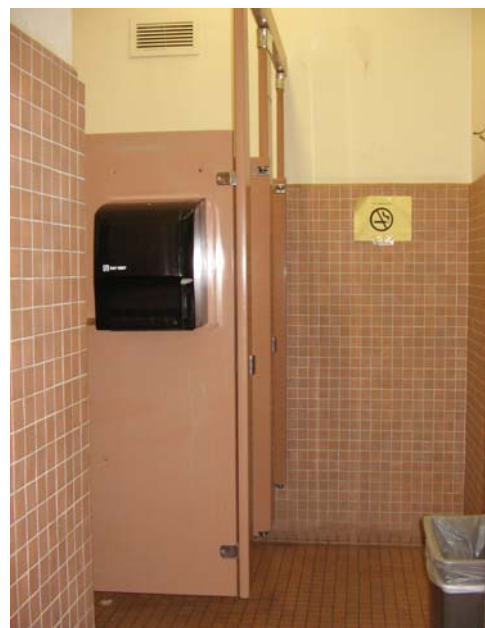
118 North view

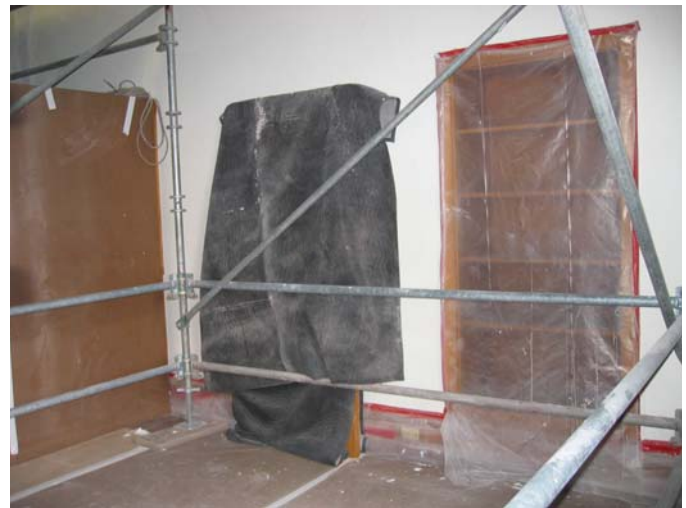
119A Northwest corner with in-filled bookshelf

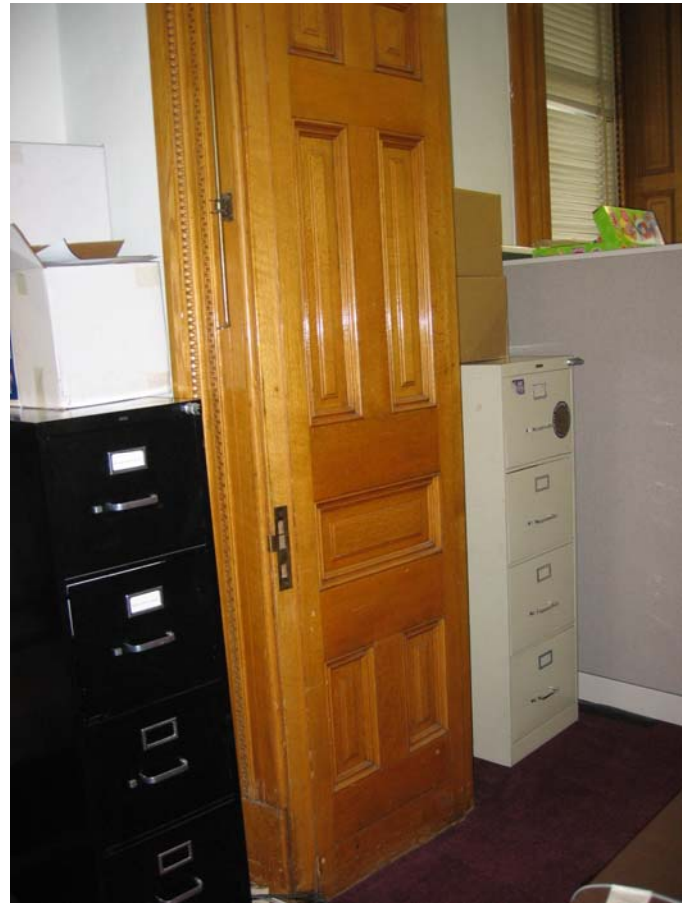
Original casing and frame; door and hardware missing; non-original clear transom glazing; trim type T1

121C Cased opening, frame and trim

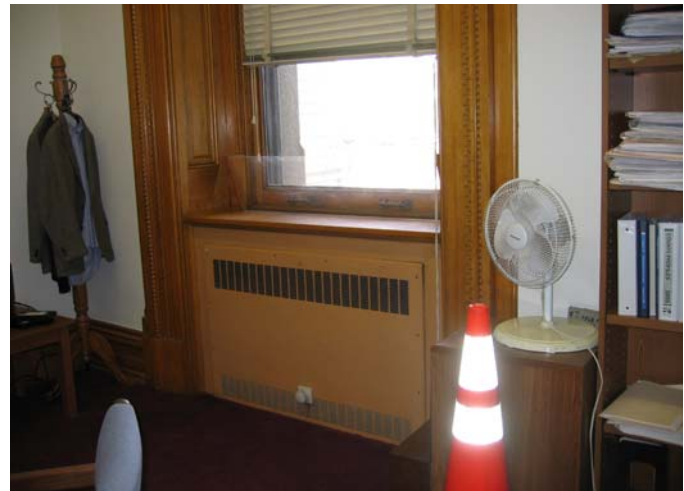
126 Non-original radiator at window

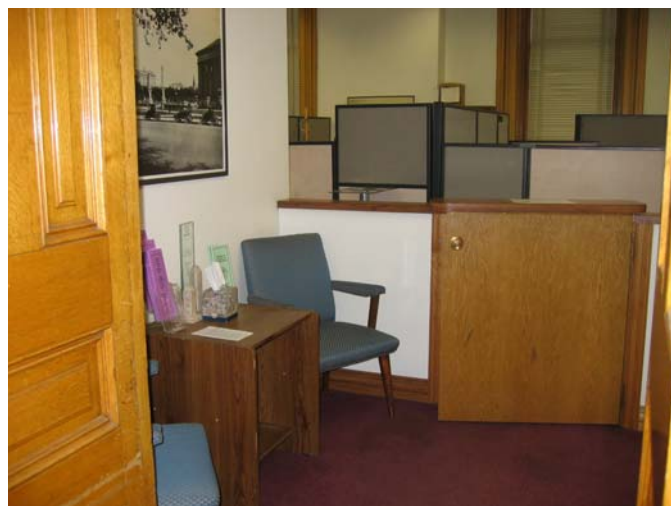
127A Dutchman door at entry

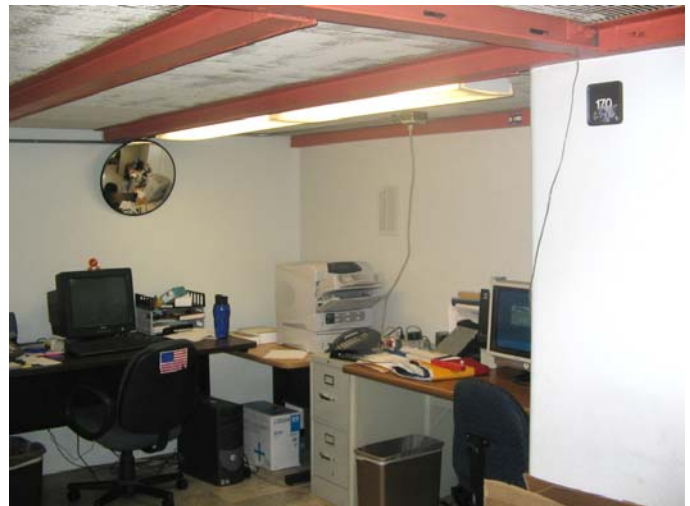
128A Looking north

#### *Functional Condition: Fair*

Finishes in fair condition; walls show signs of patching and normal wear.

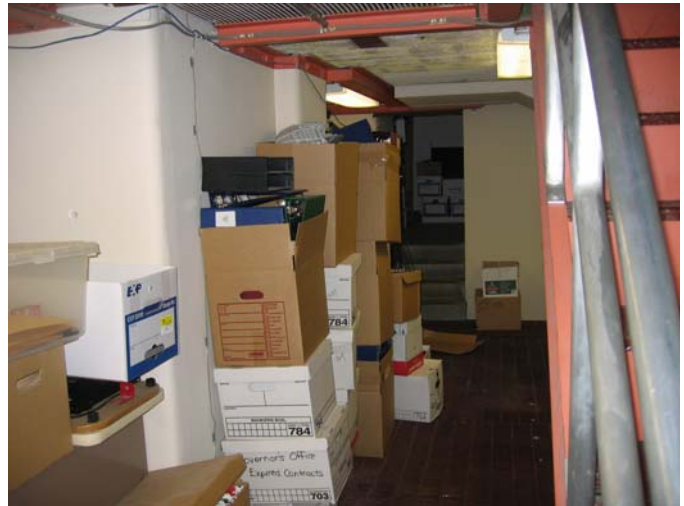
128B View north from Room 128

#### **Functional Condition: Fair**

Finishes in fair condition

No preservation work required

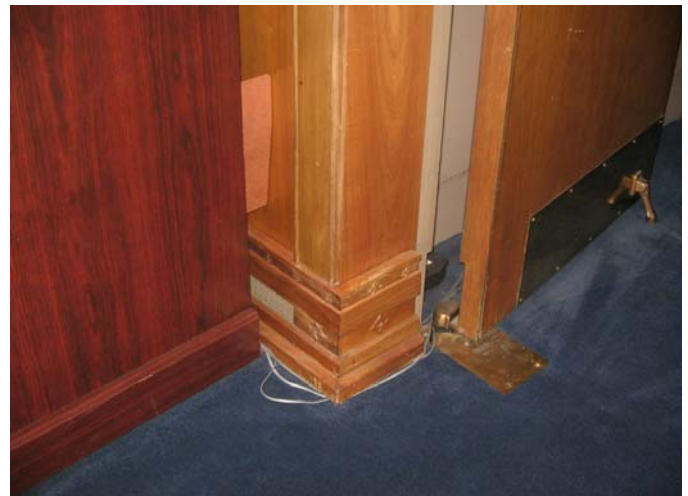
136B Wood base transition detail

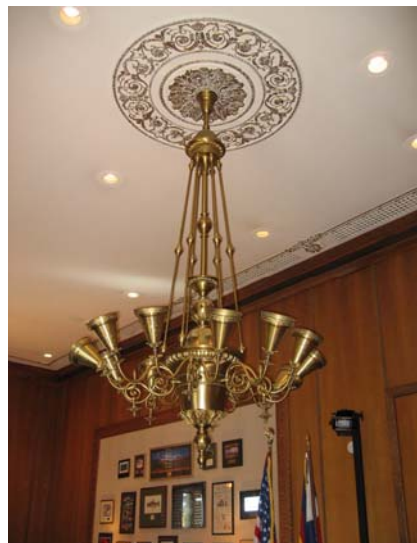
136C Modified original chandelier with gold painted plaster medallion

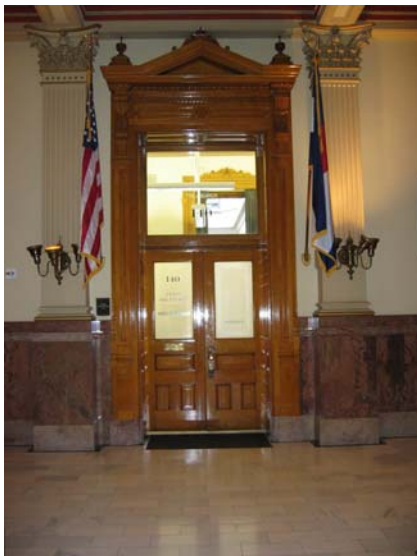
Door from Arcade: original double doors type D1; non-original clear transom glazing; original etched door glass with Greek key border; columbine plates room side, scroll plate on Arcade side; large cast knobs; one knob missing from room side; trim type T1 on room side; trim type T5 on Arcade side

140 Entry door on Arcade side

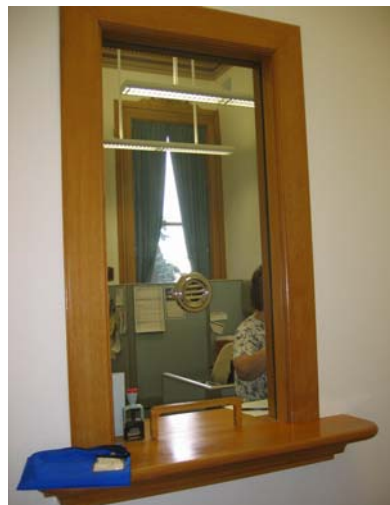
141A Non-original transaction window

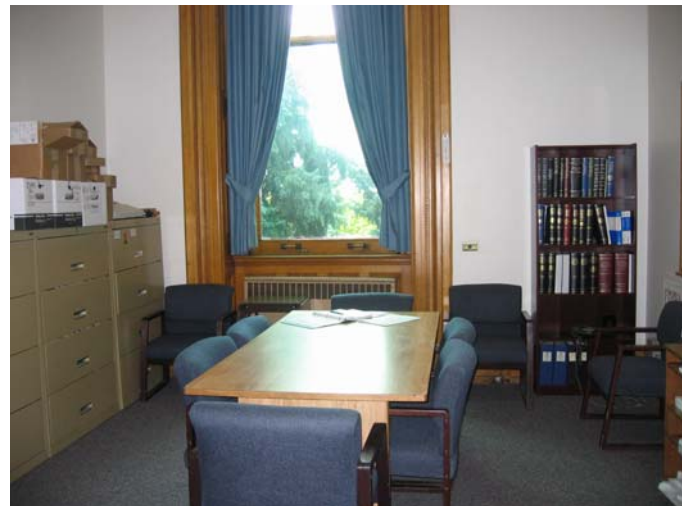
145 West wall

Finishes in good condition; walls show signs of normal wear

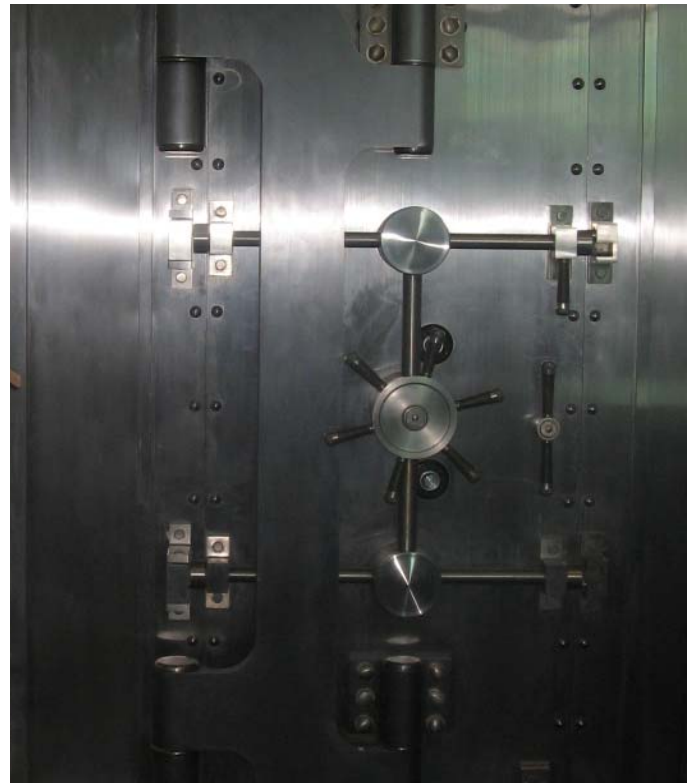
Non-original stainless steel vault door

145A Stainless steel door.

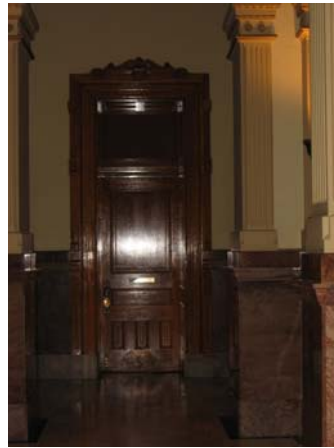
Door from future Southwest Stair: modified original door on corridor side; original D1 door has been faced with a wood panel; original trim replaced with non-original flat profile wood trim, transom covered with gypsum board; Arcade side is original door type D1; door and transom glass replaced with a wood panel; trim type T1

153A Entry door from Arcade side

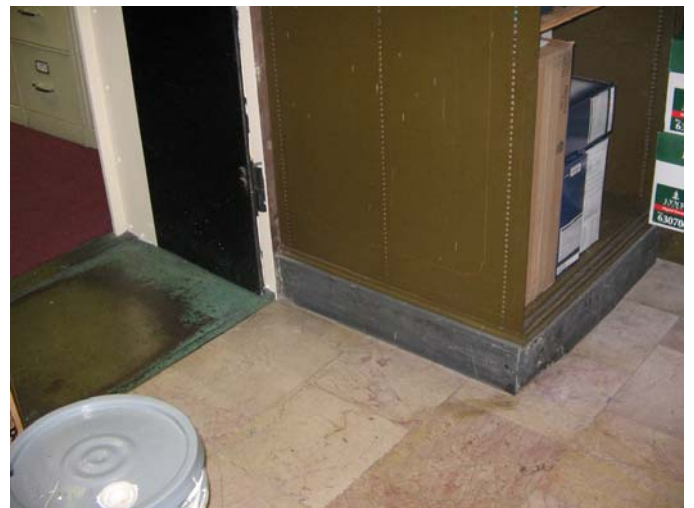
154 Rose Onyx flooring and vault threshold

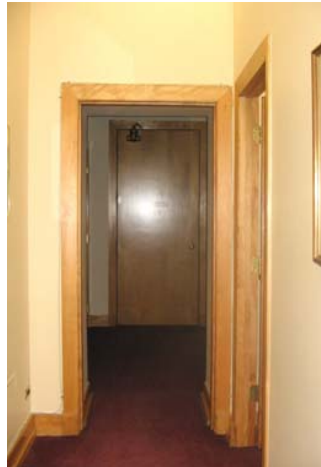
Relocated, altered original door type D1; door glass replaced with wood panel; non-original wood panel in original transom; flat wood panel covering door on room side; non-original wood frame with flat profile; drywall over transom on room side; non-original room-side hardware; original scroll plate arcade side; large cast knob arcade side; trim type T5 on Arcade side

161 Door to Arcade looking east through door of Room 162

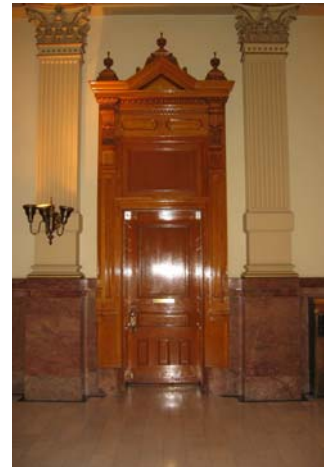
Door to 161 on Arcade side

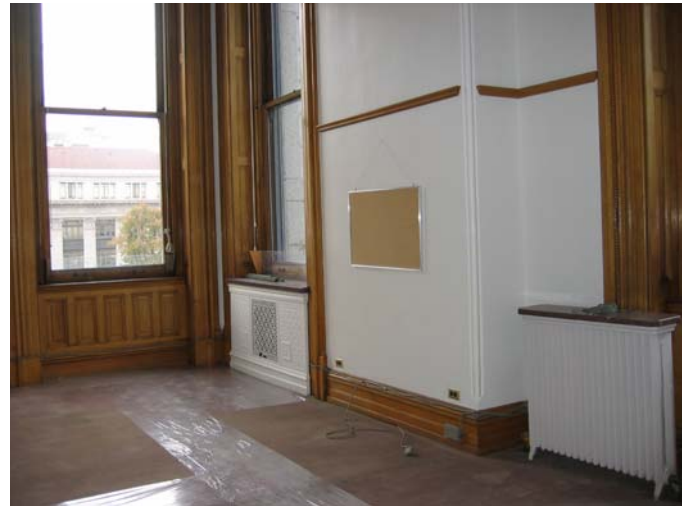
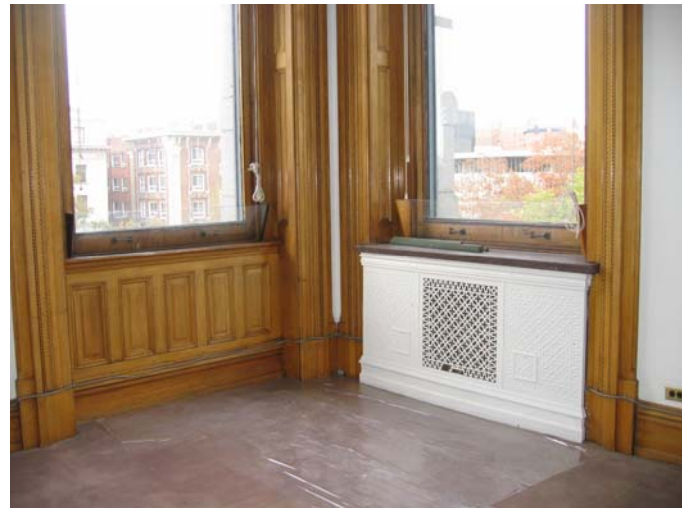
Finishes are in good condition and consistent with current use; walls show signs of patching and normal wear

200 East wall

200 Northeast corner

No preservation work required

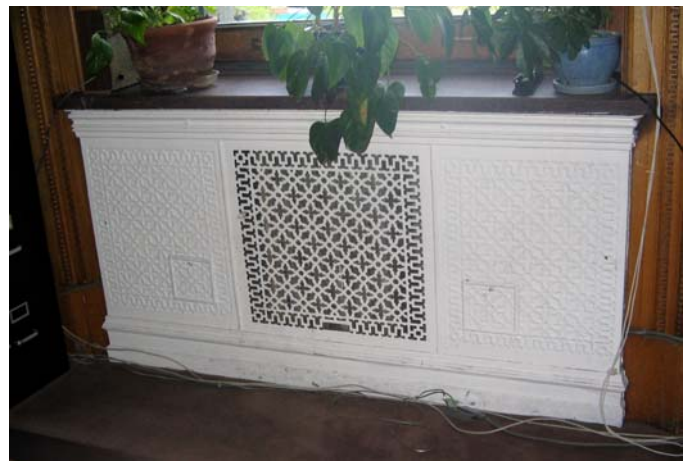
Finishes are in good condition and consistent with current use; walls show signs of patching and normal wear

201 Corner window and crown molding detail

201 Original radiator housing with Cedar marble top

201 Northwest corner looking at Room 204 and door to corridor

No preservation work required

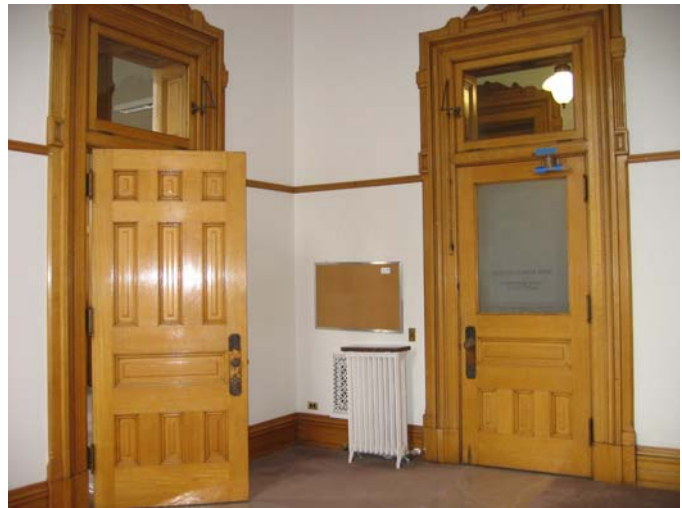
Finishes are in good condition and consistent with current use

202 Door to corridor

202 Southeast corner

No preservation work required

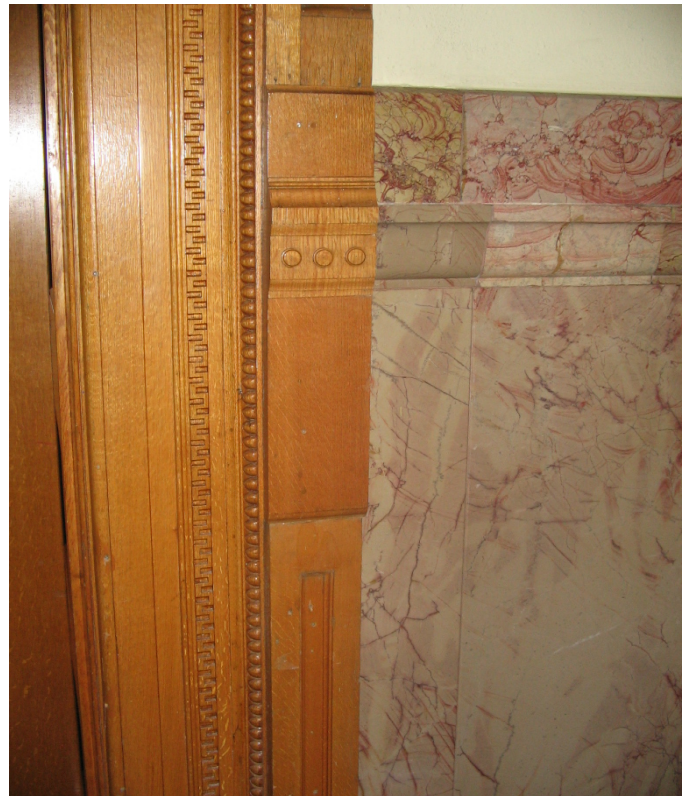
203 Original Rose Onyx marble wainscot and chair rail at door frame

Finishes are in good condition, except as noted; consistent with current use; walls show signs of normal wear

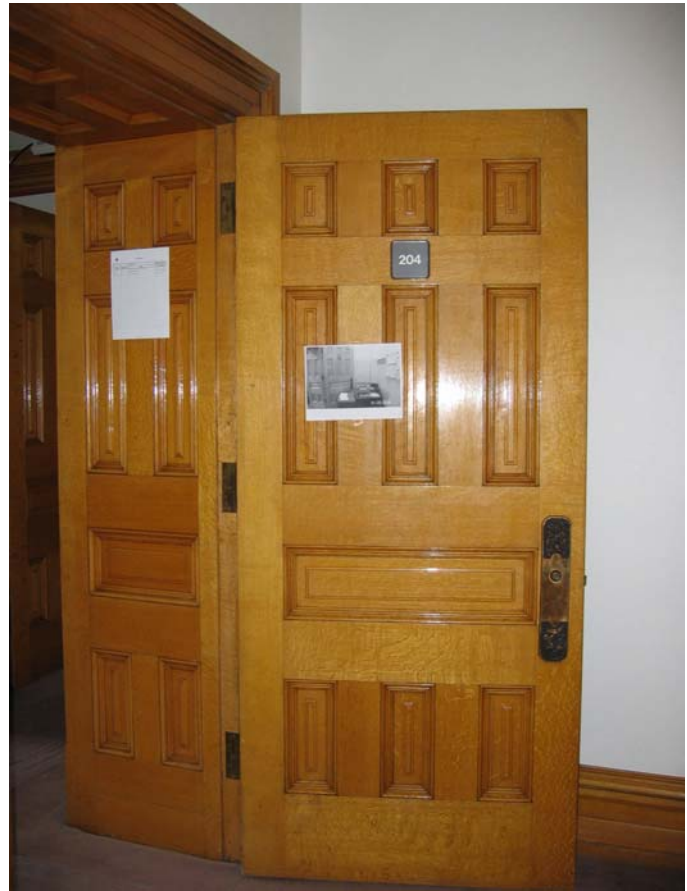
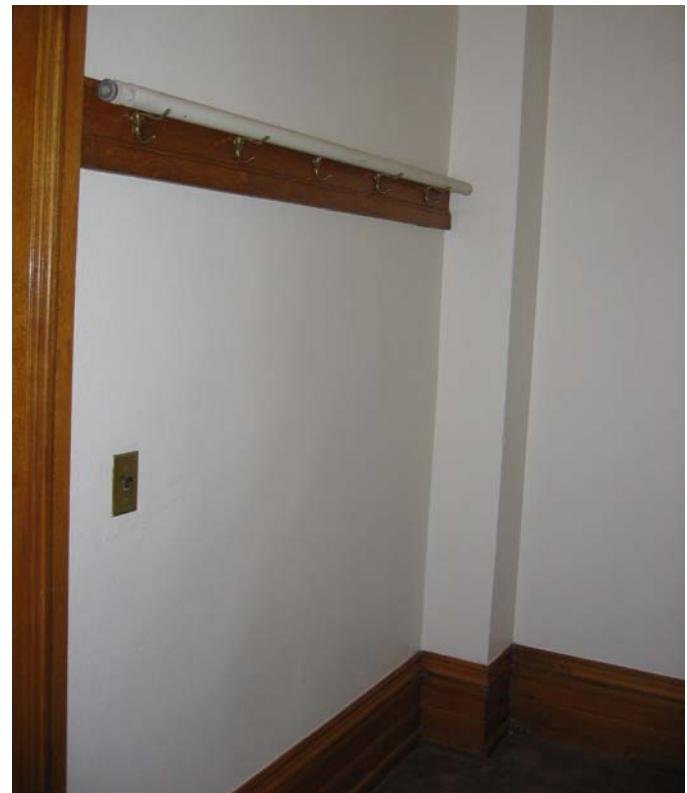
204 Door off of Room 201

204 Coat hooks on east wall

Finishes are in good condition and consistent with current use

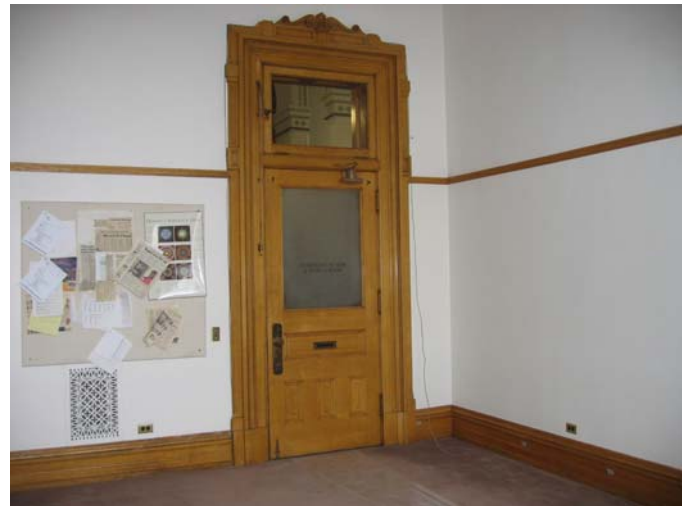
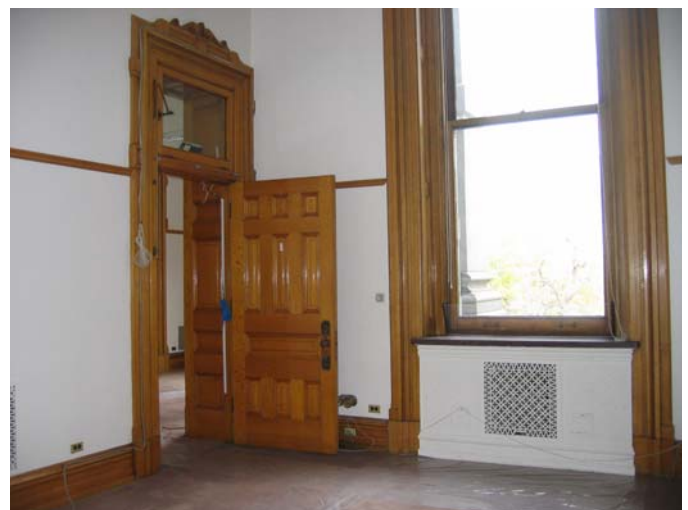
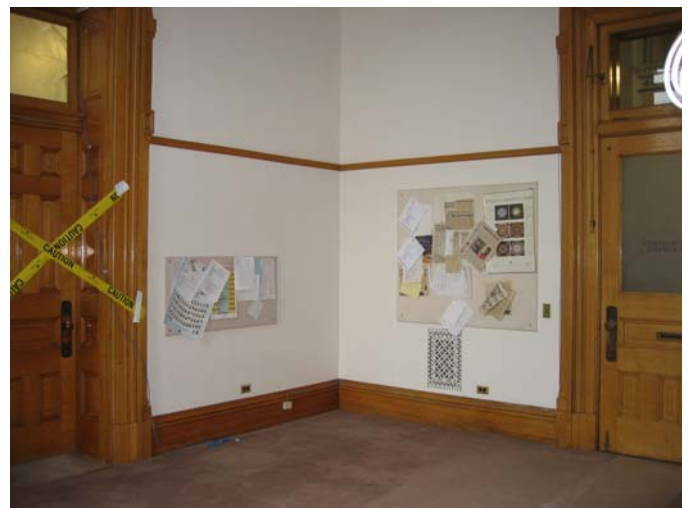
Finishes are in good condition and consistent with current use; walls show signs of patching and normal wear

205 West wall

205 Looking northeast

205 Southwest corner

No preservation work required

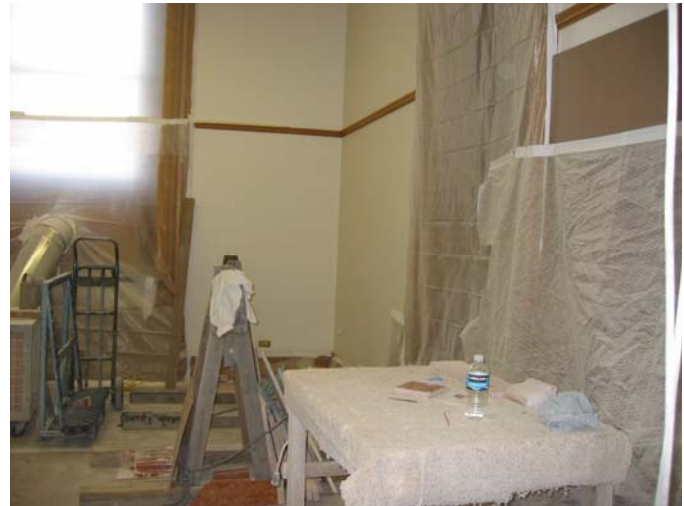
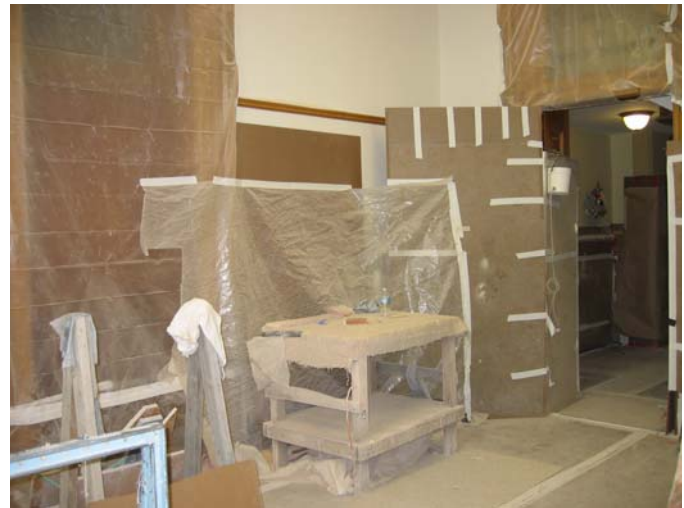
206 Southeast corner

206 Southwest corner

Finishes are in good condition and consistent with current use; walls show signs of patching and normal wear

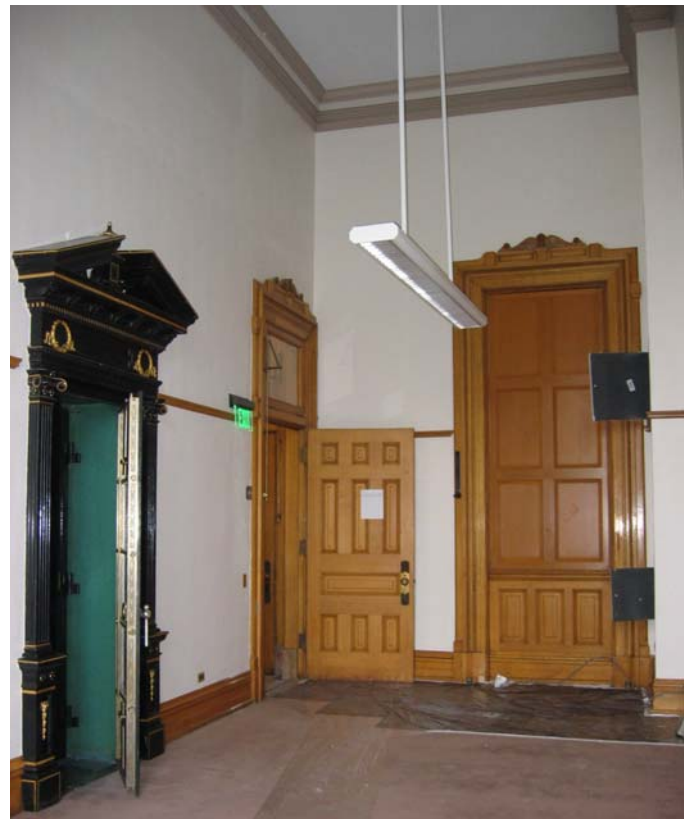
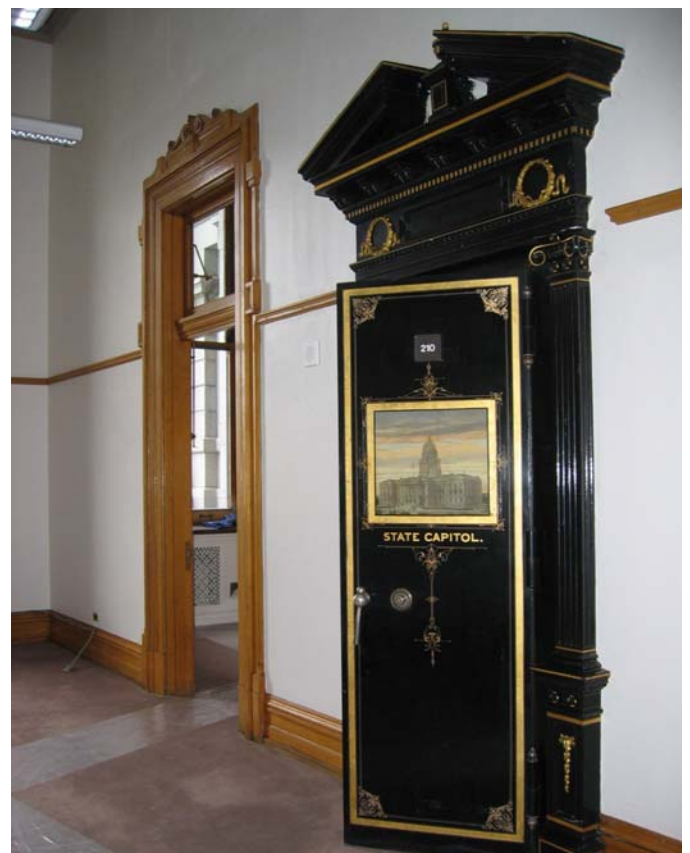
Finishes are in good condition and consistent with current use; walls show signs of patching and normal wear

207 West view

207 Northeast corner with original vault door

No preservation work required
