# COLORADO STATE CAPITOL

## HISTORIC STRUCTURE ASSESSMENT

STATE HISTORICAL FUND PROJECT NUMBER  
SHF-2006-T1-001

**December 15, 2006**

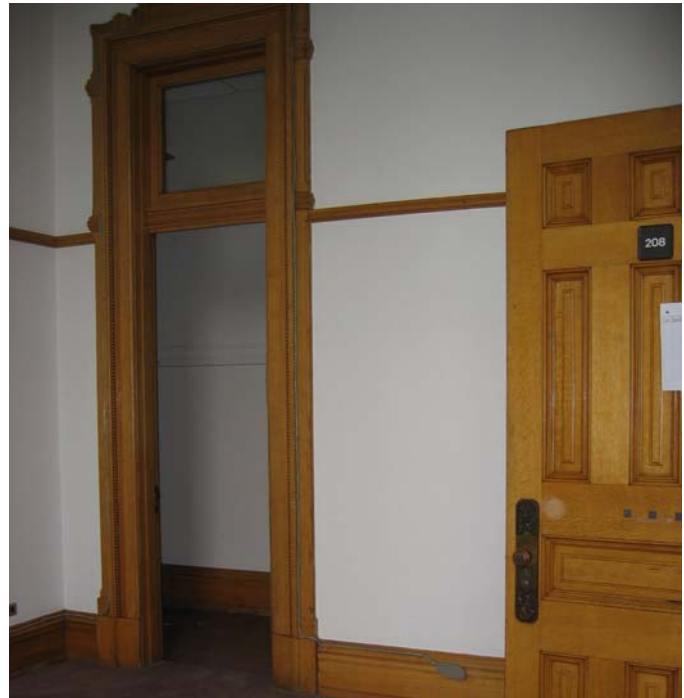
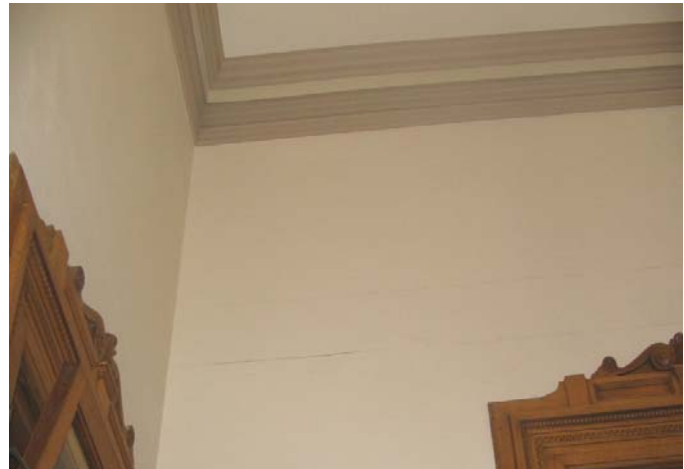
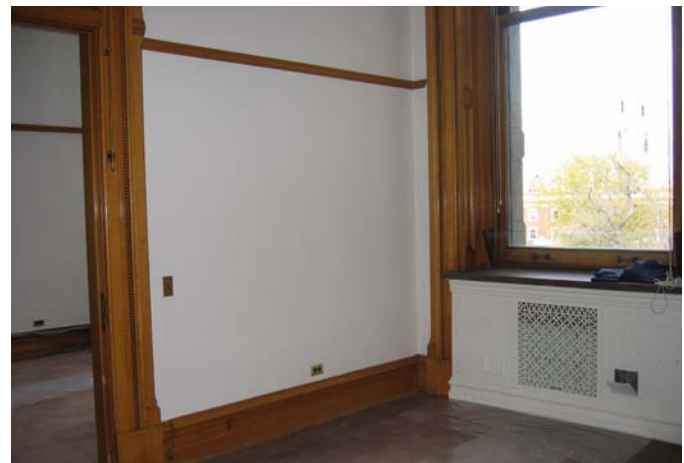
Finishes are in good condition, except as noted, and consistent with current use; walls show signs of patching and normal wear

208 View into Room 209

208 Cornice detail

208 Northeast corner

No preservation work required

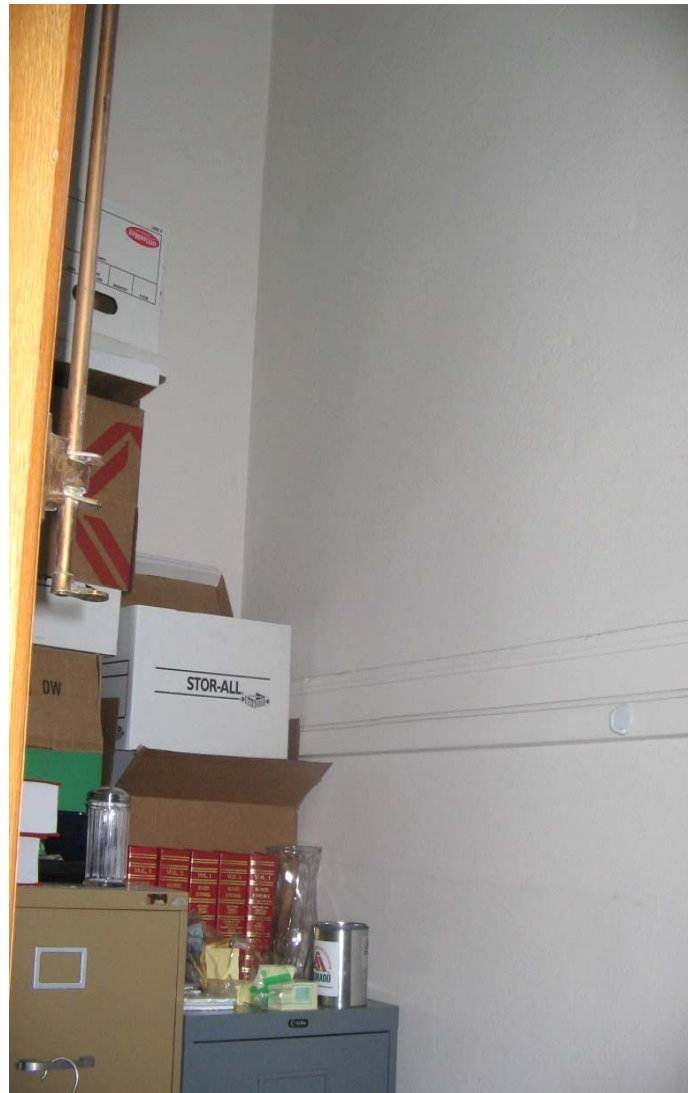
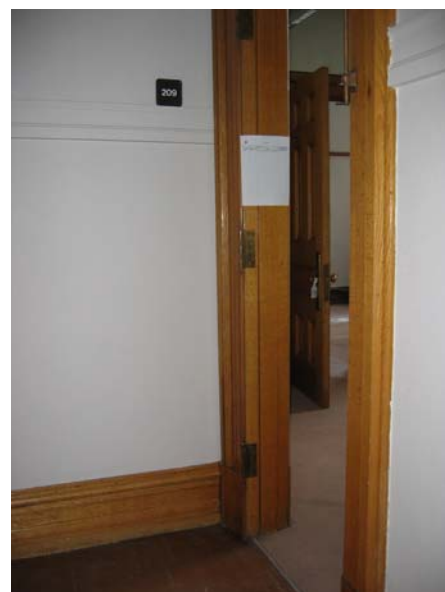
Finishes are in good condition and consistent with current use; walls show signs of normal wear.

209 Storage space

209 View into Room 208

No preservation work required

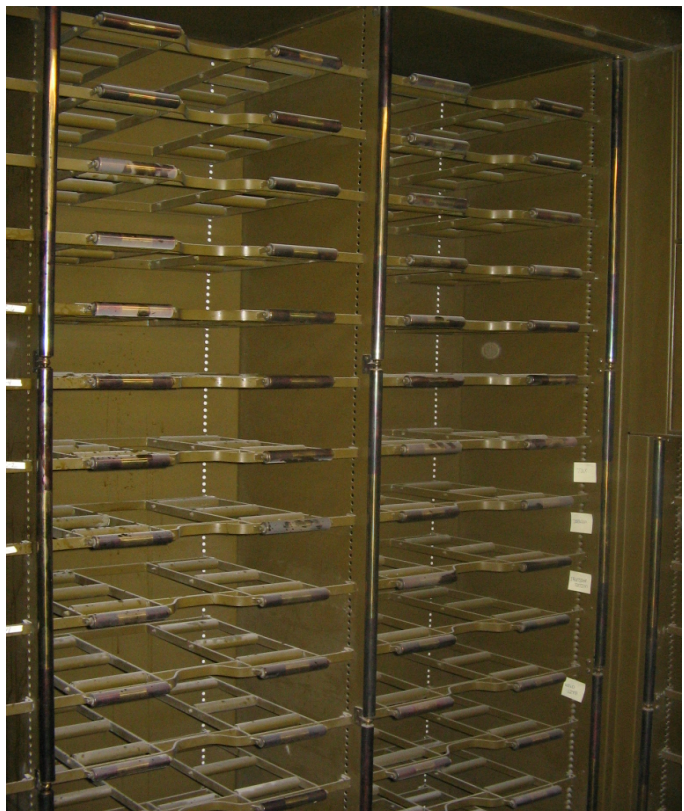
Finishes are in good condition

210 View of original vault door

210 Metal filing system

No preservation work required

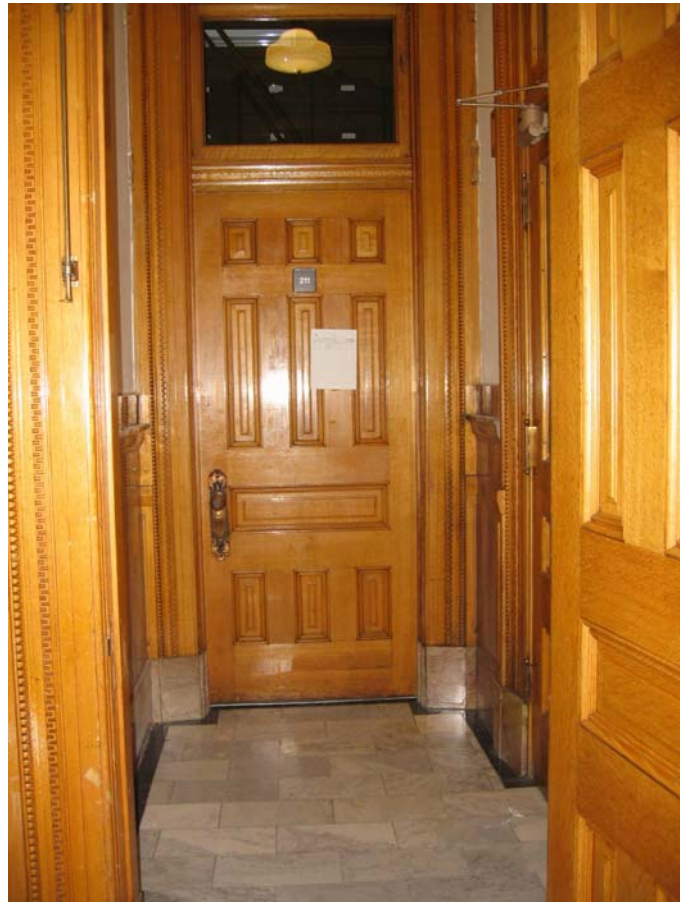
Finishes are in good condition, except as noted, and consistent with current use; walls show signs of patching and normal wear

212 View looking south

212 Lighting and trim detail

No preservation work required

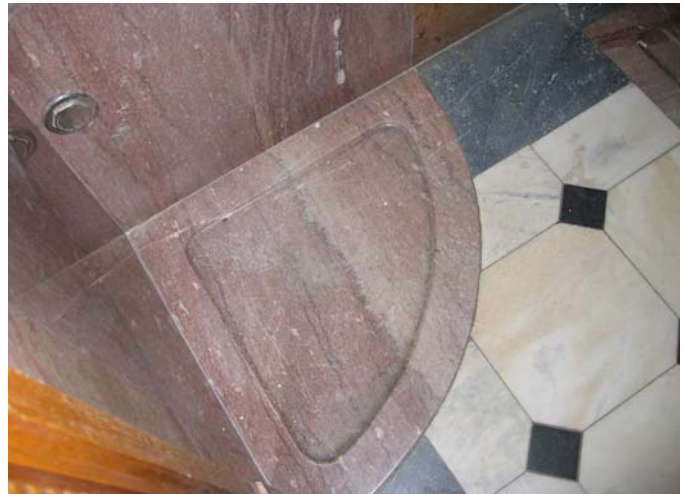
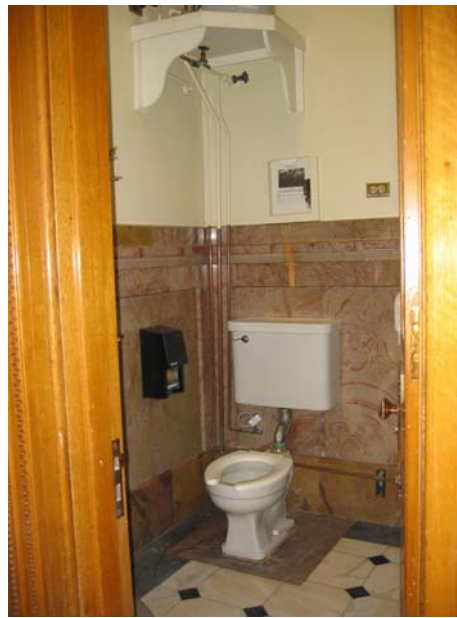
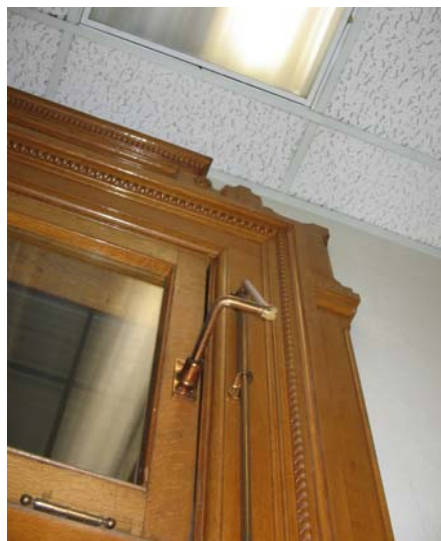
Painted plaster with sand-textured finish; 66" Rose Onyx wainscot, chair rail and recessed panels; step up Cedar marble wainscot in northwest corner; broken panel behind door (south wall); exposed plumbing pipes

Finishes are in good condition; walls show signs of patching and normal wear

215 Original Rose Onyx marble drain basin detail

215 East wall

215 Ceiling and door trim detail

No preservation work required

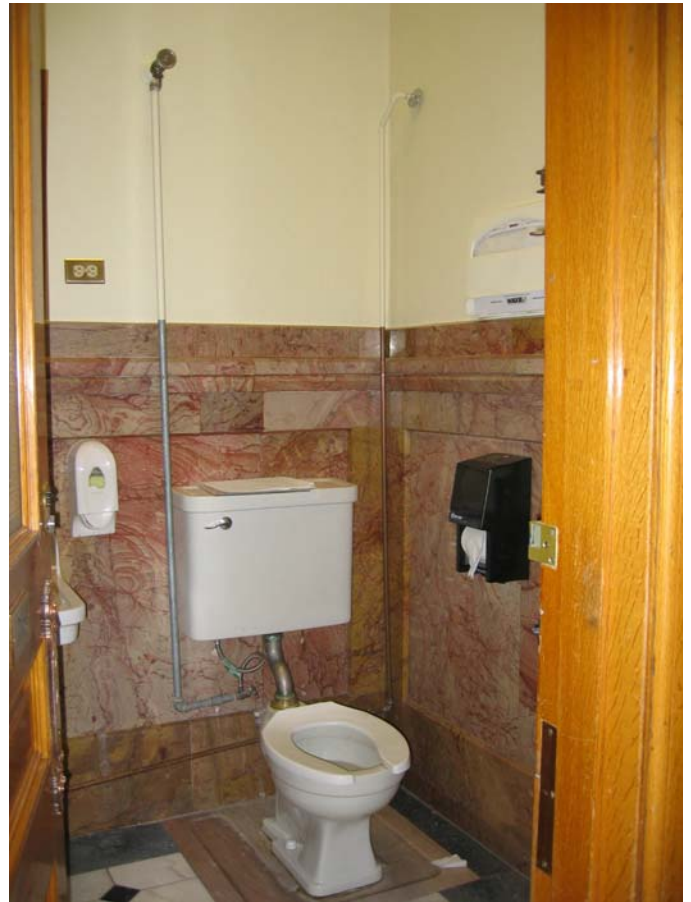
Finishes are in good condition

216 East wall

No preservation work required

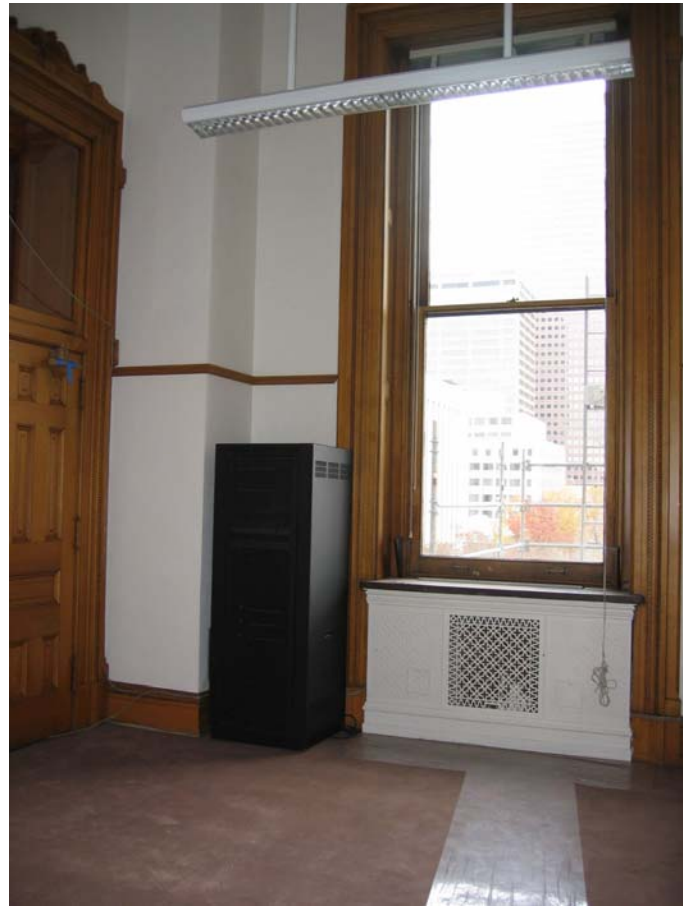
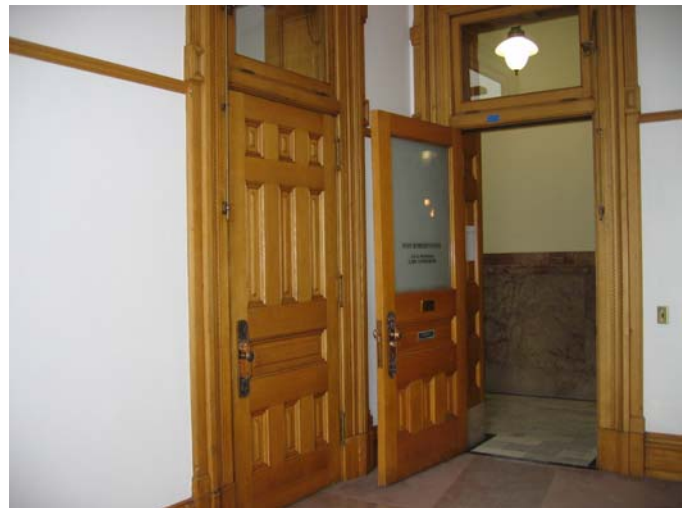
Finishes are in good condition and consistent with current use; walls show signs of patching and normal wear

217 North wall

217 Southeast corner

No preservation work required

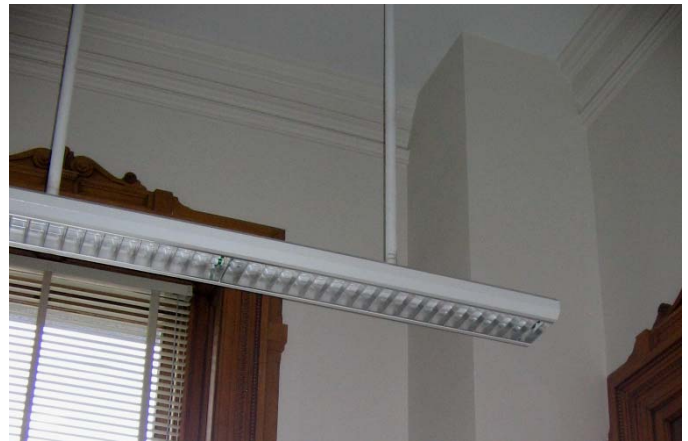
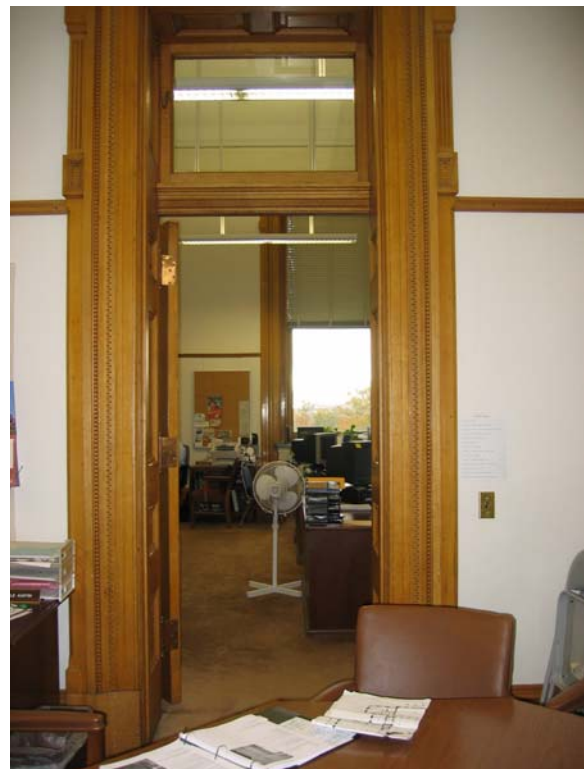
Finishes are in good condition and consistent with current use; walls show signs of normal wear.

221 Corner chase

221 original cast iron radiator front at north window

221 west door to 222

No preservation work required

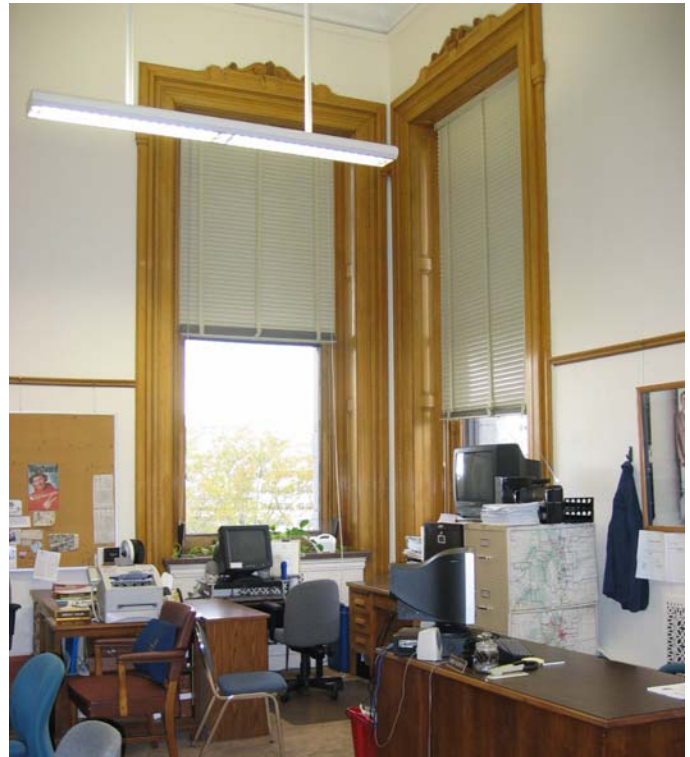
222 northwest corner

Finishes are in good condition and consistent with current use. The walls show signs of normal wear.

No preservation work required

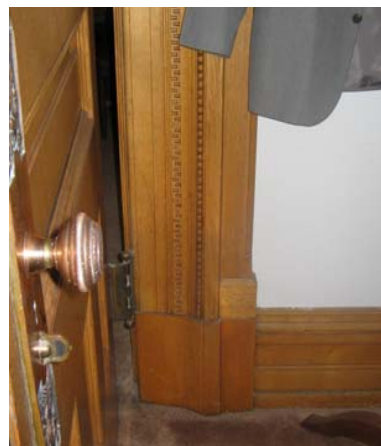
222 Wood trim and plinth

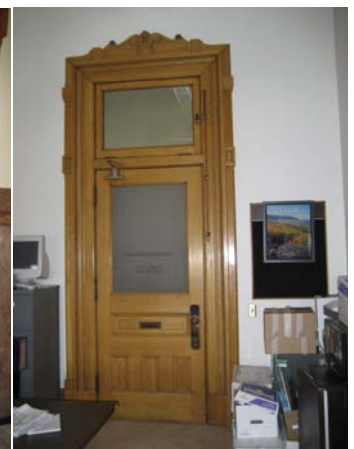
223 Entry into Arcade

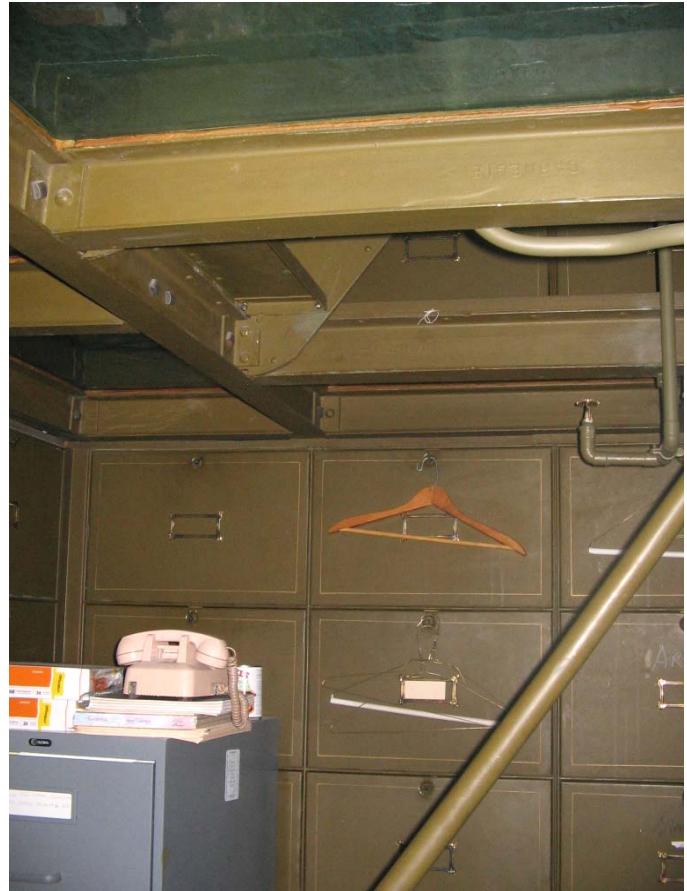
224 Original vault storage with glass flooring above

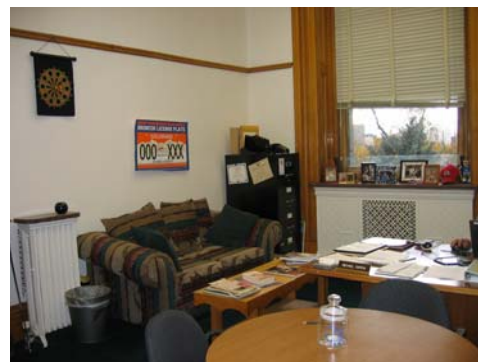
227 Southwest corner

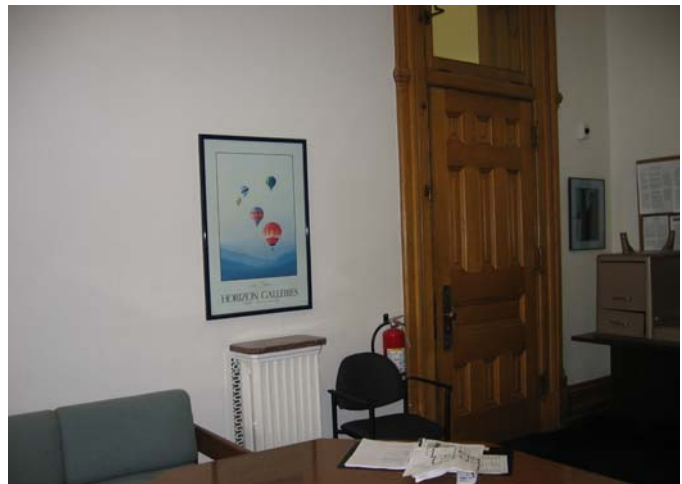
229 North wall

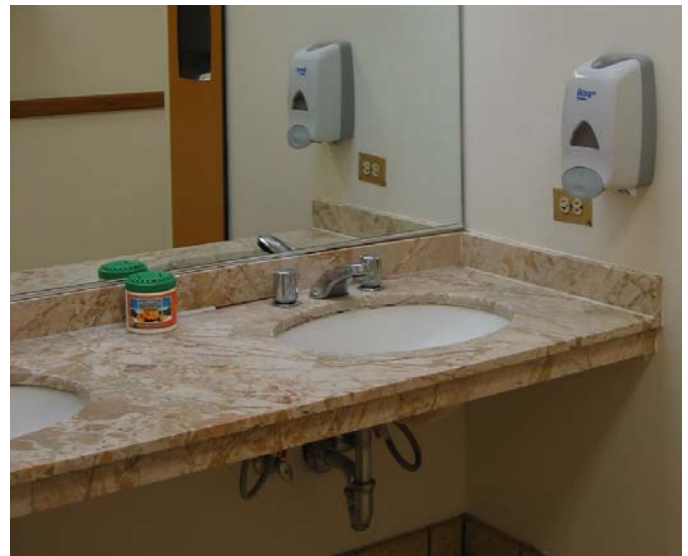
230 sink area

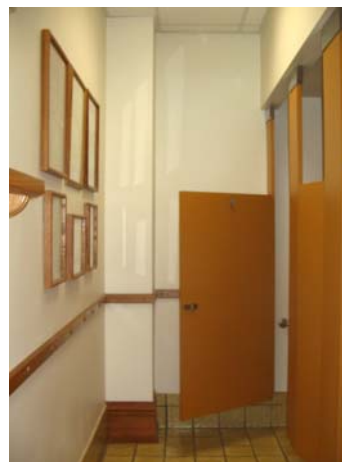
230 View looking south

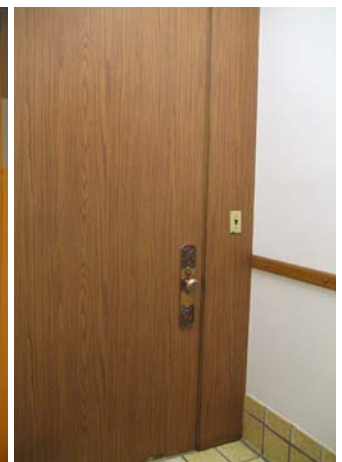
230 Door to Hallway 231

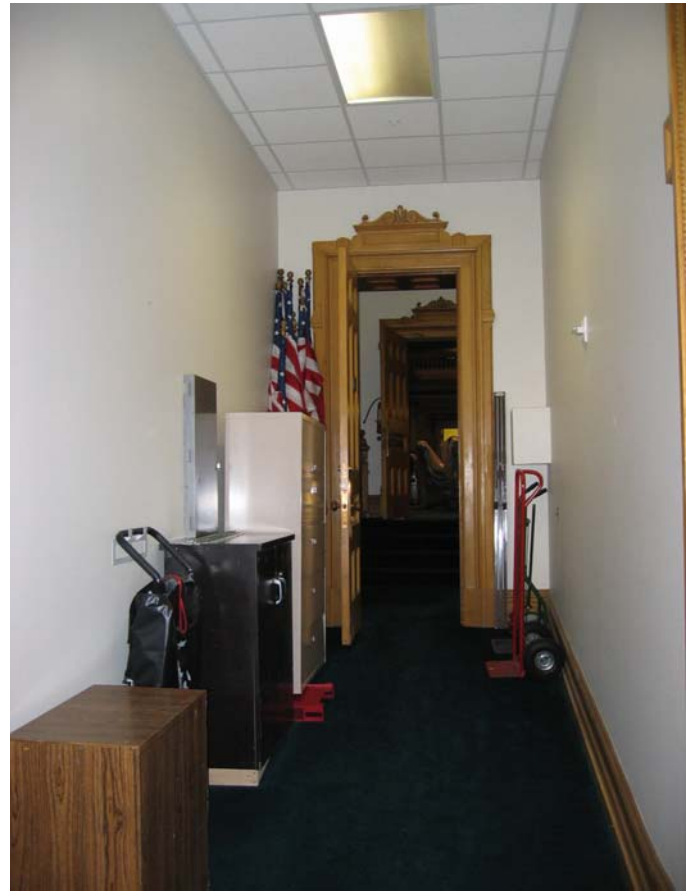
231 View south towards House Chamber

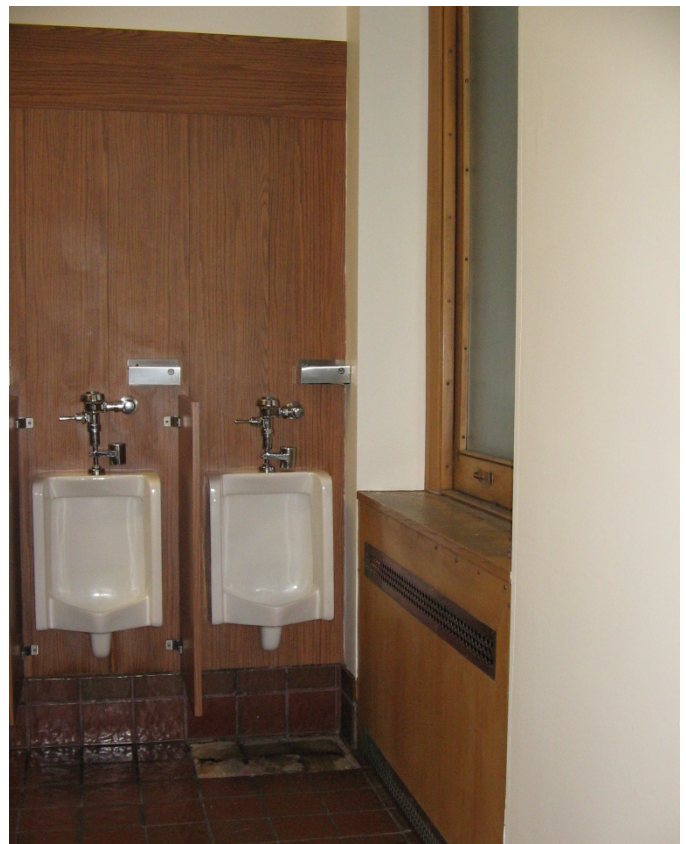
232 Plastic laminate wainscot on south wall

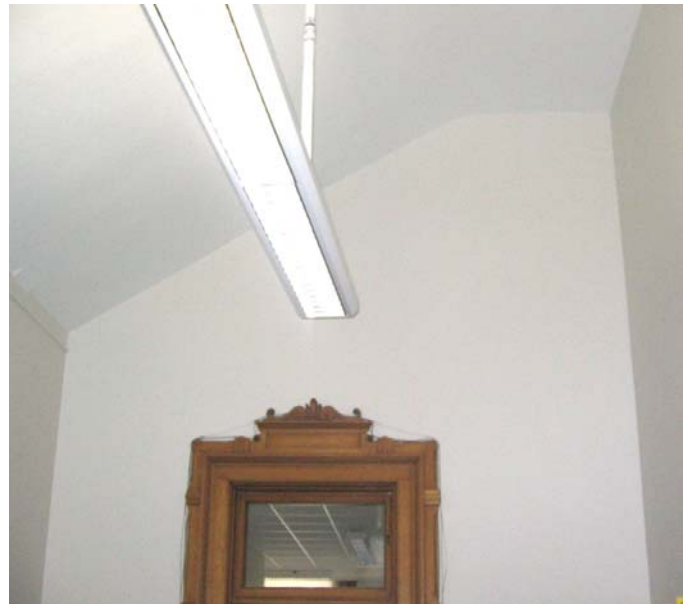
234 Sloped ceiling for Gallery seating above

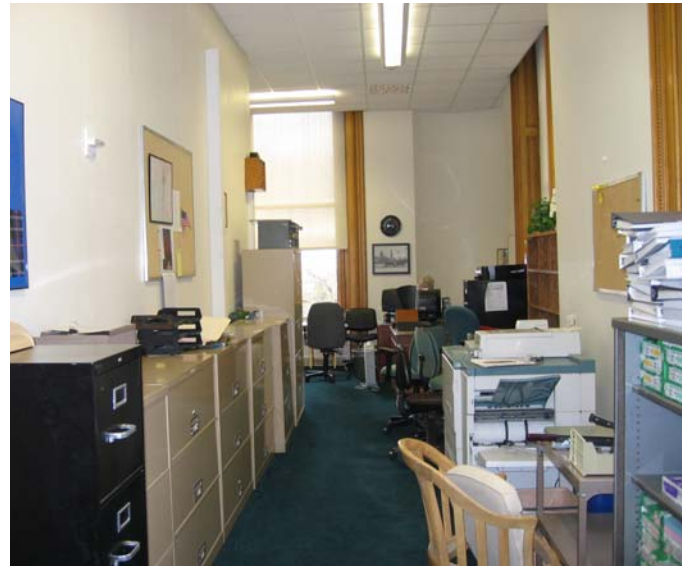
235 View looking west

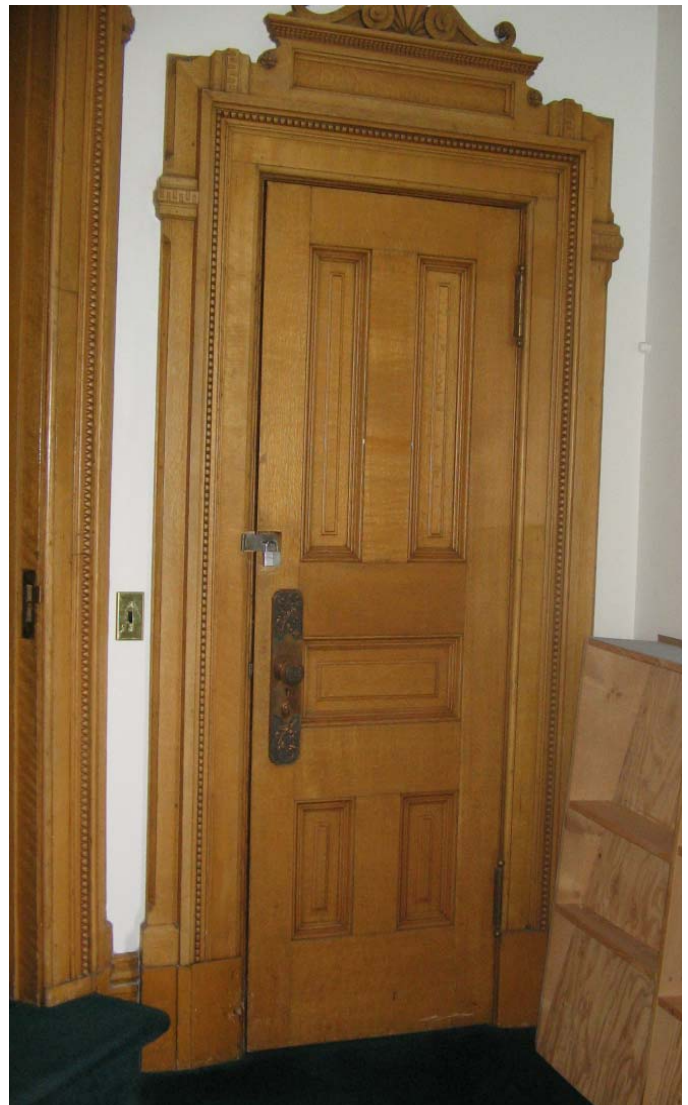
235 Original closet door

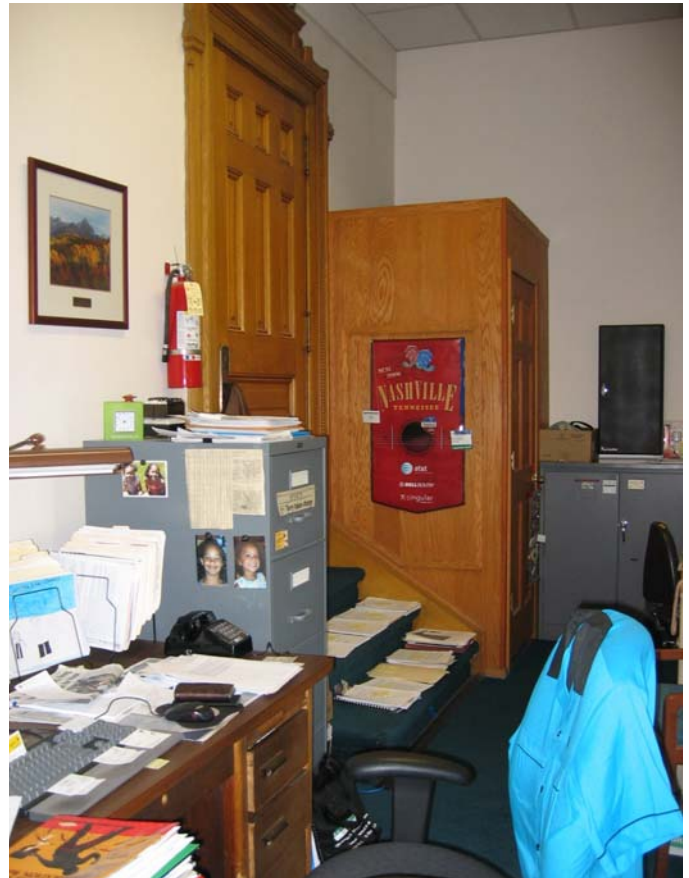
240 Non-original closet in northeast corner

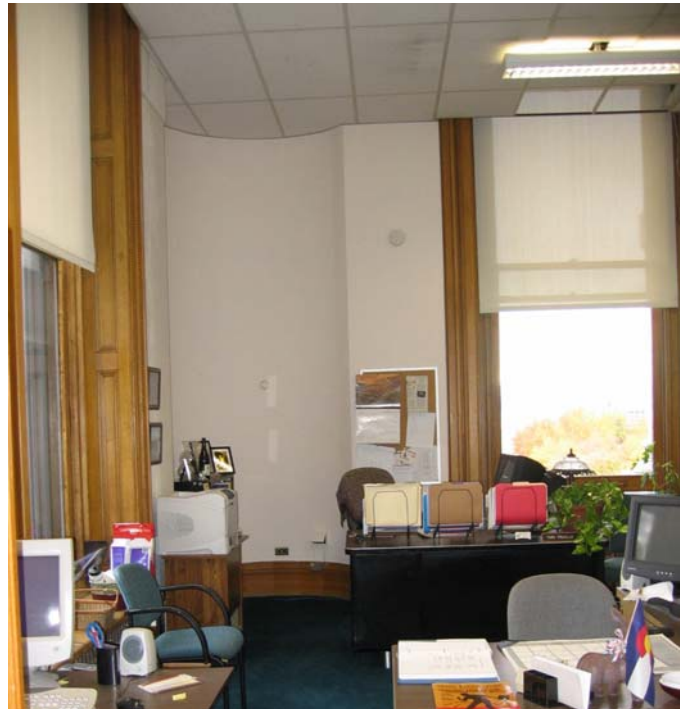
241 View looking west

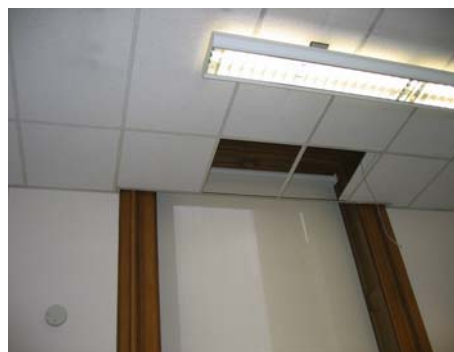
241 Lay-in ceiling covering top trim of west window

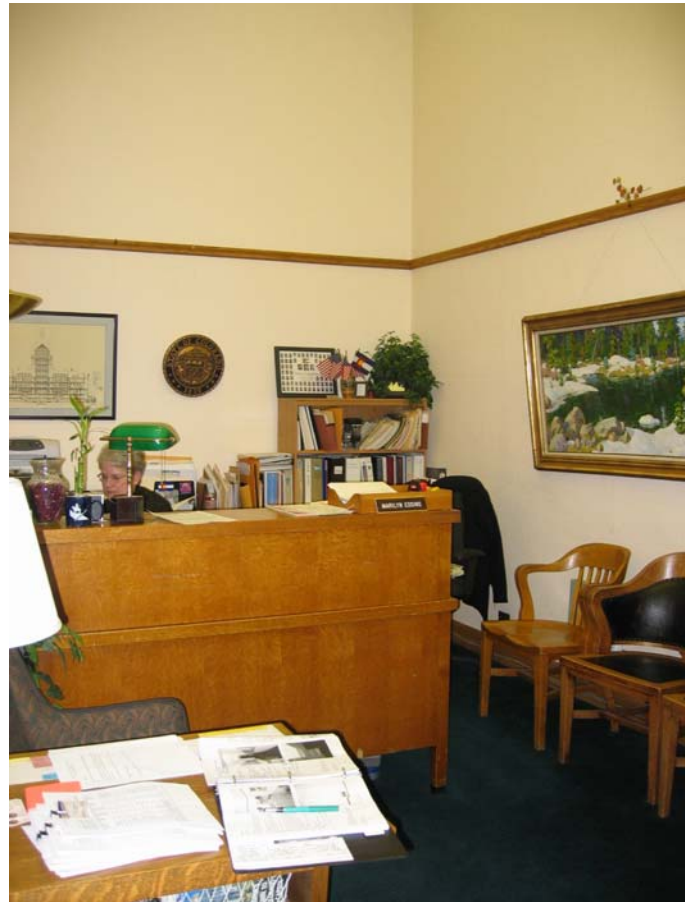
242 Larger picture on east wall is hung in former doorway location

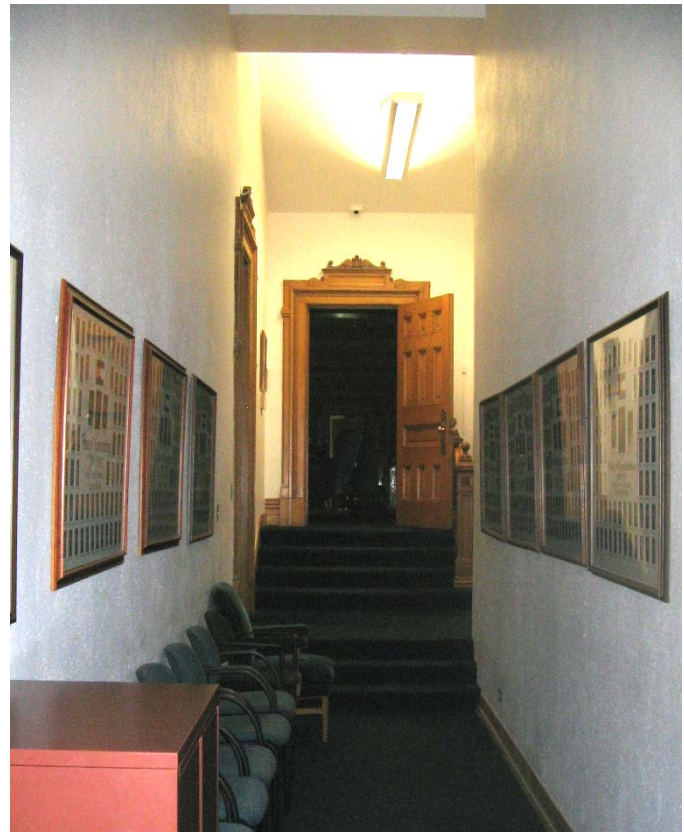
243 Non-original corridor looking north toward the House Chambers

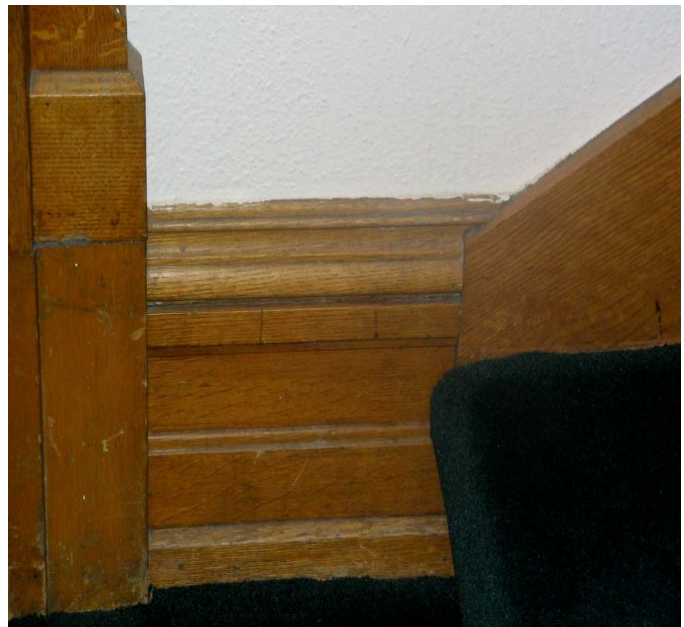
243 Detail where steps have been modified

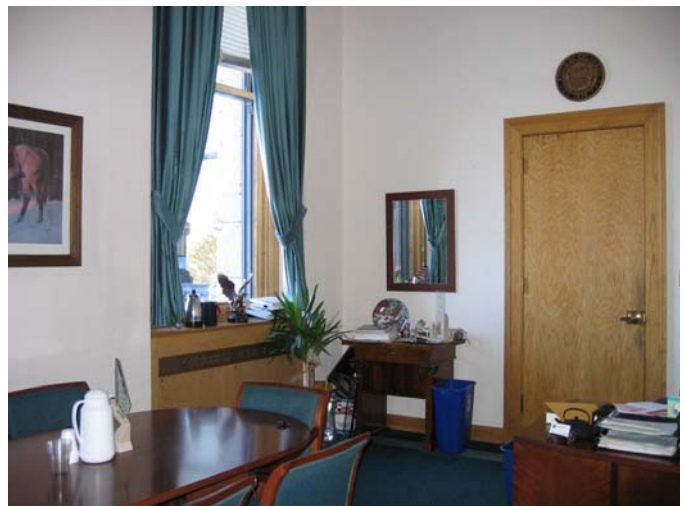
244 Non-original radiator housing and slab door on the north wall

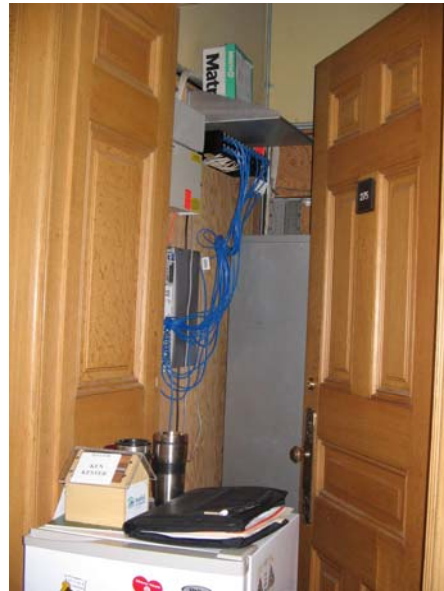
275 View into room

This space is inconsistent with current use, in fair condition; improper clearances and construction for an electrical room

Relocate electrical equipment out of room

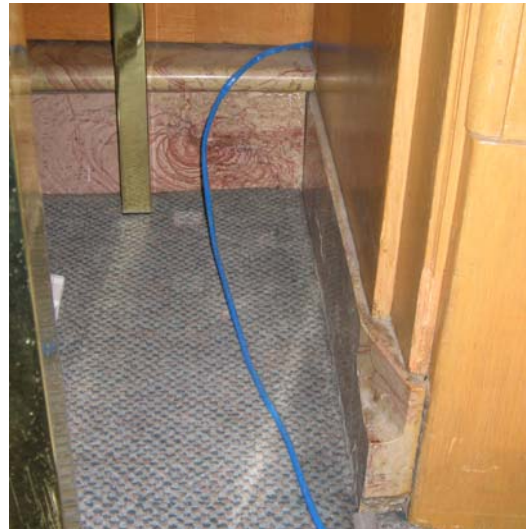
Stone tile from former restroom,; raised floor; in fair condition; most of it is covered with equipment

275 Rose Onyx marble step up to elevated floor

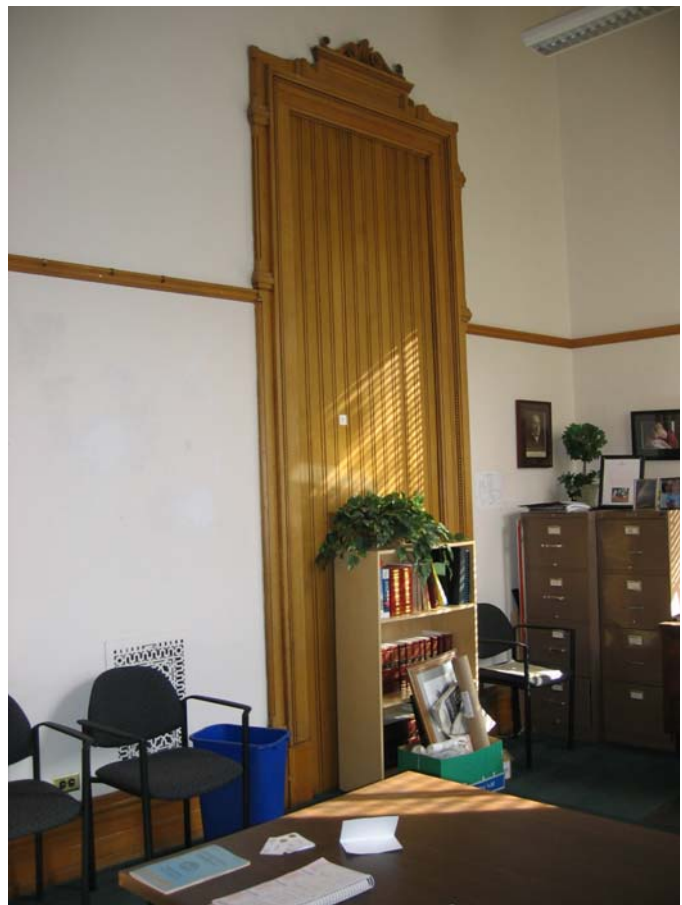
301 In-filled door to 300

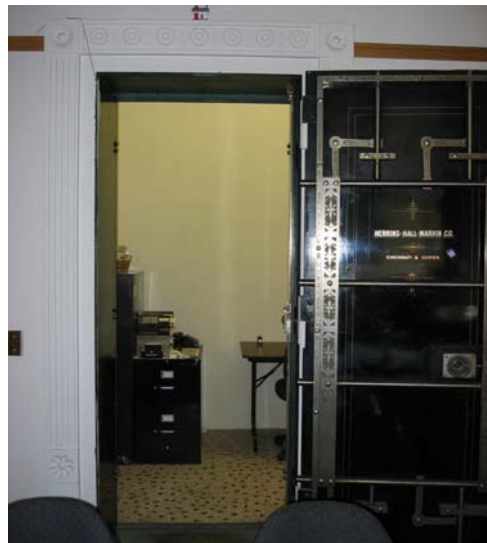
304 Vault door

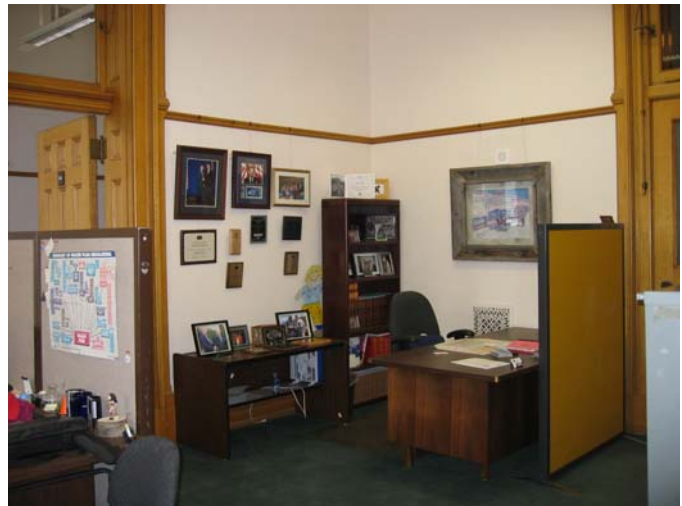
The space is in good condition, except as noted, and consistent with current use walls show signs of patching and normal wear

305 Southwest corner

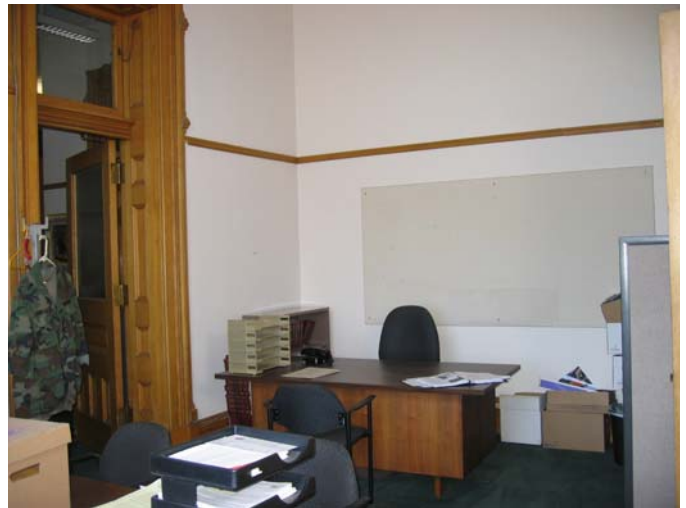
306 View to southwest corner

The space is in good condition, except as noted, and consistent with current use; walls show signs of patching and normal wear

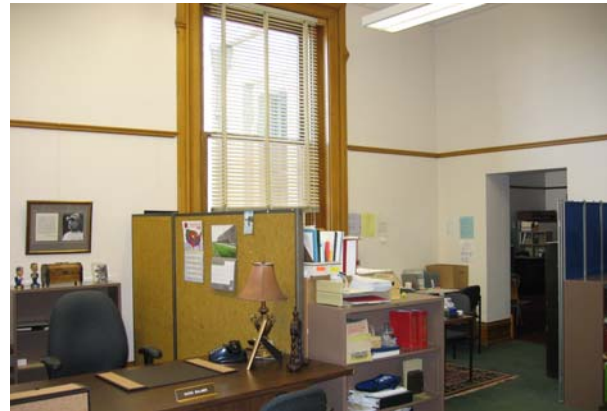
307 Southeast corner

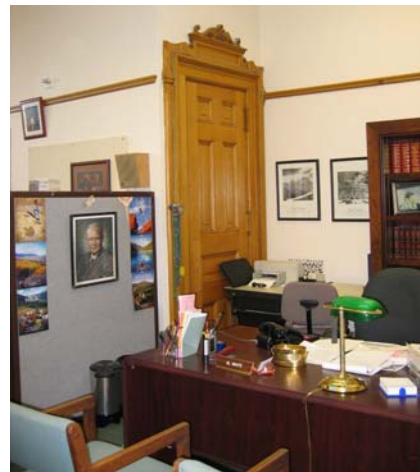
307 Door to closet

The space is in good condition and consistent with current use; walls show signs of patching and normal wear

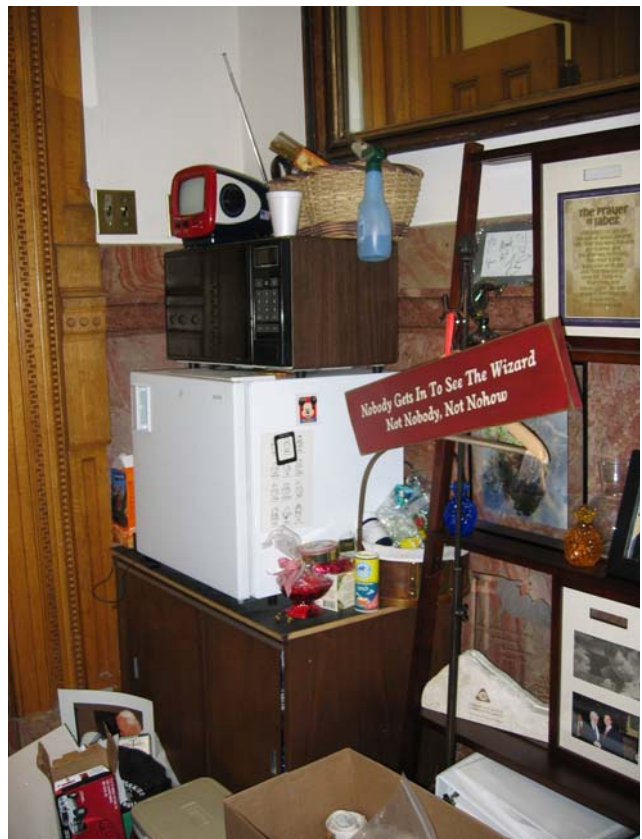
308 Southeast corner

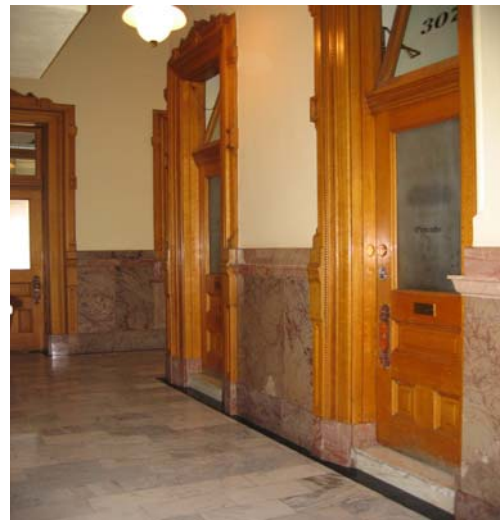
311 View to 311A

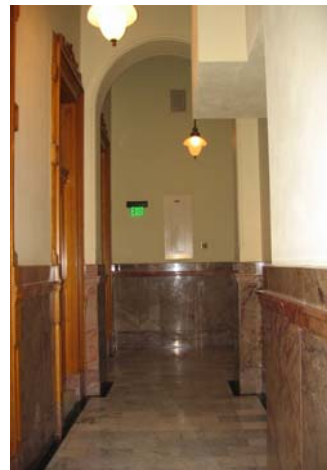
311A View looking south to 311 arched opening north

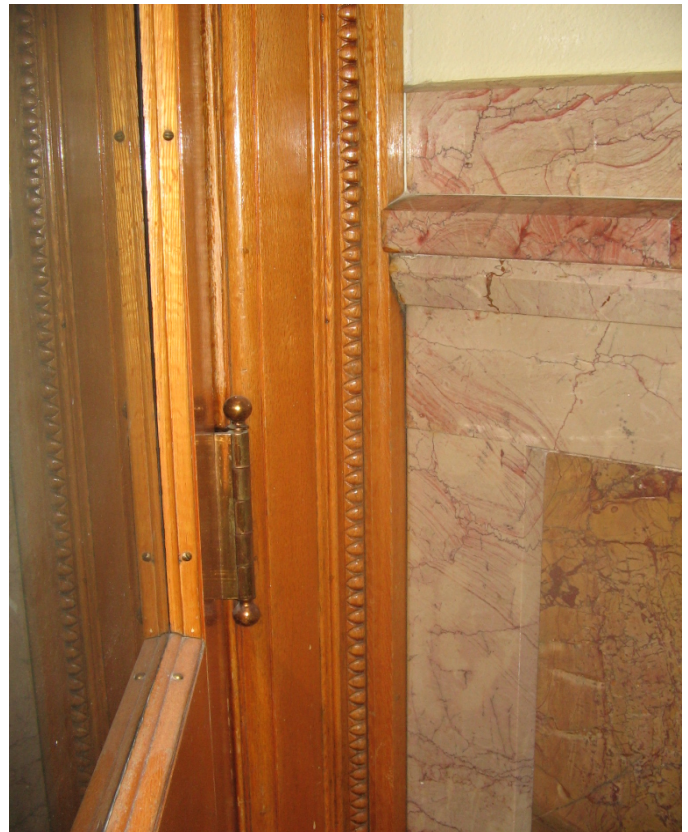
312 Framed wainscot detail

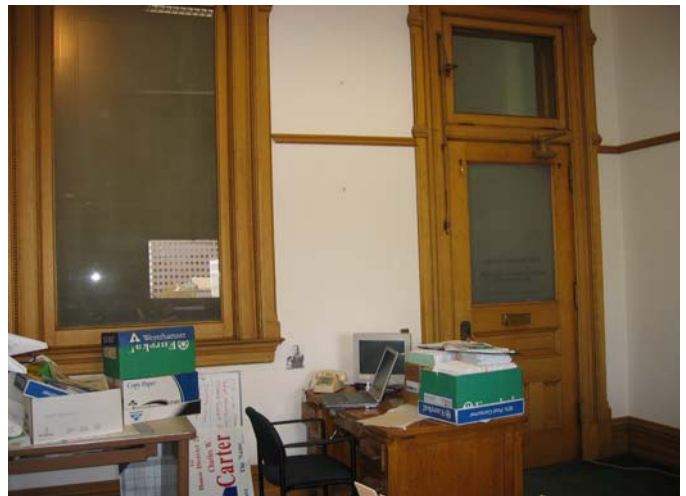
314 South wall

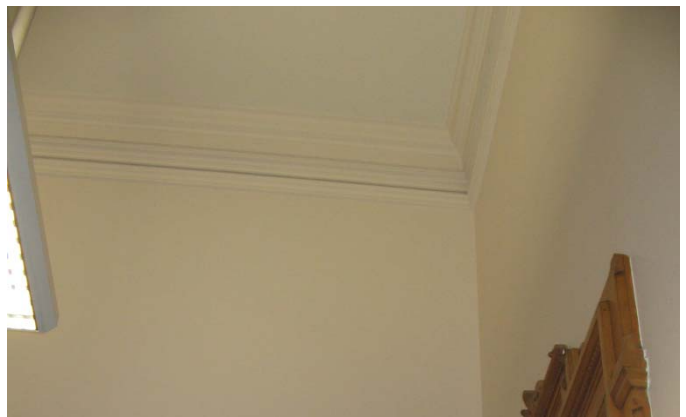
Smooth plaster in fair condition; original plaster cornice

314 Ceiling cornice detail

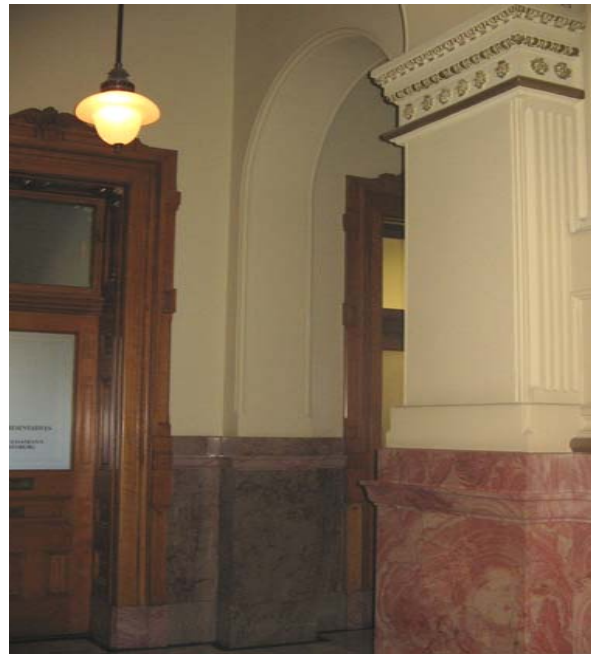
315 Corridor archway looking northwest from Arcade

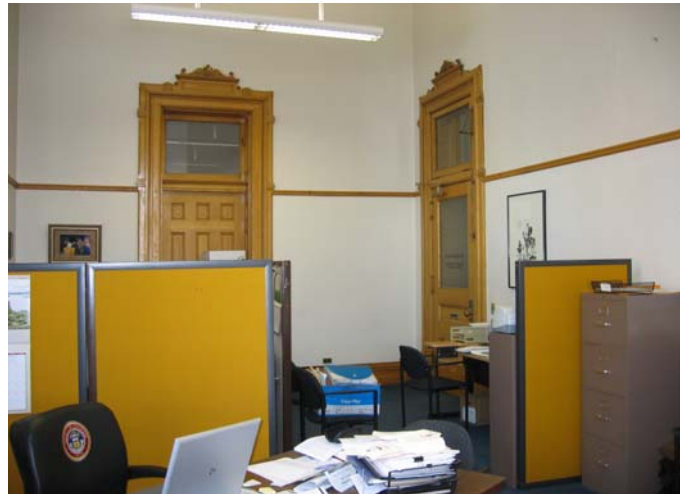
317 View looking southeast

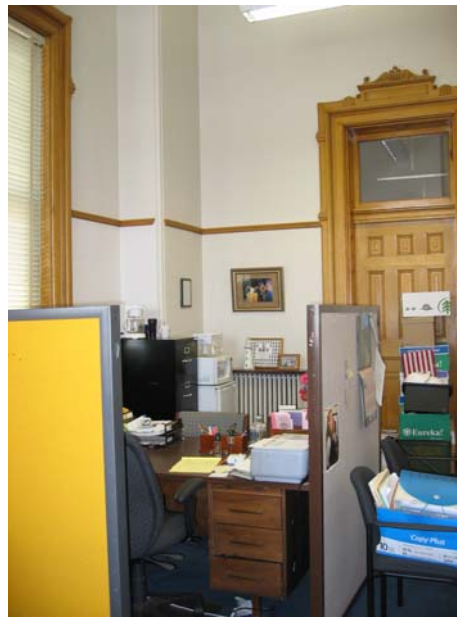
317 View looking northeast

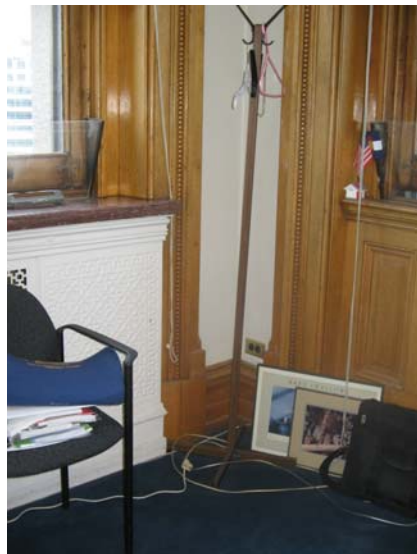
317 Original window details

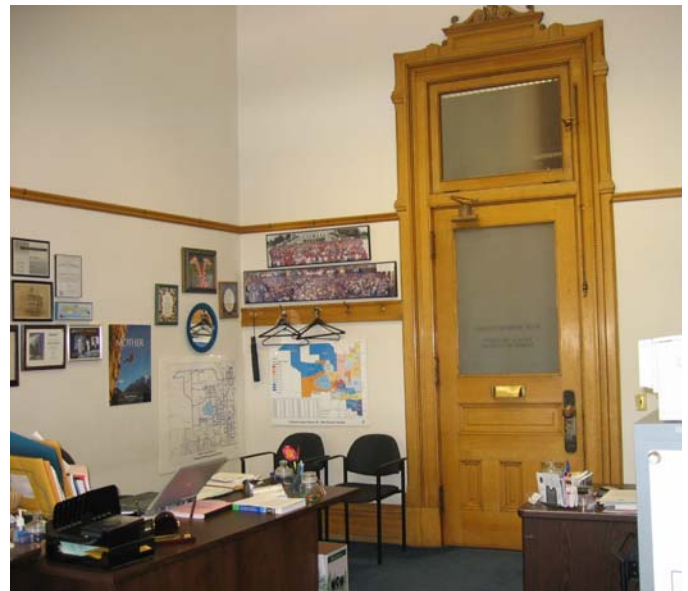
318 East wall

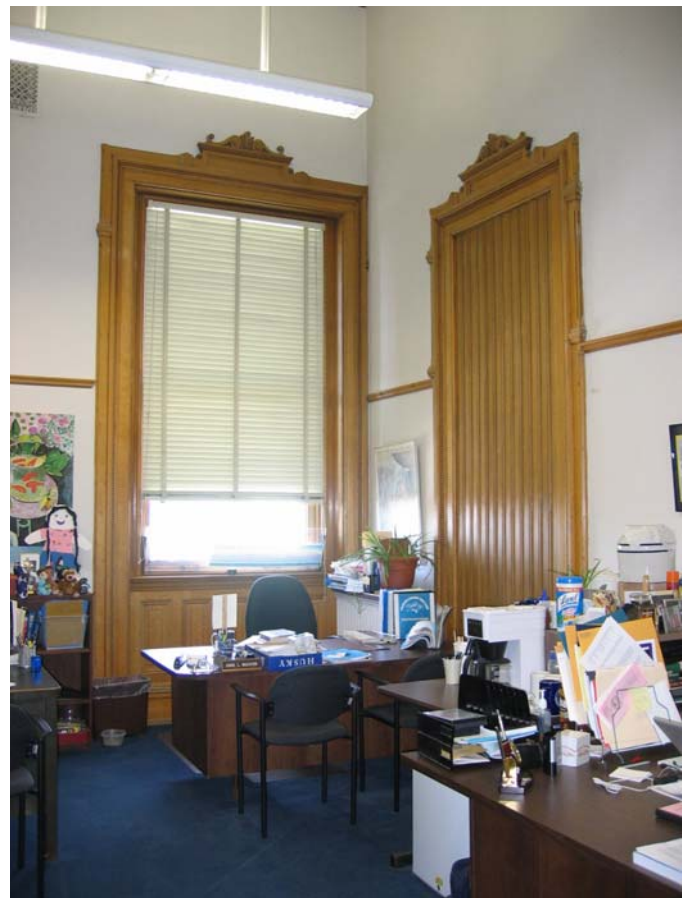
318 Northwest corner
