# COLORADO STATE CAPITOL

## HISTORIC STRUCTURE ASSESSMENT

STATE HISTORICAL FUND PROJECT NUMBER  
SHF-2006-T1-001

**December 15, 2006**

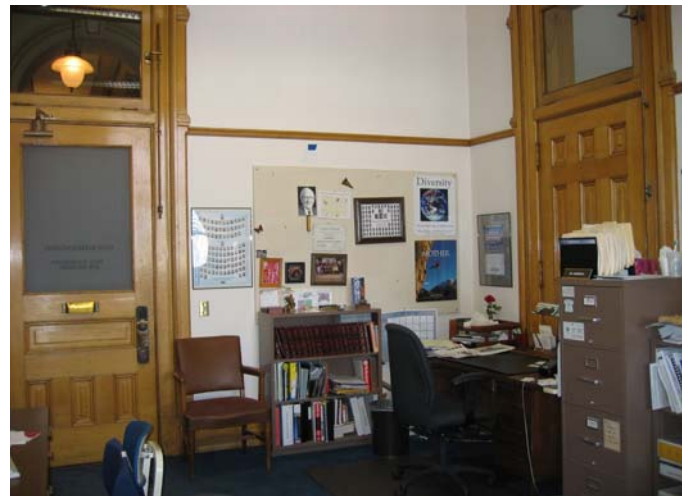
320 Southeast corner

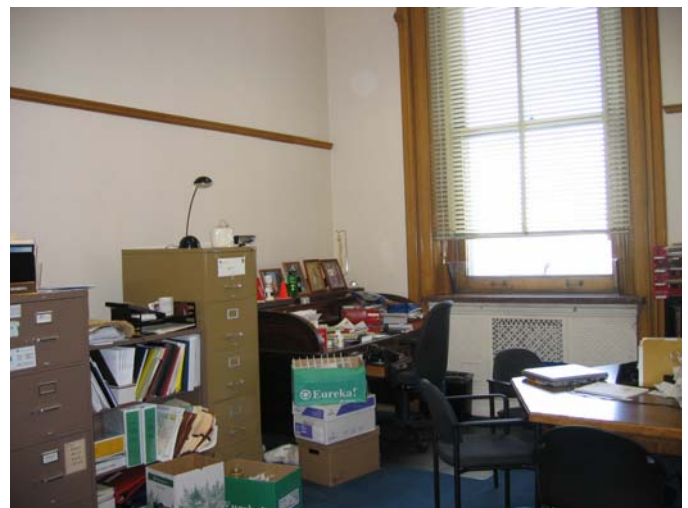
320 Southwest corner

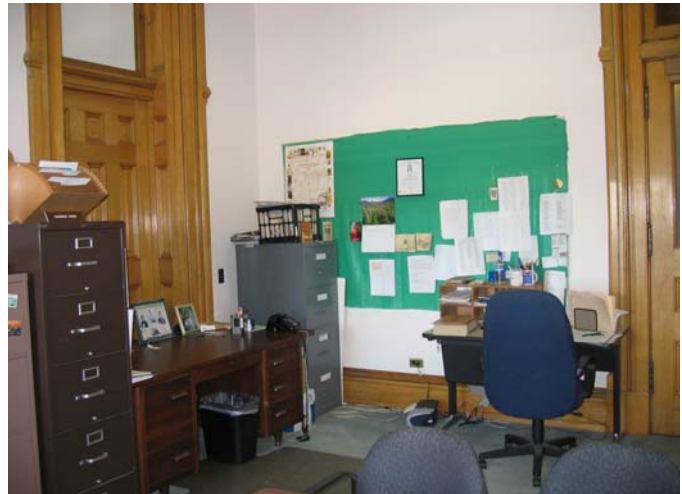
322 East wall

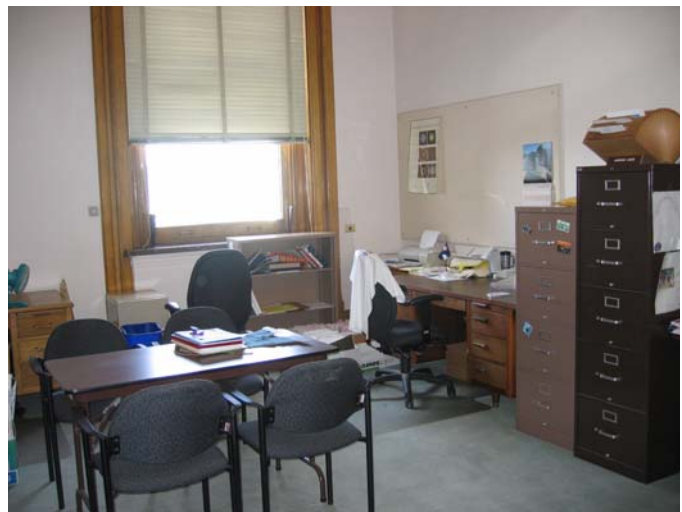
322 West wall

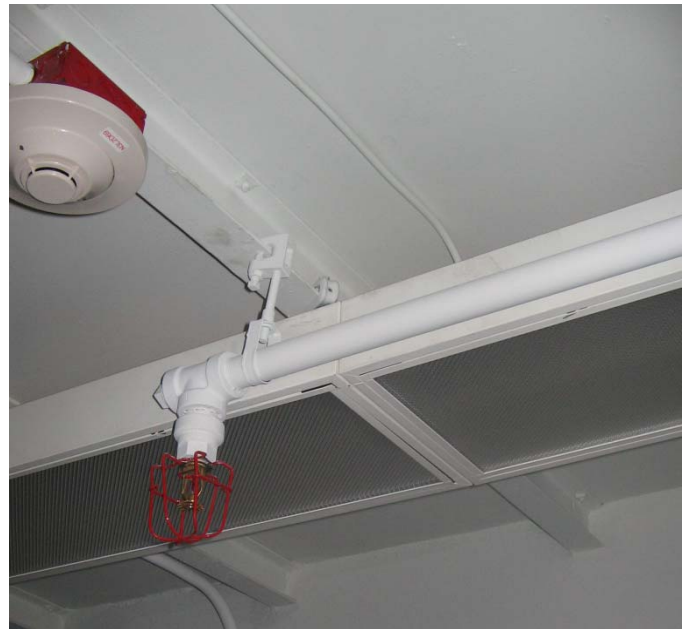
336 Detail of Life Safety System.

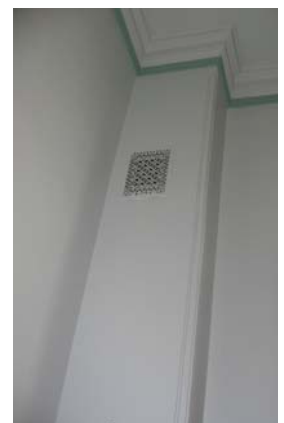
337 Existing chase

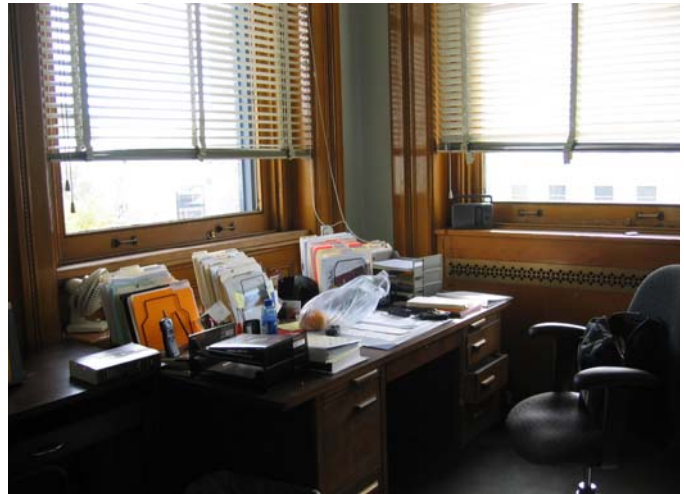
338 Southeast corner

The space is in good condition and consistent with current use; walls show signs of patching and normal wear

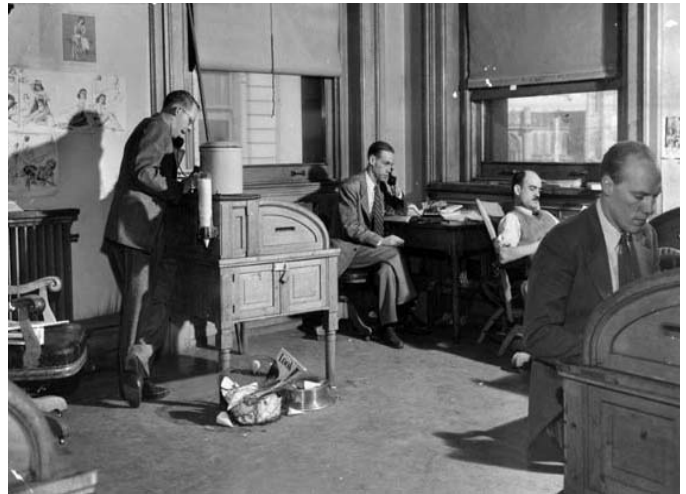
339 Early in it's use

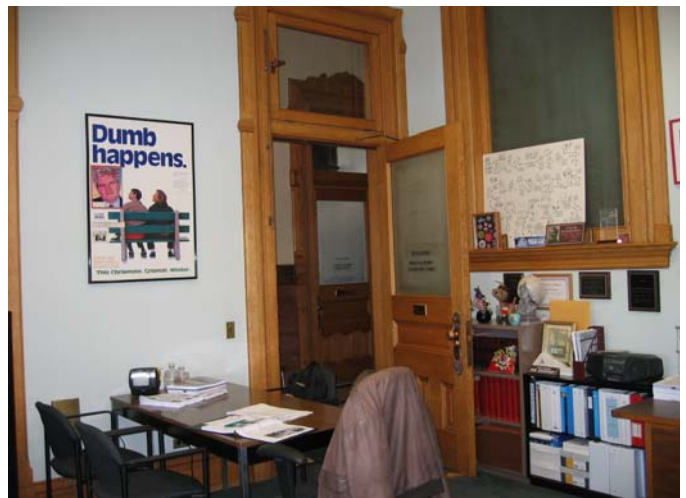
339 Southwest corner

The space is in good condition and consistent with current use, walls show signs of patching and normal wear

No preservation work required

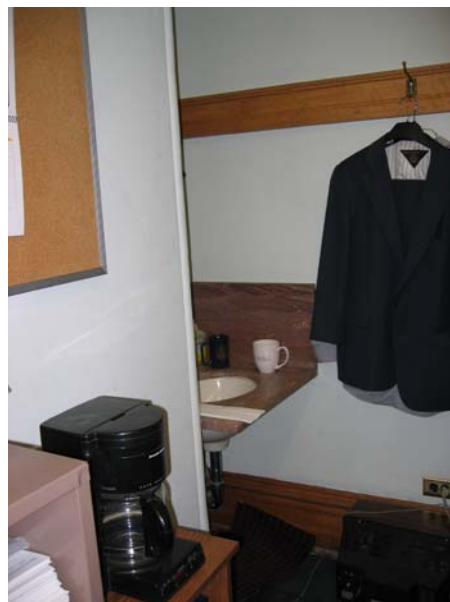
339 Original Cedar marble top sink in southeast corner

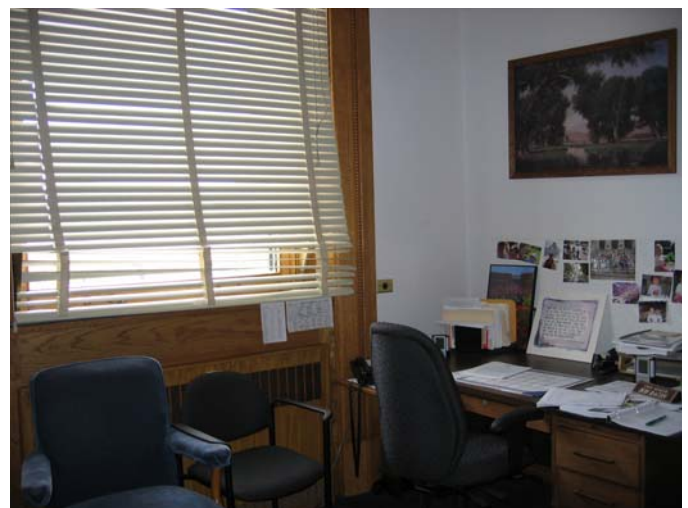
341 Southeast corner

The space is in good condition and consistent with current use; walls show signs of patching and normal wear

No preservation work required

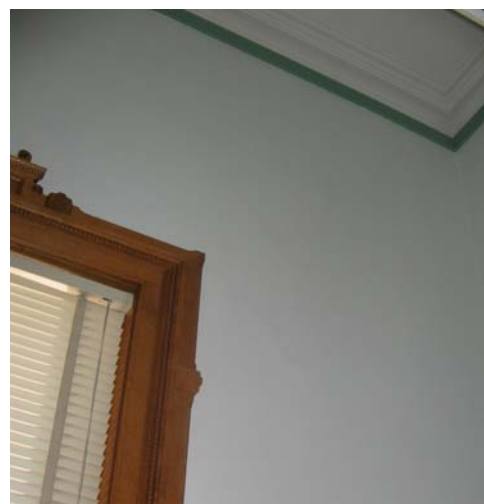
341 Wood trim and cornice detail

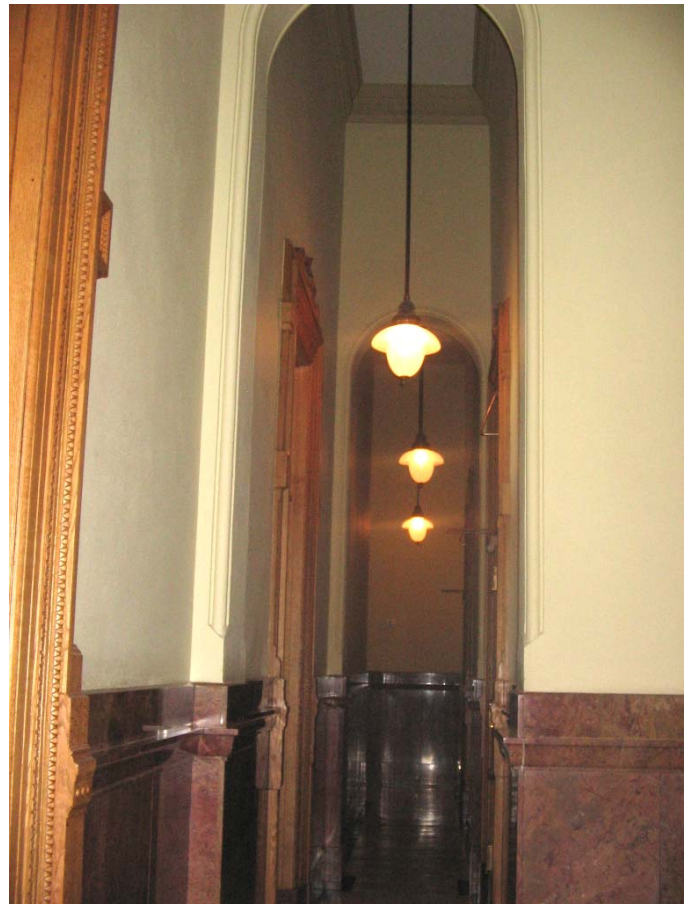
344 Corridor view

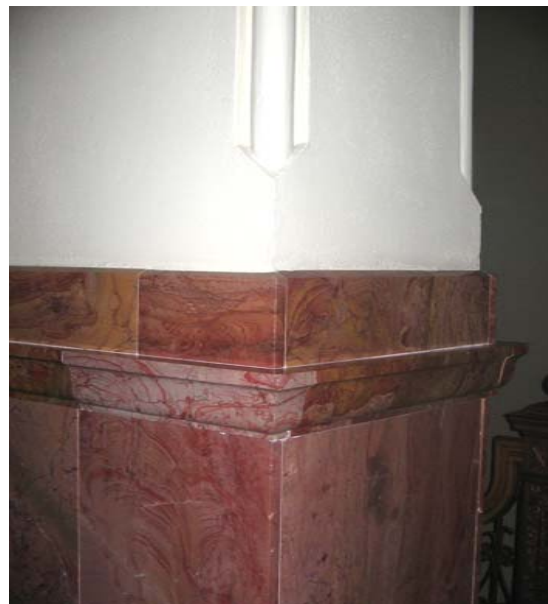
344 Rose Onyx marble wainscot, chair rail and corded corner detail

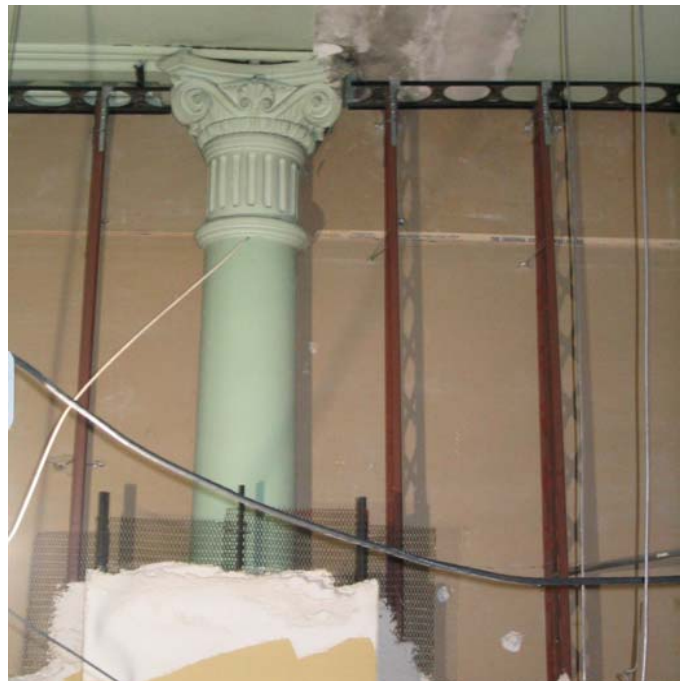
351 Original cast iron column.

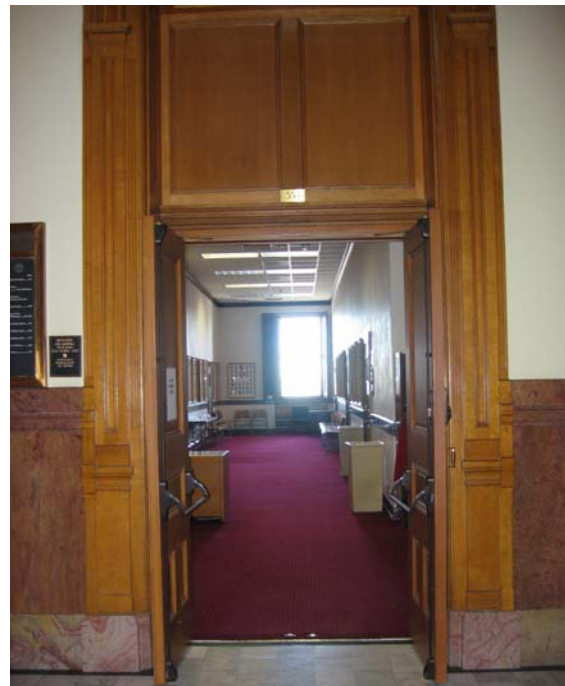
All casings, and frames have been replaced or altered; all non-original double doors; original transom glazing on the double entry doors has been replaced with wood paneling and drywall; door hardware is original on the pull side; electric hold-open closer and panic hardware was added for pressurization in 2004 as part of the Life Safety Project; frame and trim are mahogany on inside; oak on the arcade side

355 Entry door from Arcade

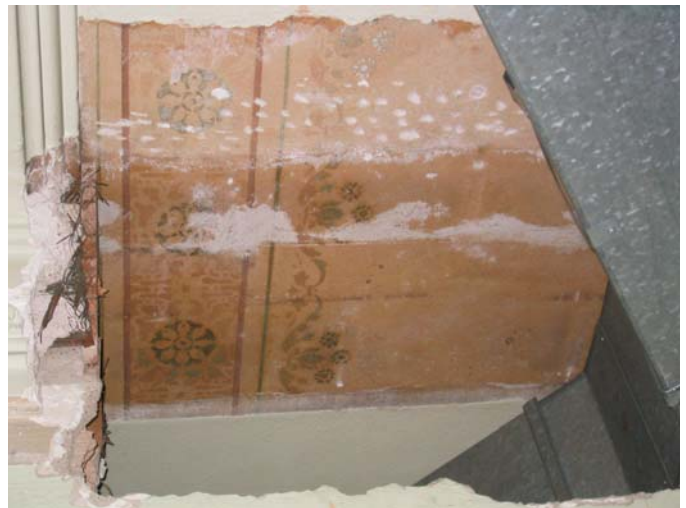
357 Existing original ceiling frescos

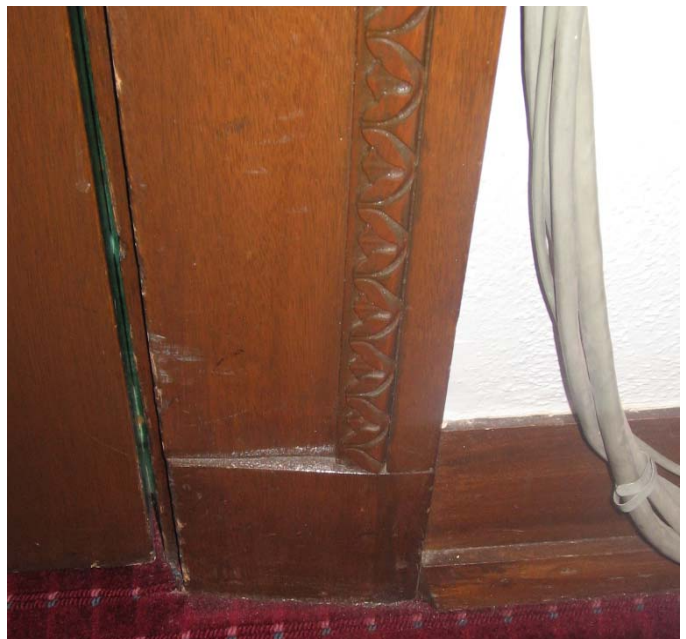
357 Existing wood trim detail

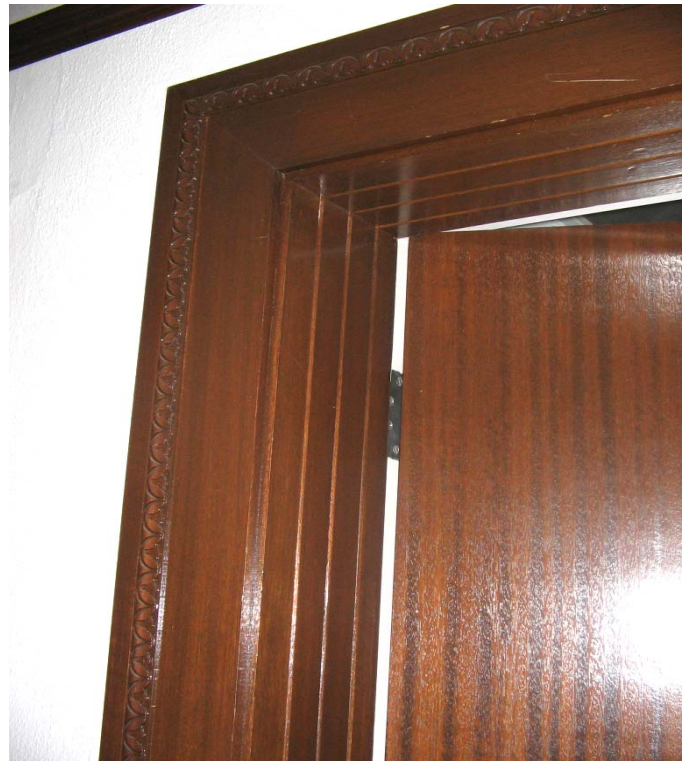
358 Mahogany door and trim detail

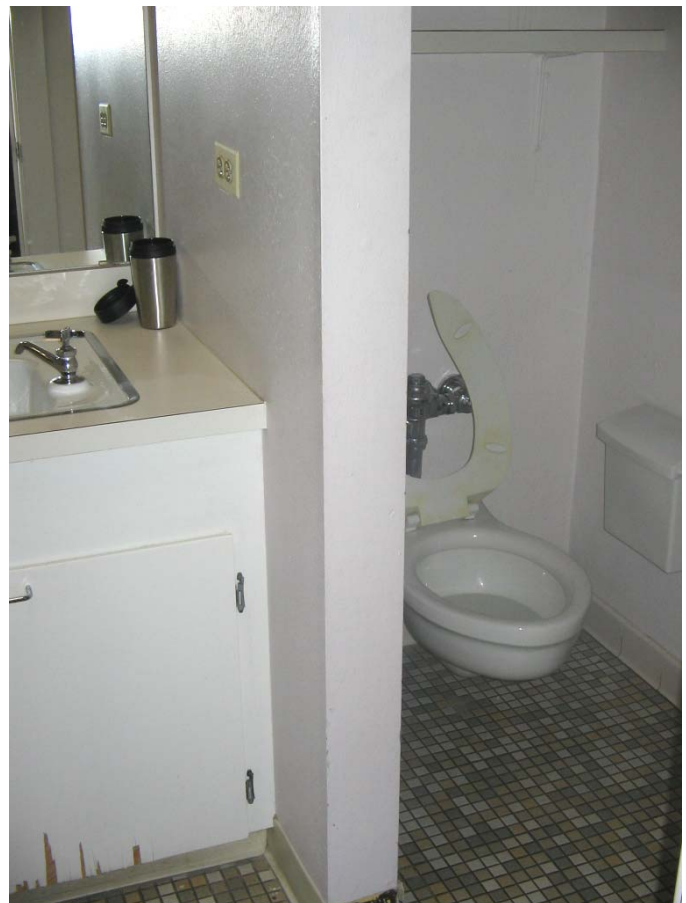
358 Existing conditions

The space is in fair condition

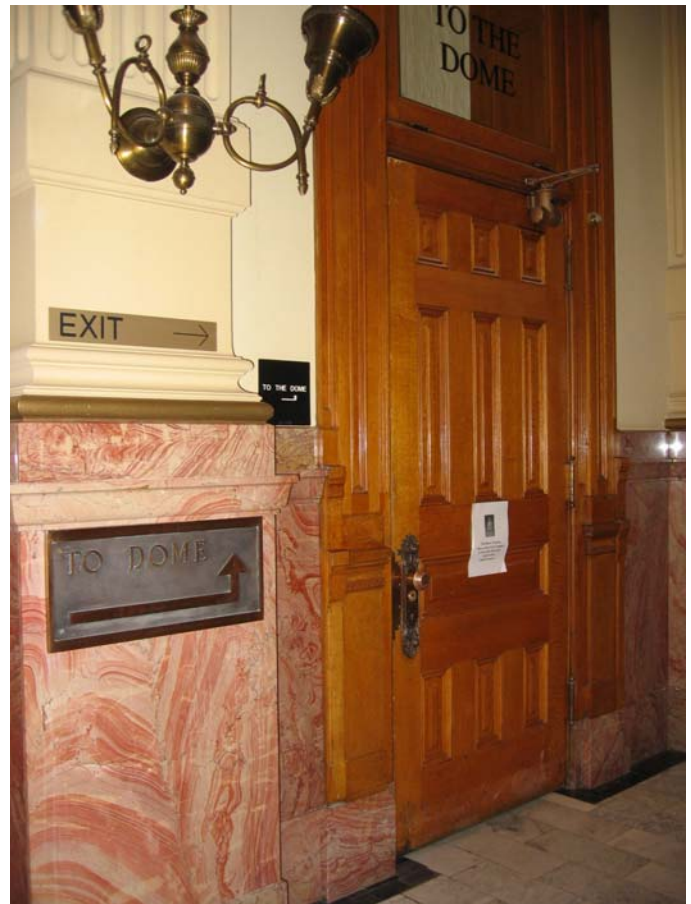
360 Entry door to original Dome Stairs from the Third floor Arcade

*Functional Condition:* Not in use

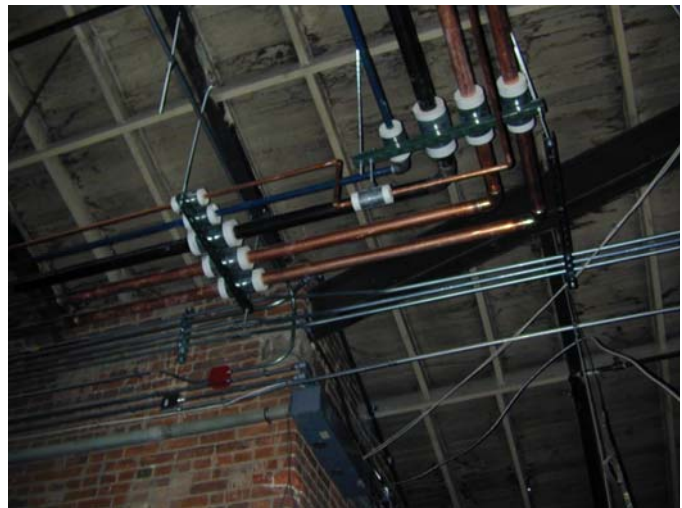
The ceiling of the Attic is the exposed underside of the wood plank roof decking. The wood has a light colored coating that is known to contain asbestos. The coating is badly stained indicating past roof leaks. Four new smoke relief hatches in the ceiling installed as part of the Life Safety Project can be opened from the Fire Command Center in the Basement. There are six glass skylights in the roof providing light into Third Floor spaces through six interior sky-

Attic: Underside of wood plank roof

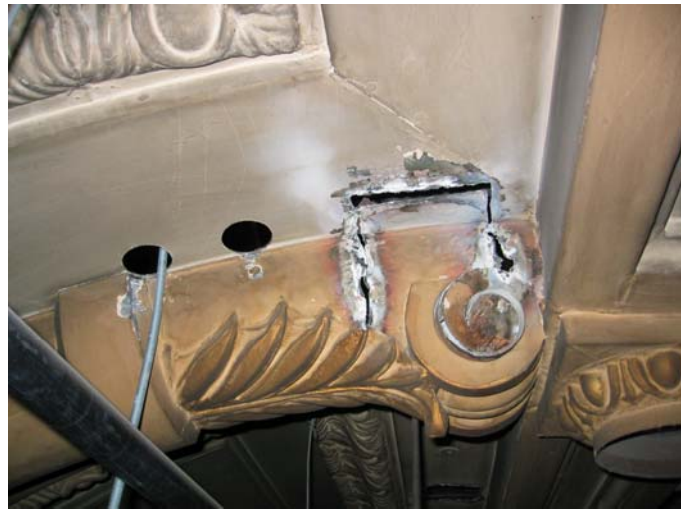
Of the six interior skylights, only the two Atria skylights are performing their intended function. The House and Senate Chambers skylights have been abandoned and obscured from view from below. These skylights are comprised of pressed tin panels with decorative tin drop pendants. The glass (now missing) was held in place by a steel framework similar to the Atrium skylights. The tin panels are painted in a light burgundy color and covered with hand painted patterns recalling the design of the stair pickets. The majority of the drop pendants are missing but a few still remain over the Senate Chambers. Platforms have been erected on the top of these skylights and winches installed to raise and lower the chandeliers in the Chambers below. This and numerous other alterations have caused severe damage to the skylights including the tin panels.

Attic: Senate Chamber skylight, damage from a cutting torch

Remove abandoned wiring and piping. Provide coordinated oversight of future work on building systems. Prevent further damage to skylights and original ornamental metalwork.

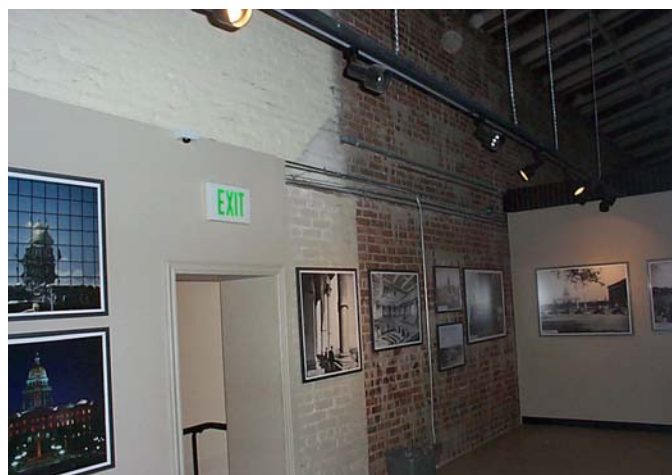
Attic Gallery: Former “small gallery with spiral stair entrance
