# Colorado Underground Coal Mine Fires 2018 Inventory Report

August 2019

**Tetra Tech**  
350 Indiana Street, #500  
Golden, Colorado 80401

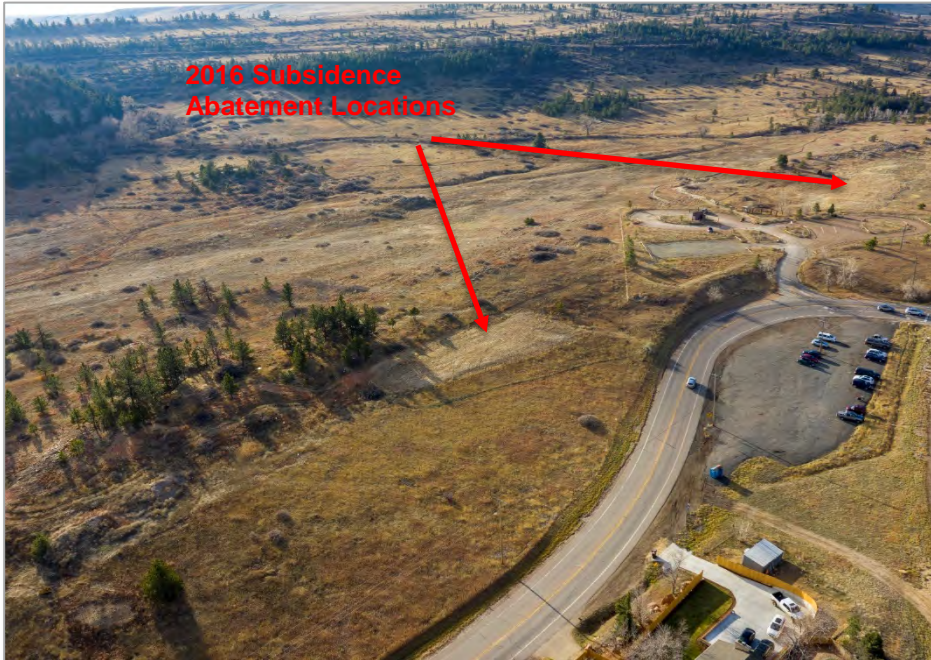
Figure 4-4 – Marshall Mine Fire Looking South

In 2016, two areas of trough subsidence were excavated, compacted, and backfilled to natural grade. Both areas, shown on Figure 4-4, were in areas where surface expression of the mine fire had been observed. During the subsidence mitigation work, a few small vents were uncovered in both locations. In all cases, the exhaust was warm, moist air with temperature less than 90°F. No new evidence of subsidence or other indicators of the coal mine fire were observed during the completion of the remedial activities. Gas monitoring during construction did not detect gases associated with coal combustion over the background levels.

No abatement is recommended. This fire has behaved erratically in the past, so it is recommended that it be monitored annually to check for increases in fire activity.

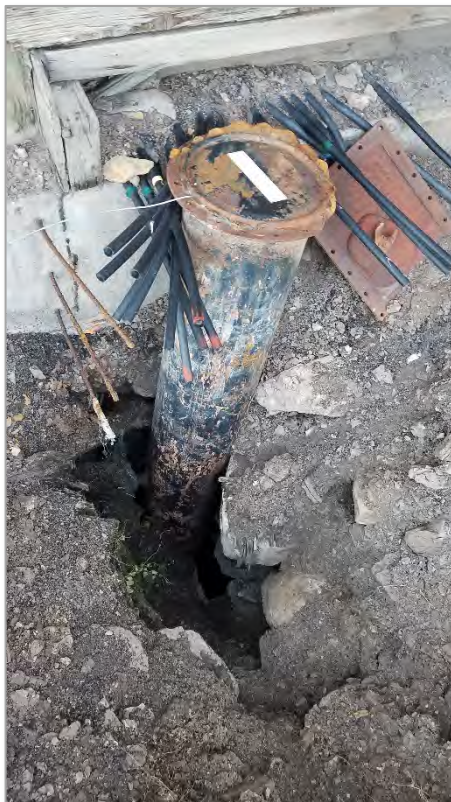
Figure 4-8 – Vent Pipe

The Davis Mine fire site is located 3.2 miles northwest of Cedaredge, CO and lies in the Grand Mesa coal field. It is a new fire to the inventory and is an unusual fire in that it is beneath a house, built directly above the mine entrance. The original owner of the house had planned to heat the house with a coal-fired boiler—which was inside the mine workings—with coal from the mine. A one-foot diameter vent pipe from the boiler system installed in the mine workings is set alongside the house (Figure 4-8). The inside of the mine can be seen through a hole immediately adjacent to the vent pipe. The fire was believed to be limited to an area at the entrance to the mine workings. Recently, DRMS backfilled the two mine entrances to reduce air flow to the fire and to allow water to build up inside the mine and quench the fire (Tafi, 2018).

It is recommended that the fire be investigated further to determine if it is extinguished. It is recommended that more permanent closures of the mine entries be constructed.

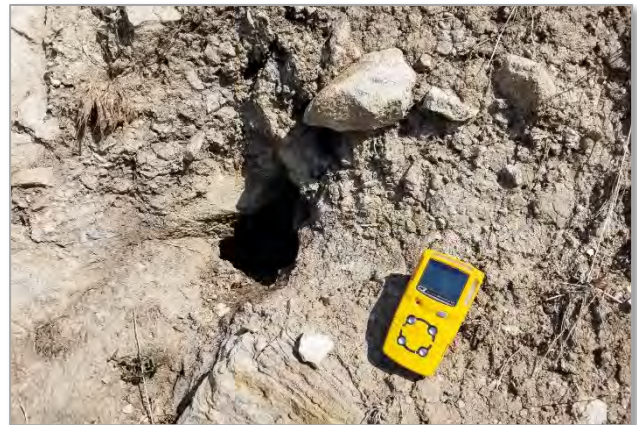
Figure 4-11 – Small Vent

south side of the cover area (Figure 4-11). The vent measured four inches by six inches and had a temperature of 103°F. Gas readings from the vent showed elevated levels of CO, low H<sub>2</sub>S, low oxygen, and no methane. A dormant vent with no elevated temperature or gas readings was found on the upper bench on the north end of surface seal. The vent locations are shown in Figure 4-10.

The Minnesota Creek Fire activity is low relative to other Colorado sites, with only one low-temperature vent located on site. This vent is not located near considerable vegetation and the exhaust temperatures are low; consequently, there is not a significant risk of wildfire. The risk to the public is low because of the remote location of the coal fire and the lack of hazardous fire features.

Snowmelt imagery could help with mapping the extents of the fire activity on site and Tetra Tech recommends that aerial thermal imagery be collected in the winter months. No other mitigation action is recommended at this time.

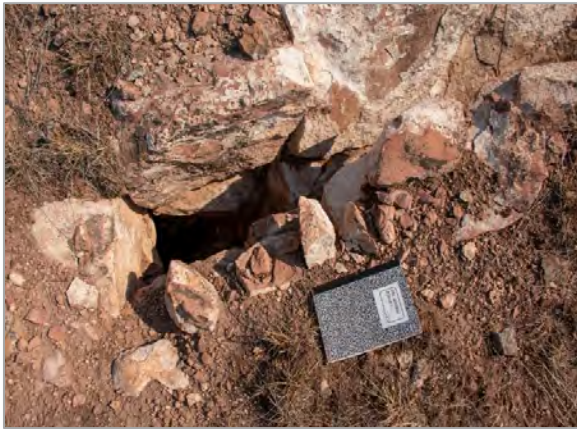
Figure 4-14 – Dormant Fractures

The States Mine Fire was visited by Tetra Tech on July 30, 2018 to inspect the site for fire activity and collect aerial and thermal imagery. Thermal imagery was not collected during this site visit because the day was sunny and hot, and ambient ground surface temperatures were greater than 90°F. A manual inspection of the entire site was completed, and no obvious fire activity was observed. Fractures on the south end of the fire were found to be at ambient temperatures and had no evidence of active venting (Figure 4-14). The landowner mentioned that an area between the road switchbacks typically does not hold snow after a snowstorm and that steam can be seen rising from this area following precipitation at the site. This area was inspected, and no vents or fractures were found. Fractures were found in the road immediately to the

The States Mine Fire activity was observed as very low with no active fire expressions located. The risk of wildfire at the site is low because of the lack of active vents. The risk to population is also low because the fire is located on private property and no active fire expressions were found.

Snowmelt and wintertime thermal imagery could help map hotspots on site and delineate the extent of any present fire activity. It is recommended that snowmelt and thermal imagery be collected for inclusion with the next mine fire inventory report.

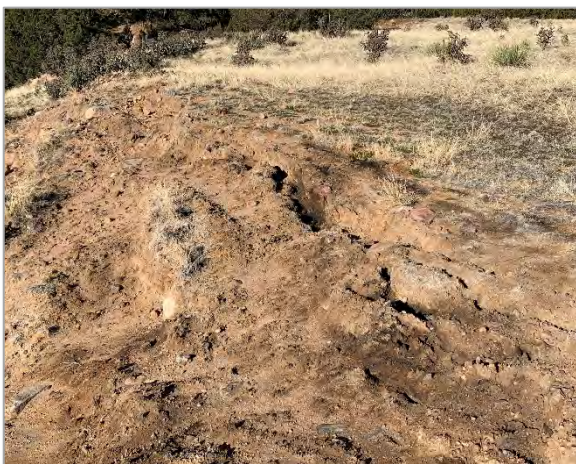
Figure 4-17 – Venting Fractures

Side in the 2005 Inventory Report) revealed numerous small cracks along the southern edge of the pile. These cracks were stained dark black and were emitting steam and some H<sub>2</sub>S at low levels. The temperatures recorded in approximately 15-20 individual cracks ranged from 100-135°F. Additionally, vegetation within the immediate proximity to the vents was absent (Figure 4-17).

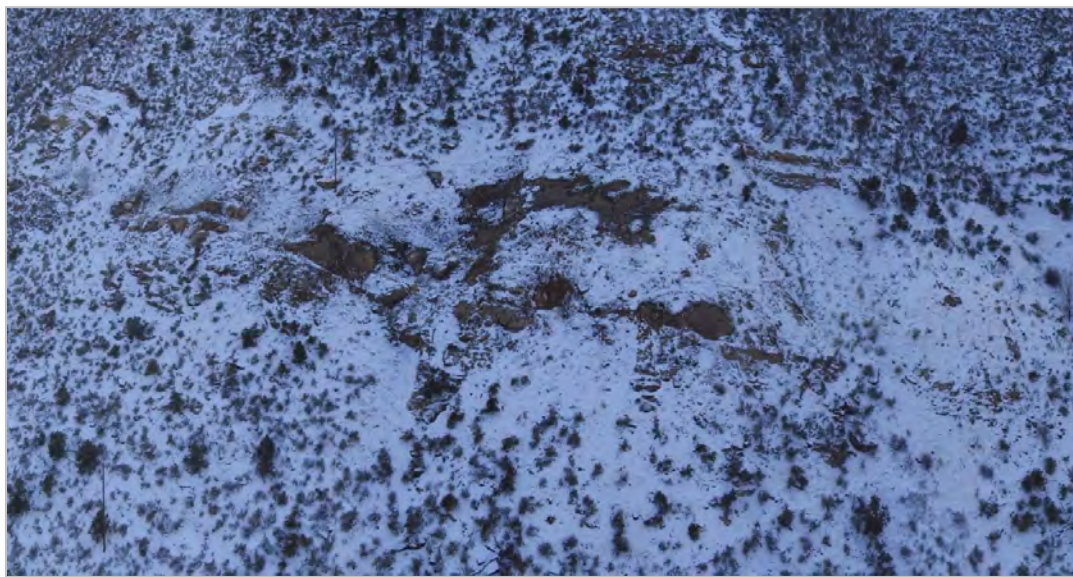
Figure 4-22 – Coryell Mine Fire Snowmelt

The snowmelt imagery delineated a primary fire expression covering approximately ½ acre (Figure 4-22). Ground temperatures in this expression area were 20°F to 30°F above ambient ground temperature.

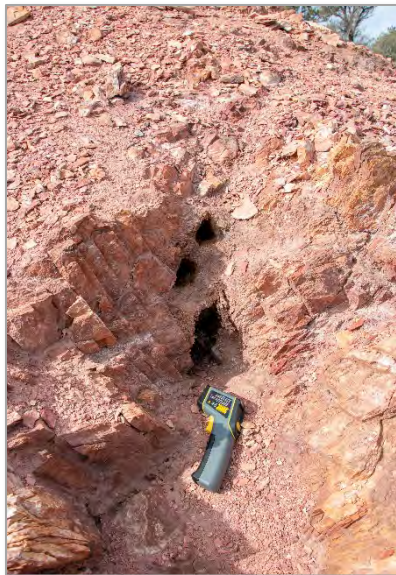
Figure 4-25 – 225 °F Vents

The Elk Creek Mine fire site was visited on July 19, 2018. Permission to access the mine fire was obtained from the landowner of a private residence on the north slope of the Grand Hogback directly below the fire. Several vents were discovered near the outcropping ridge near the highest surface elevation of the mine fire site. The temperatures at these vents were measured around 225°F (Figure 4-25). Exhaust flow was detected but flow rates were low to moderate, and no vegetation or other combustibles were nearby. Therefore, wildfire risk is limited. Additional vents were discovered within the sandstone cap overlying the steeply dipping coal seam. Numerous old vents are evident from staining of the rock, but no elevated temperatures or gases were being emitted from these vents. Gas at the active vents had slightly elevated levels of H<sub>2</sub>S and CO as detected on the 4-gas meter. On the eastern side of the site, vents in the fractured sandstone showed moderately elevated temperatures and were emitting exhaust at a low to moderate rate.

The fire is moderately active, with vent temperatures around 230°F. Elevated ground temperature has kept most vegetation from growing near the vents, reducing the potential for wildfire. The fire expressions are well defined and free of major vegetation. There is moderate risk of wildfire because of the fire's moderate activity. While the fire is on public land, there is no easy access to the site, meaning the potential for trespassing is low.

Currently, no abatement actions are recommended at the site. It is recommended that a snowmelt drone flight be performed to delineate the fire expression area.

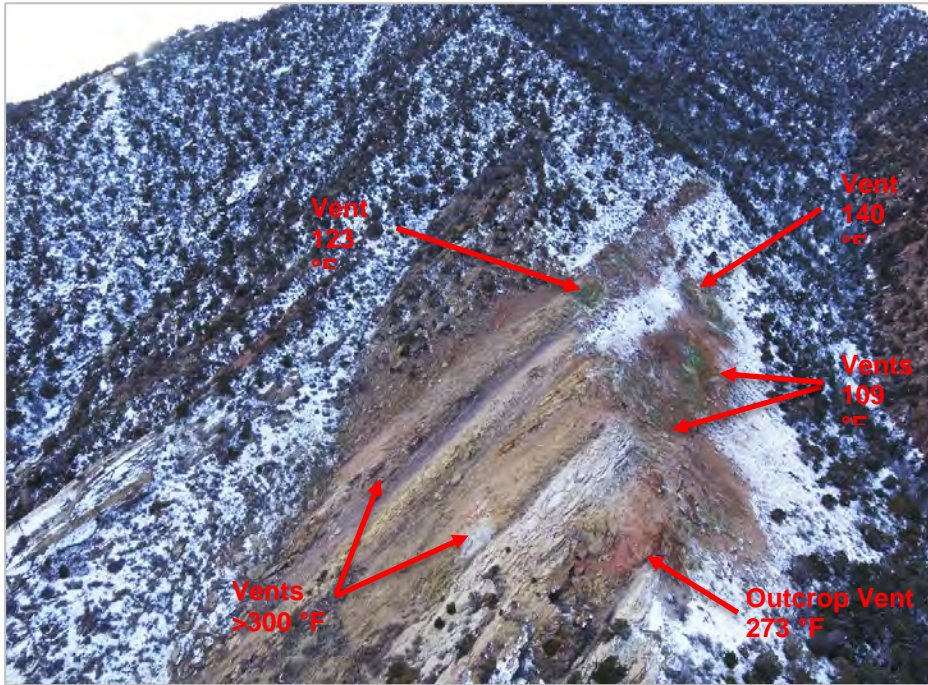
Figure 4-30 – Harvey Gap Fire Looking Southwest

area had previously been sealed with grout but was very active, venting gases at well over 300°F. The combustion gases were hot and dry with no creosote, indicating an efficient fire in that area. Vent temperatures on the north aspect of the fire area ranged from 109°F to 140°F and were smaller and more dispersed than those on the south aspect of the fire (Figure 4-31). Snowmelt imagery and the lack of vegetation indicate the fire is moving in a northwestern direction along the two mined coal seams.

The fire is moderately active with vent temperatures range from 109°F to 310°F. Ground heat has kept most vegetation from growing near the vents, reducing the potential for wildfire. The fire expressions are well defined and free of major vegetation. There is moderate risk of wildfire due to the fire’s moderate activity. While the fire is on public land, there is no easy access to the site, meaning the potential for trespassing is low.

Currently, no abatement actions are recommended at the site.

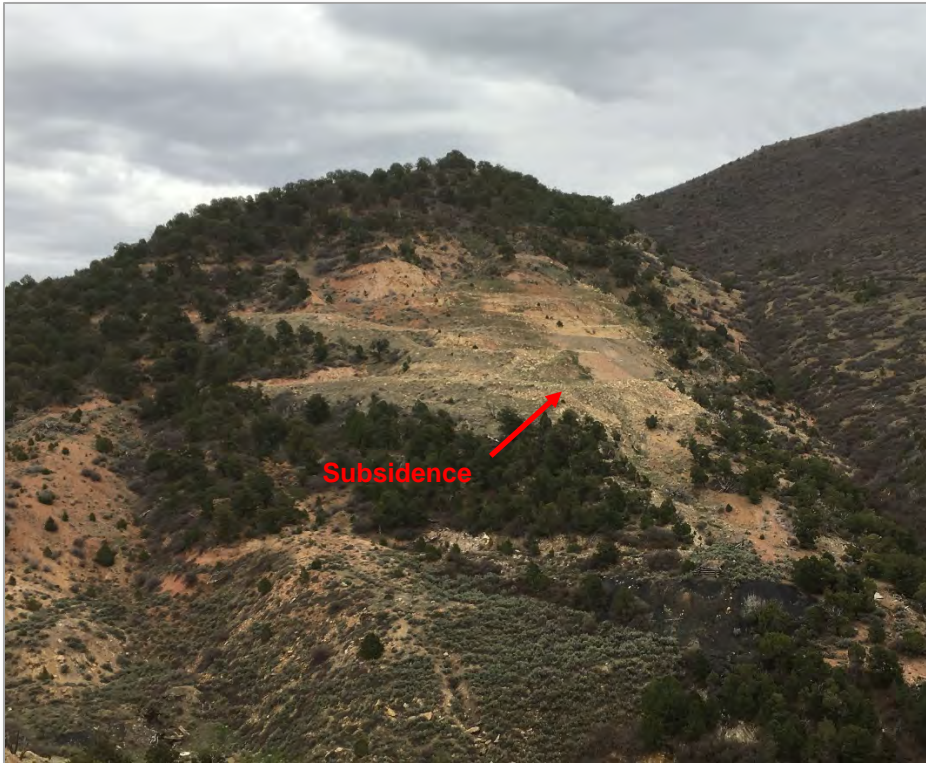
Figure 4-33 – IHI No. 2 Mine Fire Looking East

The fire’s current activity is low and presents little risk of starting a wildfire. The remote location of the mine fire and the lack of dangerous surface features means this fire poses little public safety risk.

Currently, no abatement actions are recommended at the site. Drone snowmelt imagery was not taken of the site but could help identify area of potential fire activity.

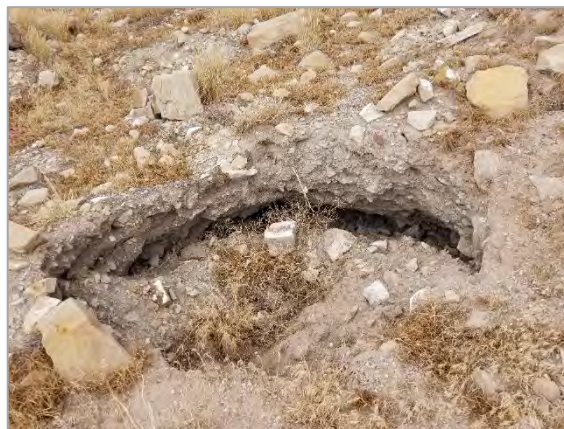
A 6-foot by 5-foot by 1-foot deep subsidence feature was discovered near the western (lower) end of the surface seal (Figure 4-34). Combustion gases were observed near the feature, but temperatures were not elevated. Besides the subsidence feature, no other combustion gases or newly stressed vegetation were observed around the site.

Figure 4-34 – Subsidence Feature

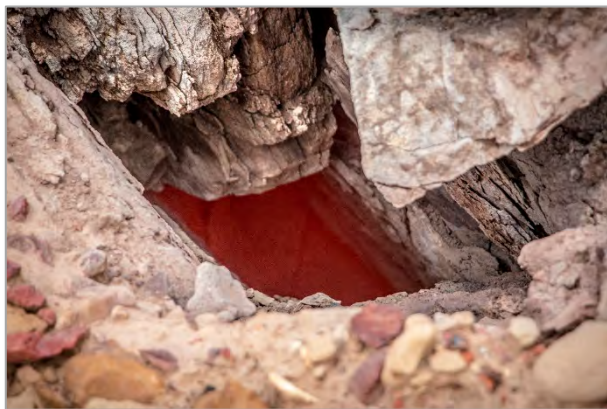
Figure 4-37 – >600 °F Vent

430°F. Combustion emissions from these vents were primarily CO<sub>2</sub>, with no CO or H<sub>2</sub>S detected. The openings were surrounded by white precipitant. Along the lower, southern portion of the surface seal, the smell of sulfur was apparent, and vents had buildups of sulfur crystals at their openings. Elevated levels of CO and H<sub>2</sub>S were encountered, and the team had to leave the immediate area. This area was circumvented, and the northwest corner of the surface seal was then evaluated. A one-foot diameter vent was found against the large sandstone outcrop bounding the northern edge of the primary fire area. This glowing orange vent had a high flow rate and temperature in excess of 600°F (Figure 4-37). The vent could not be approached due to elevated CO levels and intense heat. The nearest vegetation was approximately 30 feet up the slope about the vent. The western vents were 297°F with substantial amounts of creosote around their openings, indicating that the fire has moved into unburnt coal in this area. These vents were 20 feet away from vegetation.

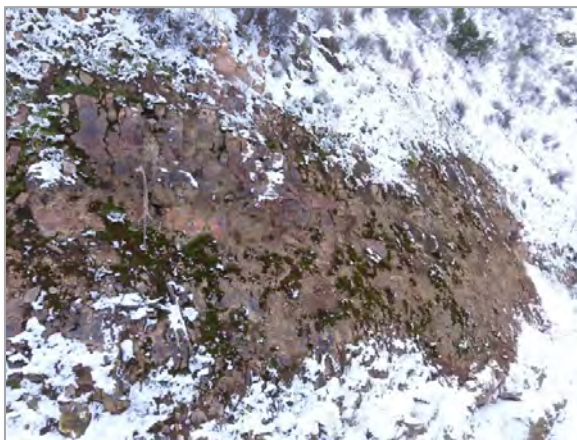
Figure 4-44 – Fire Expression

expressions and a maximum temperature of 80°F. Areas of snowmelt appear in areas of thin vegetation including small grass and moss, suggesting that the fire is relatively stable (Figure 4-44).

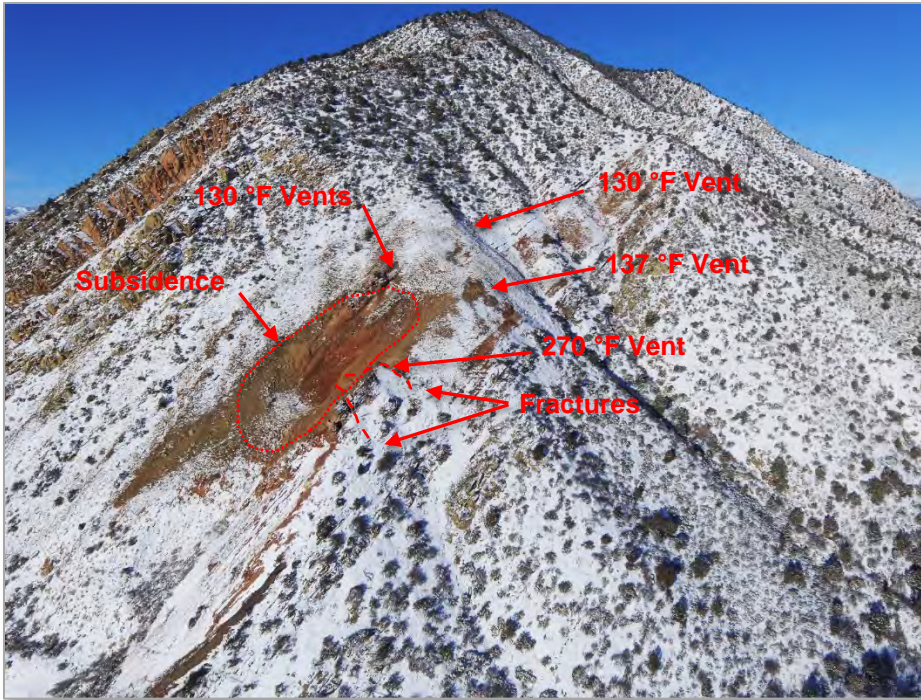
Figure 4-46 – New Castle No. 3 Mine Fire Looking West

The New Castle No. 3 Mine fire is moderately active but appears to have an established fire area. Areas where the fire is most active are denuded of vegetation, giving this fire a limited risk of starting a surface fire. The large fractures, steep terrain, and subsidence features mean this fire poses a moderate public safety risk. The fire’s visibility and ease of access means the risk of trespassing is moderate.

Currently, no abatement actions are recommended at the site. However, it is suggested that signs and a fence be installed to deter potential trespassing.

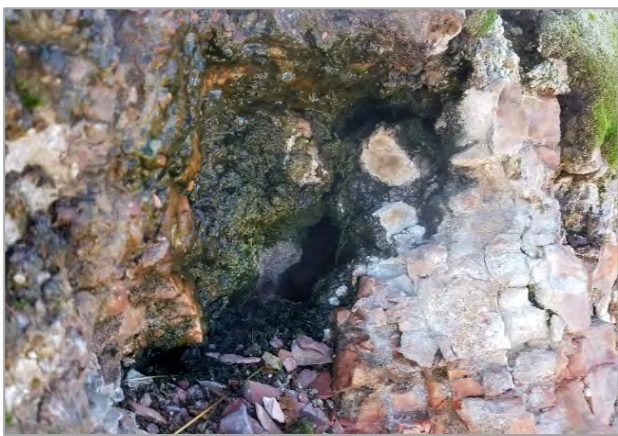
Figure 4-47 – Small Vent

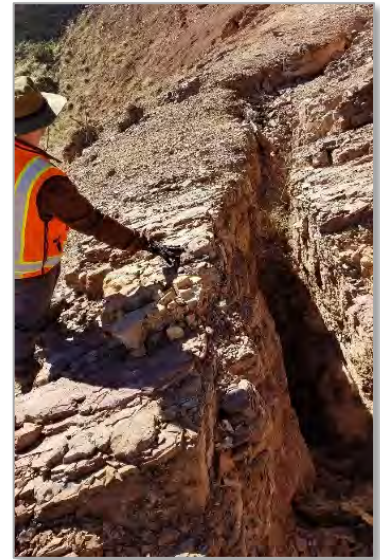
fire is a 75 ft by 200 ft subsidence feature that has warm ground and dispersed 170°F hotspots. Two fractures, spaced 20 feet apart, run perpendicular to the stratigraphy north from the subsidence feature. The lower fracture was not actively venting and had filled in with loose material (Figure 4-48), and the upper fracture had multiple vents along it measured at 270°F. Exhaust in this area of the fire was hot and dry and had very low amounts of CO and sulfur, indicating a very efficient combustion. The higher areas of the fire are on a north aspect slope. Two 137°F vents were found along the lower seam. The westmost vents of the fire were found along the upper seam and measured 130°F (Figure 4-47). Many small, dispersed vents were found on the north aspect slope between the two coal seams. The vent exhaust in this area was very low in CO and sulfur and had higher water content than exhaust of the lower area vents. The vents and much of the ground on the north aspect slope had thick moss and grass growth because of the warmth and elevated water-vapor content of the fire exhaust.

Figure 4-48 – Lower Fracture

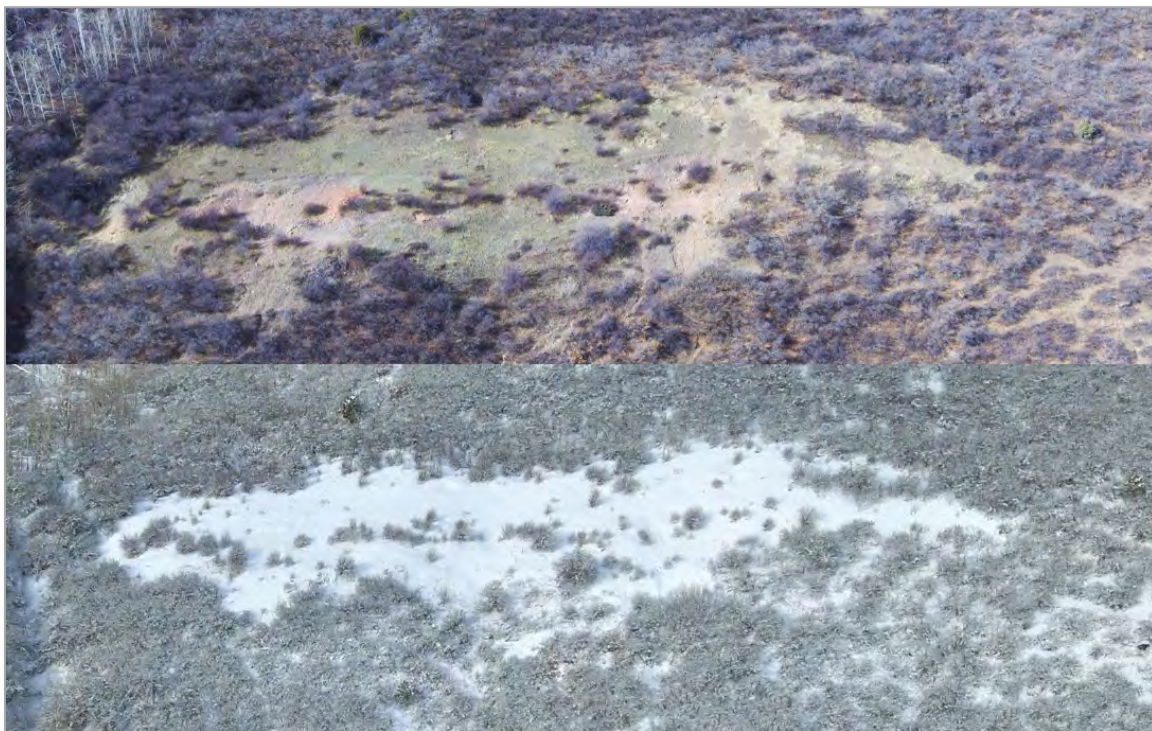
Figure 4-51 – Pocahontas Mine Fire Dry vs. Snow Looking West

The site was revisited in February 2018 to gather ground temperatures and snowmelt pictures. No indications of an active fire were observed at the surface. Ground temperatures were uniform, and no snowmelt was observed the morning after a four-inch snowstorm (Figure 4-51).

No work is recommended on this fire at this time.

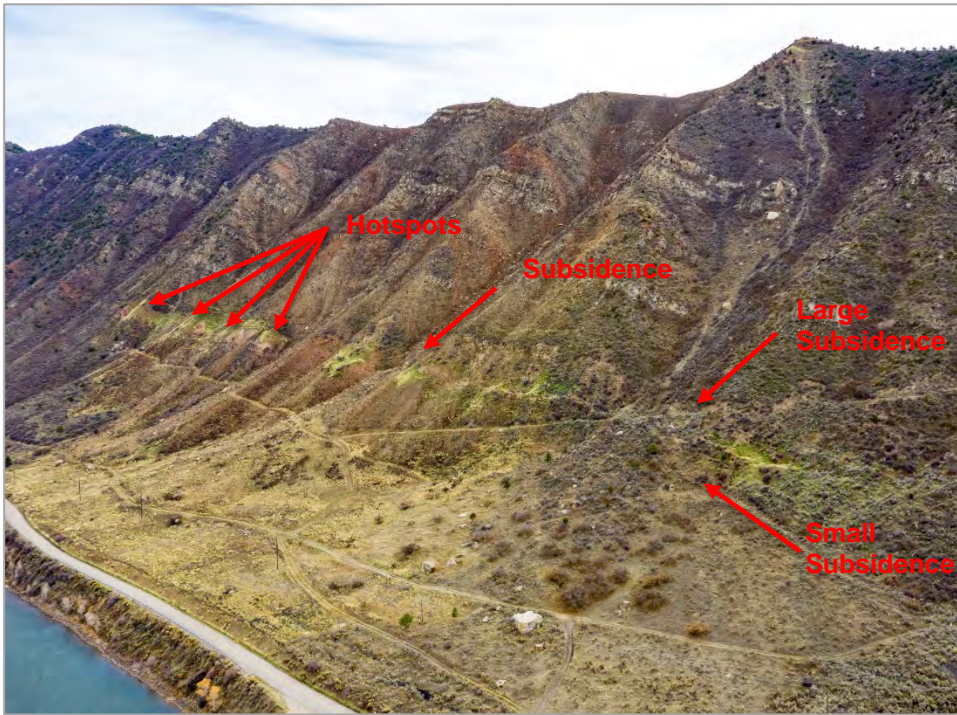
Figure 4-64 – Vulcan Fire Looking Southeast

In July of 2017, a wildfire started near County Rd. 335 and burned through the Vulcan Mine fire area. This has resulted in increased erosion on the steep slopes and debris flows in the gullies. Increased erosion is expected until ground cover has reestablished itself.

The Vulcan Mine fire’s activity is low to moderate. The fire presents a limited risk of starting a surface fire, but the recent increased subsidence activity presents a significant risk to public safety. The fire is on private property, but nearby condominiums increase the likelihood of public trespassing onto the site.

It is recommended that access to the area near the 4 ft sinkhole be restricted or the sinkhole mitigated. Subsurface investigations could identify high-risk subsidence zones.

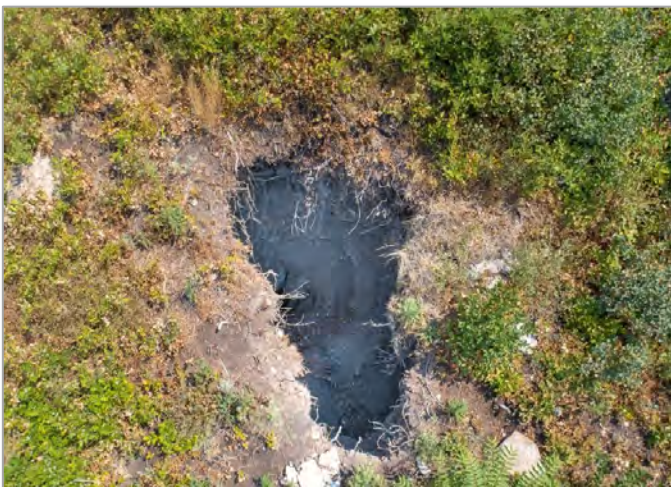
Figure 4-68 – Main Vent

The fire was first visited on October 18, 2017 to inventory the fire activity and collect aerial imagery and data to develop a 3D model of the site. The fire expression is located on top of a cliff 400 ft above the valley floor. The fire is accessed by hiking up a draw to the east side of the fire and traversing west to the expression area. The main fire expression is a subsidence feature approximately 5 ft x 10 ft x 20 ft deep with two small openings at the bottom (Figure 4-68). This feature was venting high water-vapor content, 90°F mine fire exhaust. Northwest of the main vent is a line of smaller vents along the top of the ridge. These vents were also around 90°F.

The fire was inspected again on July 31, 2018 using a drone to collect thermal and orthophotography. Ambient temperature was 85°F, and the main venting subsidence feature was cooler than ambient. No other vents were found.

The fire's activity and vent temperature are both low, but the steep terrain and unstable landforms add a level of unpredictability to the fire. The consequences of a wildfire are high due to the proximity to the town of Somerset. The steep terrain limits access to the fire, but the main vent presents a significant fall risk to trespassers. Signage and fencing were not in place as of October 2017, and it is recommended that they be installed around the subsidence and vent features. No fire abatement work is recommended for the Bear Fire because of its low vent temperatures.

Regular monitoring of the Bear Mine fire is recommended.

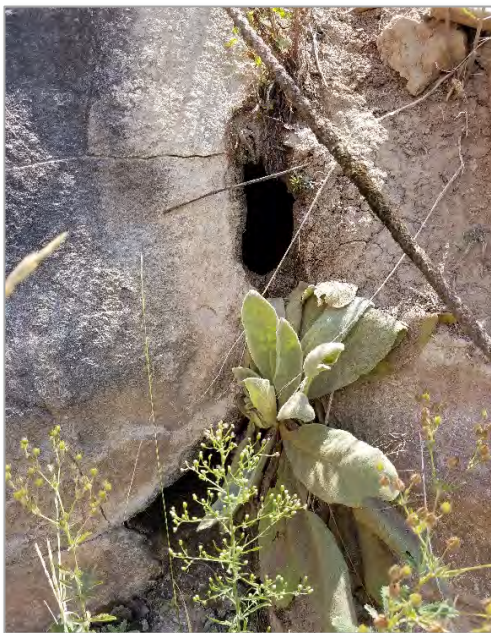
Figure 4-71 – 98°F Vent

The Oliver Mine Fire was visited on July 31, 2018 to inspect the site for fire activity and collect aerial imagery and thermal imagery. Ambient temperature was around 90°F. A cluster of three vents was found near what is believed to be the original mine entrance (Figure 4-71). These vents were 98°F, low in oxygen, low in H<sub>2</sub>S, no CO, and 2% methane. The vents were 6 inches in diameter but opened into a larger void space below the surface. A large subsidence feature was noted running south-southeast from the vents and possible entrance.

No abatement action is recommended at this time.

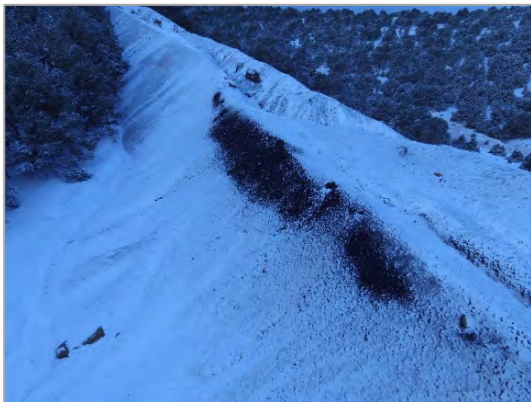
Figure 4-80 – Snowmelt

In December 2017, Colorado DRMS contracted Tetra Tech to investigate potential fire activity within the refuse pile. On January 10, 2018 Tetra Tech met with DRMS and a contractor to observe the fire and develop a plan for the fire investigation. Coal combustion could be smelled on the pile, and white and yellow sulfur precipitate was observed. Shovel excavations near the precipitate exposed elevated temperature approximately 30°F above surface temperature. On January 11, 2018, an overnight 2-inch snowstorm allowed for the collection of snowmelt pictures to help delineate the potential fire areas for further investigation (Figure 4-80).

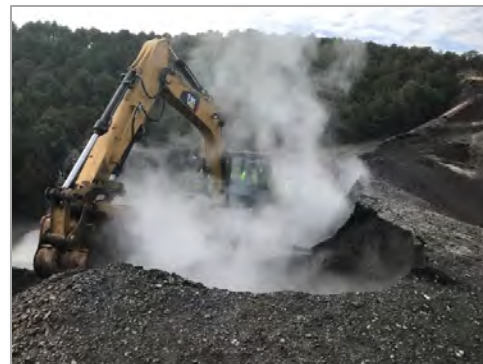
Figure 4-81 – Test Pits

On March 13, 2018 Tetra Tech performed a test pit investigation to determine the extent and intensity of the fire (Figure 4-81). Four test pits were excavated: 3 inside the suspected active fire areas and 1 outside to be used as a control. An excavator was used to dig the test pits to an average depth of 20 ft. The maximum temperature recorded was 127°F, and heat was uniform across the pile. Fire was not intercepted in any of the test pits and conditions were representative of coal oxidation. It is believed that infiltration of water into the pile erodes fines from the coal waste pile matrix, allowing airflow and starting the oxidation process and heating of the area.

Because of the lack of fire activity and the planned reclamation, no work is recommended for the West Sopris coal refuse pile at this time. It is recommended that efforts be taken during reclamation to reduce the pile's potential to oxidize and/or catch fire. This could involve mixing the refuse with more inert material, effectively reducing the coal concentration of the pile and/or using a low infiltration/oxygen cover to reduce the potential for oxidation.

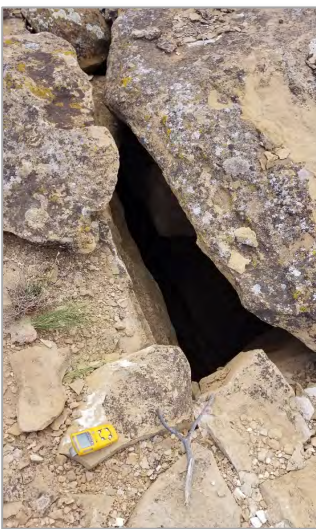
Figure 4-84 – Fracture

Tetra Tech visited the North Coal Mine fire site on September 10, 2018 to acquire drone-based aerial photogrammetry along with a ground-based assessment of the site. The drone flights took off from a clearing near the southern edge of the reclaimed area and flew north-south transects over the North Coal site. Multiple ground fissures and fractures were discovered during the site walk, including some that appeared to have been filled or plugged with cement or another grouting material. A 1 ft wide, 20 ft deep northeast-southwest trending fracture was found

near the center of the clearing (Figure 4-84). This fracture was cool and not venting. Additionally, multiple thermocouples were observed and measured during the site evaluation. Temperatures ranged from 54°F to 267°F and generally increased towards the north end of the site. Wellheads with values were distributed across the north half of the clearing.

The fire's activity is high but appears to be well confined, reducing its risk of starting a surface fire. There is a considerable public safety risk associated with the fire, but the potential for trespassers is low because of the remote location, locked gate, and many poisonous gas warning signs. It is recommended that this site be evaluated in winter months for both snowmelt and thermal photography.

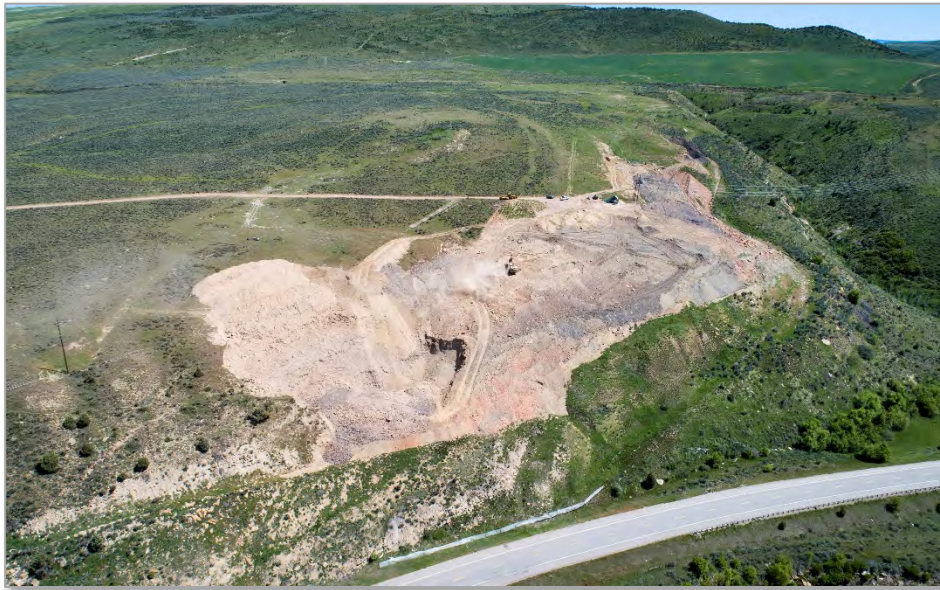
Figure 4-101 – Wise Hill Fire Abatement Looking Southeast

Since intensive fire abatement was performed from 2015 to 2018, the Wise Hill Mine fire does not present a significant risk to public health or potential to start a wildfire. However, it is recommended that 6 months after completion of fire abatement reclamation activities the site be assessed to establish a baseline for post-abatement fire activity. This should include reporting of any remaining vents, drone thermal imagery, and borehole temperatures.

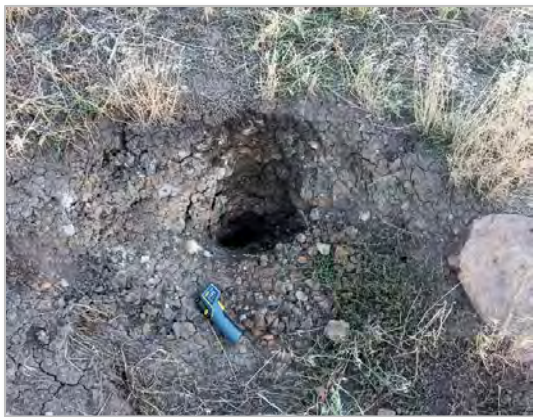
Figure 4-109 – Vent

area of the surface seal maintenance performed in 2011. The area was thoroughly inspected for evidence of fire activity. A 5 ft diameter, 2 ft deep subsidence feature was found. The ground temperature in this feature was elevated 8°F above ambient ground temperature. Fifteen feet west of this feature is another subsidence feature measuring 4 ft in diameter and 1 ft deep. Within this feature is a 5 inch by 2 inch vent with a temperature of 110°F, which seems to originate from the direction of the east subsidence feature (Figure 4-109). The revegetation across the surface seal maintenance area appears to be uniform, indicating that ground temperature is not high enough to affect vegetation growth.

The fire's activity is low, with only 1 active low-temperature vent. The fire poses a limited risk of starting a surface fire. The fire poses very little risk to public safety given its remote location, 3 miles by road from the nearest public land. No abatement is recommended for the site. It is recommended that the fire be visited every 2 years to monitor the progression of the subsidence features.

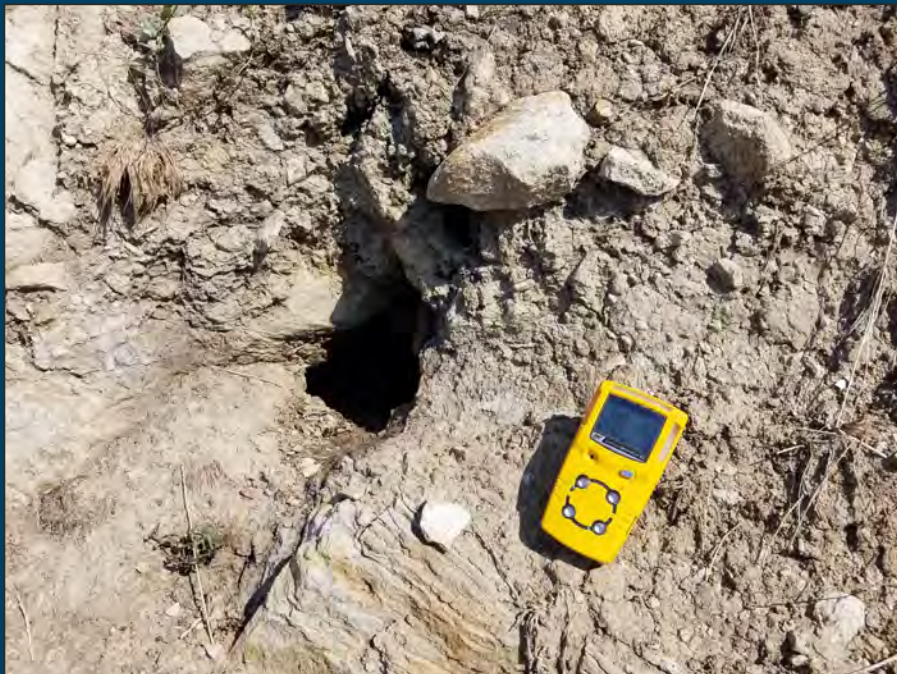
Active vent 103 °F

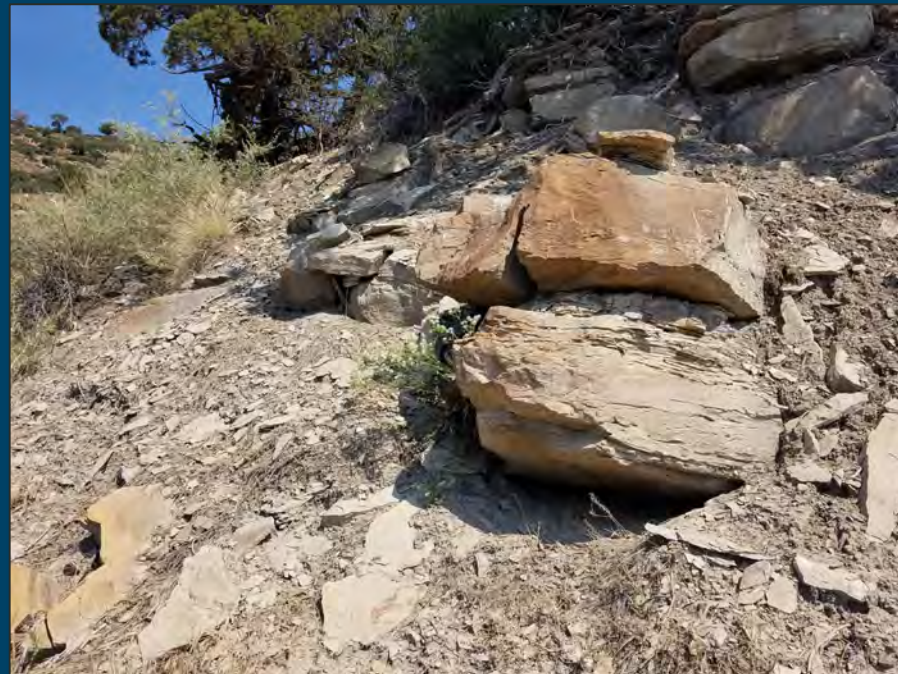
Dormant vent area

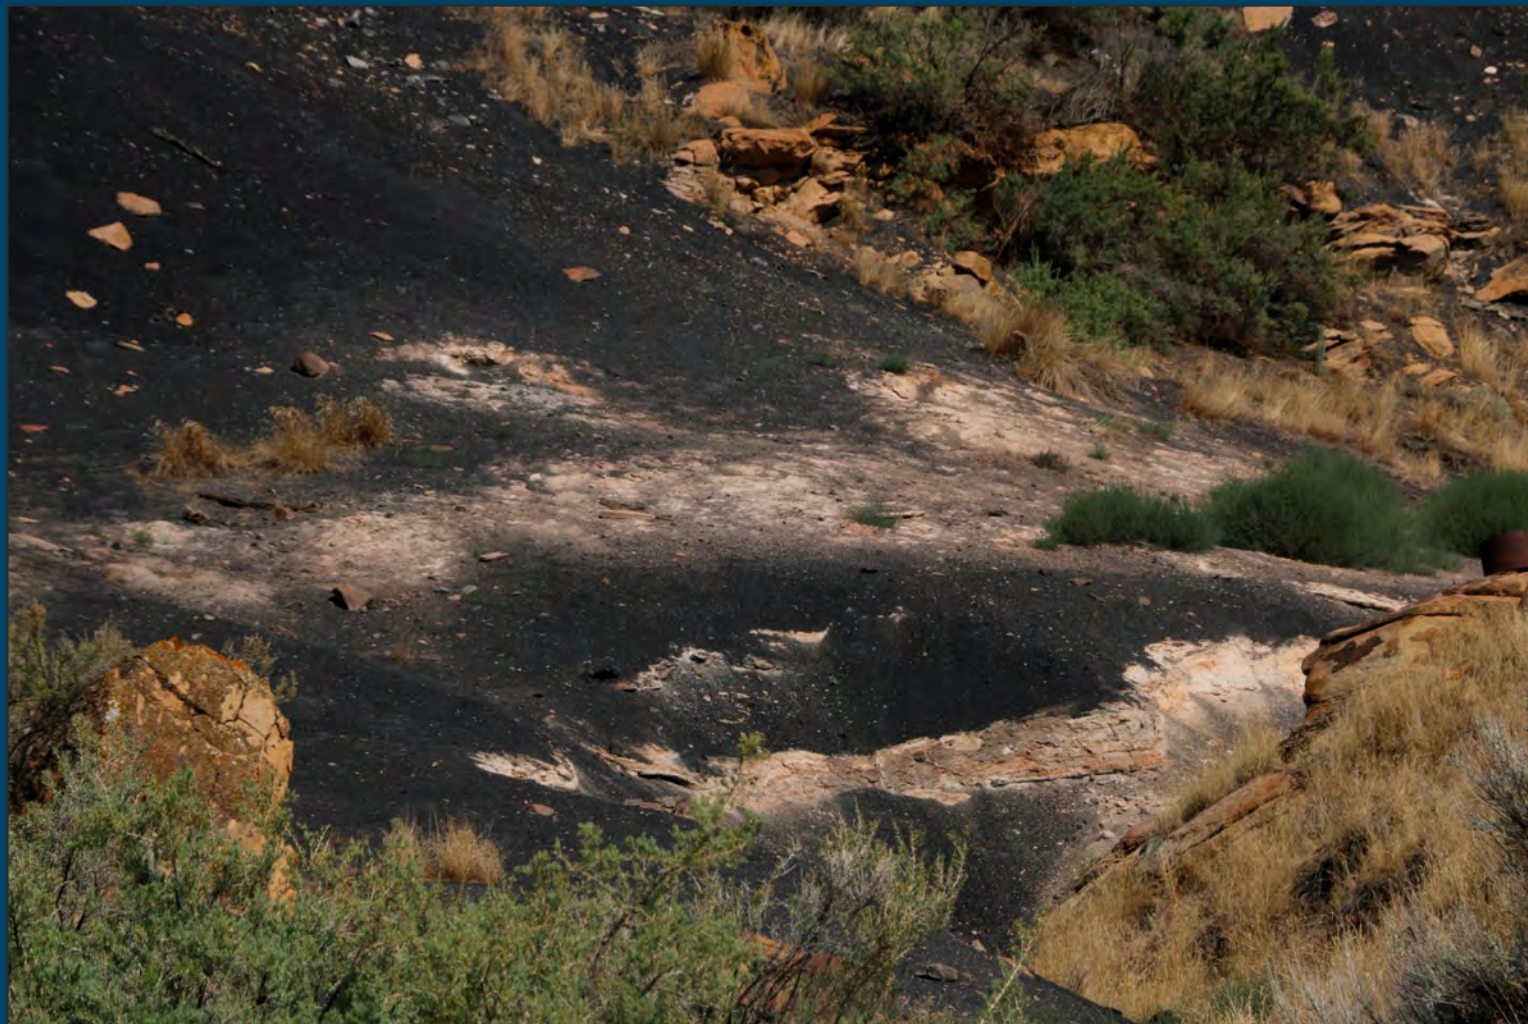
# States Mine

Ash in Coal Refuse Pile - No Active Fire

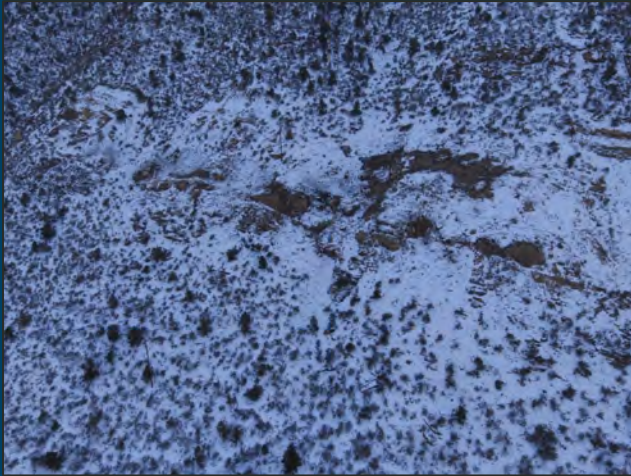
Snowmelt looking South

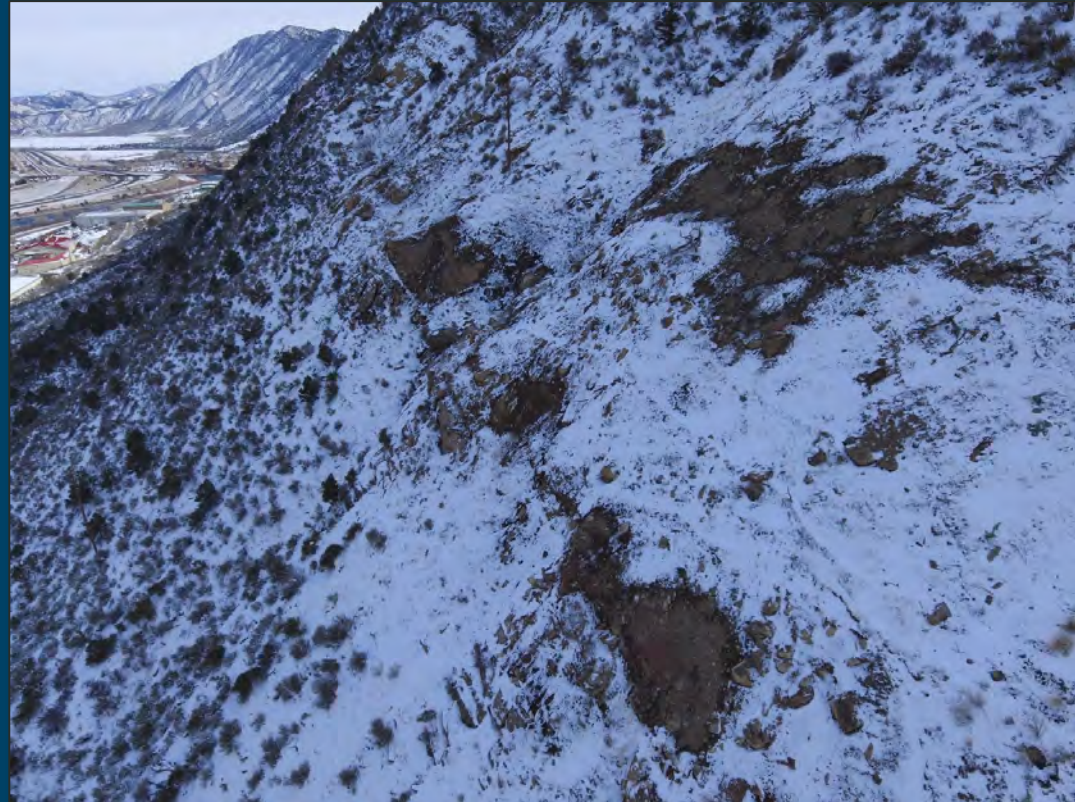
Snowmelt looking East

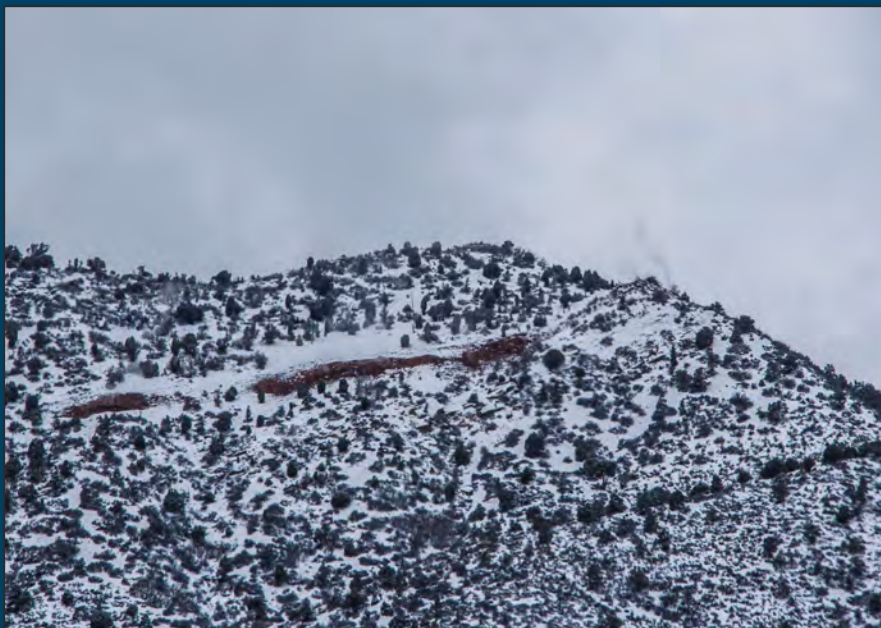
Snowmelt and steam viewed from Buford Rd.

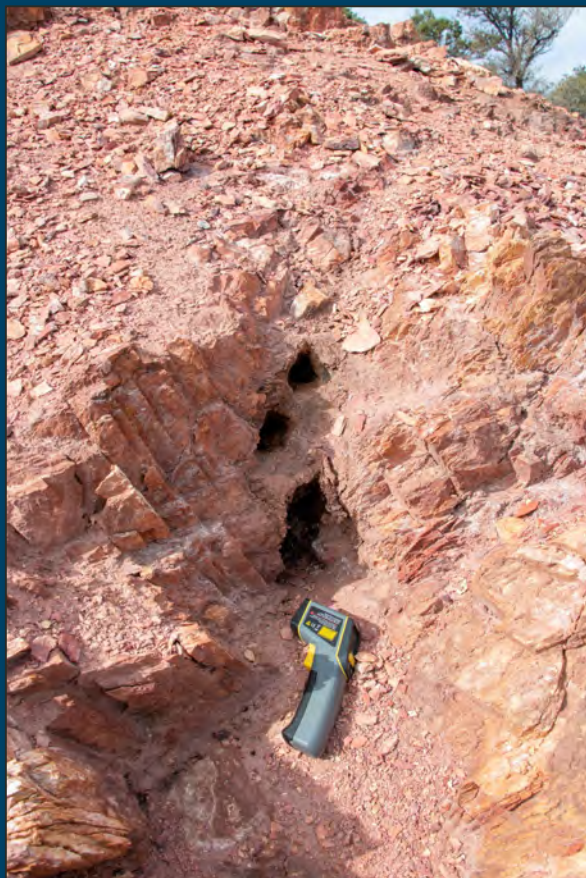
225 °F vents near ridge

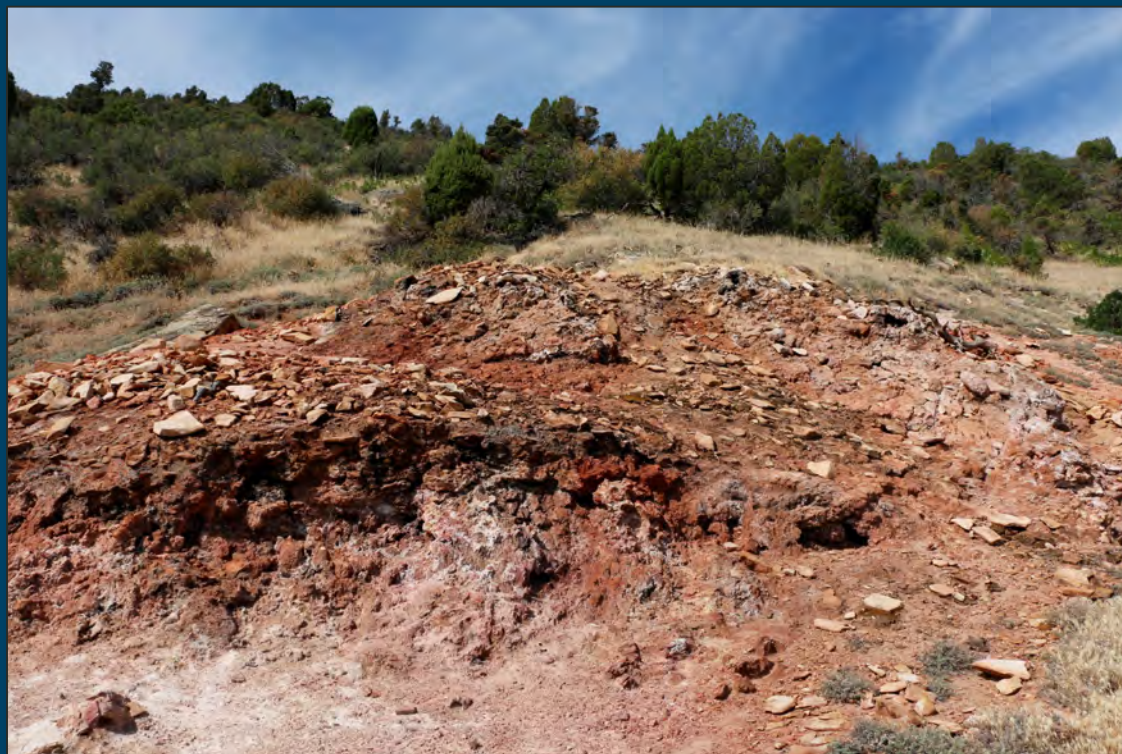
232 °F vents at outcrop

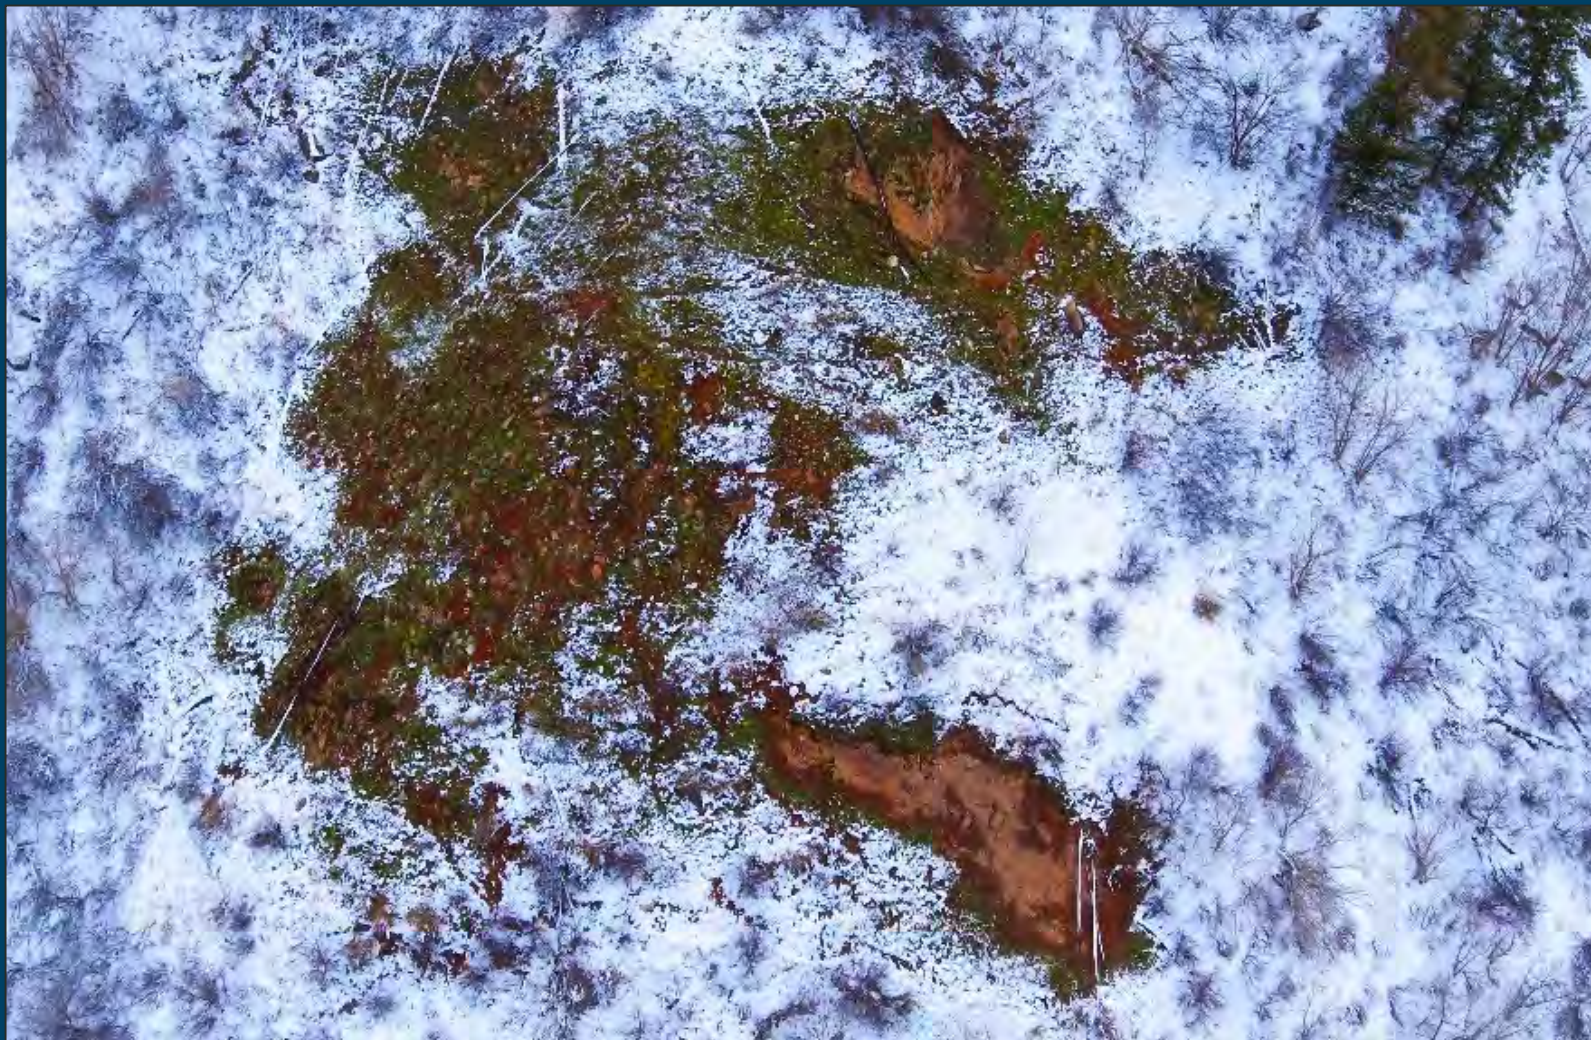
# Gem Mine

West fire expression
