# Colorado Underground Coal Mine Fires 2018 Inventory Report

August 2019

**Tetra Tech**  
350 Indiana Street, #500  
Golden, Colorado 80401

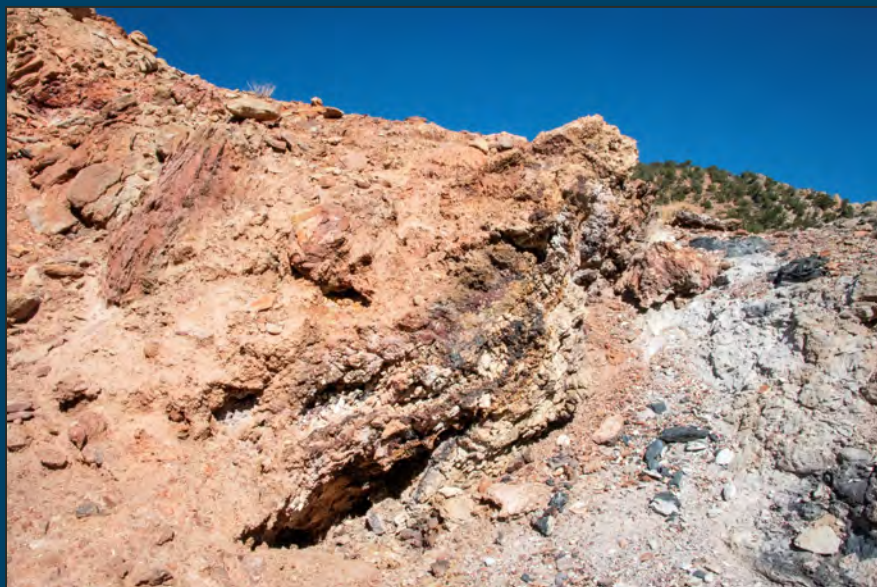
273 °F outcrop vents

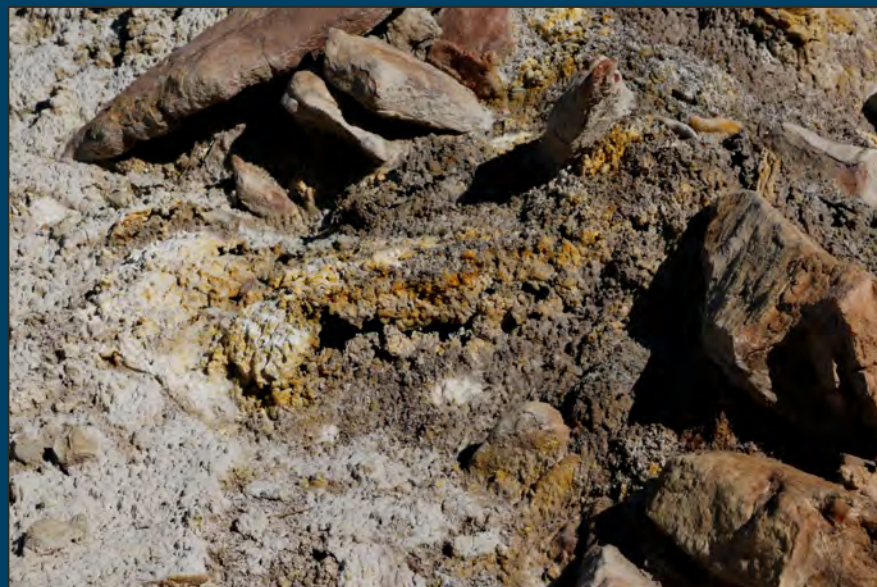
310 °F vents

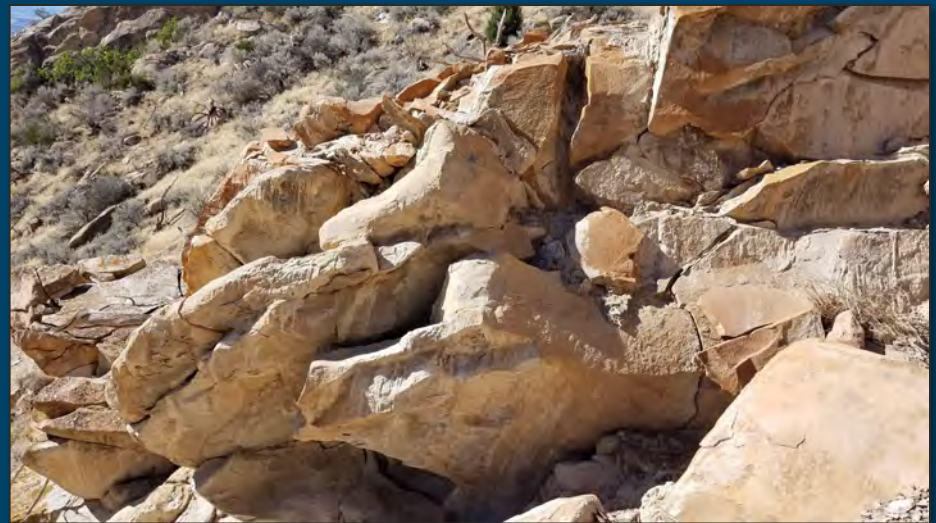
300 °F vents with grout looking South

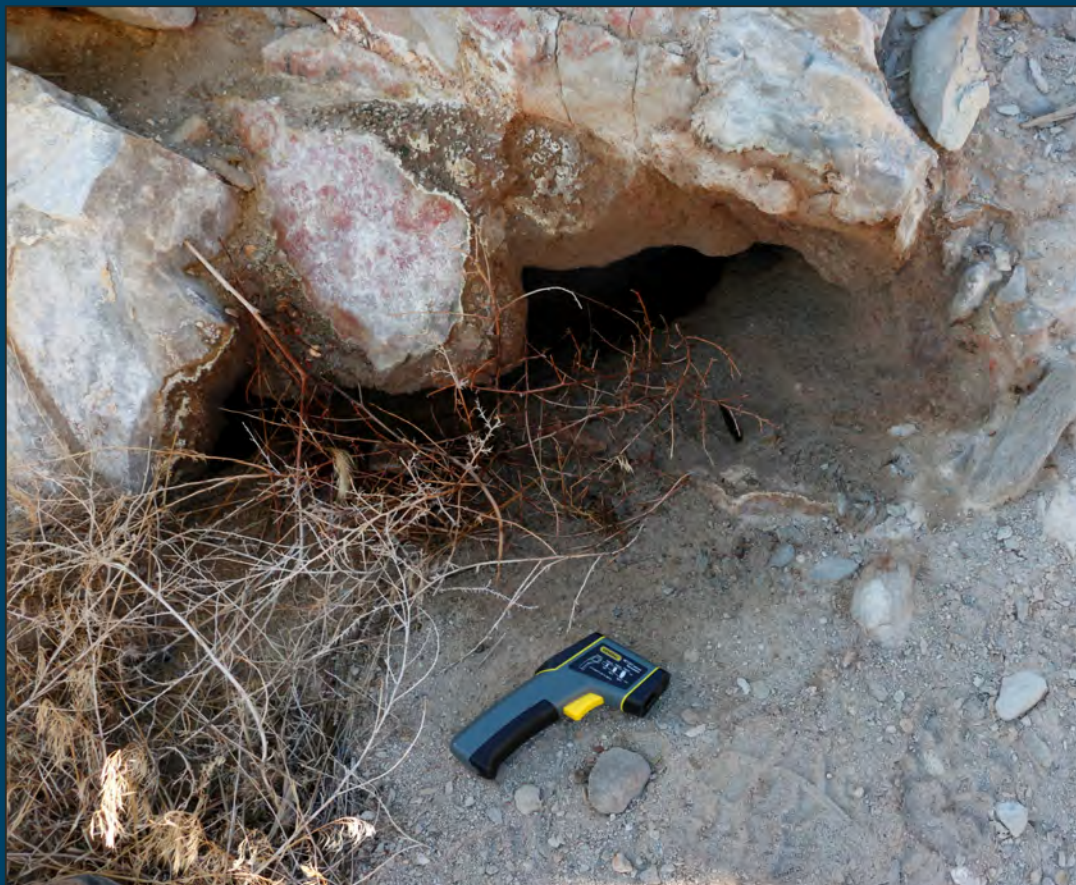
123 °F vents

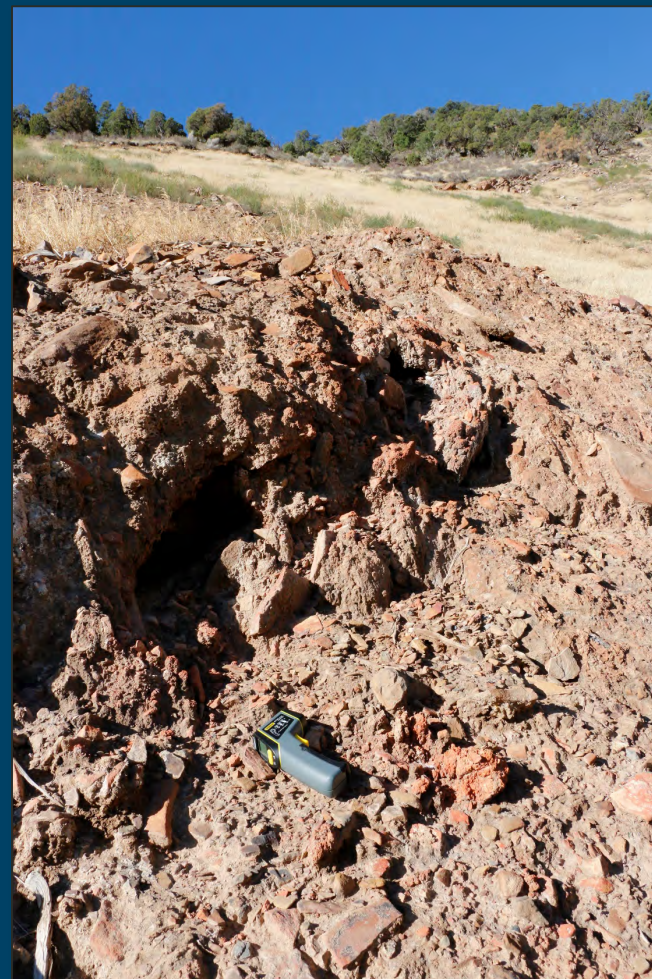
120 °F vents

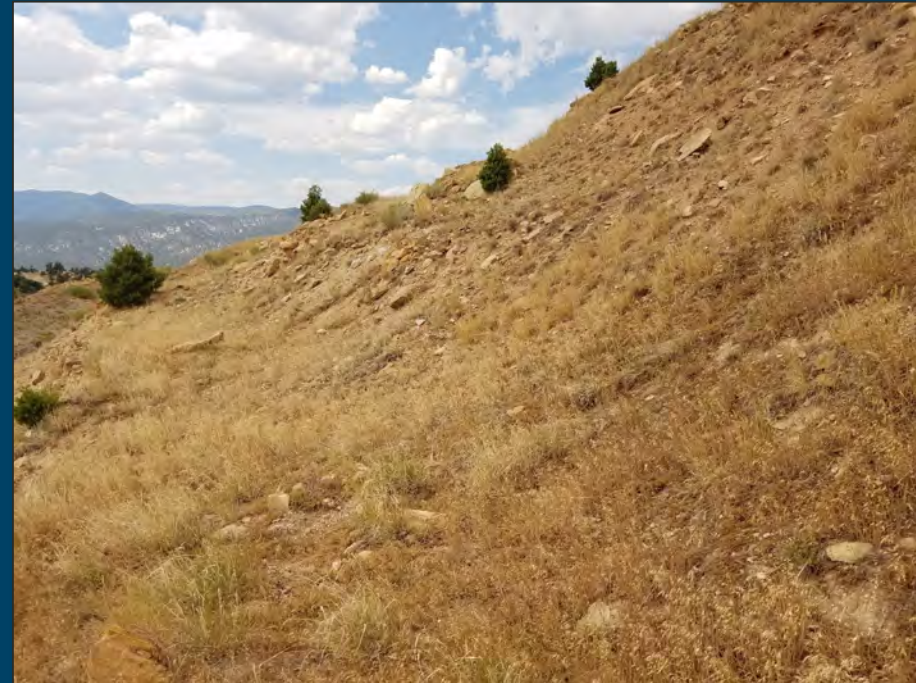
Surface seal vegetation

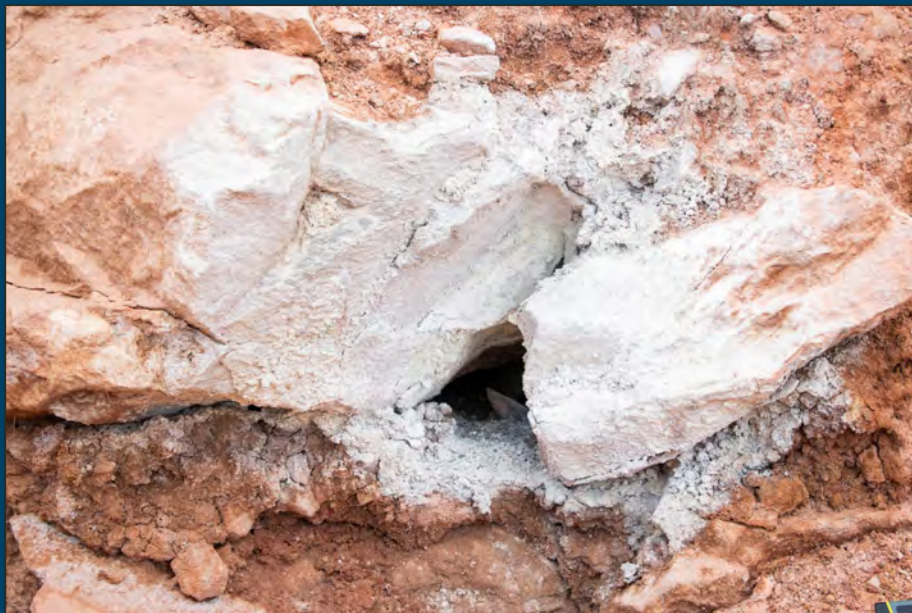
Vent with white precipitate

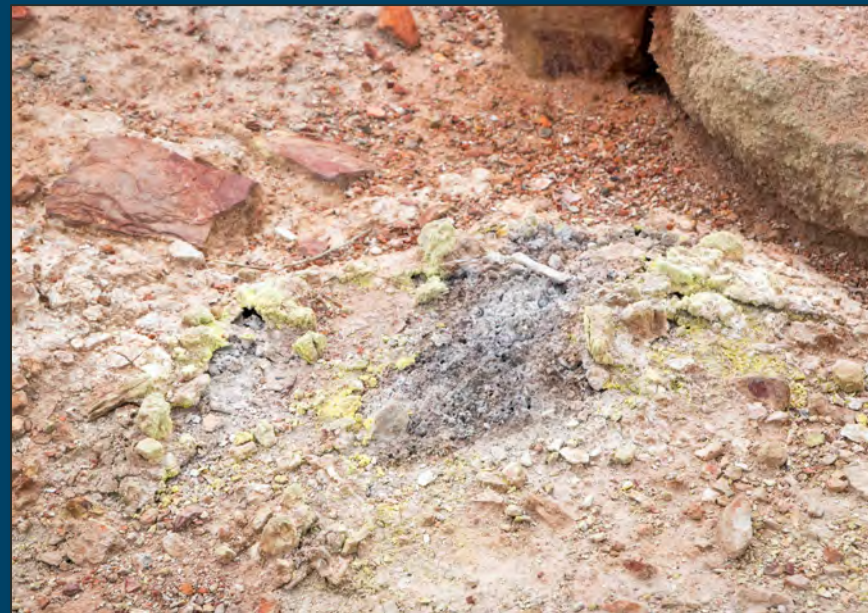
Vent with sulfur precipitate

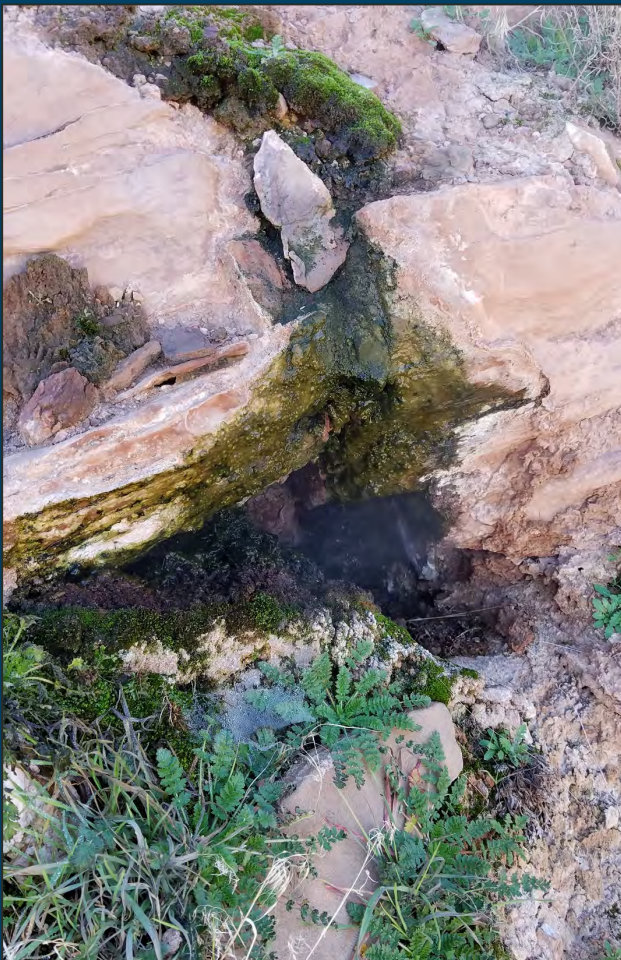
130 °F vent

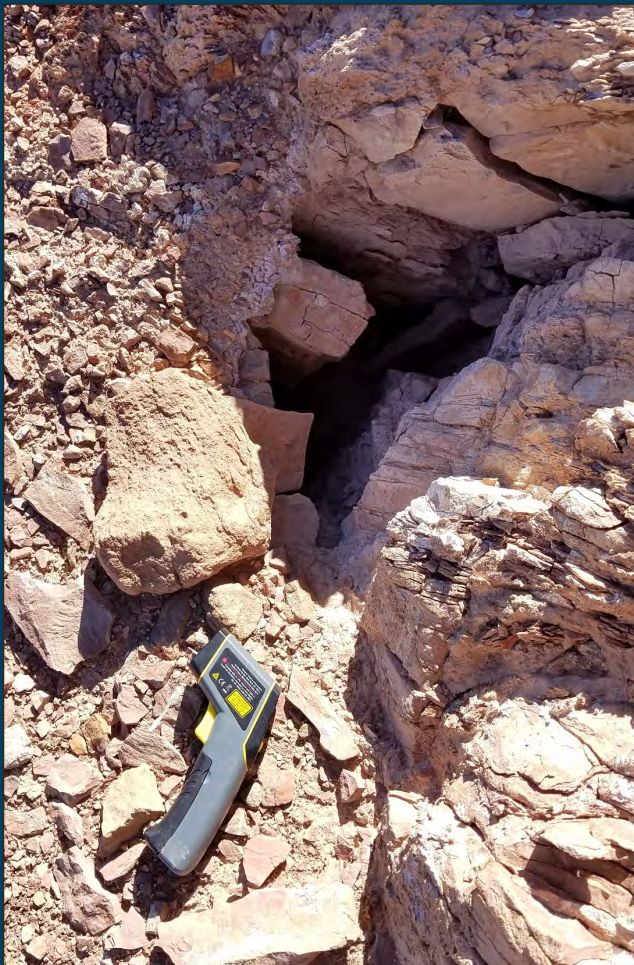
270 °F vent

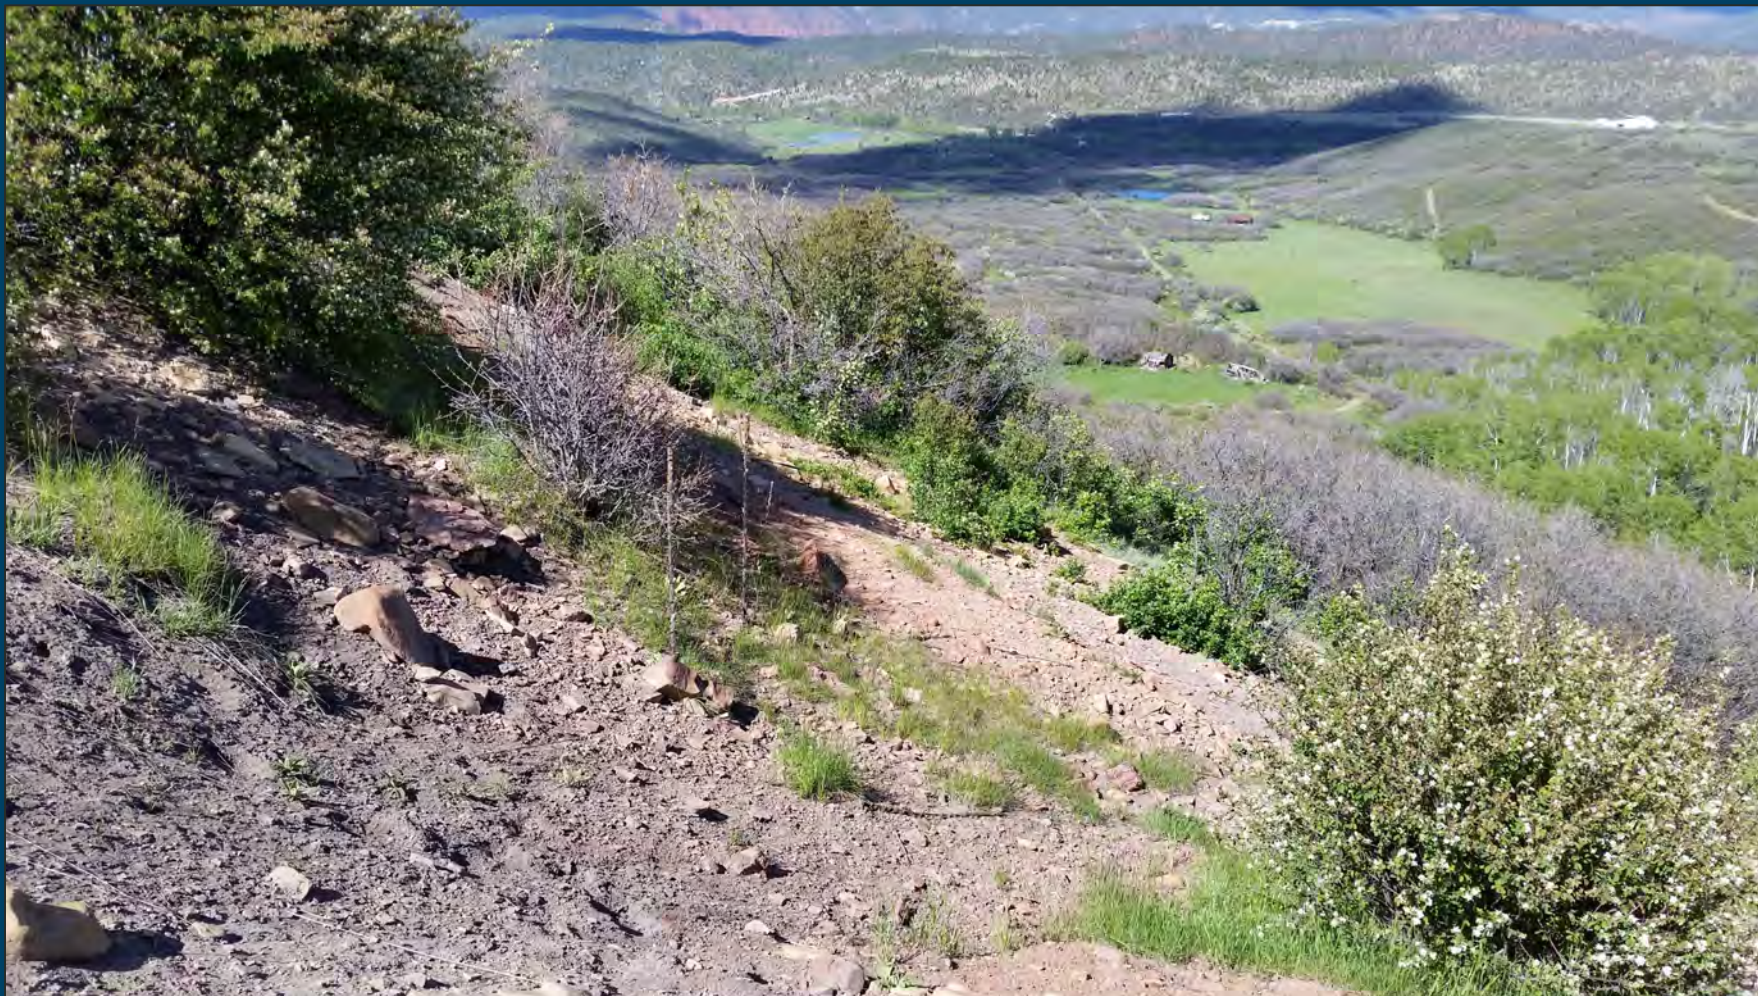
Outcrop looking North

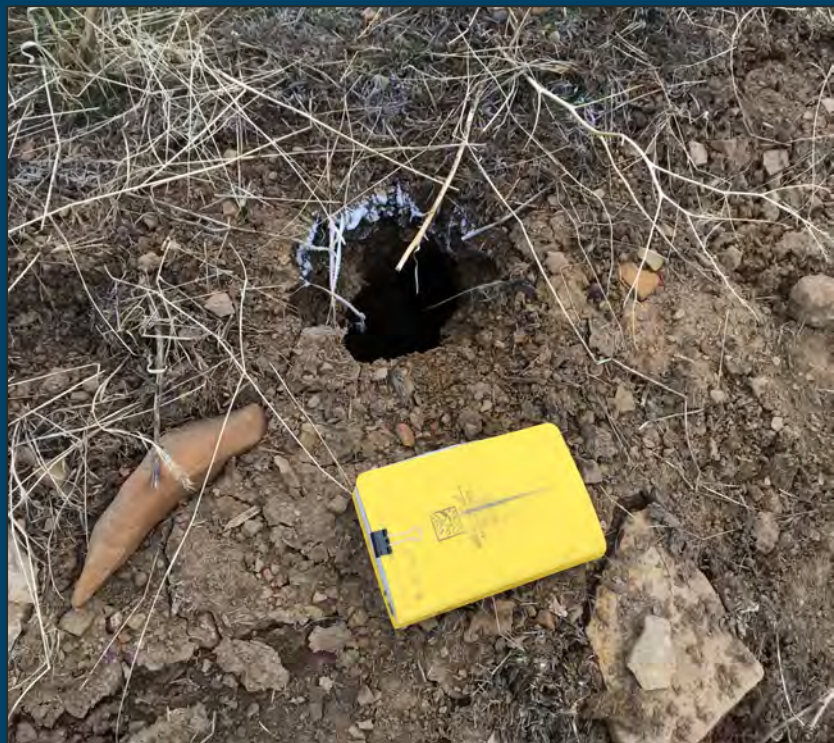
Intake hole

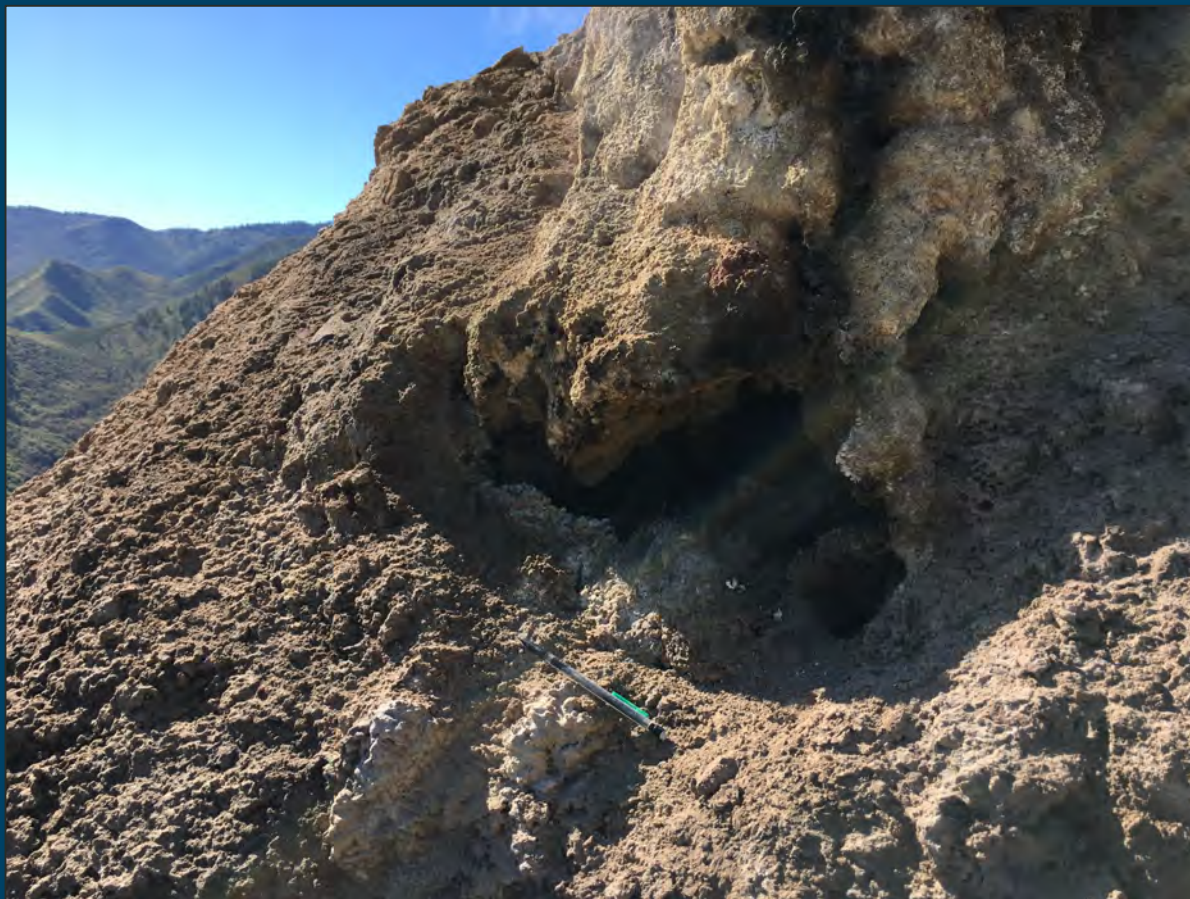
197 °F westernmost vents

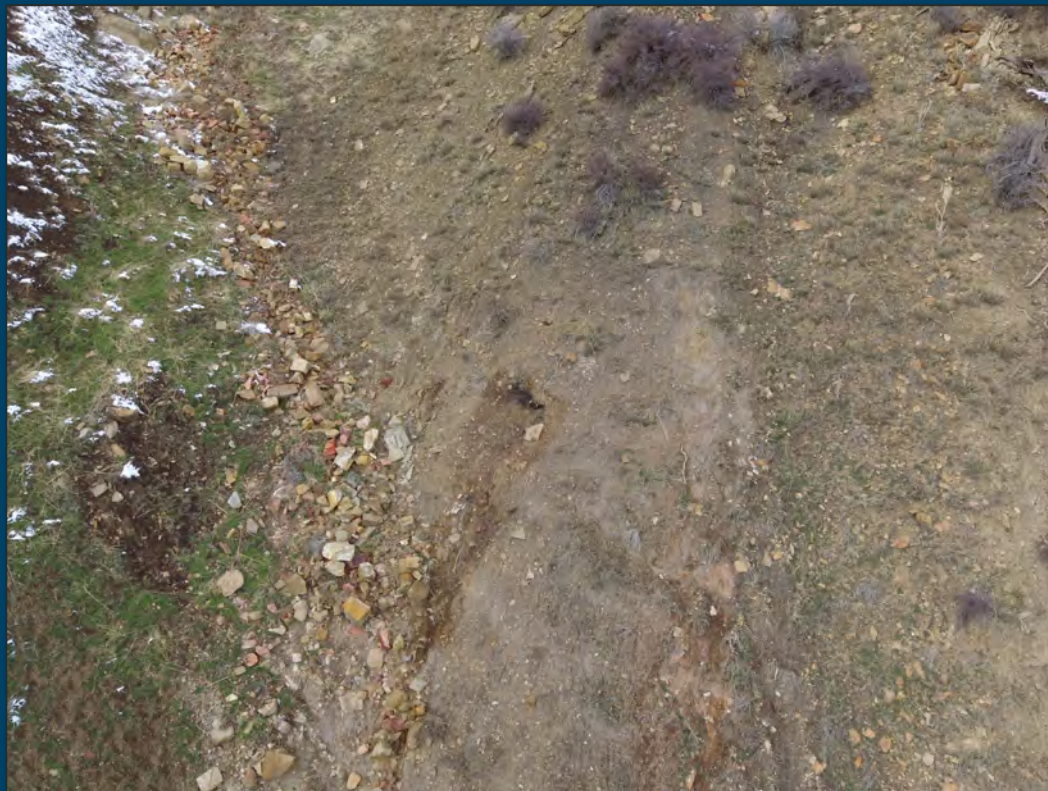
New vent January 25, 2018

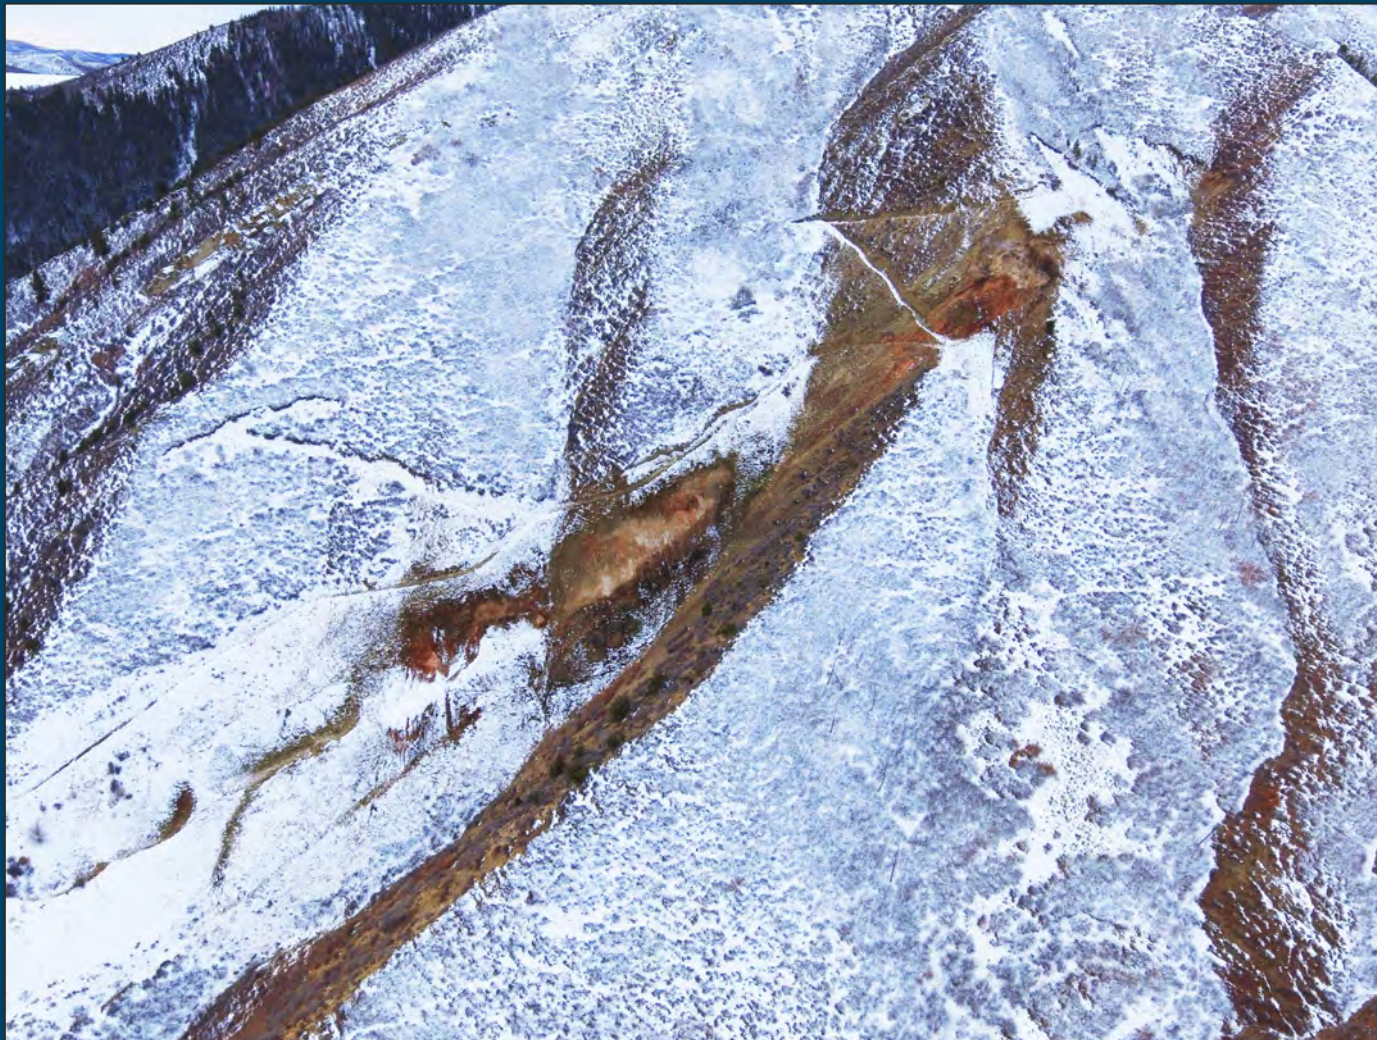
Snowmelt looking Southwest January 25, 2018

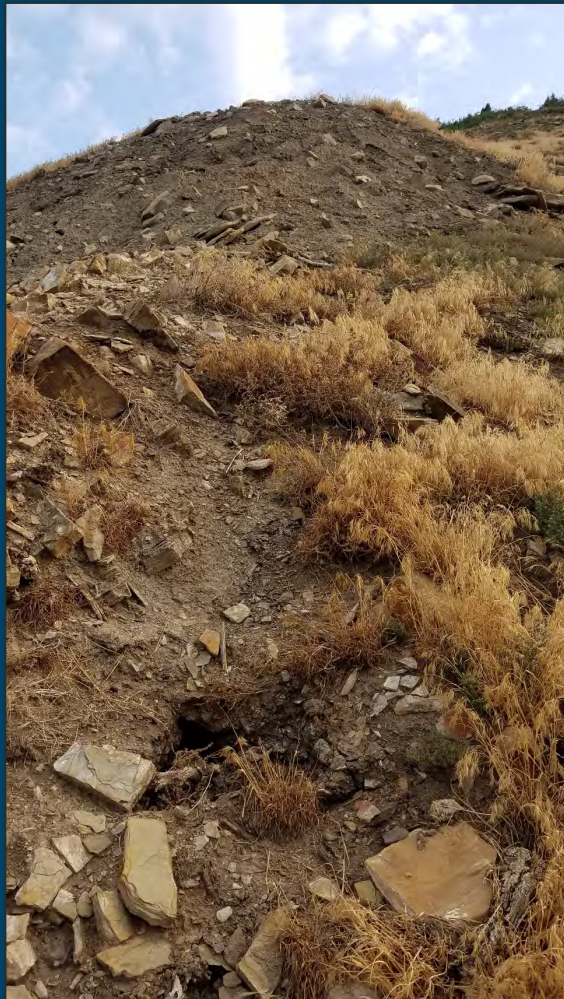
Vent Southeast of main  
expression

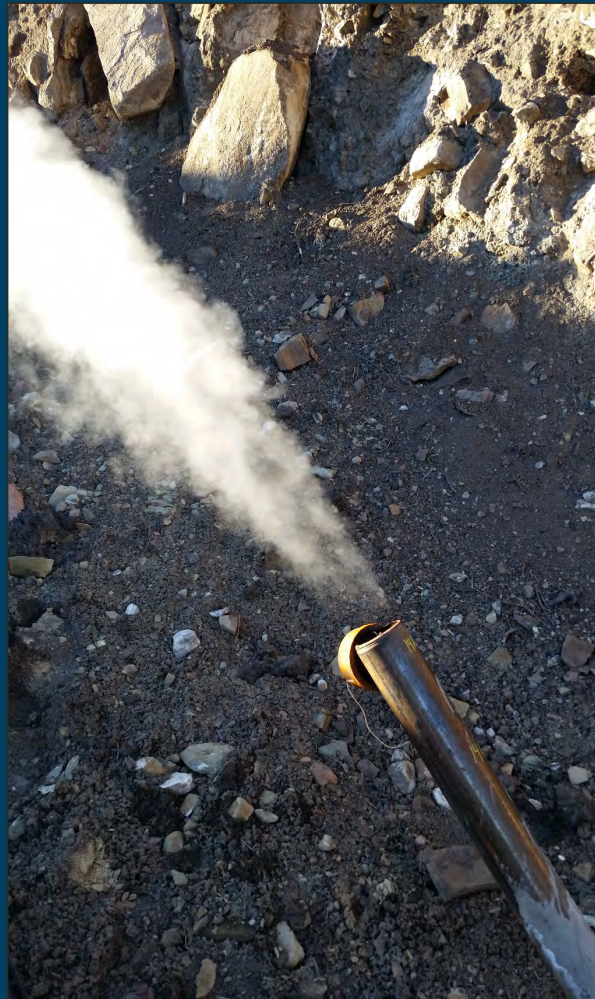
BH-14 exhaust

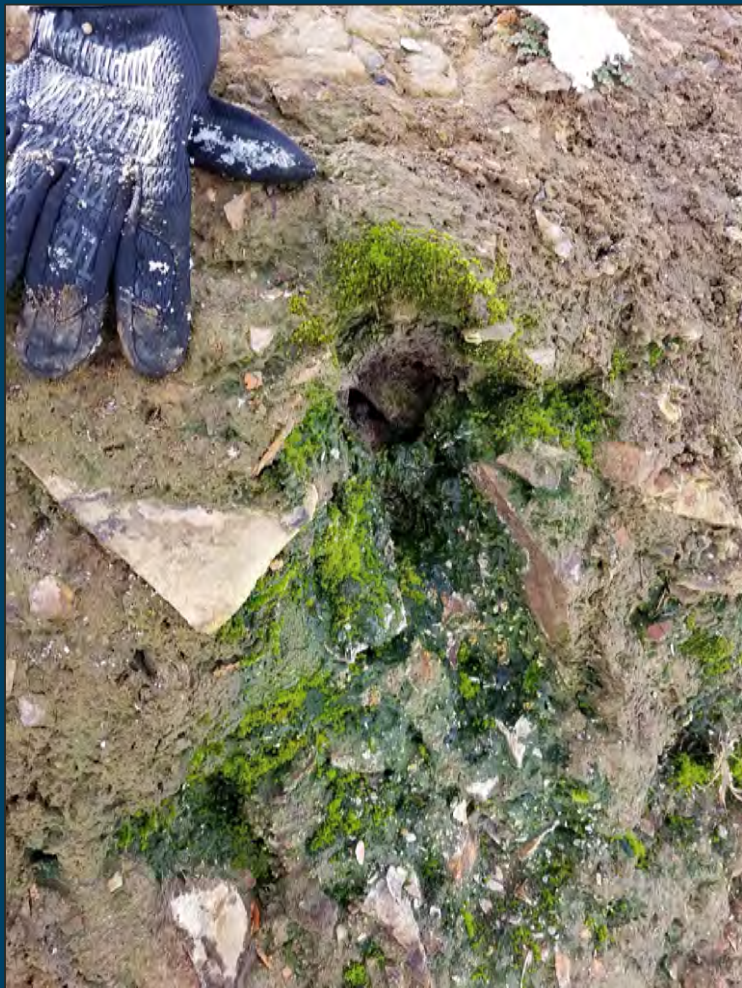
Small vent

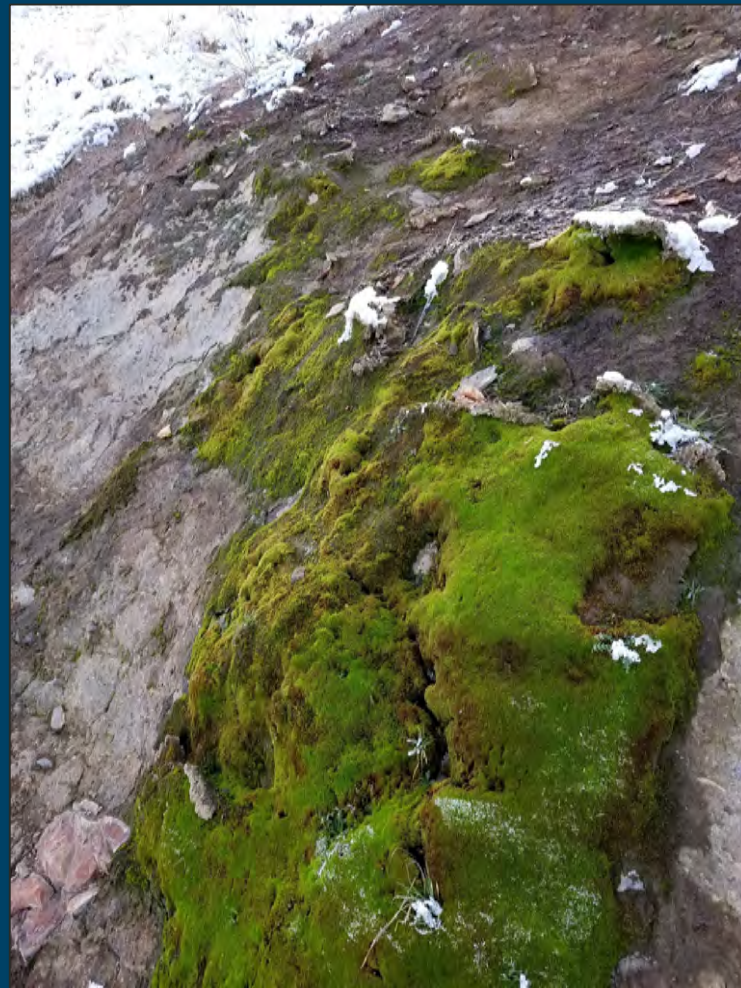
Small vents with moss growth

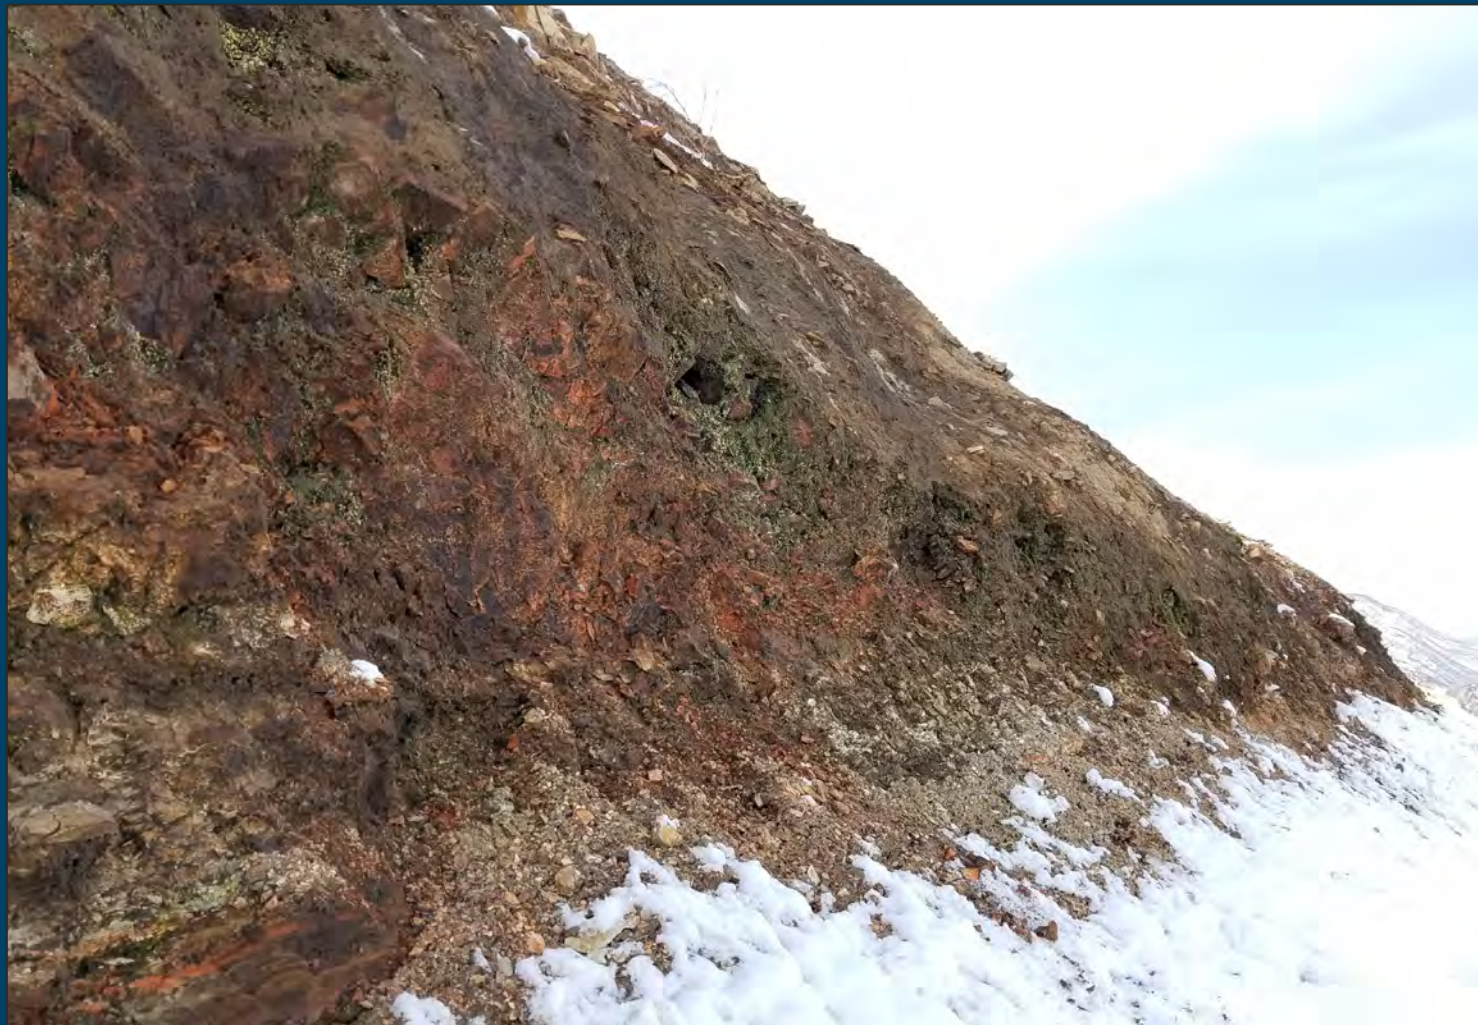
Vents in outcrop

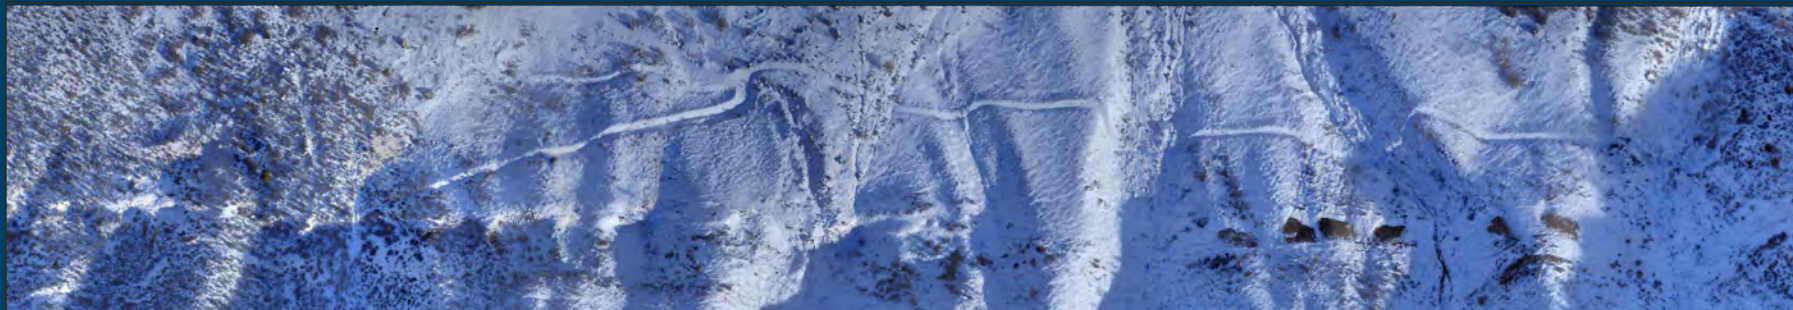
Snowmelt drone imagery February 21, 2018

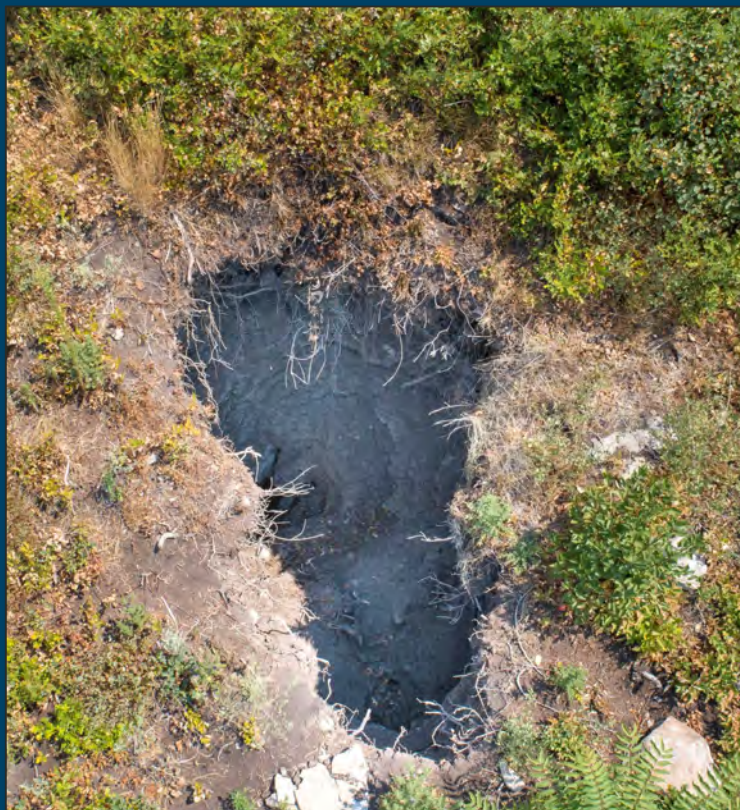
90 °F main vent

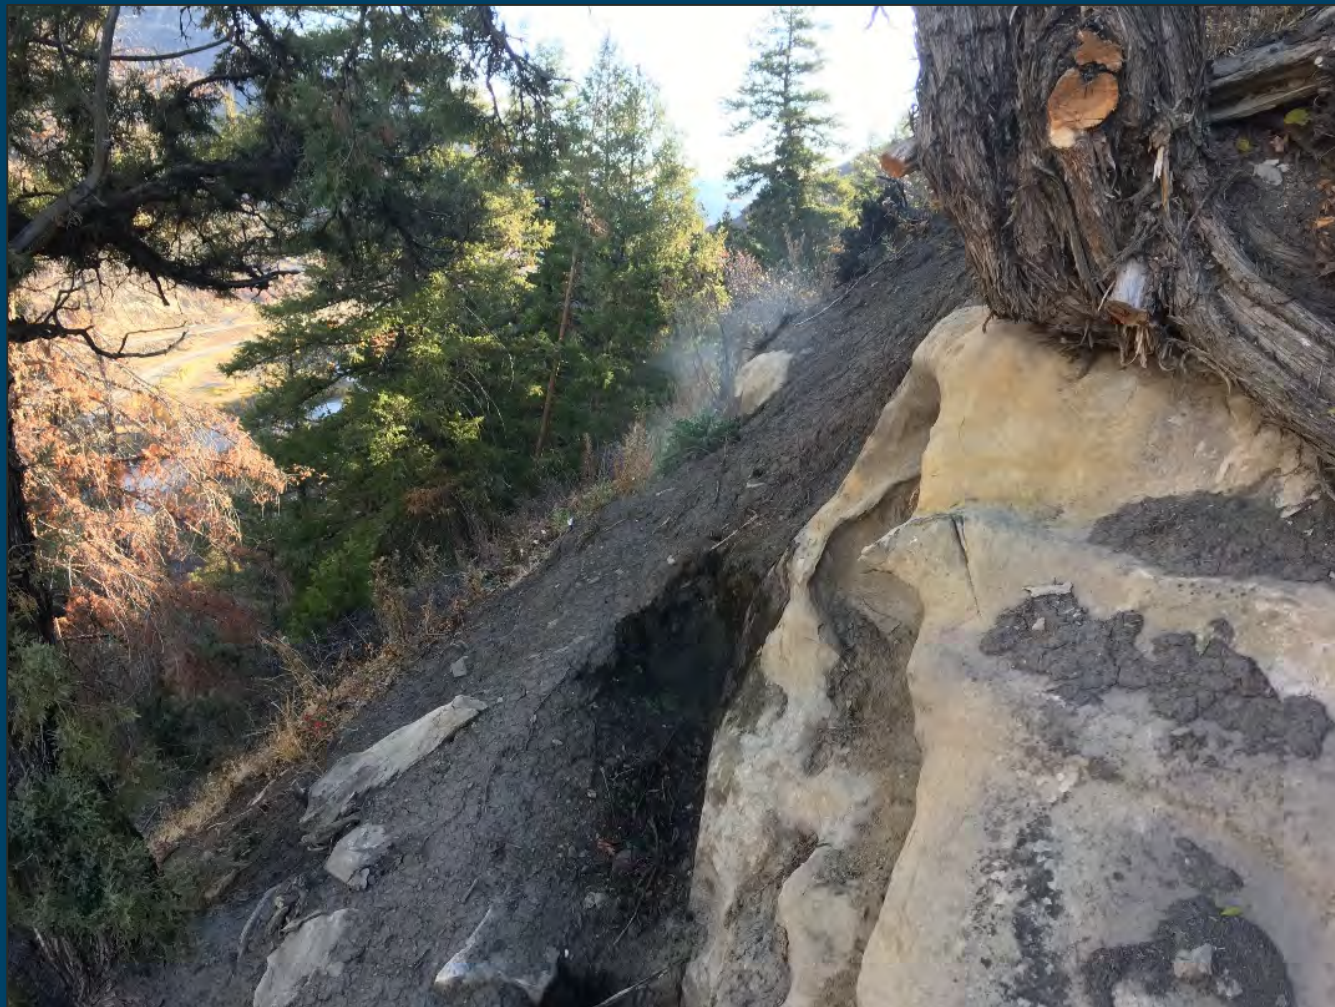
East vents

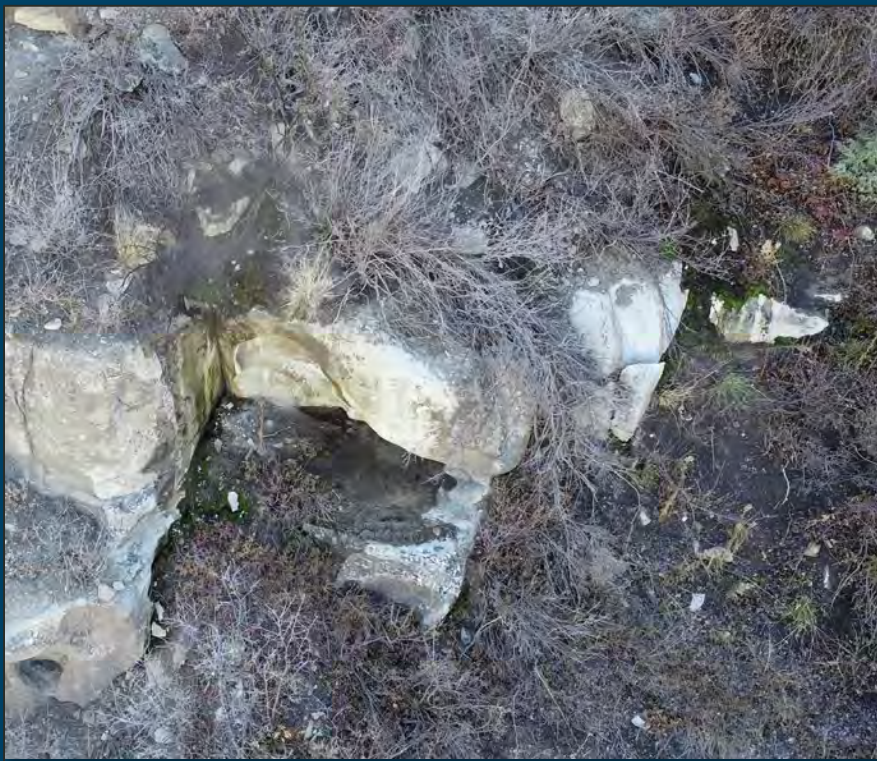
90 °F West vent

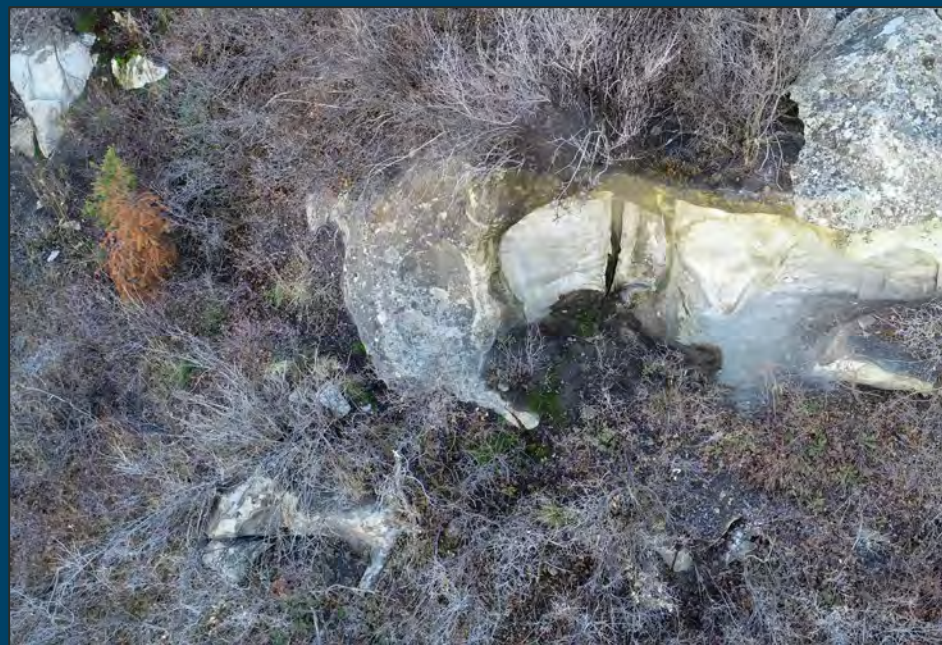
# Bear Mine

90 °F West vent

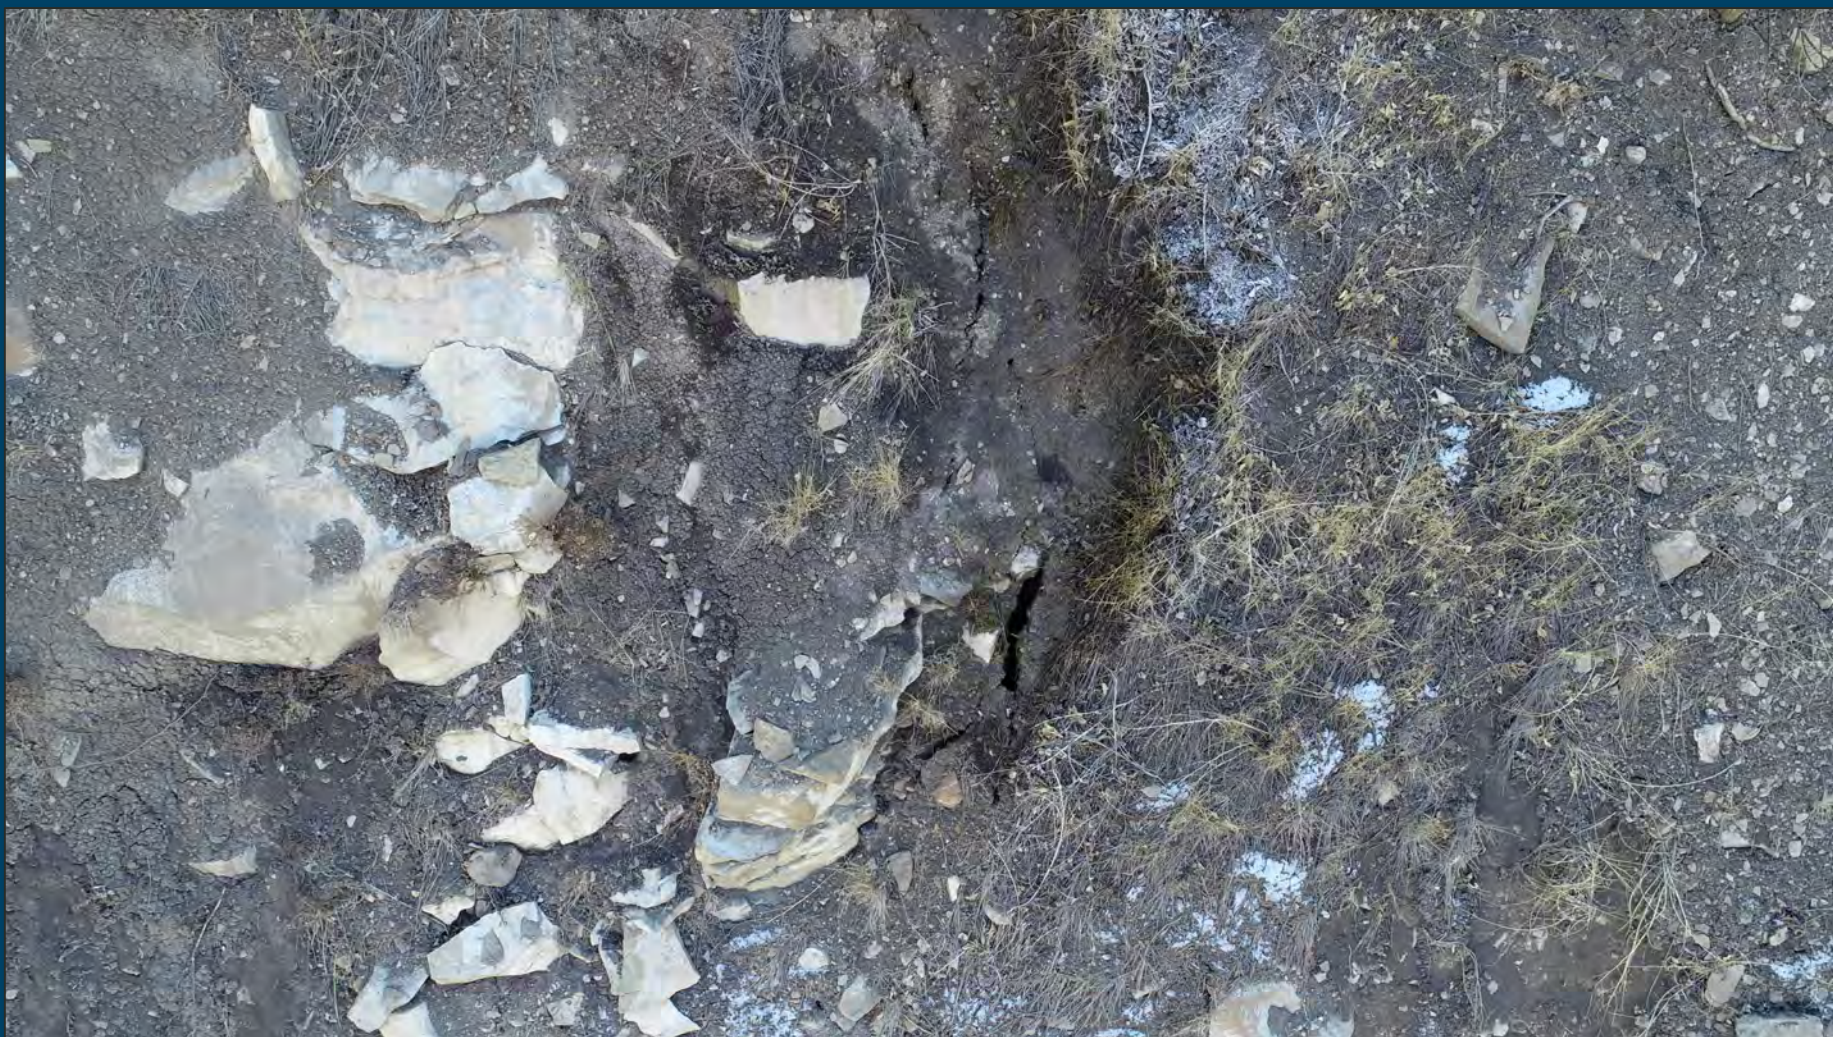
# Oliver Mine

90 °F lower vent
