# Colorado Underground Coal Mine Fires 2018 Inventory Report

August 2019

**Tetra Tech**  
350 Indiana Street, #500  
Golden, Colorado 80401

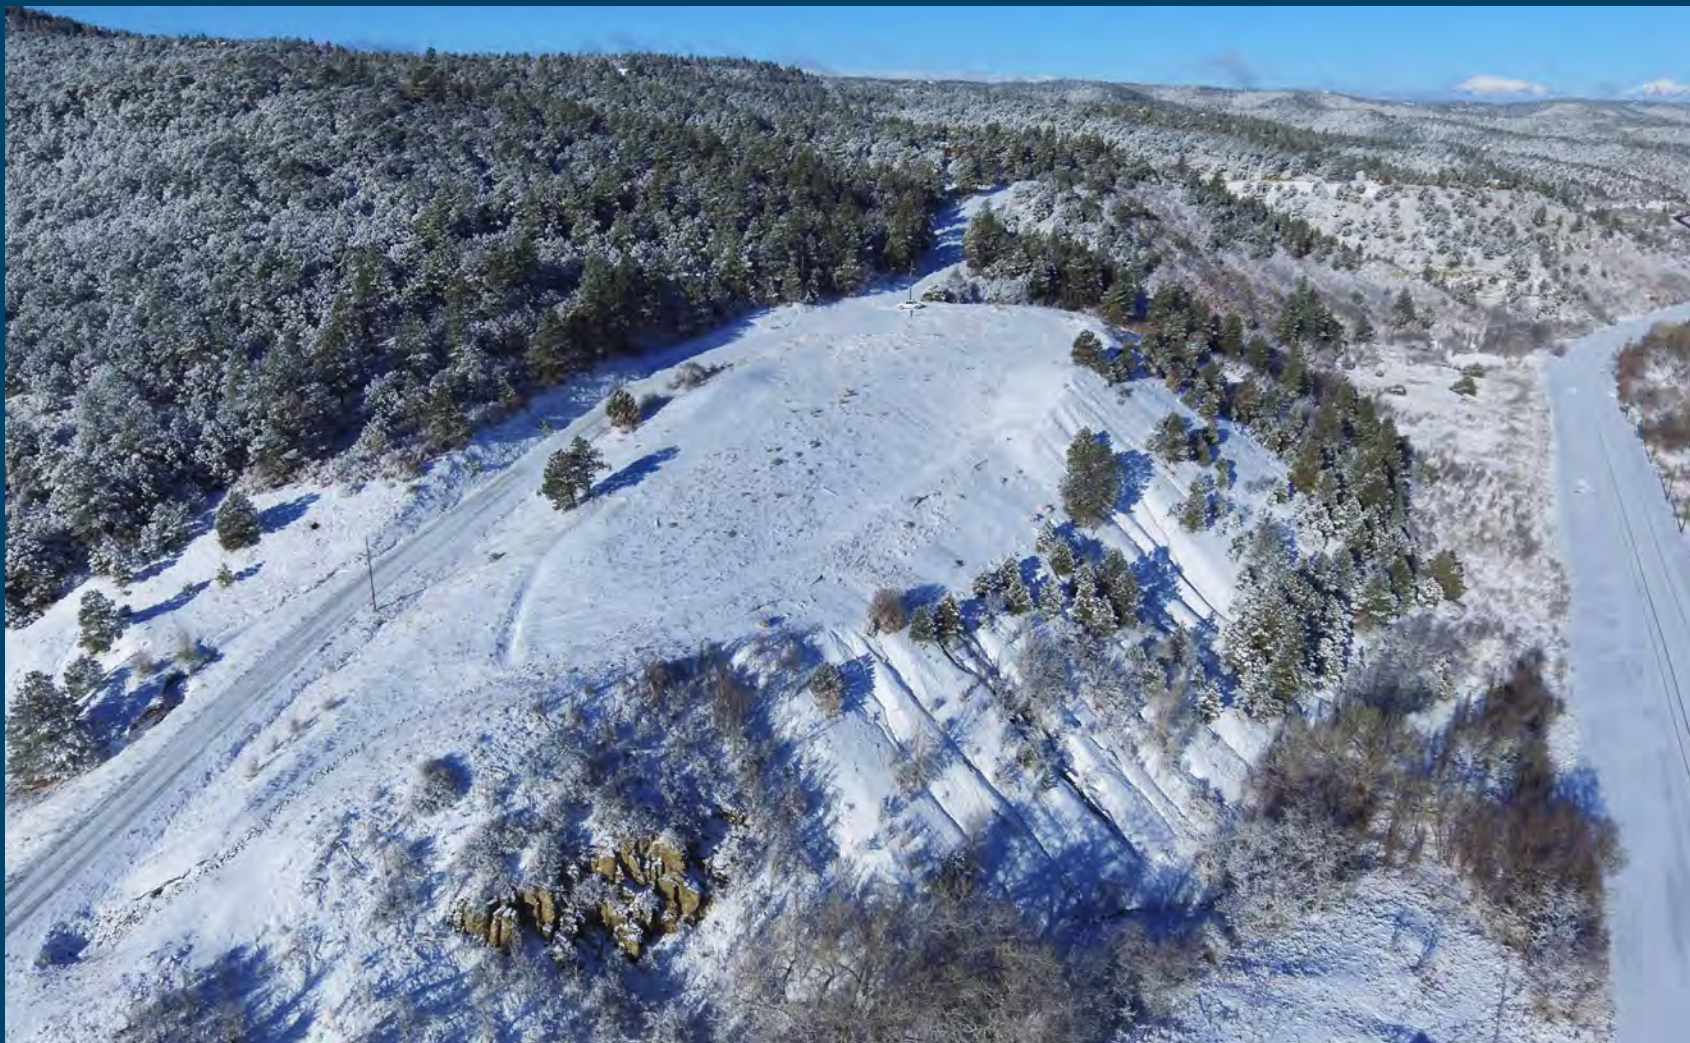
# Morley Coal Refuse Pile

Morley Coal refuse pile fire looking West

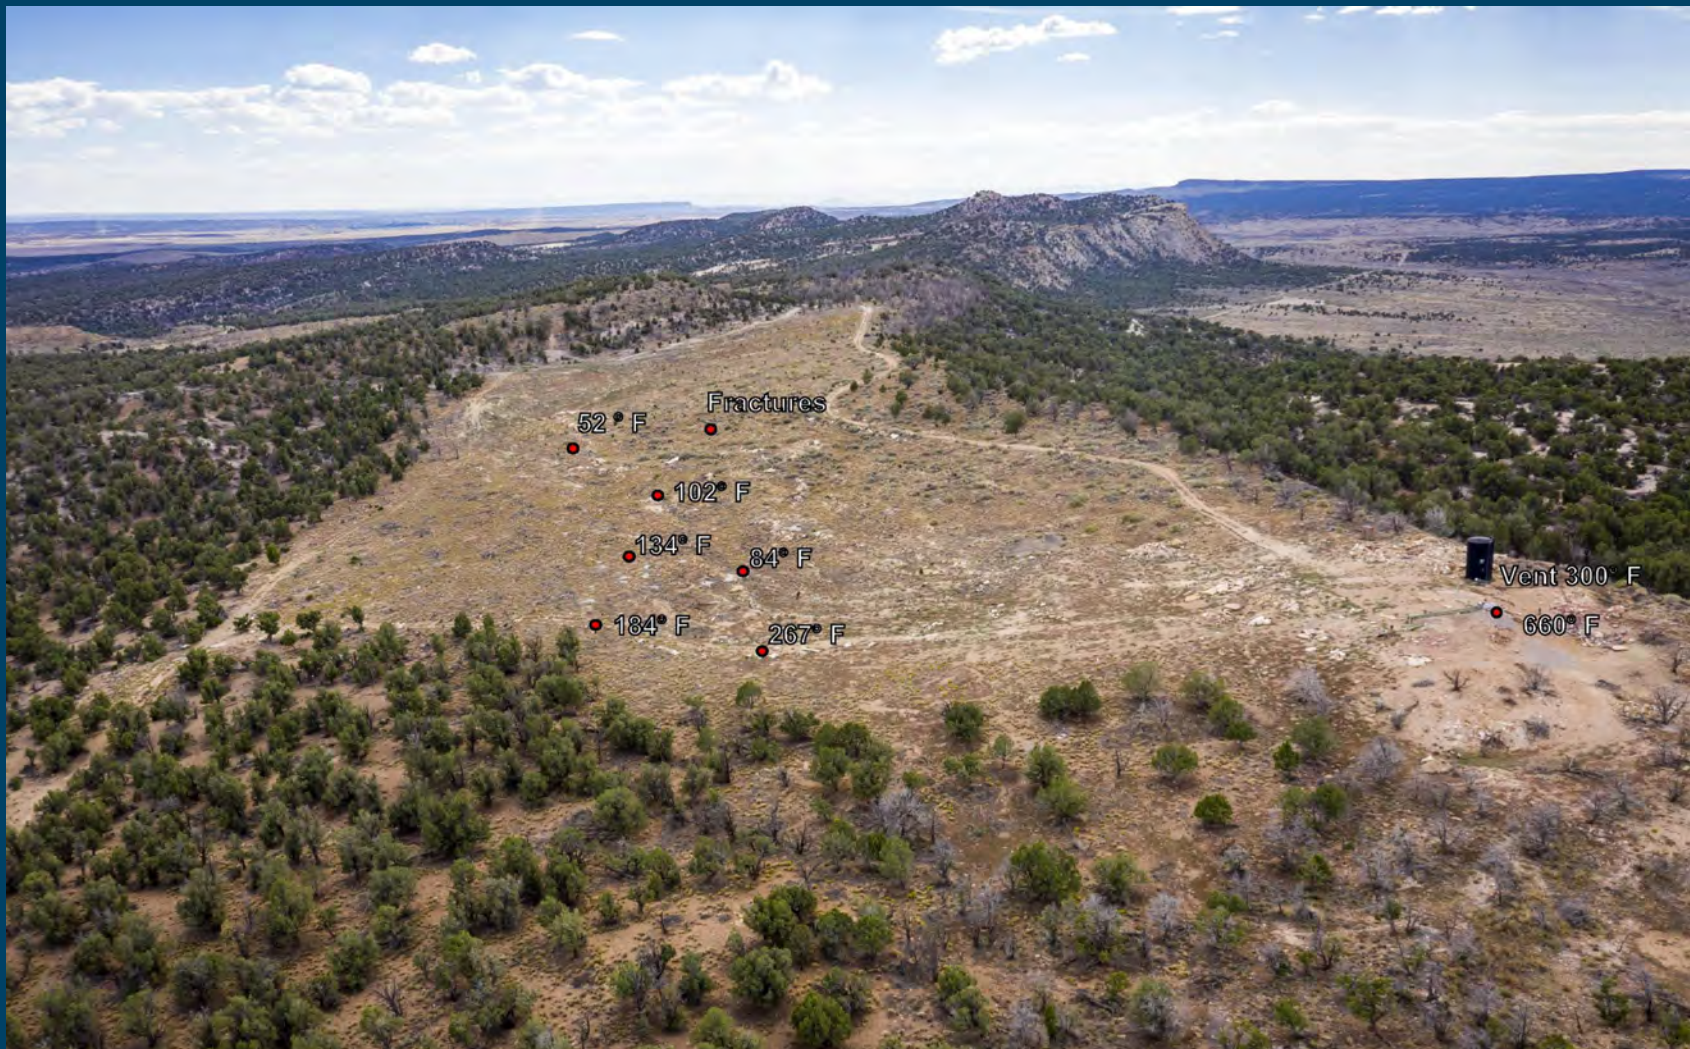
# North Coal Mine

North Coal Mine fire looking South

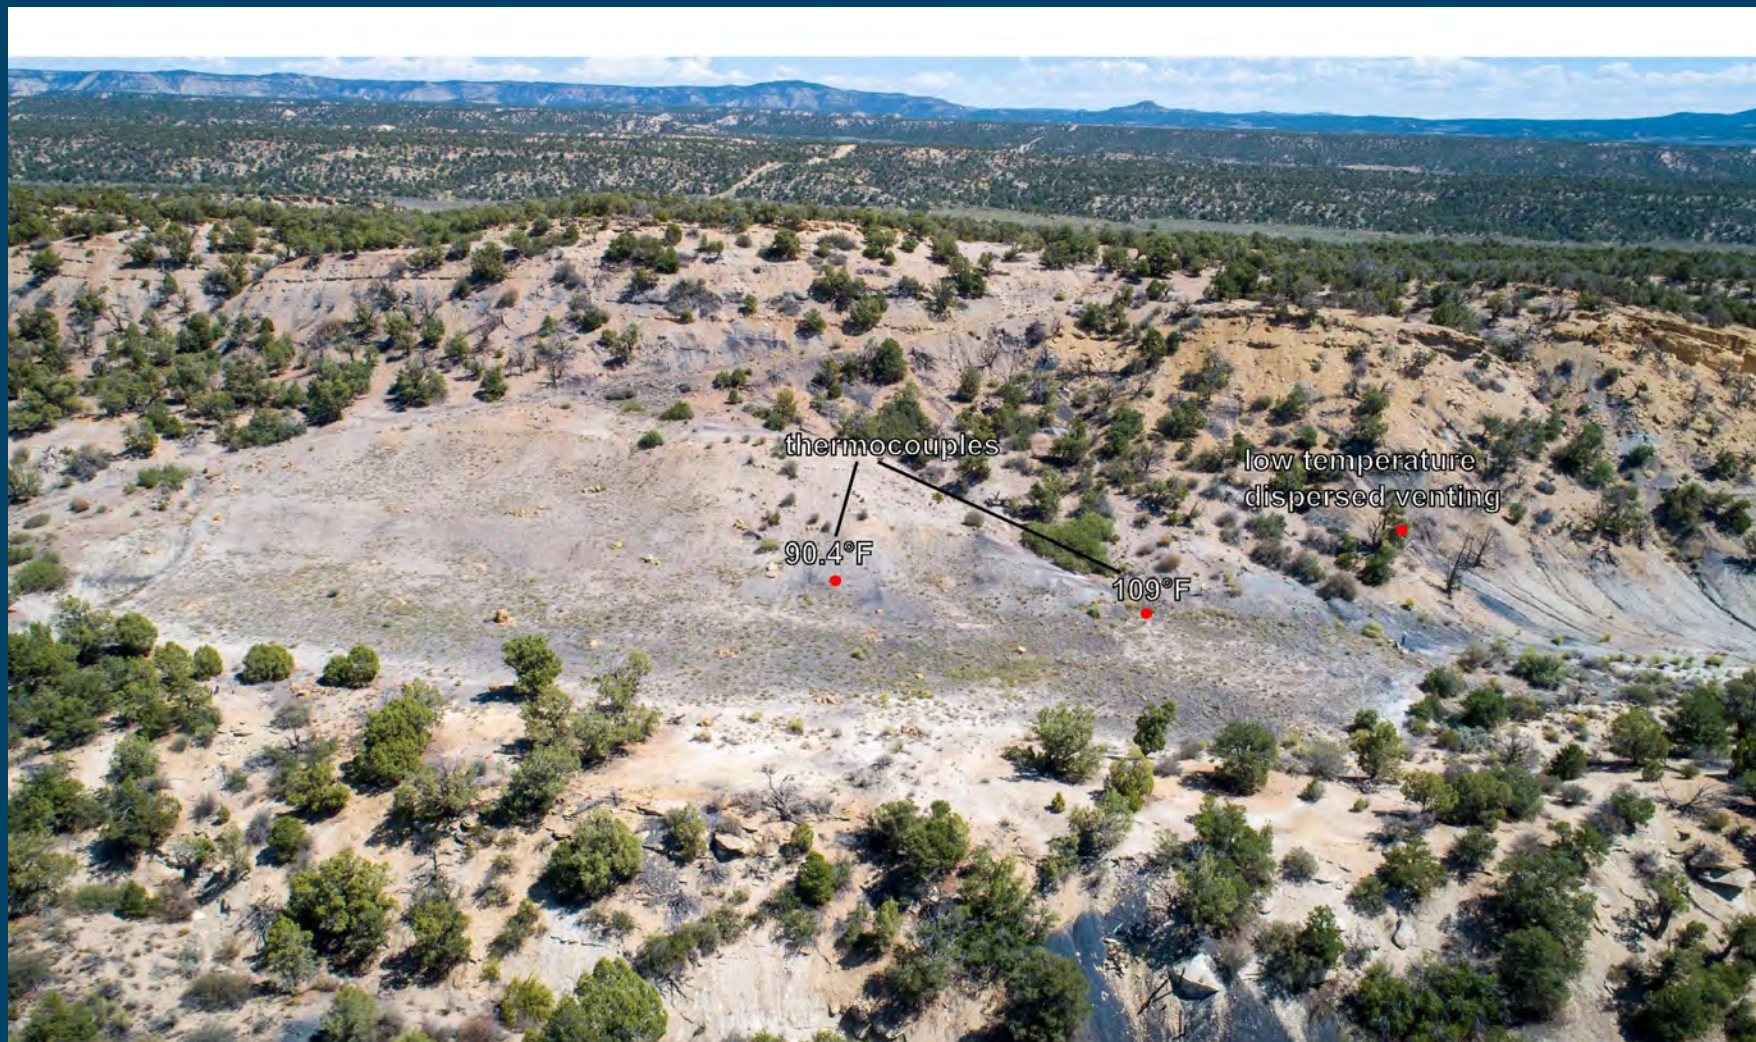
# Soda Springs

Soda Springs Mine fire looking East

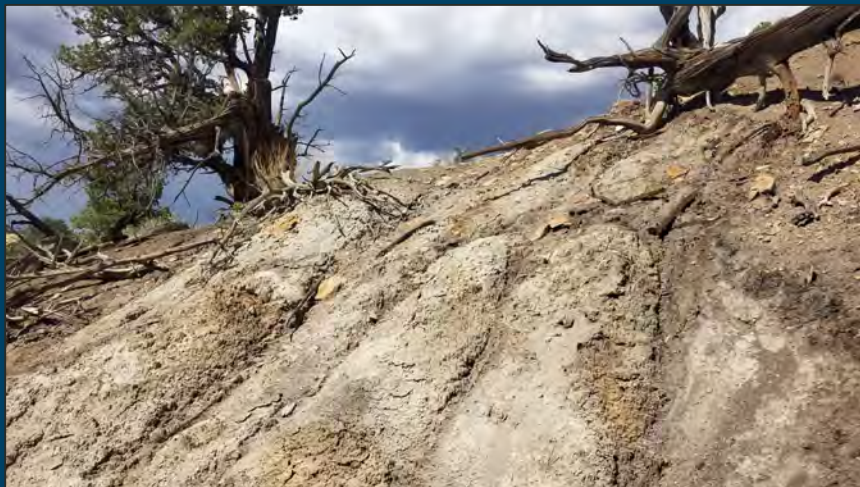
Area of low heat/oxidation looking North

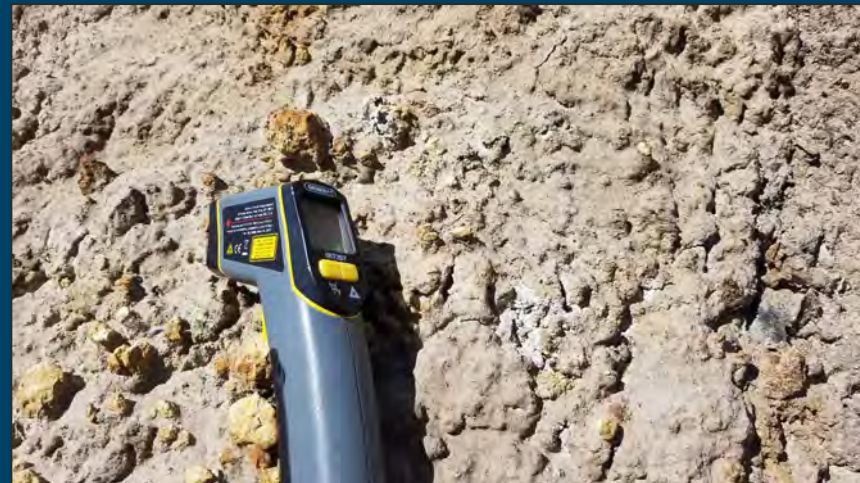
Small vents

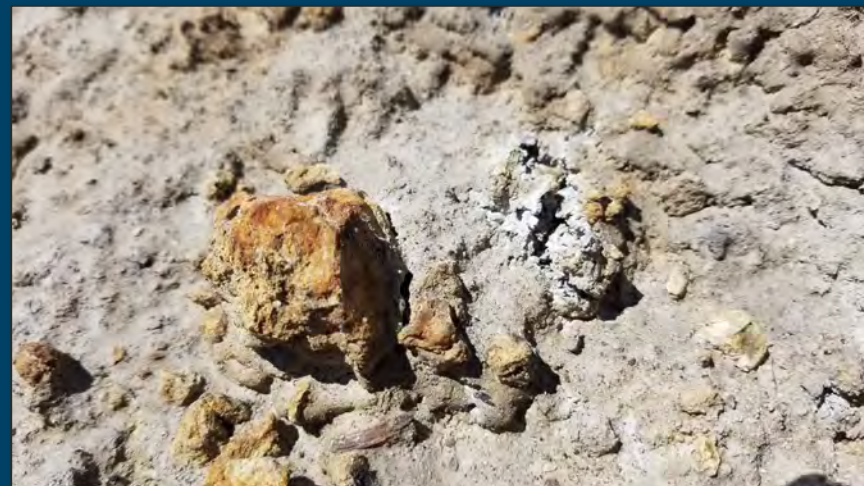
Small vents

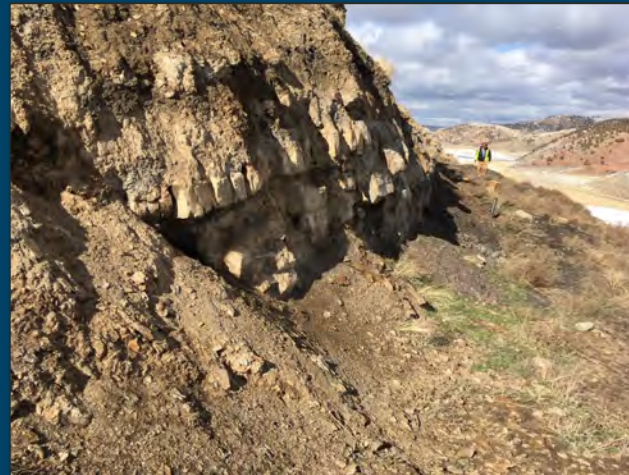
Vents in outcrop

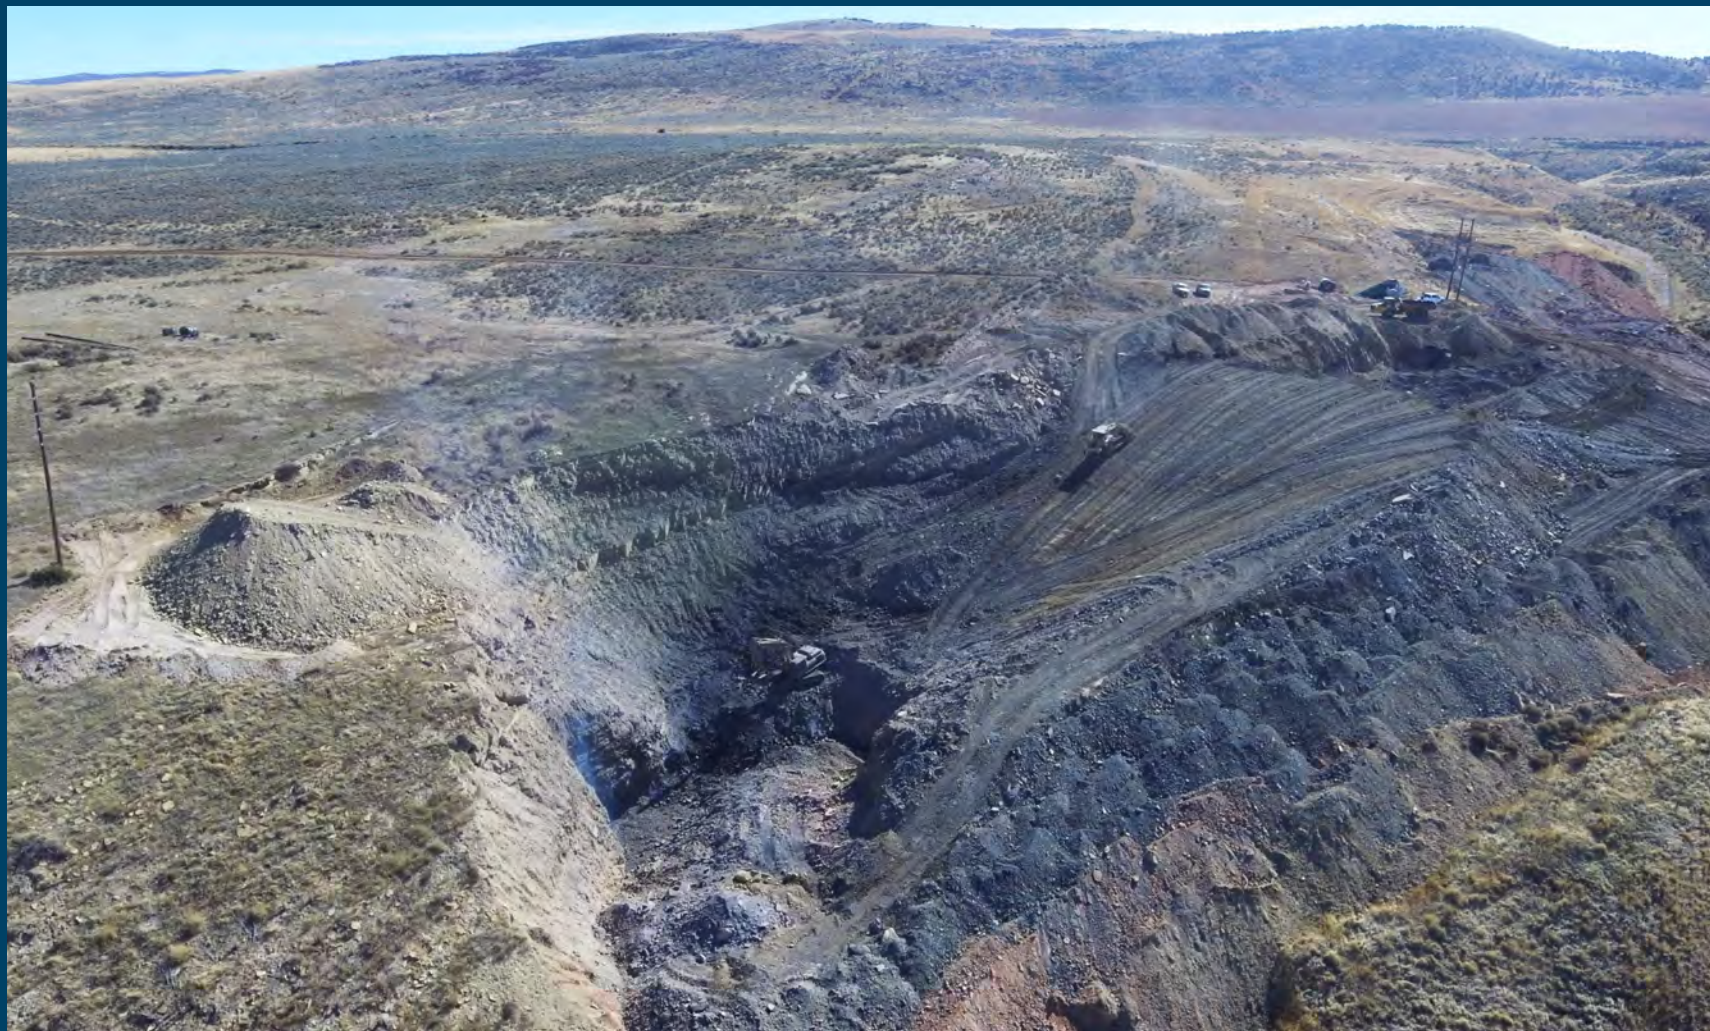
North abatement area with open seam looking Southeast (October 17, 2017)

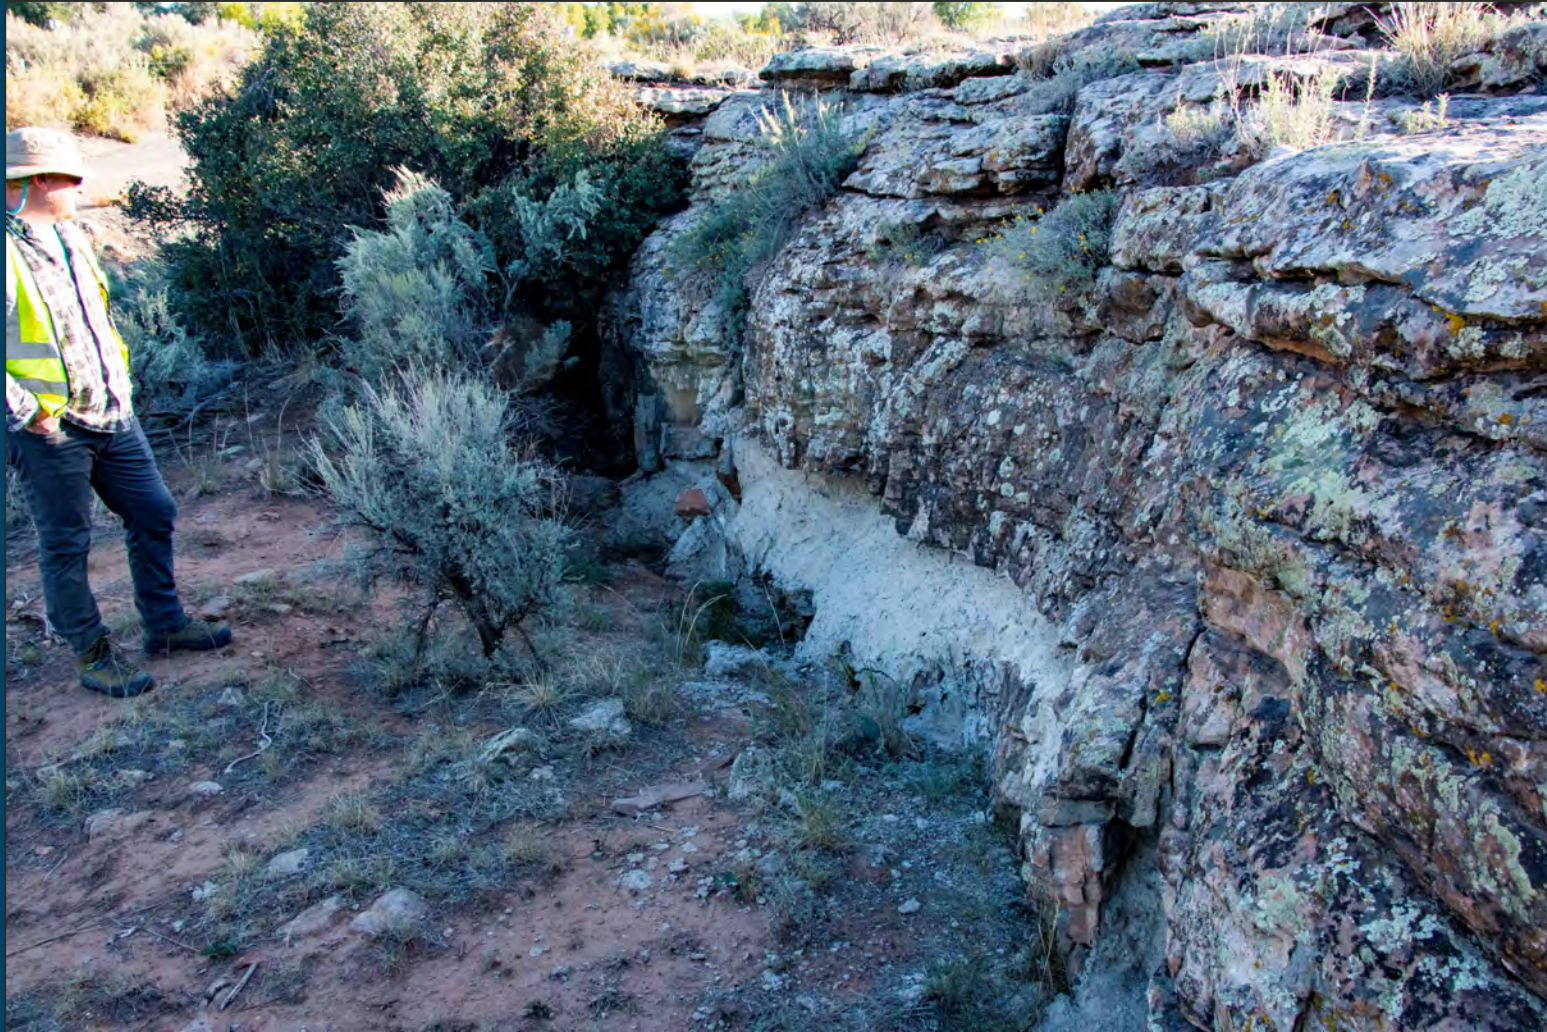
Older grout at sandstone outcrop

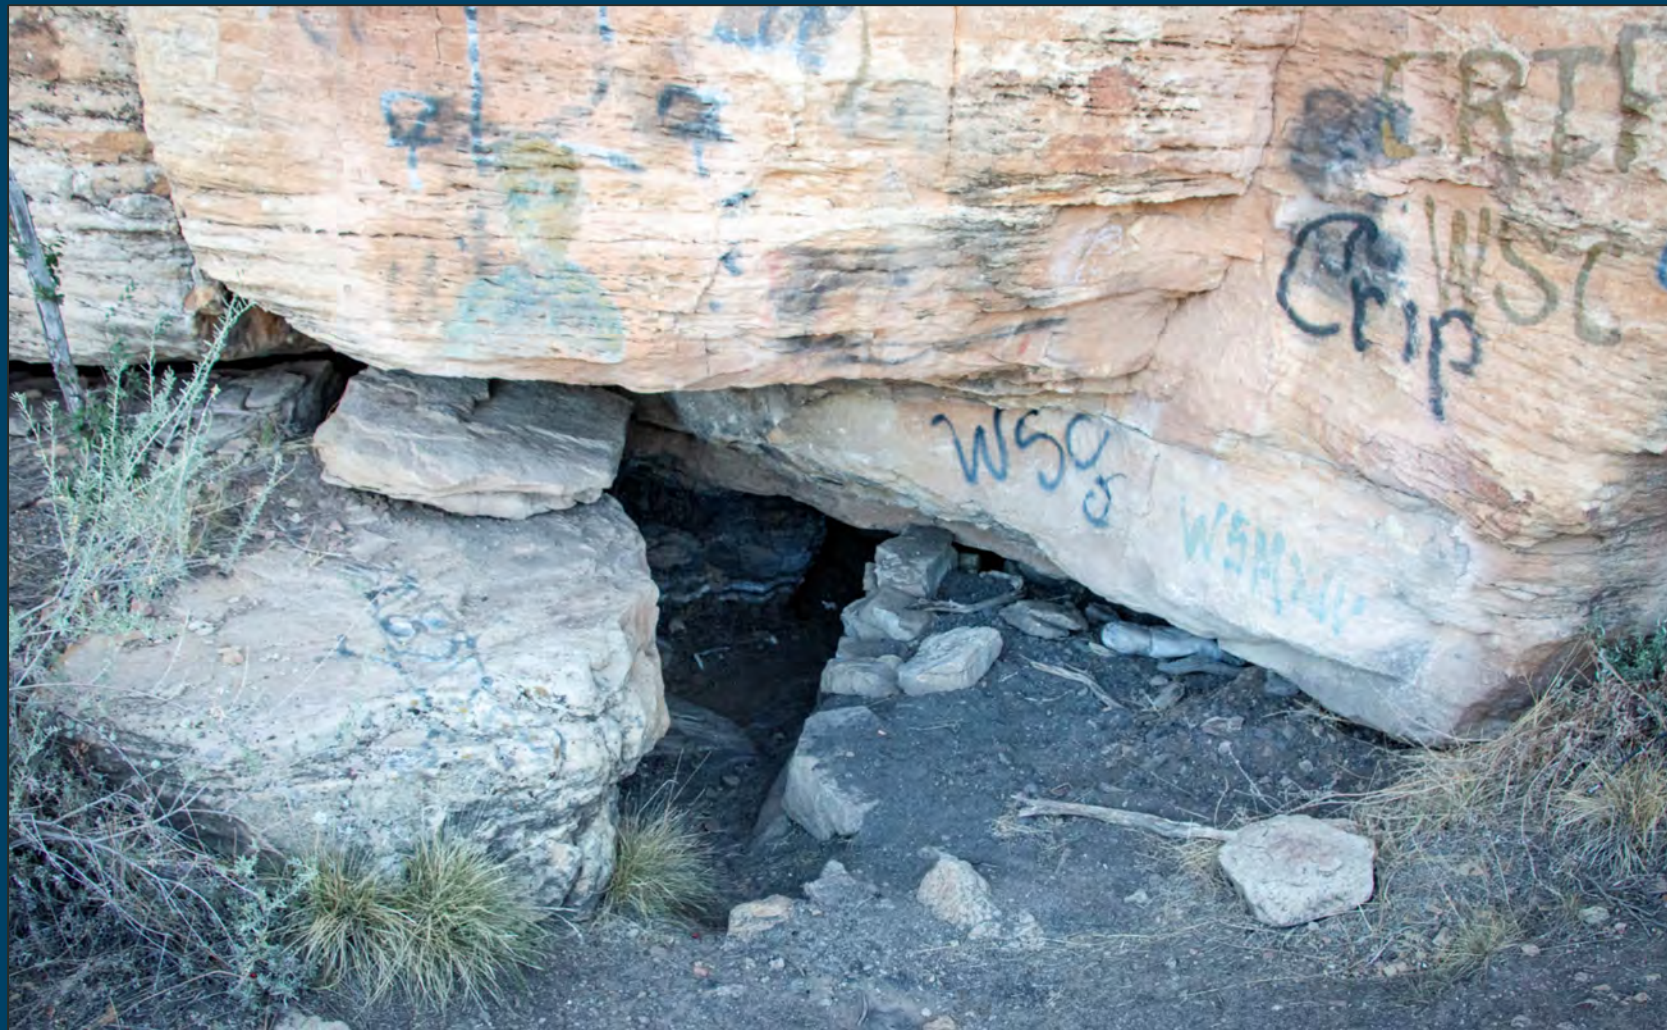
Open mine adit

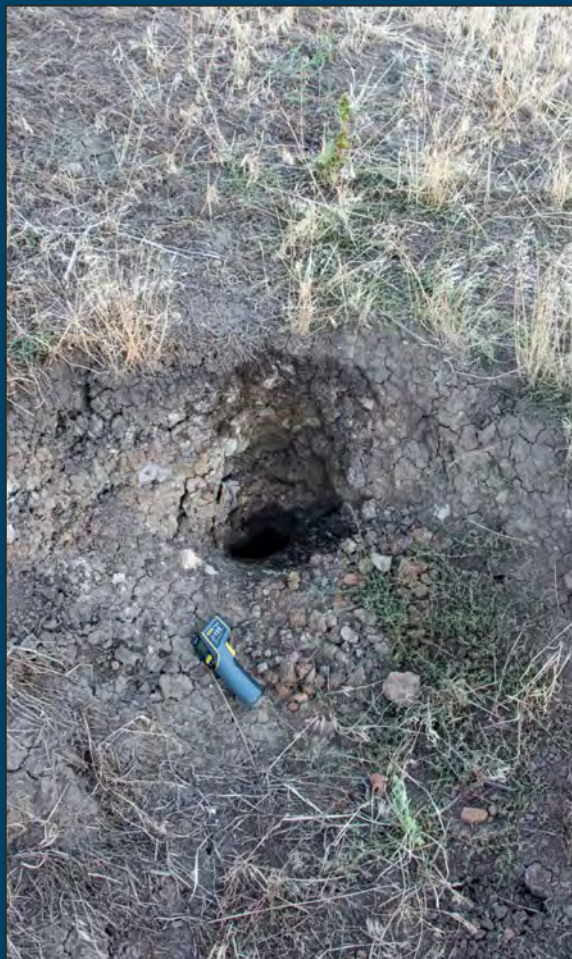
110 °F vent

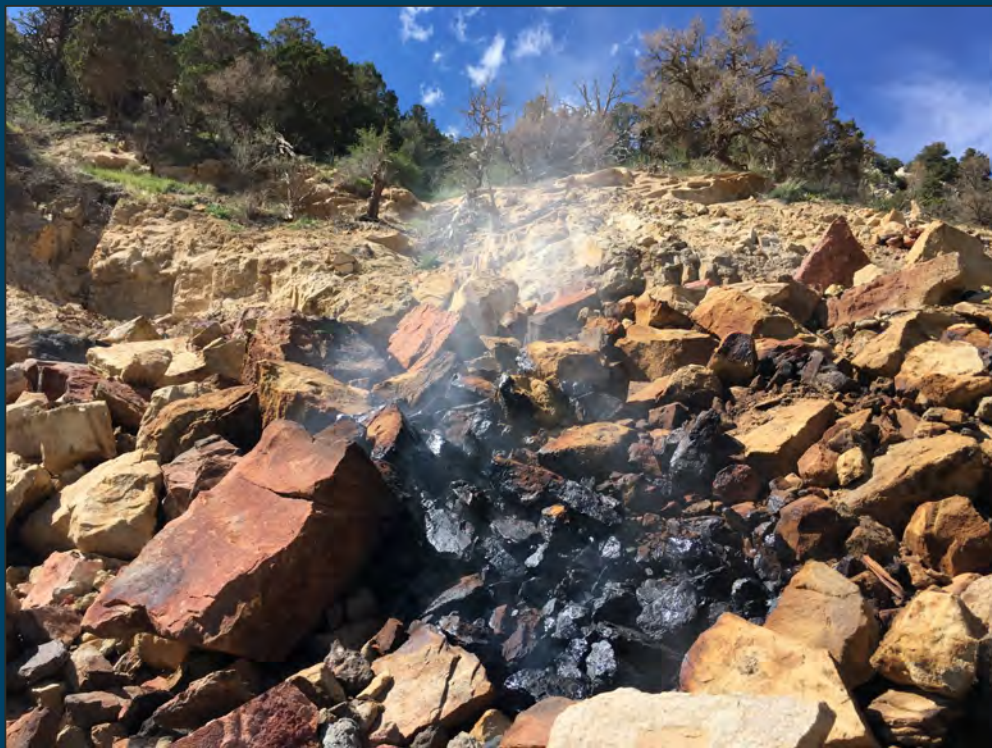
In 2015 and 2016, a mine fire abatement project was completed at the Black Diamond site. The remediation entailed excavation of the burning outcrop, regrading the slope, and covering the area with a layer of locally sourced riprap. Access for the abatement activities was granted through a partnership with BLM, and the access roads were reclaimed as new multi-use single-track trails connected to the trail system in Meeker, CO. Based on high-resolution 3D modeling and observations during the excavation, it seems likely that the outcrop fire was started after the fire in the mine progressed out the air shaft, and the air shaft continues to vent through the soil of the regraded slope and riprap armor layer. The vent location is easily identifiable by heavy creosote staining.

Large vent

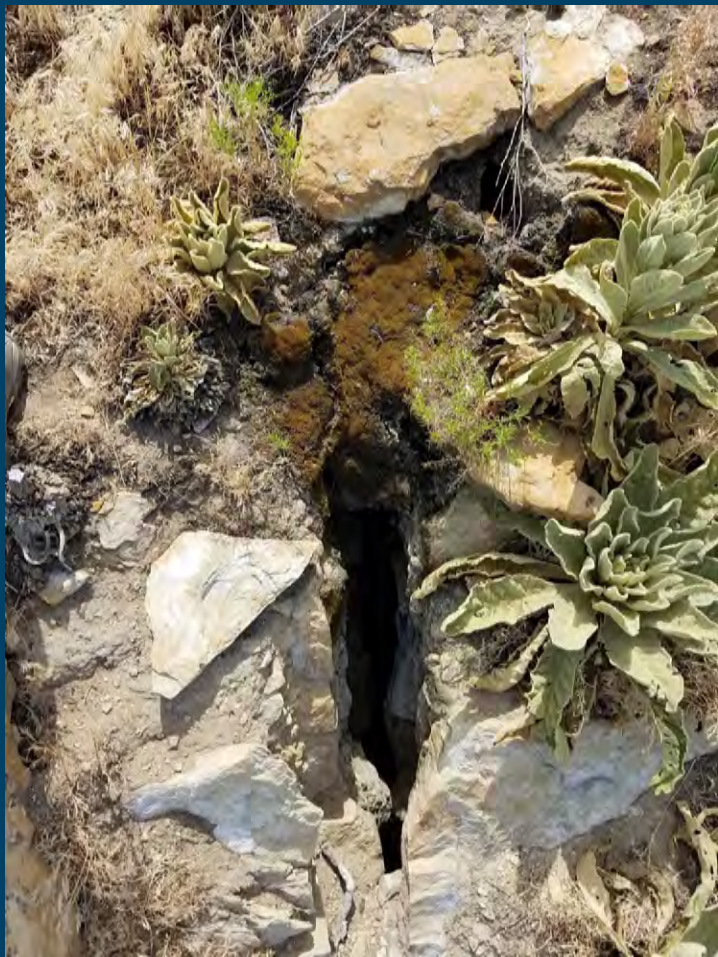
Dormant vent
